STAFF REPORT: FEBRUARY 7, 2024 MEETING

APPLICATION NUMBER: HDC2024-00022

ADDRESS: 14500 ARTESIAN

SCOPE: DEMOLISH GARAGE, ERECT NEW GARAGE, REMOVE TREES AND ALTER LANDSCAPING, REPLACE FENCE, PAINT HOUSE

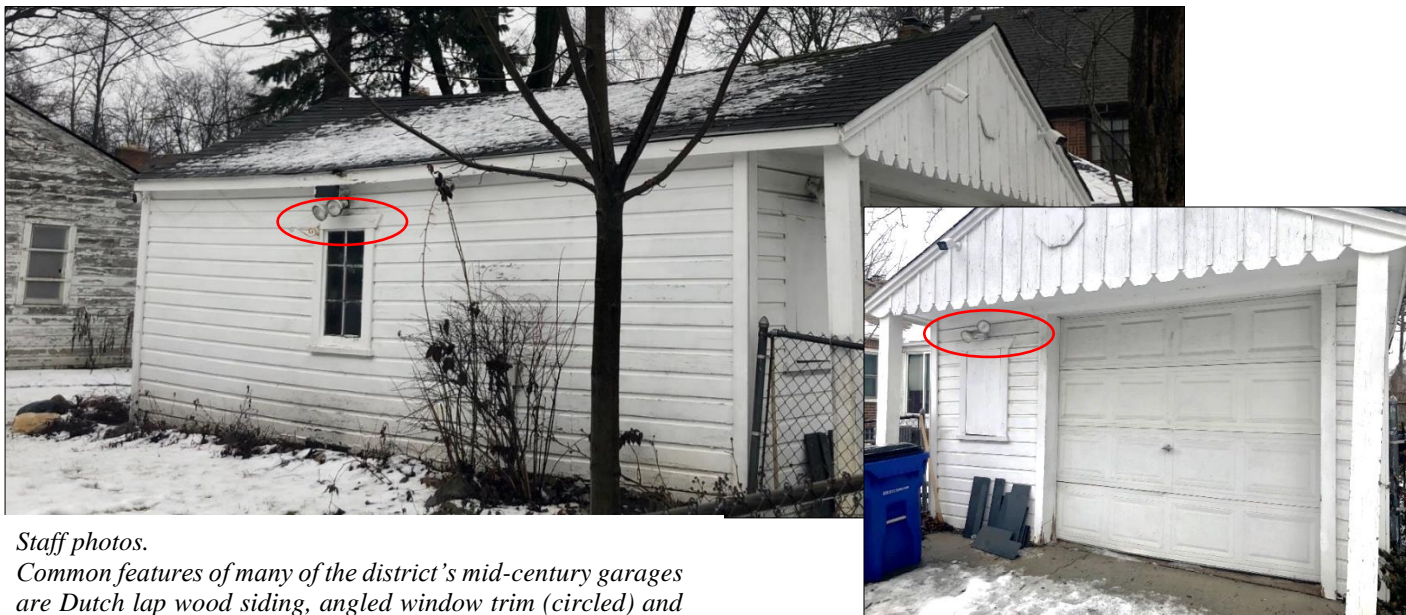
Staff photos.

Common features of many of the district’s mid-century garages are Dutch lap wood siding, angled window trim (circled) and an asymmetrical arrangement of the vehicle door and single window. The octagon shaped piece covers what was likely a false window (which is still visible on the garage at 15301 Penrod, which is included on the staff’s Rosedale Park garage survey).

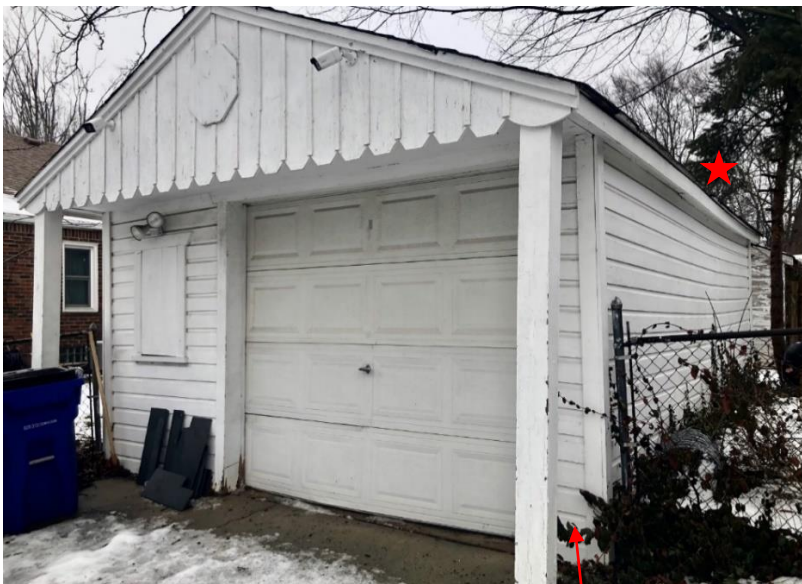
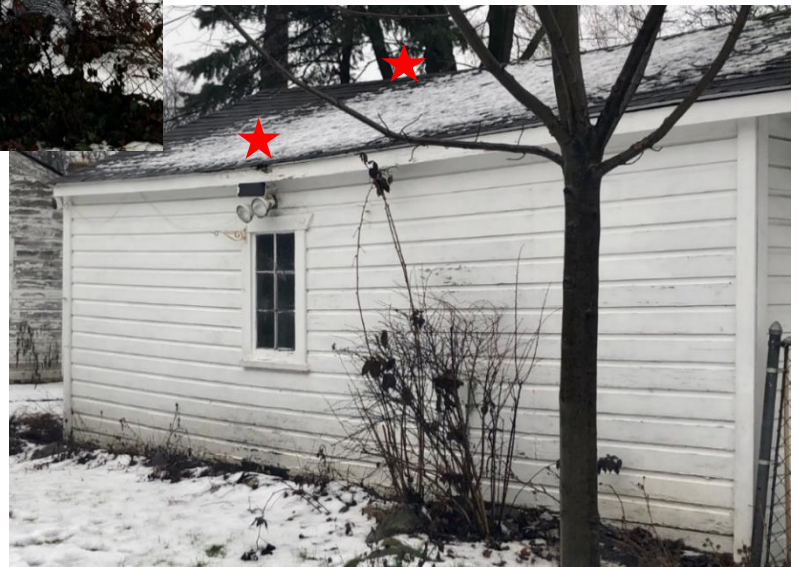
- The applicant and staff photos, two of which are below, show evidence of deterioration and structural issues. However, it is staff's opinion that the level of deterioration does not appear to be so severe that repair remains a viable option.

Staff photos.

The southeast corner is sinking — as seen by the wood siding angling downward. The centers of the east and west walls are buckling in the center, as well as at the center of the roof. ★

- The applicant states the reason for this application is the need for a two-car garage in which to safely store vehicles. An addition to the existing structure could be considered if the existing garage remains intact. As the west elevation (shown above) has significant features (straight wall as part of the rectangular footprint, single window opening with 2-over-3 window sash and angled header trim, and uninterrupted Dutch lap wood siding, termination of gabled roof), a separate and minimally attached one car bay addition, could be possible. This option would meet Standard 10: *New additions and adjacent or related new construction shall be undertaken in such a manner that if removed in the future, the essential form and integrity of the historic property and its environment would be unimpaired.*

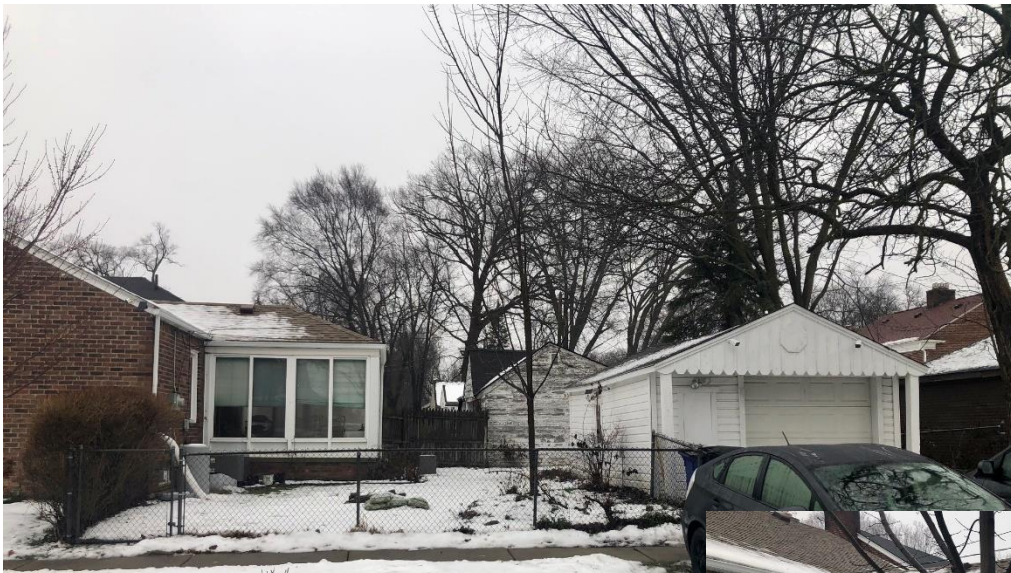
Staff photos. The additional width of the proposed garage will be absorbed slightly by its extension towards the rear lot line. The remaining width (which needs to be confirmed once the rear yard setback is confirmed) will extend into the existing rear yard.

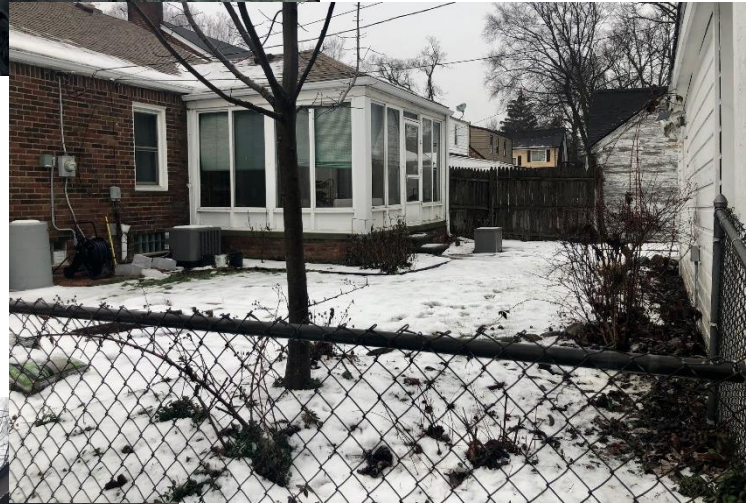
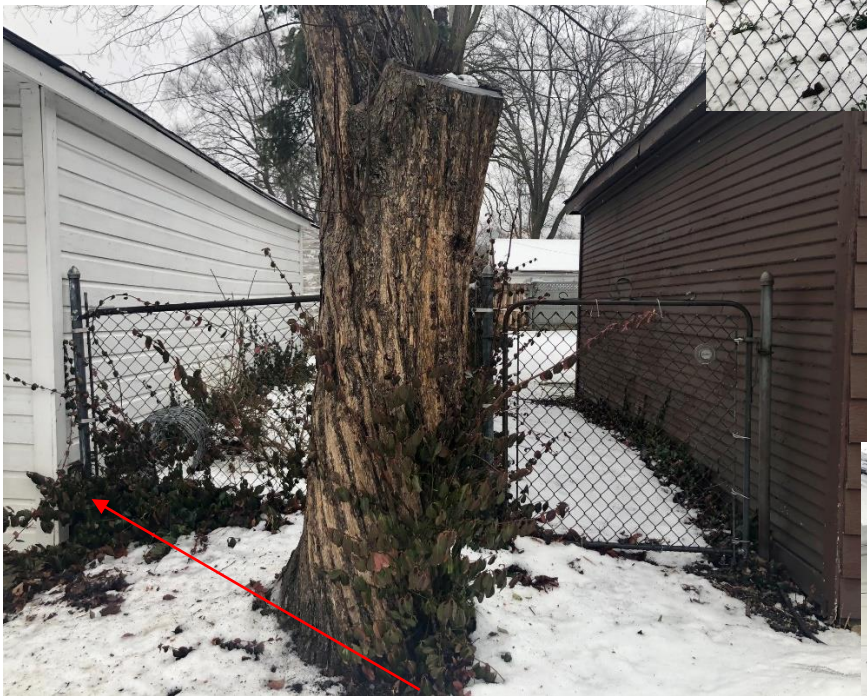
Staff photos. The applicant's existing garage is on the left side of the photo. The neighbor's garage appears to be about 3'-0" from the lot line, but it doesn't appear to staff that the distance between the applicant's garage and the fence is more than twice the width of the neighbor's open space.

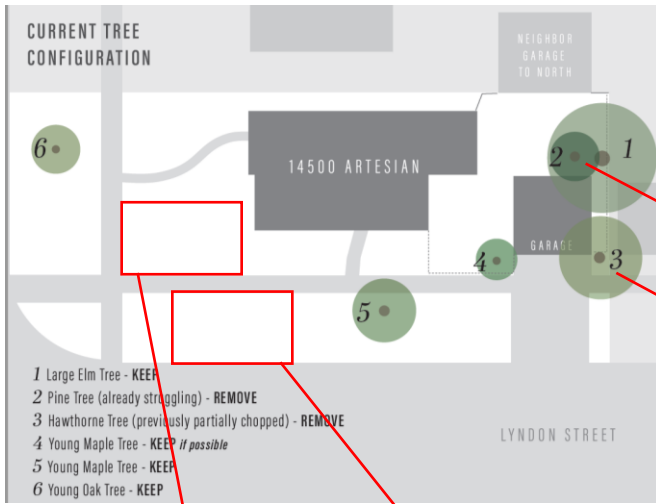
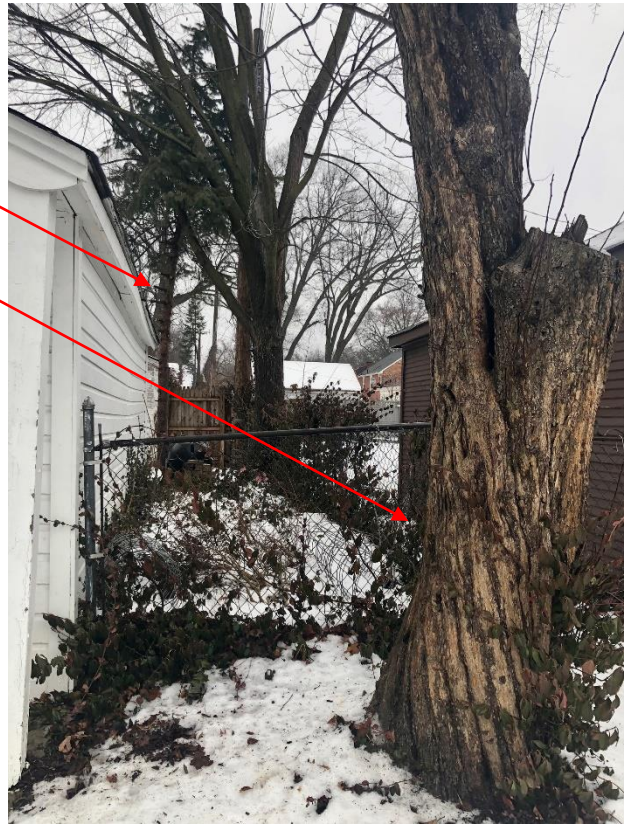
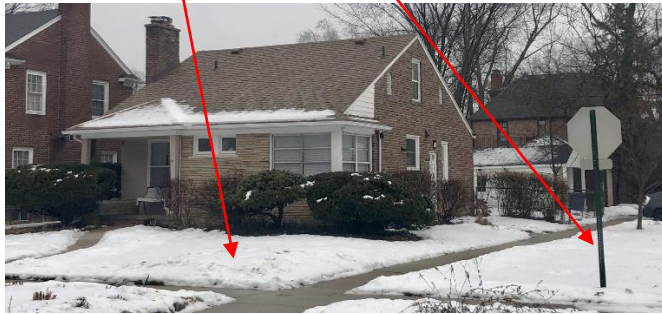
- Staff agrees that the trees proposed for removal are deteriorating as well as being in locations that would not be greatly impacted by removal. However, retaining a tree canopy in the district is important. Therefore, staff believes at least one new tree should be planted elsewhere on the lot. It appears that the southwest quadrant of the front yard and tree lawn may have adequate space.

Applicant tree plan, staff photos.

- One tree will be planted on the property to replace the formerly substantial shade tree located adjacent to the rear yard sidewalk and garage. The location and tree species will be submitted for staff review.
- A revised landscape plan will be submitted for staff review.
- Confirmation of the physical support for the fence, along with a color sample and specification for the opaque fence stain, will be submitted for staff review.

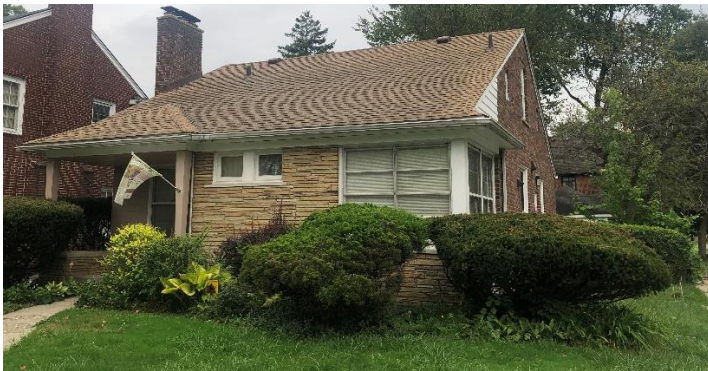
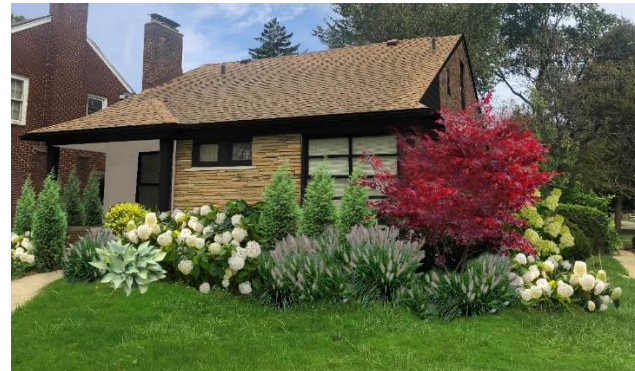
- Staff has two concerns related to the proposed landscaping.
 - The placement of the arborvitae and maple tree are very close to the house and porch. Adequate spacing must be given so the branches and roots won't cause damage to the historic structure.
 - The arborvitae and maple, if not maintained, can grow to substantial heights, and would restrict the view of the front elevation of the house.

Applicant photos.
