**STAFF REPORT: FEBRUARY 7, 2024 MEETING**

**APPLICATION NUMBER: HDC2024-00064**

**ADDRESS: 640 W. WILLIS, AKA "WEST WILL"**

**SCOPE: REPLACE WINDOWS**

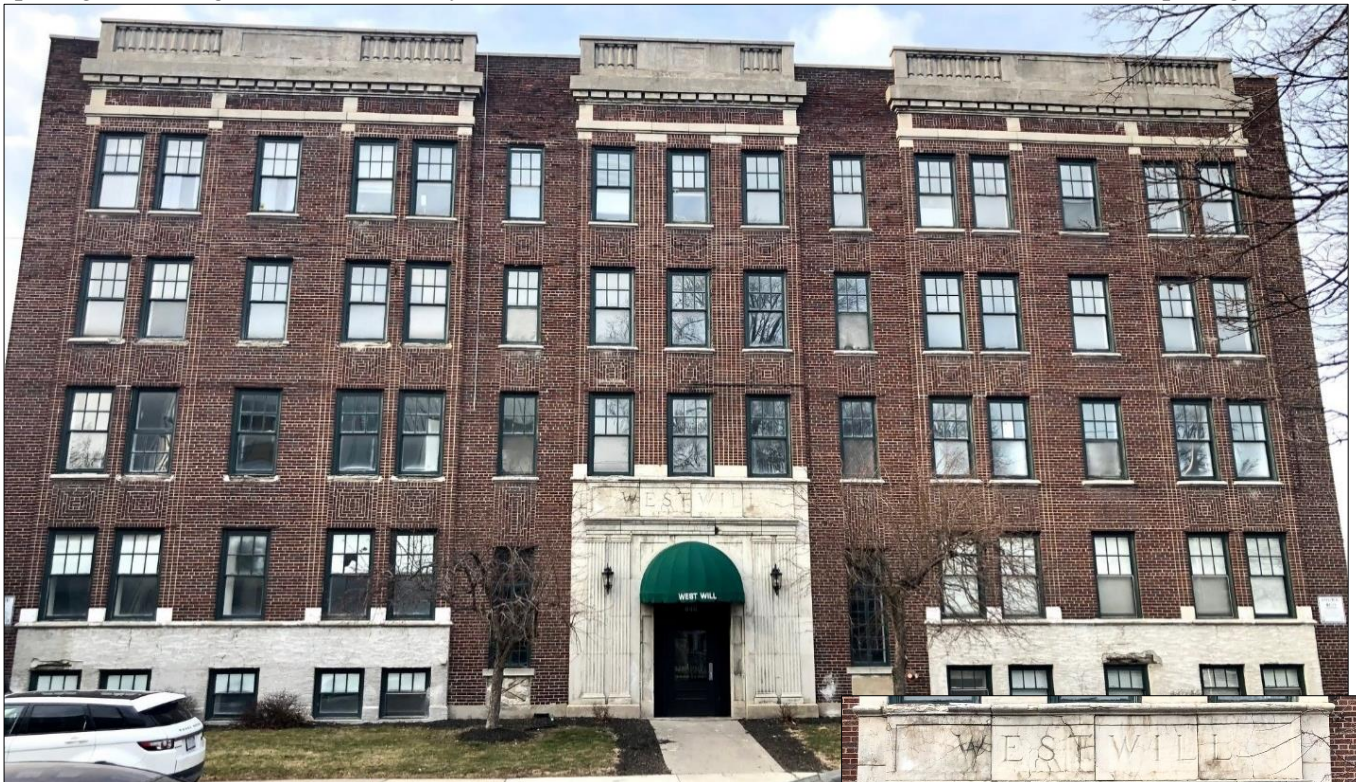
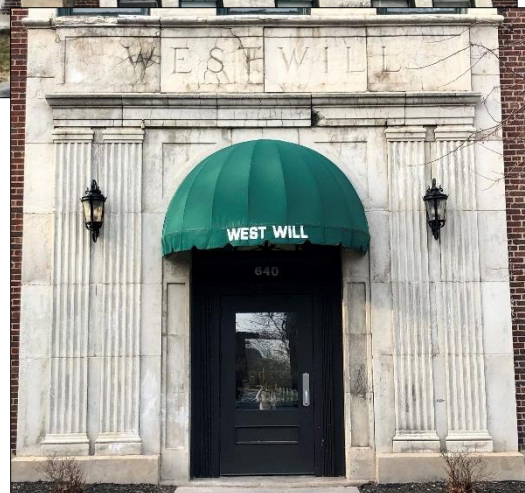
*Staff photos, February 21, 2024*

Single window openings, with symmetrical placement, dominate the front elevation. The side and rear elevations have single and grouped window openings. Wood double-hung window sash on the front have a six-over-one pattern and tall, narrow steel fixed units remain on either side of the front entrance. The sides and rear window openings have beige one-over-one vinyl windows. Wood brickmould remains within the window openings.

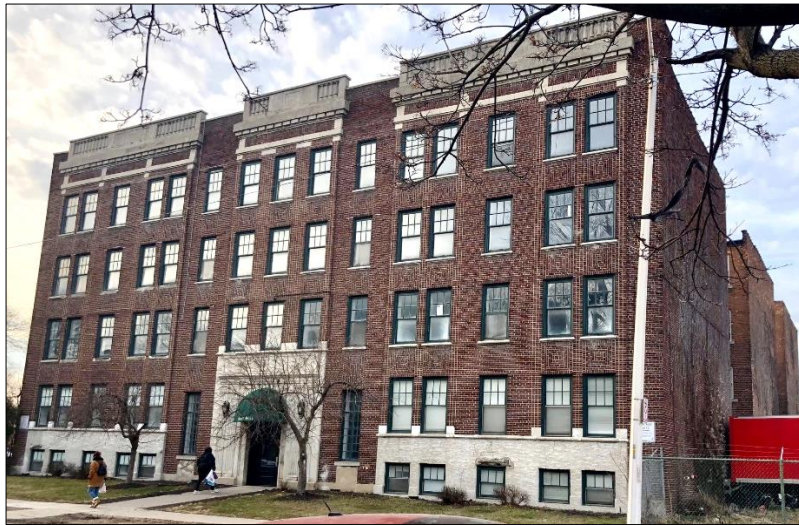
Staff photo, February 2024.

Reminders of the past: The West Will building, erected in 1925, had a setback that matched the residential houses that were then-present on either side. The 1950 Sanborn map is drawn incorrectly, as it shows the front of the building extends to the street edge.

As noted in the previous map, the garage and house immediately to the right/east (620) was demolished in 1959 and 1960, respectively. Ghost lines remain visible in the walls of 640 W. Willis.

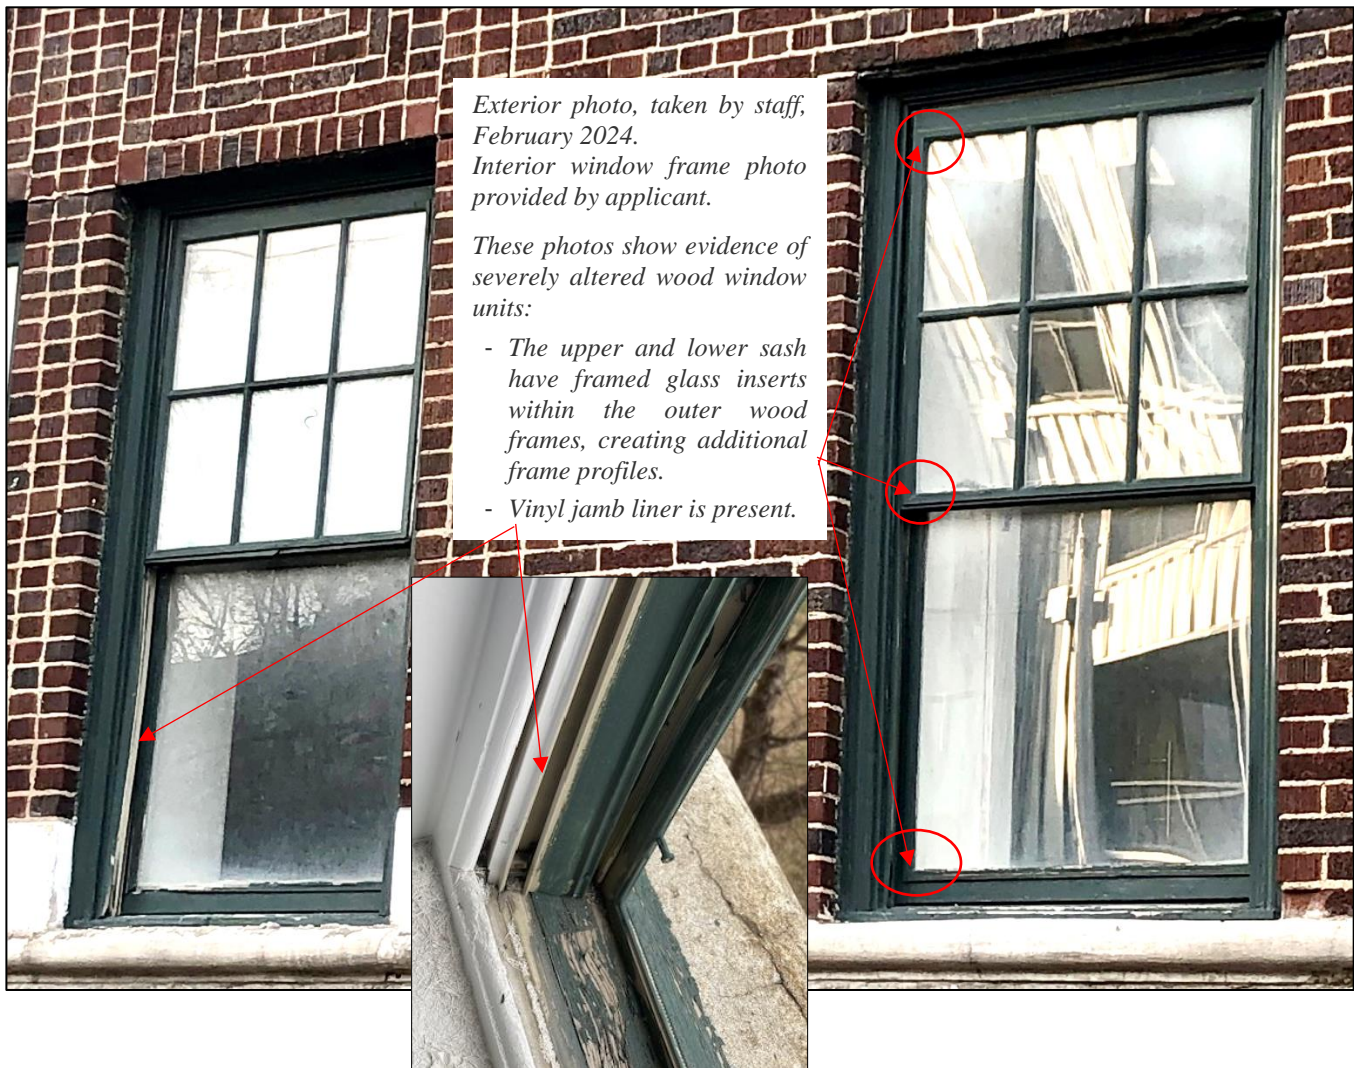
- While the applicant was compiling the dimensions of the existing and proposed windows, staff conducted the site visit to assess the existing windows. Based on field conditions and photos submitted by the applicant, it is staff's opinion that the windows on the front elevation are not historic, as the vast majority of the window components have been replaced with contemporary materials which added dimensionality to the window units along with visible vinyl components.

- Replacing existing incompatible, non-historic windows with similarly incompatible new windows does not meet the Standards.
  - Upon determination that the front elevation windows are not historic, it is staff's opinion the selected Weathershield replacement windows will be compatible with the historic appearance of the building. The selected window line offers simulated divided-light "grilles", butt-joint cladding, and wood jamb liners (so the liners can be easily painted to match the cladding color, unlike the example shown above).

- The existing steel windows flanking the front entrance will remain in place.
- The 5/8” grille will be selected for the six-over-one upper sash, and the exterior cladding color will be submitted for staff review.
- The completed window order(s) for the building will be submitted for staff review.
- The existing wood brick mould will remain in place within each window opening and will not be covered with aluminum trim.

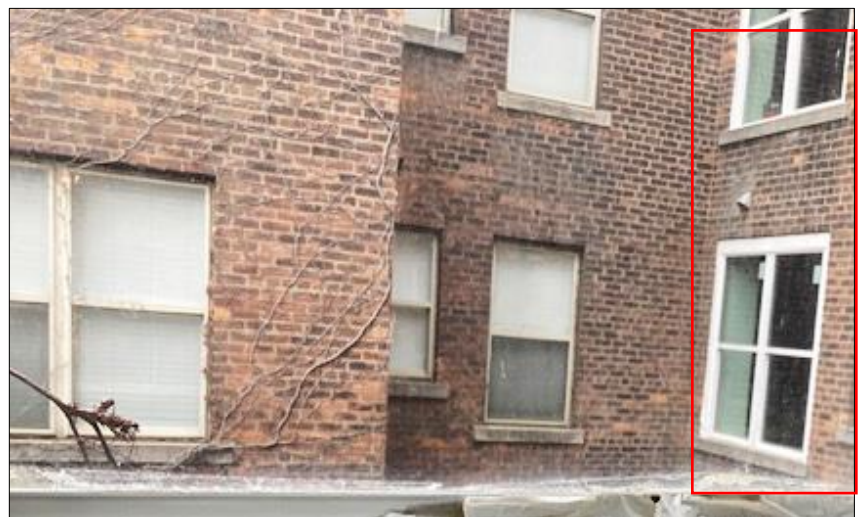
- This applicant photo (below right) of one of the courtyards shows two openings in which the proposed windows have been installed. It is evident the new windows are not consistent with the general characteristics of a historic window of the type and period.

- Flat/thick window frames do not match the proportionality of historic windows (and not even the dimensions of the existing replacement windows).
  - The bright white color offers a jarring and noticeable contrast to the brown brick and makes the windows too dominant.

- The window frames are almost in plane with the masonry walls and eliminates the three-dimensional appearance of the wall.

Applicant photo. Recently installed non-approved vinyl windows are in the red lined box.

### **Recommendation One – Denial – Replacement of vinyl windows with new vinyl windows**

*Staff therefore recommends that the Commission issue a Denial for the work as proposed, as it does not meet the Secretary of the Interior’s Standards for Rehabilitation, specifically Standard 9:*
