STAFF REPORT: MAY 8, 2024, REGULAR MEETING
APPLICATION NUMBER: HDC2024-00079
ADDRESS: 3844 BAGLEY
HISTORIC DISTRICT: HUBBARD FARMS
APPLICANT: LUZ JANNET AYALA-MORENO
PROPERTY OWNER: LUZ JANNET AYALA-MORENO
DATE OF PROVISIONALLY COMPLETE APPLICATION: MARCH 4, 2024
DATE OF STAFF SITE VISIT: APRIL 23, 2024

SCOPE: ALTER SIDE PORCH (WORK STARTED WITHOUT APPROVAL), REPLACE WINDOWS AND DOORS, INSTALL VINYL SIDING

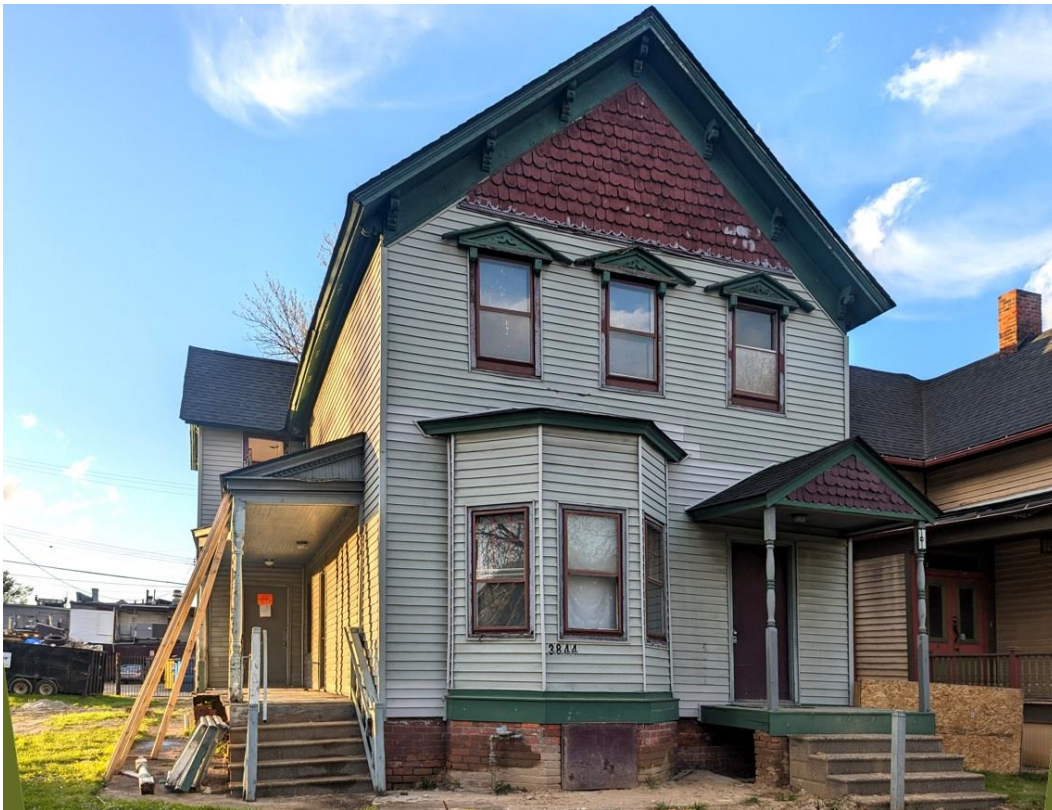
April 2024 photo by staff. Note porch elements removed without approval are sitting on the ground at the lower left corner of this image.

Some posts and part of the balustrade on the side (west) porch were removed without approval in 2023, prompting a Stop Work order. The removed elements remain on site and have not been discarded.

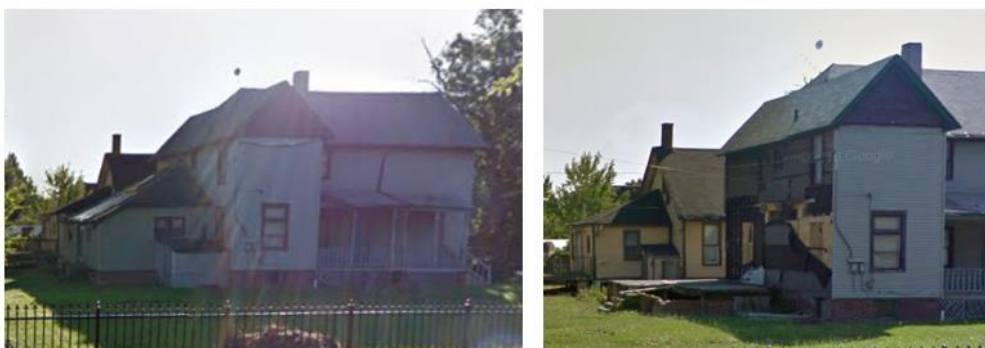
In 2015 or 2016, a hip-roof, single-story, rear (north) projection was removed without approval by the Historic District Commission. The applicant has been encouraged to submit an application for this work. The brick foundation remained in place until 2022 or 2023; this has since also been removed.

Google Maps photos from 2015 (left) and 2016 (right).

- The removal of the hip-roof rear section (done without approval) dramatically altered the form of the building and eliminated character-defining features, contrary to Standard #2, which requires that “the alteration of features and spaces that characterize a property shall be avoided.”
- Adding siding and a new entrance to the rear (north) elevation of the building is inappropriate in that it furthers and makes permanent a condition (i.e., the removal of the building’s hip-roof rear section) that was created without approval.
- The proposed colors—grey siding, sand windows, and forest green gutters—are individually appropriate; however, when taken together, they create an awkward hybrid between the paler colors of nineteenth-century vernacular architecture and the more saturated tones of the Queen Anne style.

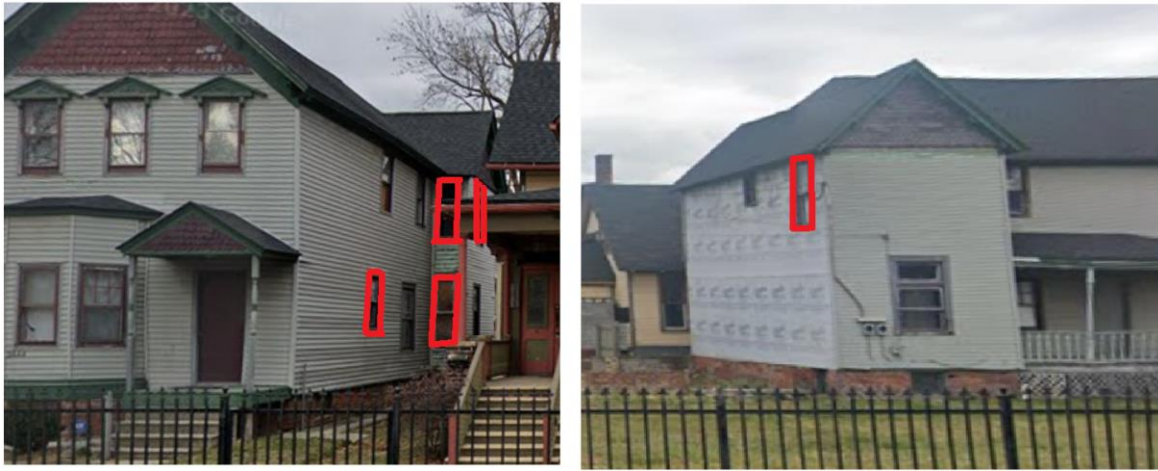
One window on the rear (north) elevation and four windows on the east side of the building are missing, removed without approval. These windows are visible in November 2022 Google Street View images; thus, their removal is relatively recent.

2022 Google Street View images. Red boxes added by staff to show windows that have since been removed without approval.

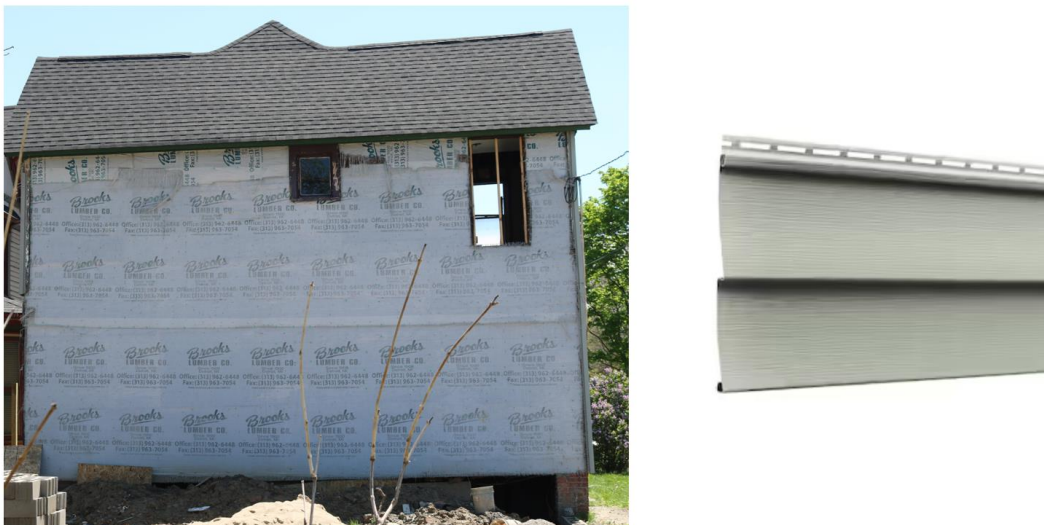
Left: Rear (north) of house where new siding is proposed. April 2024 photo by staff. Right: Proposed siding. Image from product website.

- Vinyl is an inappropriate window and siding material. Standard #6 requires that historic materials be used “where possible;” if substitute materials are warranted, vinyl is not an appropriate substitute material (see National Park Service, *Preservation Briefs 16: The Use of Substitute Materials on Historic Building Exteriors*, 2023).

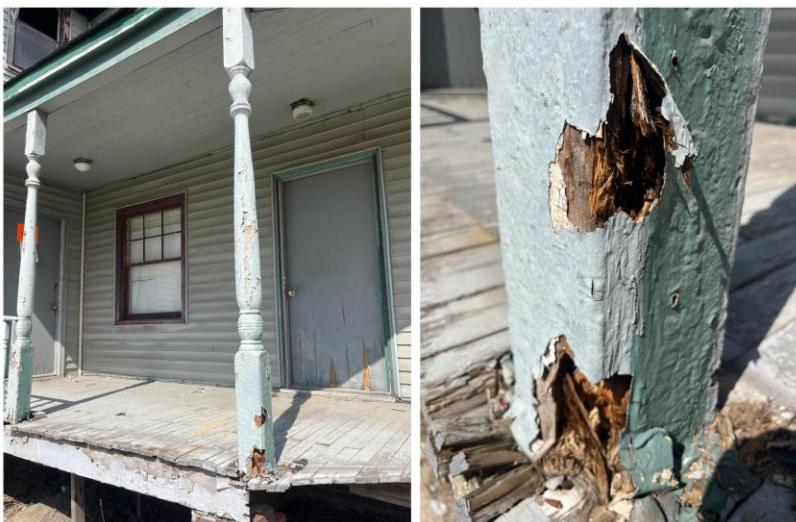
- The applicant has provided photos showing advanced decay of the porch posts and flooring. Google Street View photos also show the porch in a state of deterioration. Staff suggests that partial replacement of some elements is likely warranted, pending further inspection and documentation. (Full replacement is likely avoidable; for example, the rectangular lower portion of a column could be replaced without needing to replace the turned upper portion.)

Photos of decaying porch components, from application documents.

- A porch repair should generally consist of minimal new material and the retention of most of the existing components. Staff suggests the existing porch is likely not structurally sound enough to be repaired without the insertion of some amount of new wood decking, railings, and columns. However, any new components should match the old, as directed by Standard #6 (quoted below).

- Replacement of porch elements shall be limited to those that are deteriorated beyond feasible repair; new elements must match the old, subject to approval by staff.
- The first and second floor windows shall be double-hung wood or clad-wood sash windows, subject to approval by staff.
- The basement windows shall be installed according to the Glass Block Guidelines.
- The doors shall be wood or metal panel doors with a rectangular vision panel, or no vision panel, subject to approval by staff.
- The color scheme shall be taken from either Color System A (mid-century vernacular), or Color System B (Queen Anne), but not both; or, another appropriate color scheme may be used subject to approval by staff.

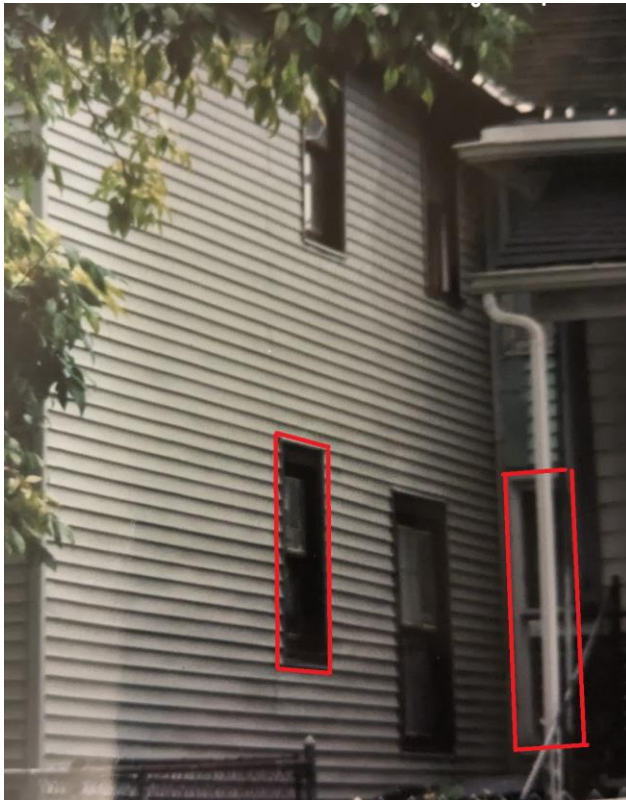
- In conclusion, the only remaining historic windows appear to be as follows: one, relatively large, one-over-one window with transom on the west elevation; two one-over-one windows on the east elevation, and one small square window on the north elevation. Additionally, two historic windows on the east elevation, first floor, appear to have been removed without approval.

East elevation as seen in 2001 Historic District Commission staff photo, red boxes added to indicate likely historic windows that have since been removed without approval.
