STAFF REPORT: 06/12/2024 REGULAR MEETING

APPLICATION NUMBER: HDC2024-00260

ADDRESS: 553 ARDEN PARK

SCOPE: REPLACE REAR PORCH WITH DECK, PERGOLA, AND GAZEBO, INSTALL FENCE AND SECURITY CAMERAS (WORK COMPLETED WITHOUT APPROVAL)

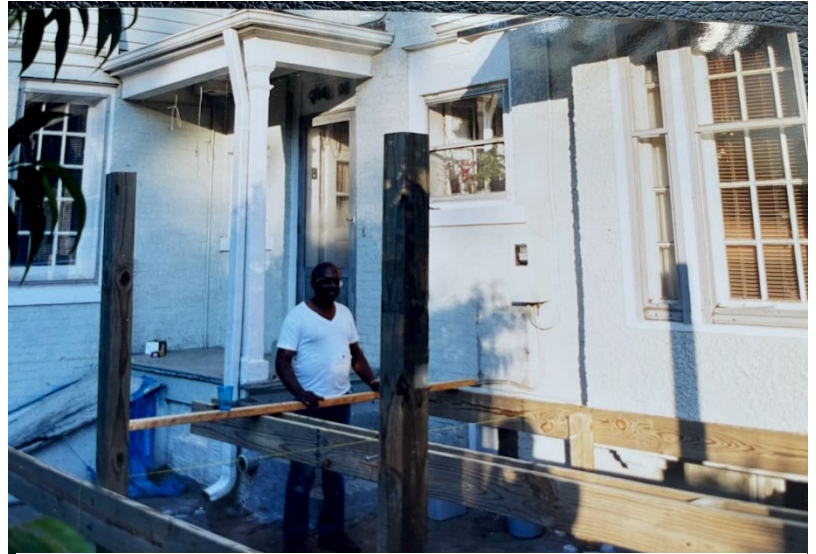
Site photo 2, by Applicant, year unknown (approx. 1999-1994): (North) showing original rear porch before alteration.

- It is staff’s opinion that the rear porch with the simple roof and post detailing that matched the front of the house’s post detailing was a distinctive character-defining feature. Staff recognizes that the porch may have been altered when the rear extension to the house was constructed by potentially eliminating a secondary post, as may have been evident in the 1915 Sanborn (*see figure 2*) and the timeline of construction described above. However, staff maintains that the rear porch remained

predominantly intact and still historically identifiable as a rear porch and therefore a distinctive character-defining feature prior to its alteration. (See Site photo 2.)

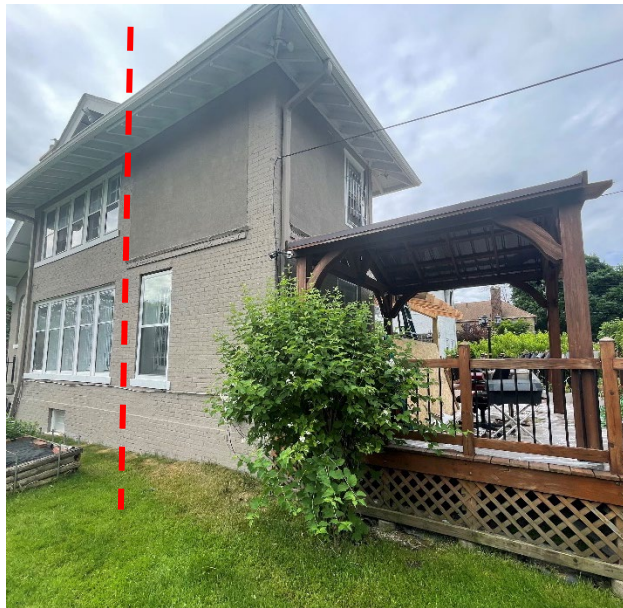
- Pictured to the right (*site photo 3, Figures 2-3*), the rear extension was permitted for construction in 1924, as shown in city files, 10 years after the house was initially constructed, also shown in building permit cards and sanborn maps. Staff was not able to determine when the upper windows of this rear extension were filled in. The applicant has noted that this work was completed prior to his moving in the house in 1970, which is also before designation. This work is not in the application.

Site Photo 3, by Staff May 28, 2024: (Northeast) side and rear elevation, showing rear extension with enclosed windows at second floor. Also showing erected gazebo and deck (work completed without approval). Red dashed lines added for clarity.

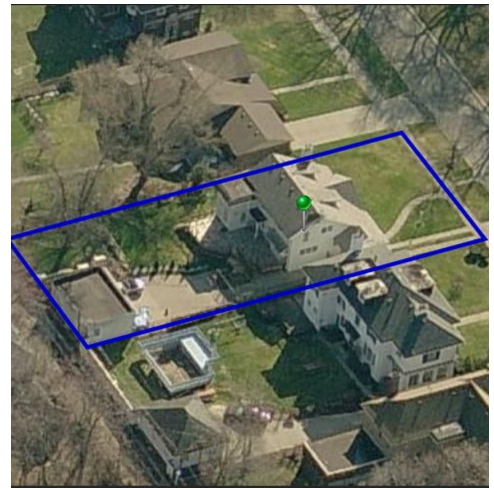
- The applicant had built the deck initially 25-30 years ago, leaving the rear porch in place. In this 2006 aerial, it is staff's opinion that this initial deck installation with the original porch in place and without the gazebo, lampposts, and arbor may have been a potential appropriate proposal without further changes. (See Aerial 2)

Aerial 2 of Parcel # 03002670. by Eagleview.com, showing 2006 view of rear elevation with new deck and original rear porch roof and post still in place.

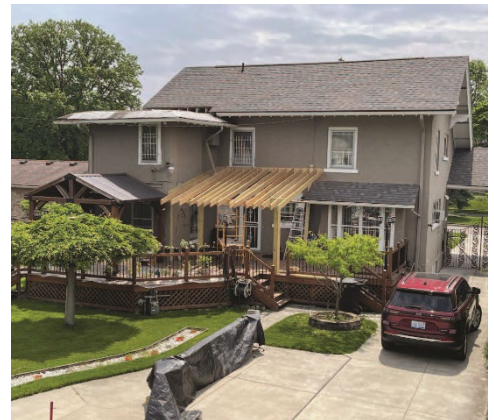
- It is staff's opinion that the removal of this porch and covering the original porch deck with a new deck, arbor and gazebo is inappropriate. The original porch's simple roofline, porch post detailing, which matched the post at the front of the house, are characteristic of the Arts and Crafts architecture of the property. The simplicity of the form, scale and the detailing of the post, and then the removal of all these elements, reduces the form and greatly alters the porch's distinctive, historic expression. (See photo 2 and 4)

- the angles and pitches of the gazebo and arbor roof lines conflict with those of the house,
 - the materiality of these new structures do not harmonize with the house's bracketed eaves,

- construction detailing of the arbor and gazebo shows the elements being joined together (see site photo 6),
 - the introduction of the lampposts adds additional features that are not appropriate to the architecture nor appropriately placed on a wood deck structure. (See site photo 4)

Site Photo 4, by Applicant, May 2024: (North) rear elevation, showing deck, arbor and gazebo and contrasting rooflines with the house.

Staff finds that the replacement of the rear porch with the deck, pergola, and gazebo does not meet the Secretary of the Interior’s Standards for the following reasons:

- The demolition of the compatible roofline of the rear porch and its single square column post that replicates the detailing of the front porch column destroys distinctive, character-defining historic features that are characteristic of the Arts and Crafts architectural features of the house. Removal of all these elements, reduces the form and greatly alters the porch’s distinctive, historic expression.

- The angles and pitches of the gazebo and arbor roof lines conflict with those of the house.
- The materiality of these new structures does not harmonize with the house’s bracketed eaves.

- The introduction of the lampposts adds conjectural features that are not appropriate to the scale, or characteristic of the Arts and Crafts architecture of the house, nor appropriately placed on a wood deck structure

Staff therefore recommends that the Commission issue a Denial for the above work items, as it do not meet the Secretary of the Interior's Standards for Rehabilitation, specifically Standards:

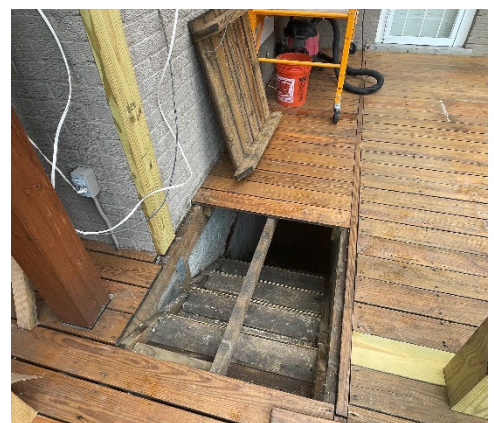
- Staff received a description from the applicant that the purpose of the deck was offset storm drainage into the cellar below, which is located next to the rear porch (See site photos 2-3.) The applicant also provided narrative on the purpose of the proposed arbor for the same purpose; basement flooding and dampness has been an issue and the applicant is attempting to offset this condition.

Site Photo 5, by Staff May 28, 2024: (North) rear elevation, showing rear deck with removable doors and staircase to cellar below.

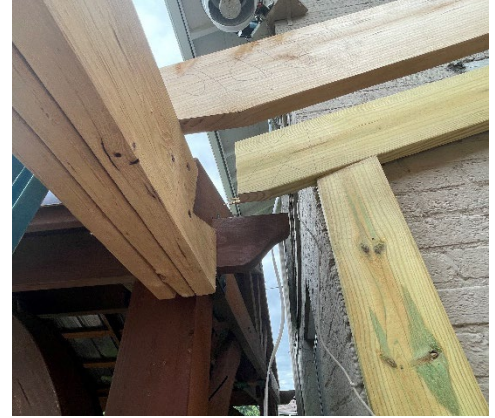
Site Photo 6 by Staff May 28, 2024: (North) rear elevation, showing elements of the arbor and gazebo construction tying the two structures together.

- Inappropriate construction detailing, such as the fusing of the arbor and gazebo roofline or the scale of the arbor itself, is not compatible by introducing an inappropriate design.

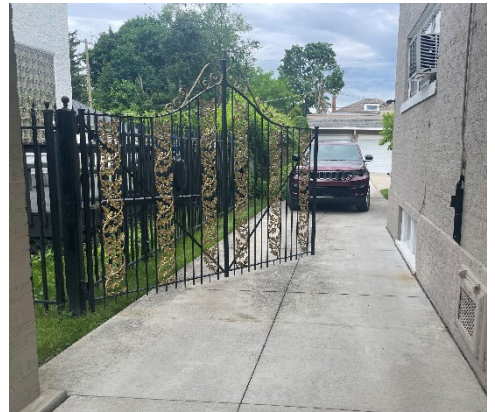
- Staff has the opinion that the fence and gate are appropriate as they follow most of the HDC's (Historic District Commission's) guidelines. However, for better compatibility with the style, design, color of the historic building of this Arts and Crafts design, it is staff's opinion the gate's color should be a solid appropriate color in a dark tone. (See site photo 7)

- While the fence and gate are appropriate, the black with gold contrast do not follow the HDC guidelines as they are not appropriate colors for the front gate and are not compatible with the Arts and Crafts style of the house.

Site Photo 7 by Staff May 28, 2024: (West) side elevation, showing gate at driveway.

- The applicant paints the gate a solid appropriate color in a dark tone, approved by HDC staff.
- The applicant relocates the security cameras at the front porch post to an appropriate height or location.

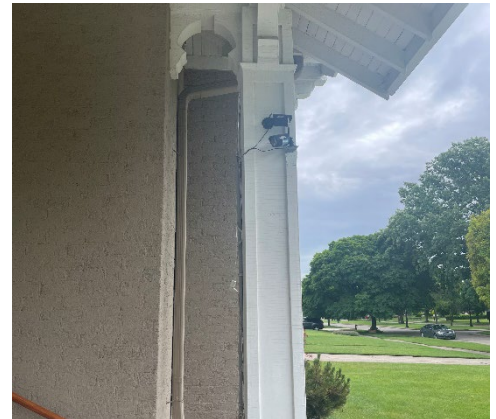
- Most security cameras are appropriately placed and follow the HDC guidelines. However, staff recommends one location at the front of the house be considered for more precise relocation: the cameras mounted the front post are within view and not mounted up in the eaves as recommend by the HDC guidelines, making them inappropriately visible.

- While most security cameras have been placed appropriately and follow HDC guidelines, staff recommends that the front porch column has security cameras that are located too visibly and should either be relocated or placed higher in the eave to be in compliance with the guidelines.

Site Photo 8 by Staff May 28, 2024: (South) front elevation, showing security cameras mounted on front post near front entrance.
