STAFF REPORT: JUNE 12, 2024, REGULAR MEETING **PREPARED BY:** T. BOSCARINO
APPLICATION NUMBER: HDC2024-00149
ADDRESS: 570 LODGE
HISTORIC DISTRICT: BERRY SUBDIVISION
APPLICANT: JOHNATHON FISHER
OWNER: JOHNATHON FISHER
DATE OF PROVISIONALLY COMPLETE APPLICATION: APRIL 30, 2024
DATE OF STAFF SITE VISIT: MAY 23, 2024; JUNE 5, 2024

SCOPE: DEMOLISH GARAGE, ERECT GARAGE, ERECT REAR PORCH, PAINT DWELLING (WORK STARTED WITHOUT APPROVAL)

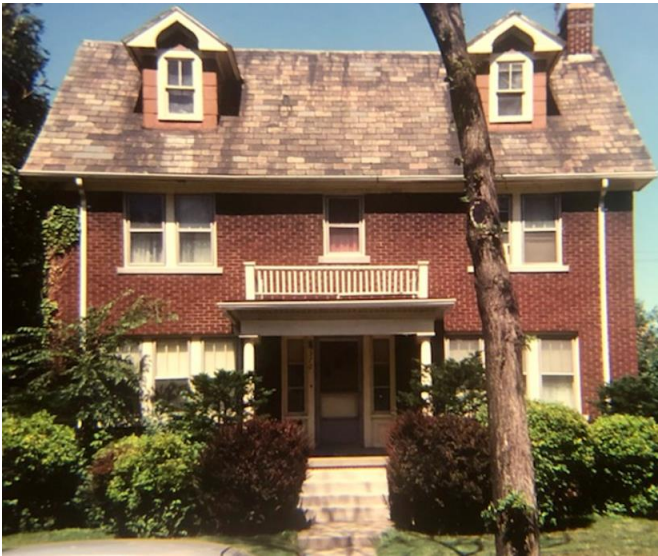
1978 photo by the Historic Designation Advisory Board. Note balustrade and slate roof that no longer remain.

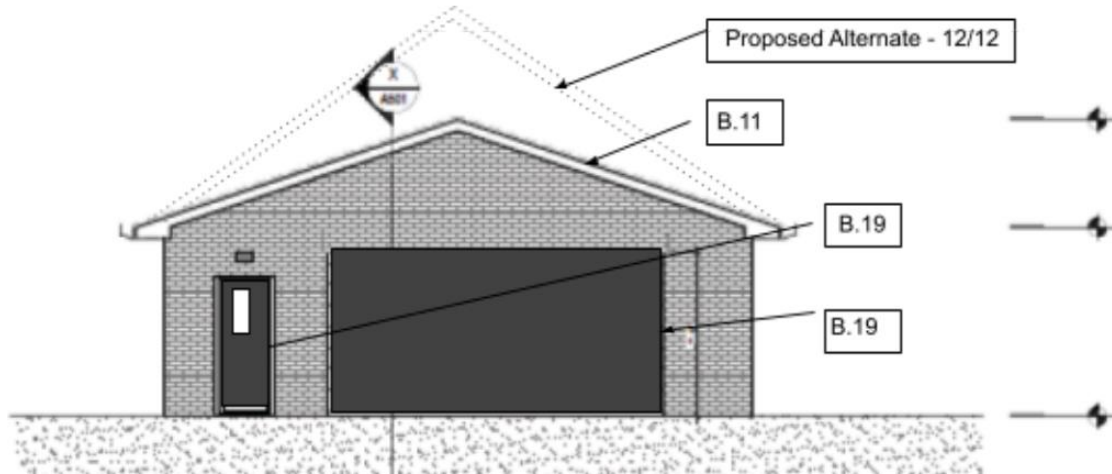
The front (west) elevation of the proposed garage. Image from application documents.

- The front-facing gable end of the proposed garage creates a relatively large, blank expanse of brick that is out of character for the district. The attic story of a masonry or brick veneer garage would traditionally use a contrasting, and lighter, material, usually wood siding. The proposed design, therefore, is contrary to Standard #9 (quoted above).
- Specifications for garage materials are not provided.

- *The front-facing, gable end, attic story of the garage shall employ a contrasting material, such as wood or a synthetic substitute.*
- *Garage materials and revised design shall be subject to review by staff.*

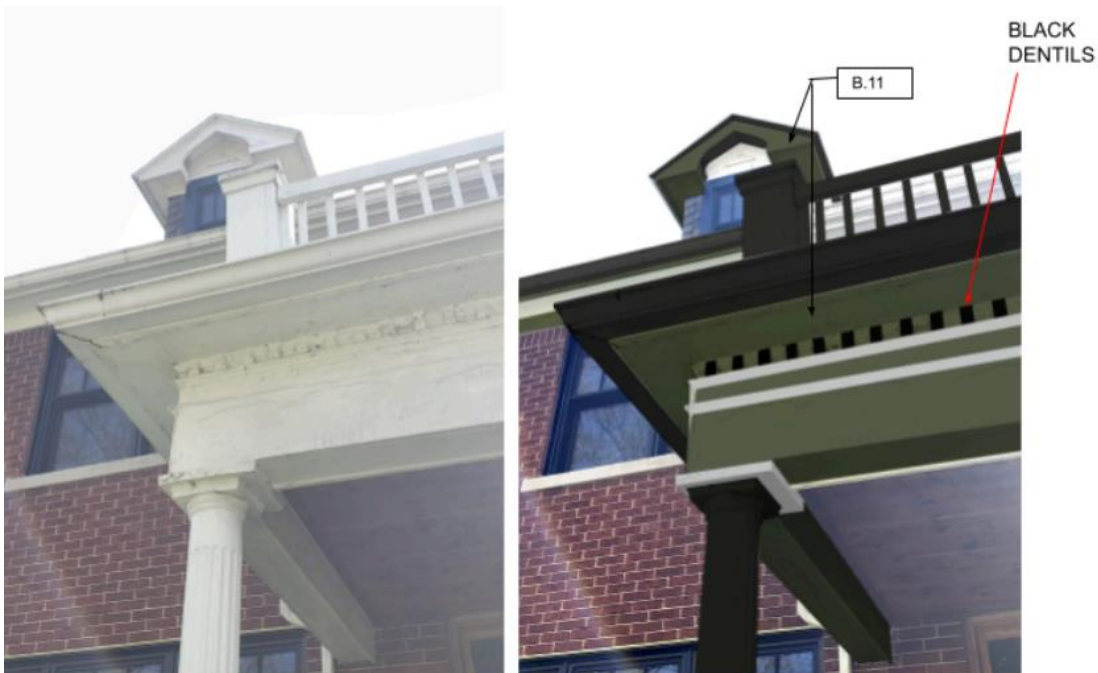
Existing colors (left) and rendering of proposed colors (right). Images from application materials.

- The proposed color scheme is creative and atypical, though perhaps not to the extent that it is incompatible with the building or the district. Lighter trim colors are more appropriate for Colonial Revival architecture, as described in the Berry Subdivision Elements of Design and in Color System C, with black or dark green reserved for window sashes and shutters. The use of contrasting white and dark accents on the same architectural feature would also be unusual.

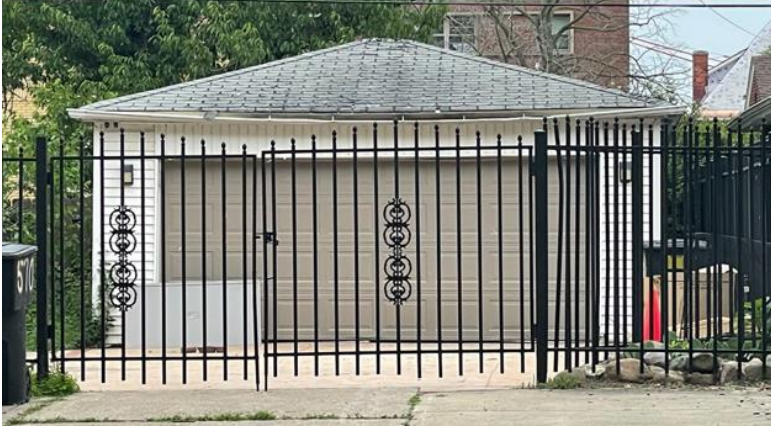
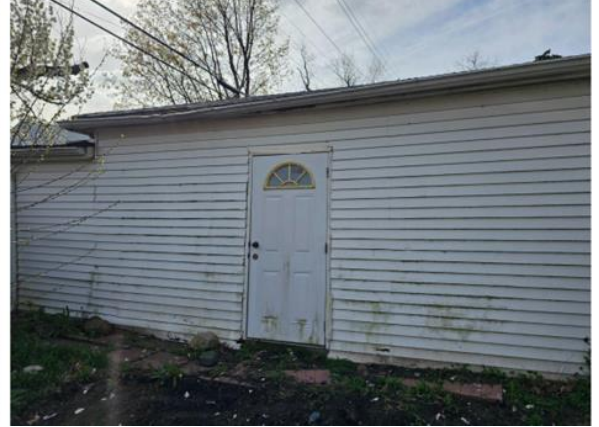
- The garage is in a state of deterioration. Interior photos included with the application materials show sections of the bottom plate are rotted or missing and the studs, no longer attached, are also deteriorating.

- Regardless of the age of the garage and irrespective of its degree of deterioration, staff opinion is that the garage is not a contributing resource. The alterations of mid-twentieth century asphalt siding, 1997 vinyl siding, and pre-designation, two-bay (two-car) door have eliminated any materials and features characteristic of the Period of Significance. The demolition of a noncontributing resource is appropriate as long as the resulting condition is compatible with the resource and the district.

Left: June 2024 staff photo of the garage, east (front) elevation. Right: 2024 image from property owner showing north (side) elevation.

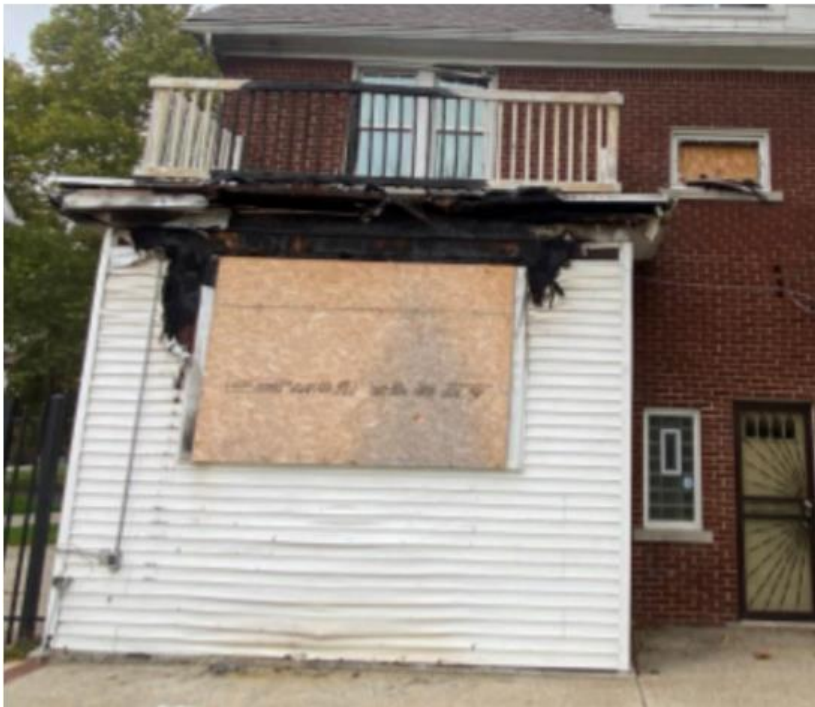
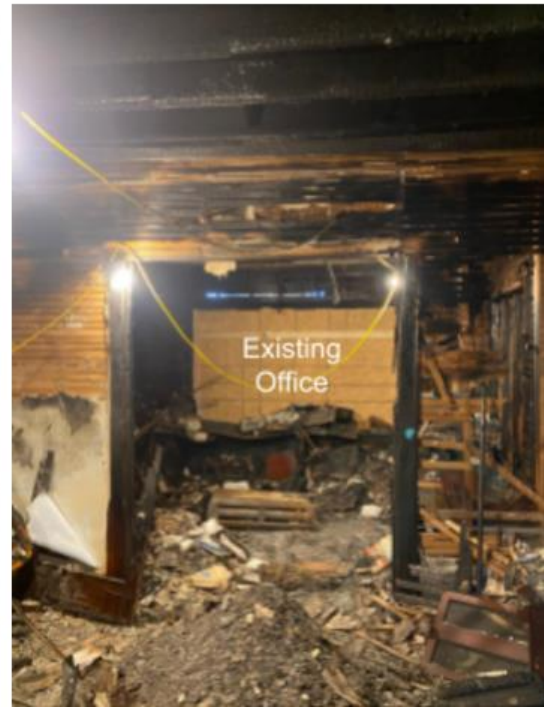
- The application materials show that the rear addition, removed without approval, had been damaged by fire.

Exterior (left) and interior (right) views of the addition. Undated, likely 2022 or 2023, photos from application materials.

- The addition does not appear to have been original to the building, as its siding and foundation materials were different and it lacked the Classical expression associated with the front (west) entrance and the historic rear (east) porch. (See photo on page 2.) Staff opinion is that it was not a character-defining or distinctive feature requiring preservation.
