STAFF REPORT: JUNE 12, 2024, REGULAR MEETING **PREPARED BY:** T. BOSCARINO
APPLICATION NUMBER: HDC2024-00204; HDC2024-00275
ADDRESS: 971 BURNS
HISTORIC DISTRICT: INDIAN VILLAGE
APPLICANT: EMMA BORNGESSER, BRUTTELL ROOFING; DENINE NGOYI
OWNER: DENINE NGOYI
DATE OF PROVISIONALLY COMPLETE APPLICATION: MAY 21, 2024
DATE OF STAFF SITE VISIT: MAY 23, 2024

SCOPE: REPLACE WOOD SHINGLE ROOF ON HOUSE WITH ASPHALT SHINGLE ROOF, REPLACE ASPHALT SHINGLE ROOF ON GARAGE, OTHER GARAGE REPAIRS

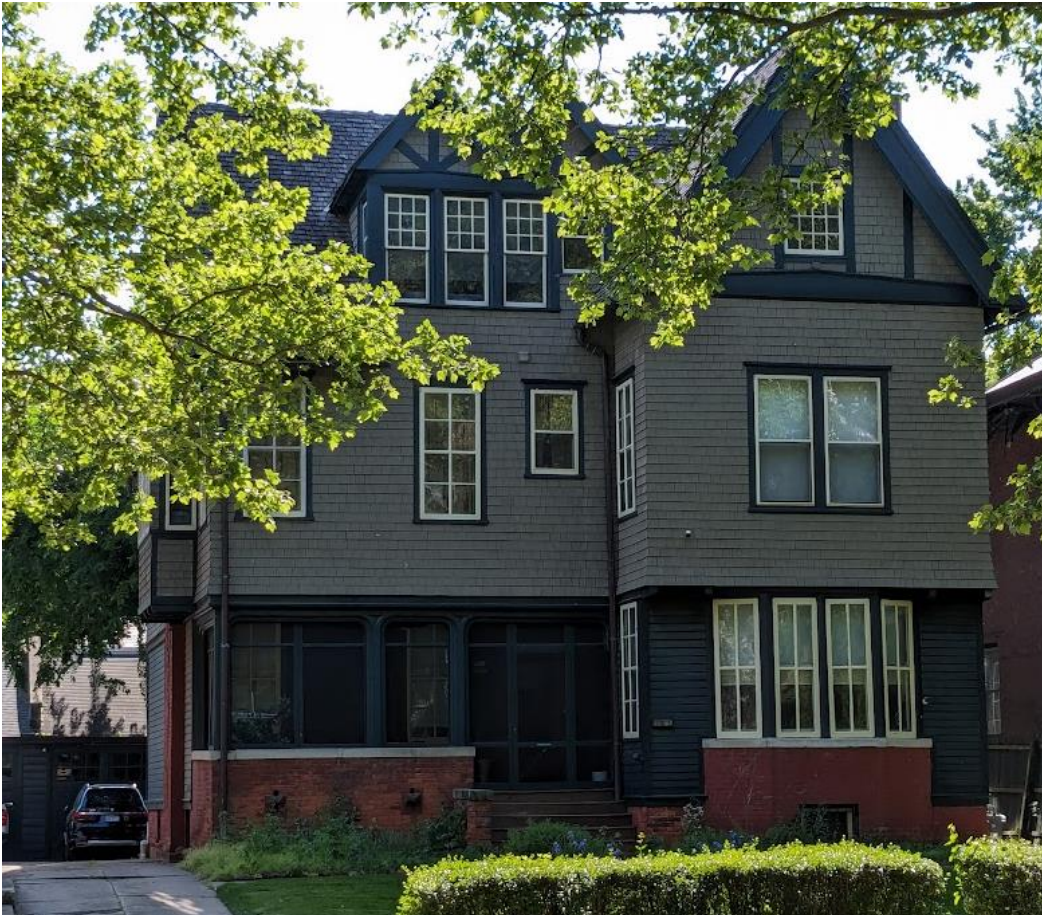
971 Burns viewed from the street; May 2024 photo by staff. The roof material, subject of this application, is not clearly visible due to tree cover. The garage can be seen in the background.

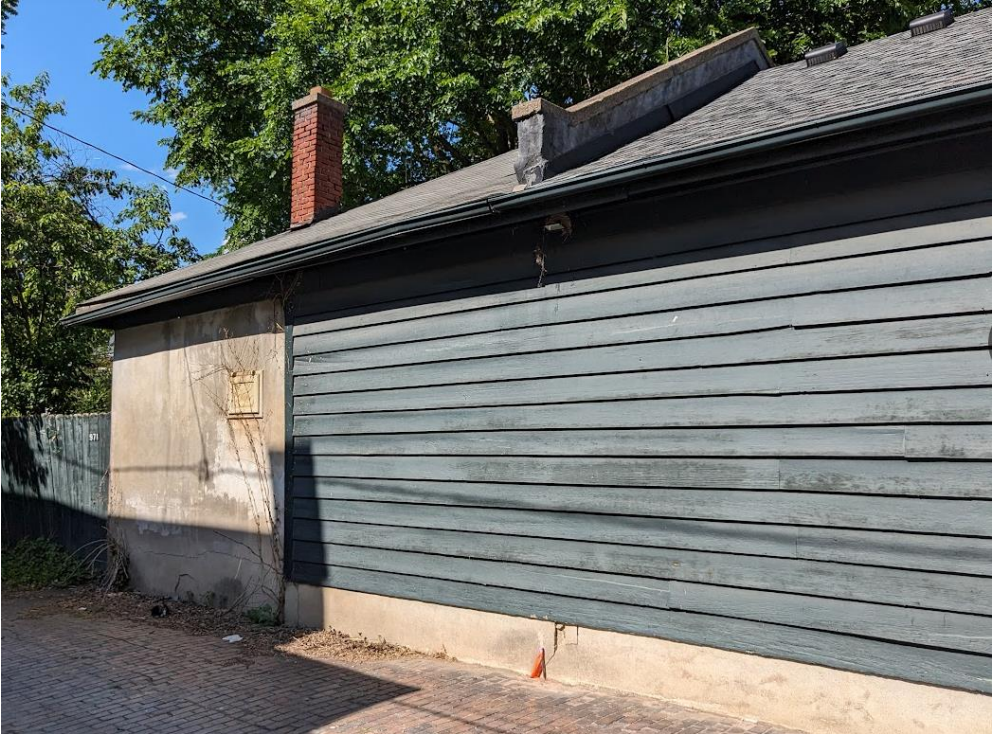
The garage, also subject of this application, is from the 1910s or 1920s and clad with wood siding and stucco. The alley-facing (west-facing) wall is leaning outward slightly. A brick slope chimney is also leaning, potentially due to the erosion of its mortar over time.

The garage. May 2024 photo by staff.

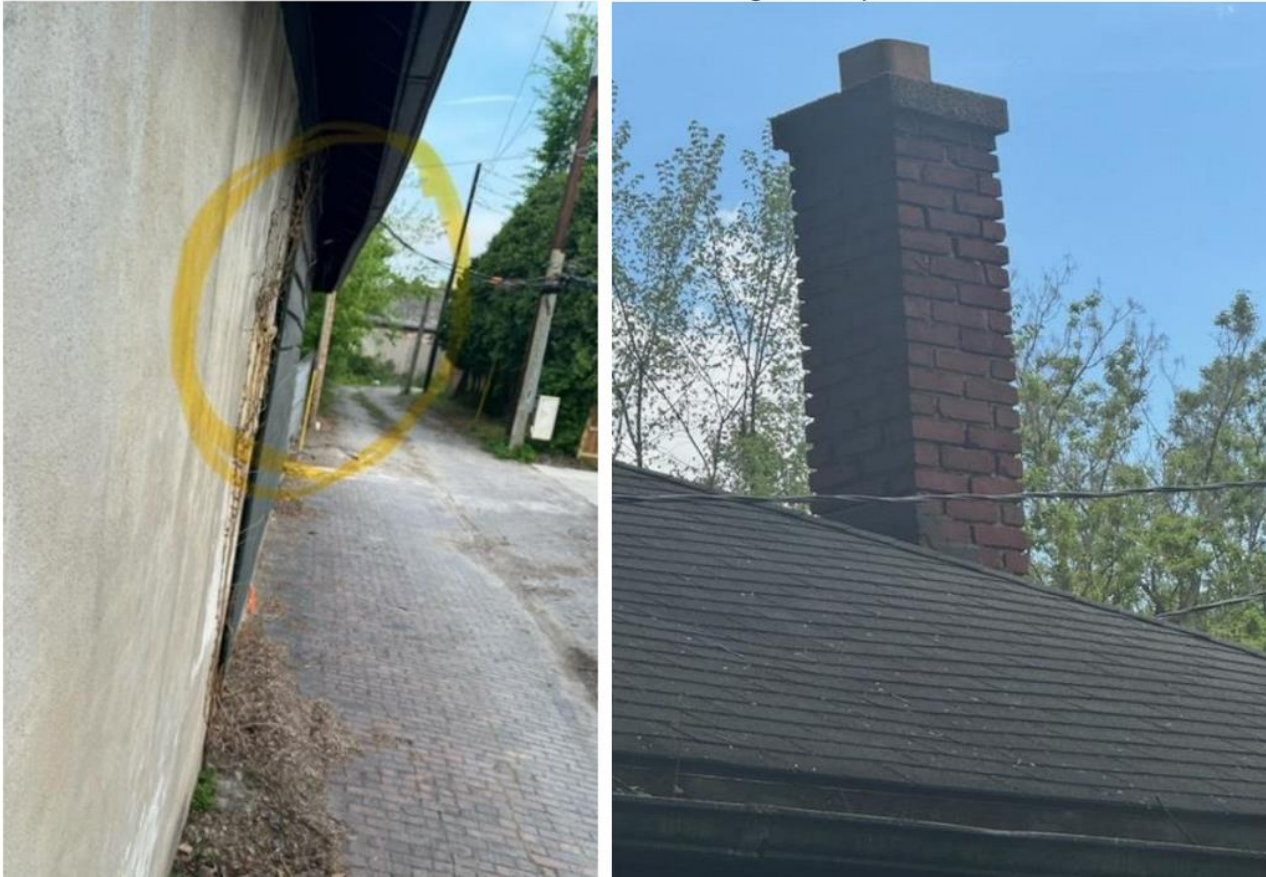
West wall (left) and chimney (right). Photos from application materials.

The applicant proposes to rebuild the compromised structural clay tile masonry of the alley-facing (west-facing) wall with wood framing. This repair work would result in a loss of the stucco surface, which would be

replaced with new stucco. Existing wood siding would be retained and the ash door would be kept in place.

The proposal would also rebuild the chimney with new brick.

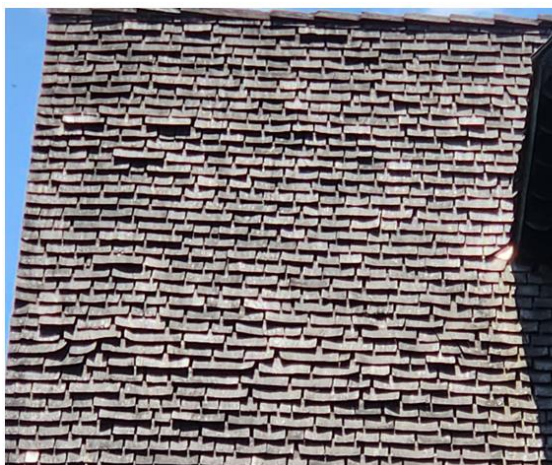
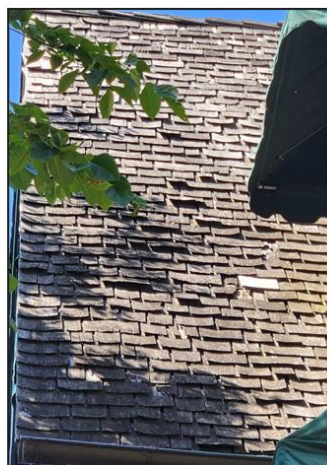
- The present wood shingles were installed in 1998.
- A wood shingle roof is almost invariably a character-defining feature of a building, as is the case on this house and garage on this property. The current wood roof represents a replacement of the original and historic roofing material. The character-defining nature of the roofing material is furthered by the architectural style of the building, which employs wood shingles as part of a cohesive design that also encompasses the second-floor cladding material.
- *Preservation Briefs 19: The Repair and Replacement of Historic Wooden Shingle Roofs* guides that “If over 20% of the shingles on any one surface appear eroded, cracked, cupped, or split ... replacement should be considered.” This is clearly the case, as seen during the staff site visit and in photos provided by the applicant.

2024 photos provided by the applicant.

15 to over 60 years, but the shingles should be replaced before there is deterioration of other wooden components of the building.” The same document also states “Fifteen to thirty years, however, is a more realistic lifespan for most premium modern wooden shingle roofs.” The current roof is 26 years old.
