**STAFF REPORT:** 07/10/2024 REGULAR MEETING

**APPLICATION NUMBER:** HDC2024-00289

**ADDRESS:** 627 W. CANFIELD

**SCOPE:** REPLACE WINDOWS, TUCKPOINT BRICK CLADDING (WORK COMPLETED WITHOUT APPROVAL)

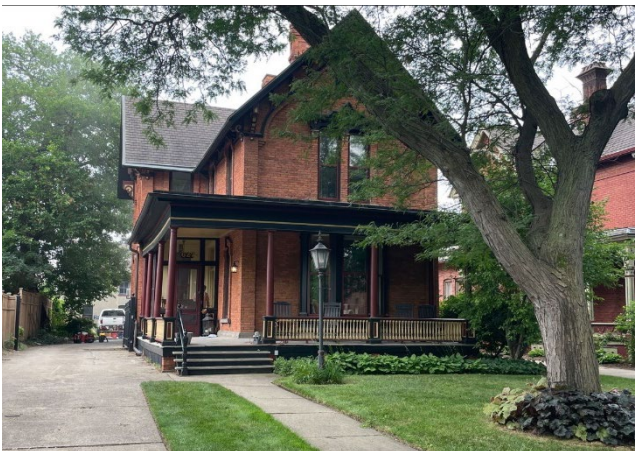
*Site Photo 1, by Staff June 26, 2024: (North) front elevation showing current conditions.*

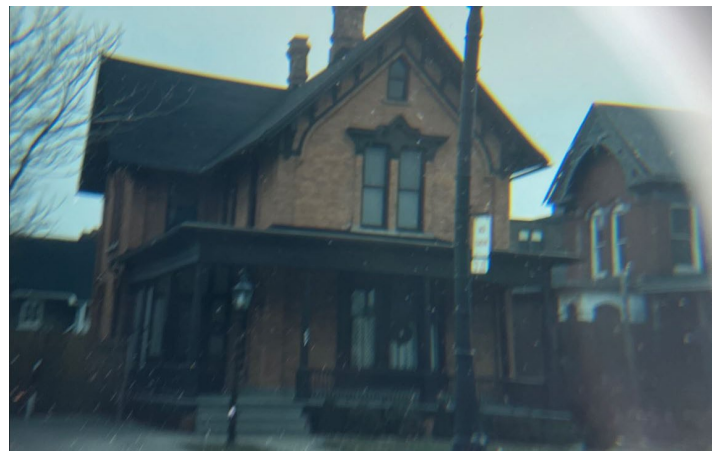
*Image HDC hard files, 1973: (North) front elevation showing original windows.*

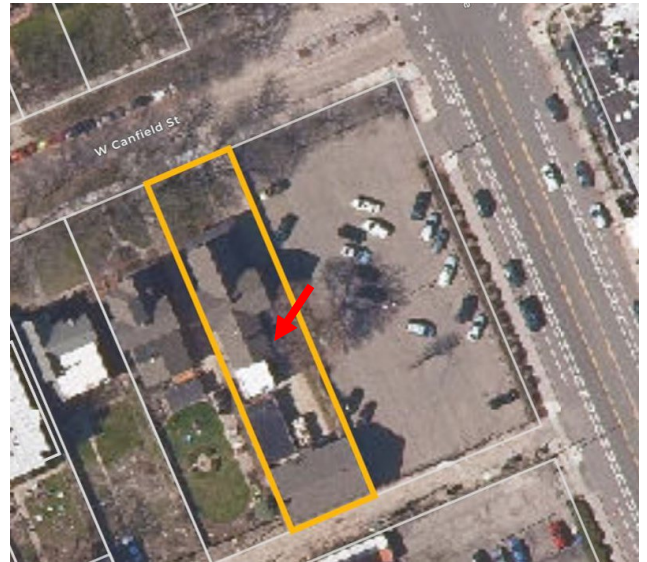
*Aerial 1 of Parcel # 04000894. by Detroit Parcel Viewer, showing the proposed kitchen windows location (arrow).*

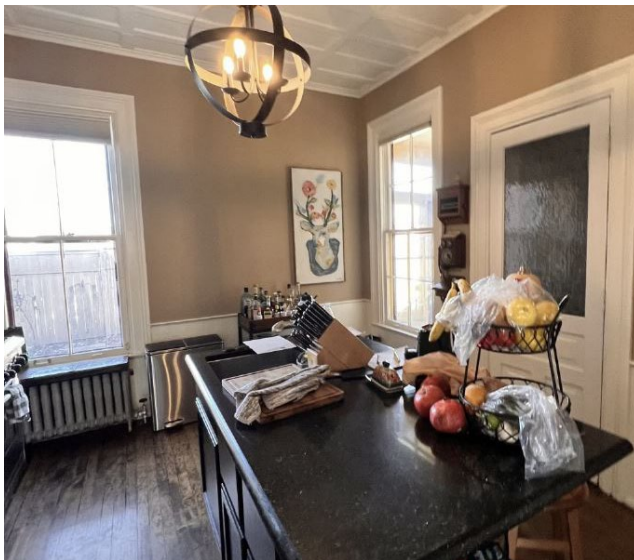
*Site Photo 2, by Applicant, date unknown: (Interior Kitchen) showing former original windows prior to removal and disposal.*

- The West Canfield Historic District was established in 1970.
- It is staff's opinion that the original wood windows with the divided light, double-hung operation and original wood trim are distinctive, historic character-defining features. *(See site photo 2)*

- When staff initially received the application, the photos presented showed the original windows in place. Staff requested detailed photos of these windows and a professional assessment of their condition. Staff then learned from the applicant that the windows were removed by the applicant's contractor. The applicant stated that their contractor had assessed that the windows were damaged beyond repair, but no documentation was presented or made available to staff. From the previous photos presented, it is staff's assessment that the windows were not shown to be irreparable.

- The subject windows were apparently original to the house, 150 years old, and distinctive, character-defining features important to the property's historic character.
- No documentation establishing that the original condition of the windows is beyond repair was submitted or available.
- The details of preserving brick mould and original wood trim of each of the windows is unknown.
- The method of installation of the windows, how it sits in the window opening, and whether other materials, such as the use of coil stock will be introduced is unknown.
- Therefore, the replacement of the original wood windows with aluminum-clad wood windows is not compatible with historic architecture in the house in that they destroy the distinctive, character-defining features of the original windows, particularly the true-divided lights surrounding wood trim detailing.

Staff therefore recommends that the Commission issue a Denial for the above work items, as it do not meet the Secretary of the Interior's Standards for Rehabilitation, specifically Standards:

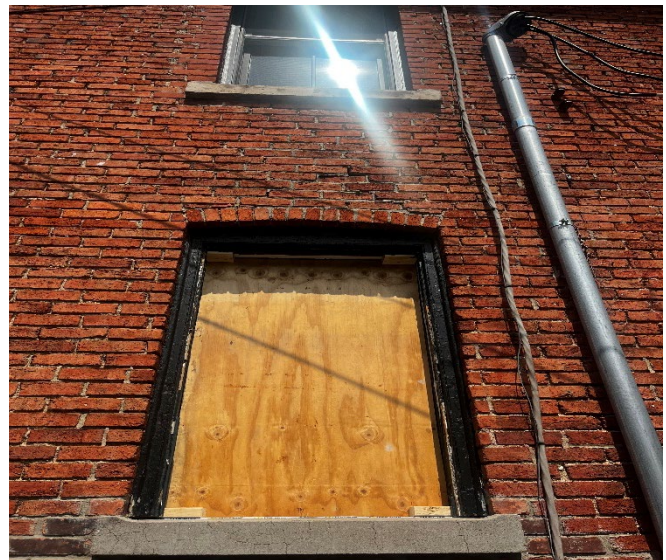
*Site Photo3, by Applicant: (Looking at rear east elevation) showing location where kitchen window was removed and replaced with plywood (without approval) and showing original wood trim still in place.*

- Staff has not yet received a response to the following questions as of the date of this report:
  - While the applicant states that he will be using the same wood trim as the other windows, he has not clarified if he is using the existing wood trim and brick mould or if these will be replaced with new wood trim and brick mould.

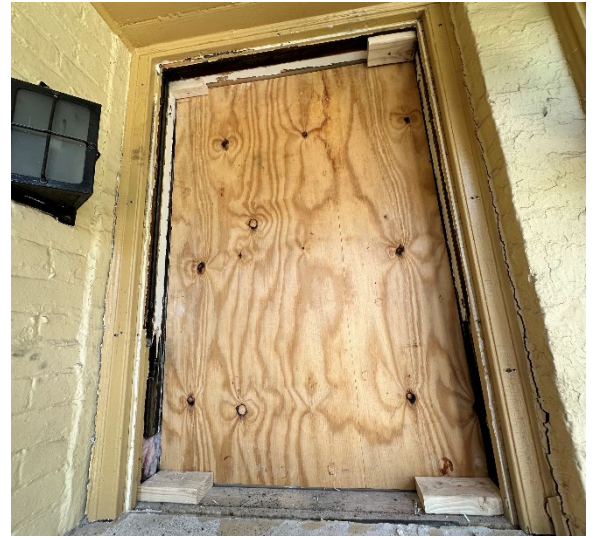
*Site Photo 4, by Applicant: interior kitchen window location, showing interior wood trim.*
