**STAFF REPORT: JULY 10, 2024 MEETING**  
**APPLICATION NUMBER: HDC2024-00229**  
**ADDRESS: 2310 EDISON**

**HISTORIC DISTRICT: BOSTON EDISON**  
**APPLICANT: JONATHAN TAYLOR**  
**PROPERTY OWNER: JONATHAN TAYLOR**  
**DATE OF PROVISIONALLY COMPLETE APPLICATION: JUNE 18, 2024**  
**DATE OF STAFF SITE VISIT: MAY 22, 2024**

**SCOPE: REPLACE WINDOWS (WORK COMPLETED WITHOUT APPROVAL)**

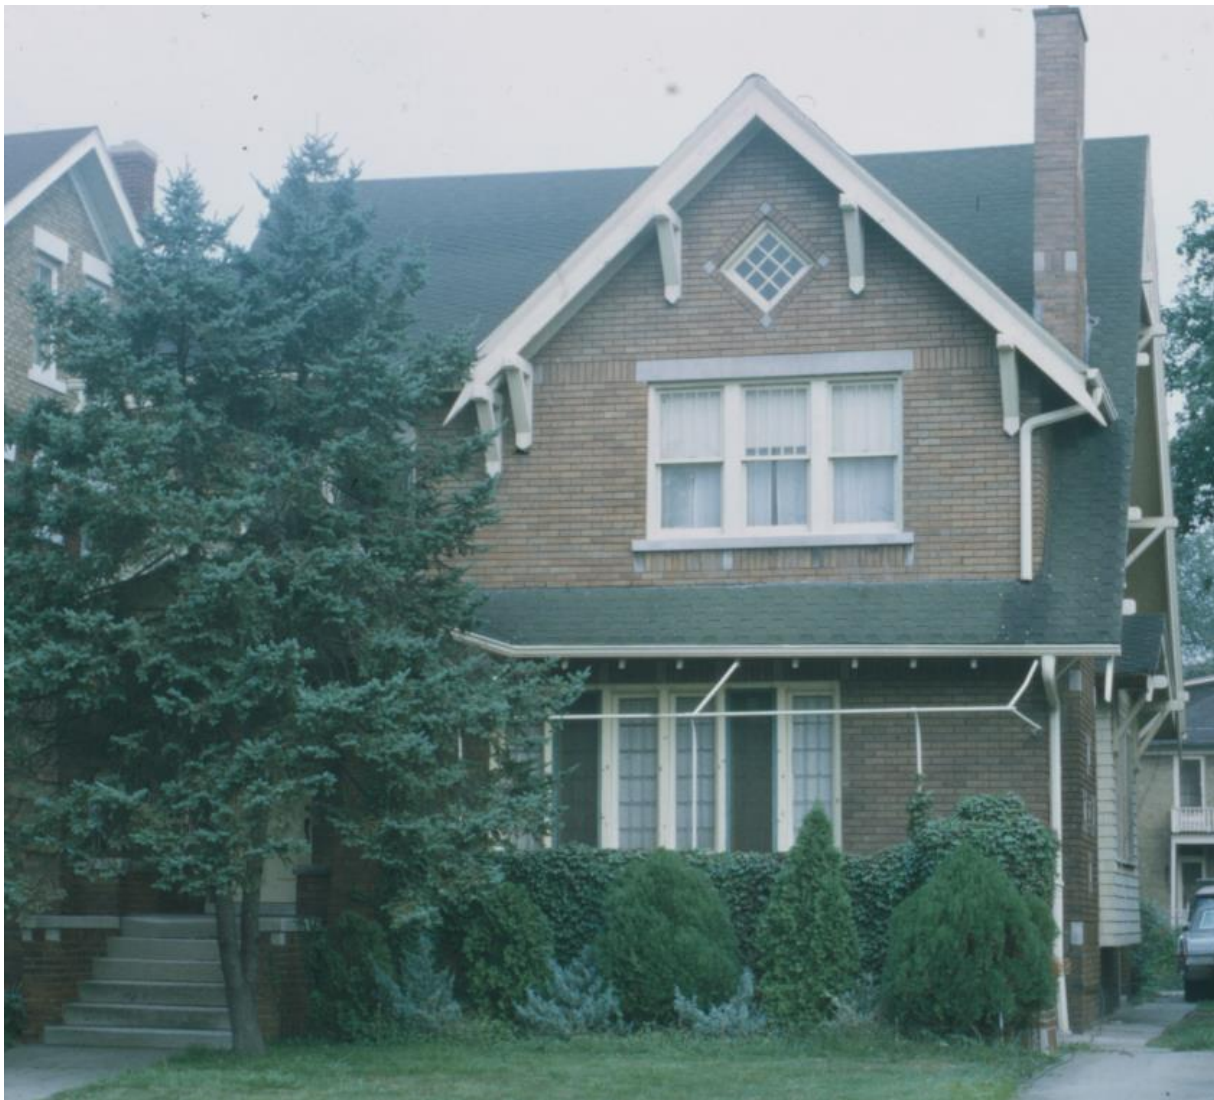
The designation photo documents the original windows within the main bay of the facade. The grouped window opening at the first floor consisted of six narrow 18-lite (three-wide x six-high) casement units with leaded comes. The double-hung windows on the house had vertically divided multi-paned upper sash over single glass lower sash. The uniquely patterned windows on the house were common designs for arts and crafts-style houses and are identified as distinctive character-defining features.

*1974 designation photo, HDAB.*

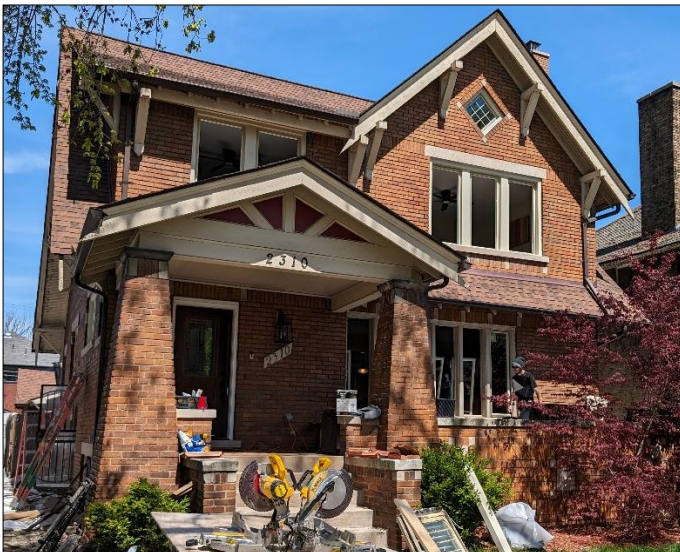
Façade

- Work crew finishing up last few windows at porch upon arrival to site, advised to stop work and restore wooden windows.
- Original historic wooden windows on all four elevations have been replaced with beige vinyl units, some of them with between-glass grids.

Staff photos, April 26, 2024  
Showing window replacement in progress.

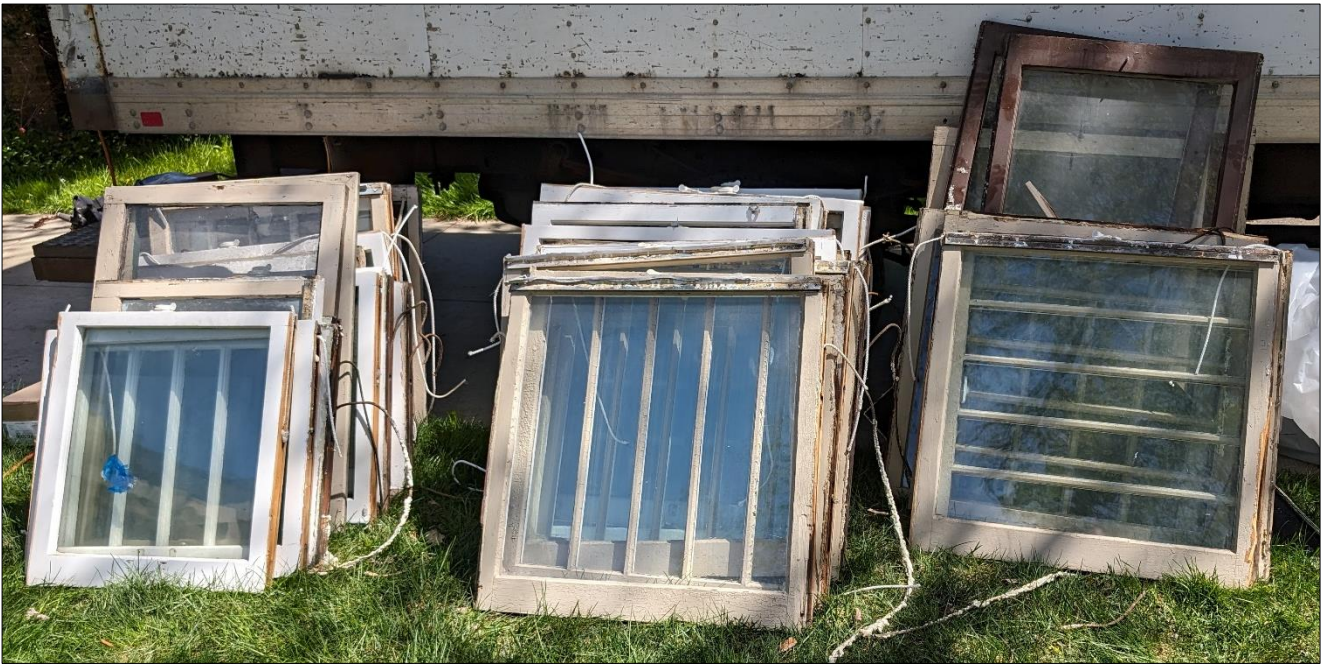
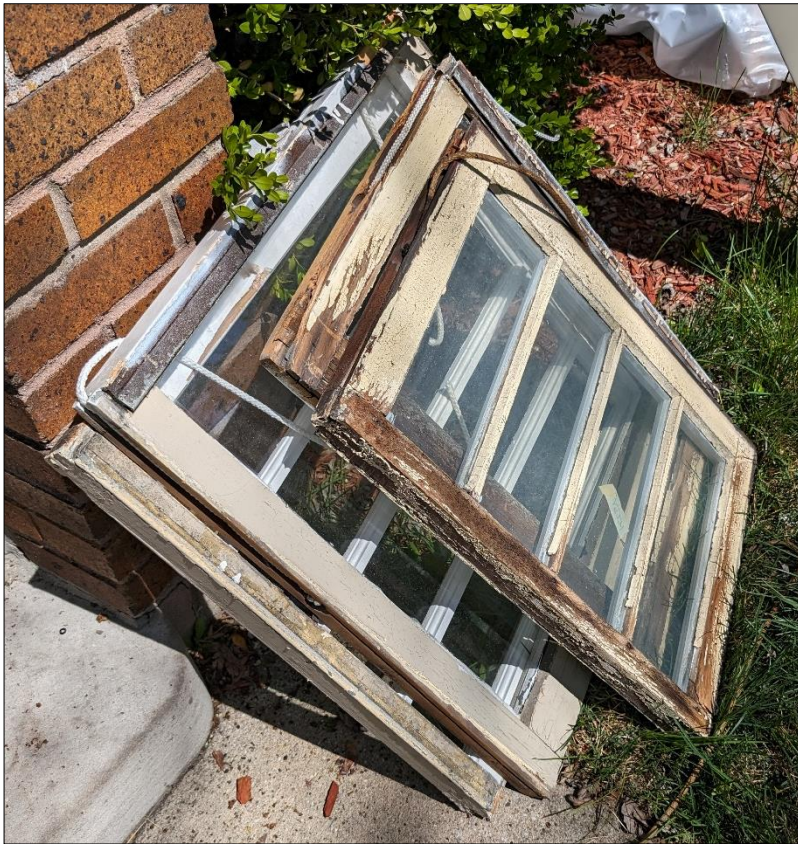
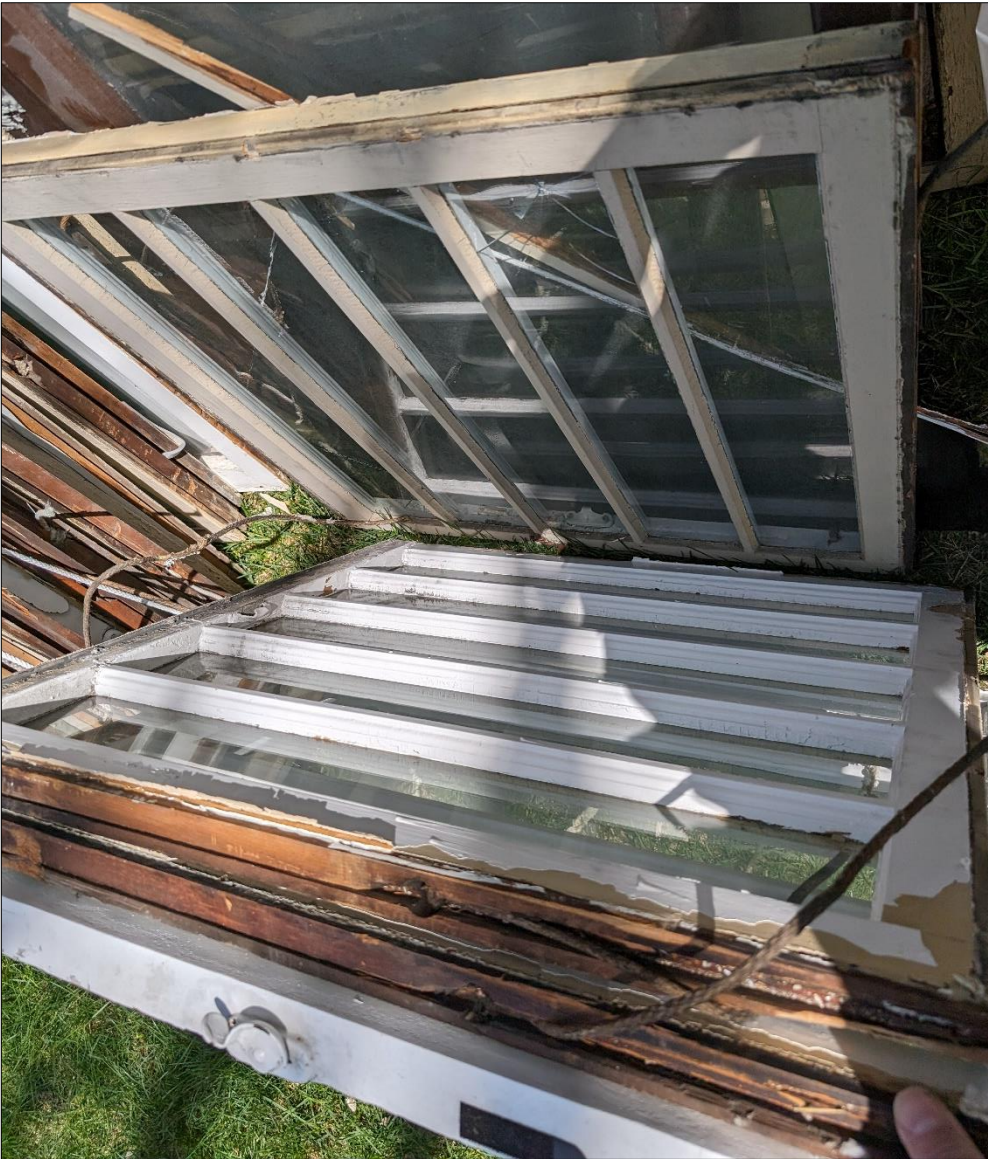
- Inspected historic wood sash stacked in front yard, all of which appeared to be in good repairable condition
- Crew's work trucks marked with "Robert's Installation" from Oxford and Troy, MI. Claimed to be a sub hired by contractor responsible for permitting.

*Staff photos, removed window sash.*

The application did not provide sufficient documentation outlining the deterioration of the original wood windows that were removed without approval. Based on staff's site assessment and the photographs of the removed windows, it is staff's opinion that the window sash were intact prior to removal and the wood frames and glass panes appeared to be in repairable condition.

As the windows were removed without Historic District Commission approval; based on the Standards, new windows should match all the details of the historic windows that were removed. In this instance, the wood windows that were removed should be repaired and reinstalled within their respective window openings.

The Standards require that historic windows be repaired, and only when they are deteriorated beyond repair, can replacement windows be considered. Furthermore, replacement must match the details of the historic windows. In this instance, the wood windows that were removed are repairable and could be reinstalled within their respective window openings.

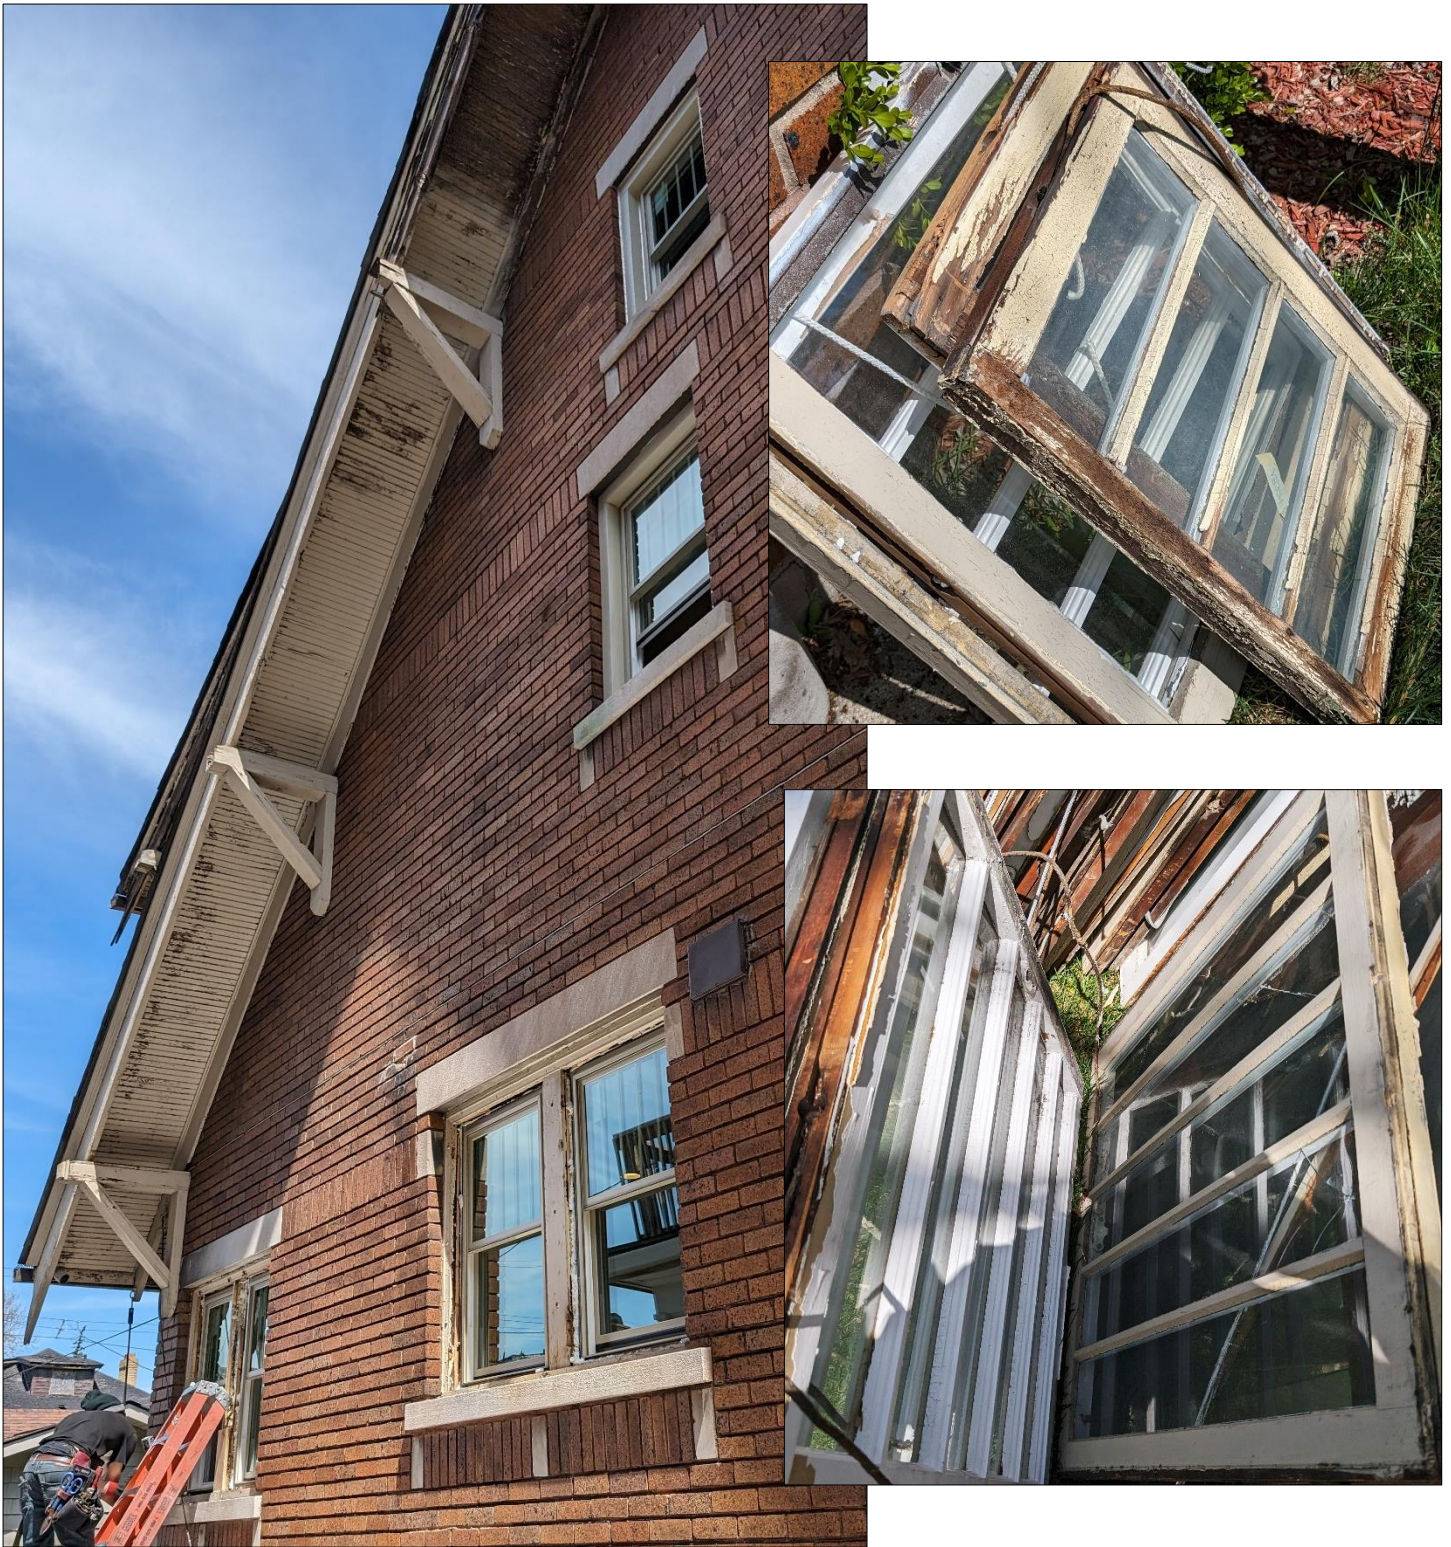
- Vinyl windows and wrapped brickmould offer a plasticity and flat/thick appearance that does not adequately match the profile/dimensionality and appearance of historic windows, such as wood.

- Vinyl windows have "grids" between the glass, which means the dimensionality of historic windows, which have thick highly profiled muntin bars separating the panes of glass, is lost.

*This staff photo of the west-side wall shows the reflectivity of the replacement glass, as well as the loss of dimensional profiles within the windows, due to the between-the-glass grid/muntin placement. The windows are now flat surfaces and sit in contrast with the highly detailed and dimensioned wall surfaces and applied ornament. The removed windows offer a clear comparison of the dimensional profile of true divided-light windows and a clear comparison on how these replacement windows do not match the original/historic windows.*

Staff therefore recommends that the Commission issue a Denial for the work as proposed, as it does not meet the Secretary of the Interior's Standards for Rehabilitation, specifically Standards 2, 5, and 6:
