**STAFF REPORT:** 08/14/2024 REGULAR MEETING  
**APPLICATION NUMBER:** HDC2024-00330  
**ADDRESS:** 14835 ROSEMONT  
**HISTORIC DISTRICT:** ROSEDALE PARK  
**APPLICANT/PROPERTY OWNERS:** CHAMEEKA AND JOHN DAVIS  
**DATE OF PROVISIONALLY COMPLETE APPLICATION:** 07/22/2024  
**DATE OF STAFF SITE VISIT:** 07/25/2024

**PREPARED BY:** D. RIEDEN

**SCOPE:** REPLACE WOOD WINDOWS WITH VINYL WINDOWS

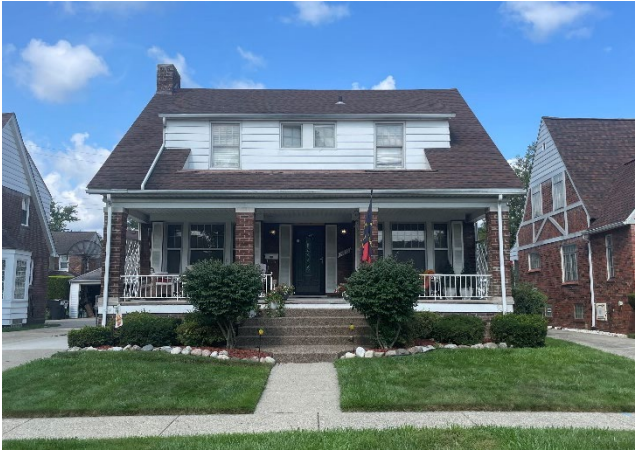
*Site Photo 1, by Staff July 25, 2024: (East) front elevation showing original wood windows.*

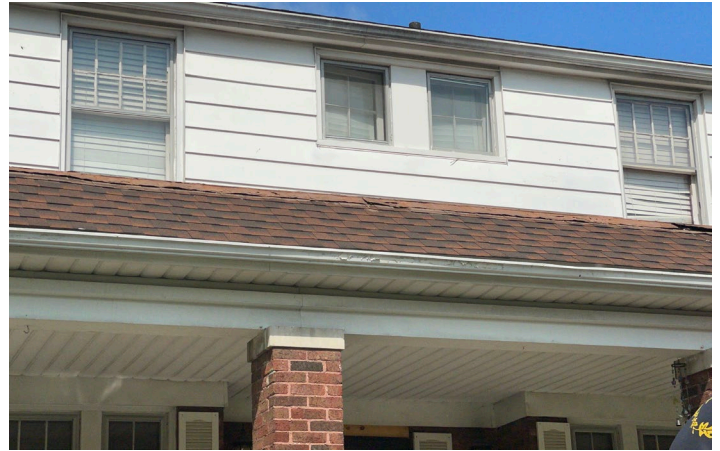
*Site Photo 2, by Staff July 25, 2024: (East) front elevation showing original wood, double-hung windows with true divided light.*

- The front upper story and the side elevation upper story windows are particularly visible from the public and are proposed for replacement with vinyl windows. Except for the rear kitchen windows, which are 1/1 double-hung, wood windows, the other windows have true divided-light mullions, most of which are 8/1 configuration. It is staff's opinion that these true divided-light, double-hung windows are distinctive character-defining features. Their loss would substantially detract from and destroy the historic appearance of the building. (See photos 1-3)

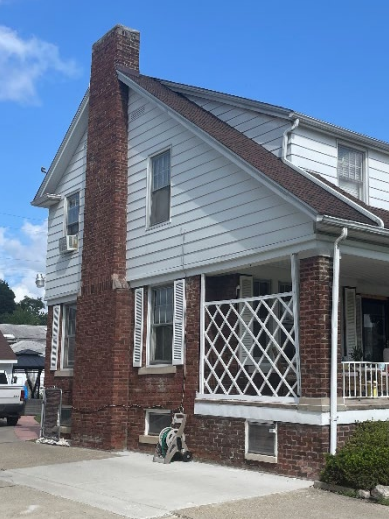
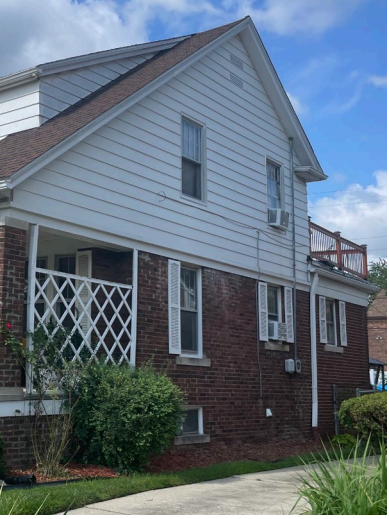
Site Photos 3&4, by Staff July 27, 2024: north and south side elevations, showing original wood windows.

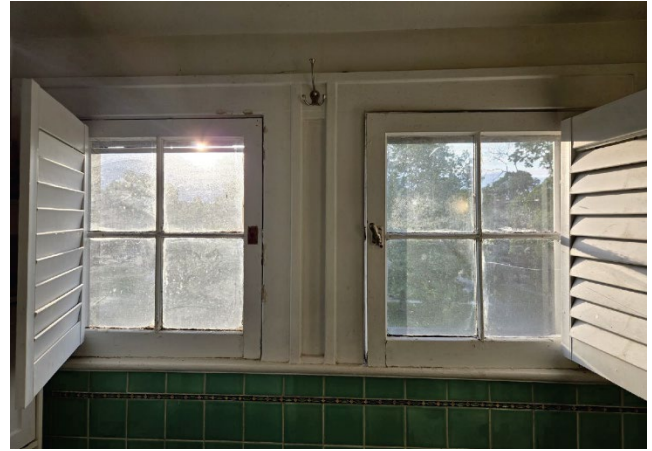
Figure 2, by Applicant: (East Interior Bathroom) Interior bathroom casement windows proposed to be replaced with vinyl windows.

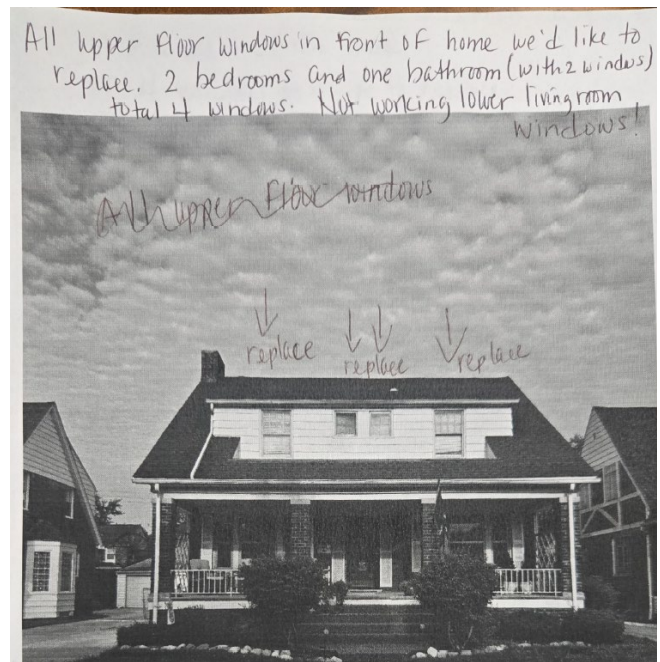
- In addition to a material change from wood to vinyl, the configuration and operation of the windows would also change. For example, the front elevation casement windows on the second floor are replaced with double hung windows and the light configuration changes from 8/1 to 4/2 grids between the glass according to the attached window order.

Figure 3, by Applicant: (east) front elevation showing proposed 2<sup>nd</sup> floor windows for replacement with vinyl.

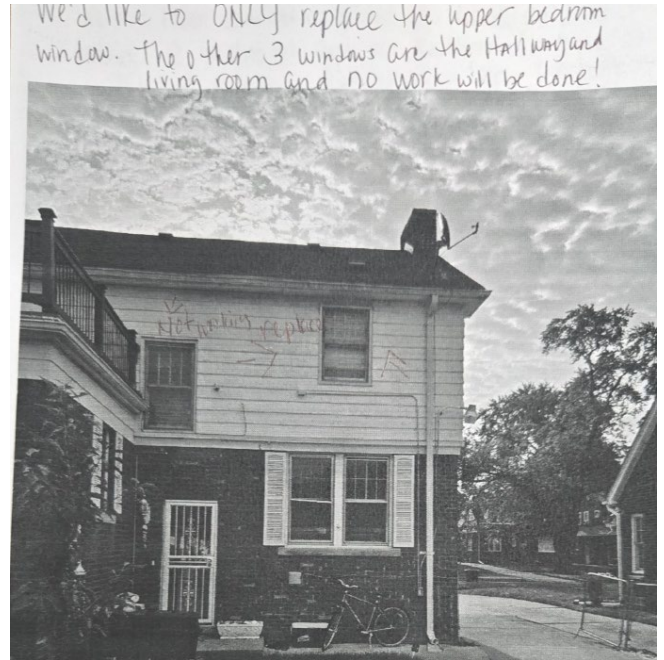
Figure 4, by Applicant: (west) rear elevation showing proposed 2<sup>nd</sup> floor windows for replacement with vinyl.
