**STAFF REPORT:** AUGUST 14, 2024 MEETING

**APPLICATION NUMBER:** HDC2024-00114

**ADDRESS:** 14539 ARTESIAN

**SCOPE:** REPLACE WINDOWS WITH VINYL WINDOWS

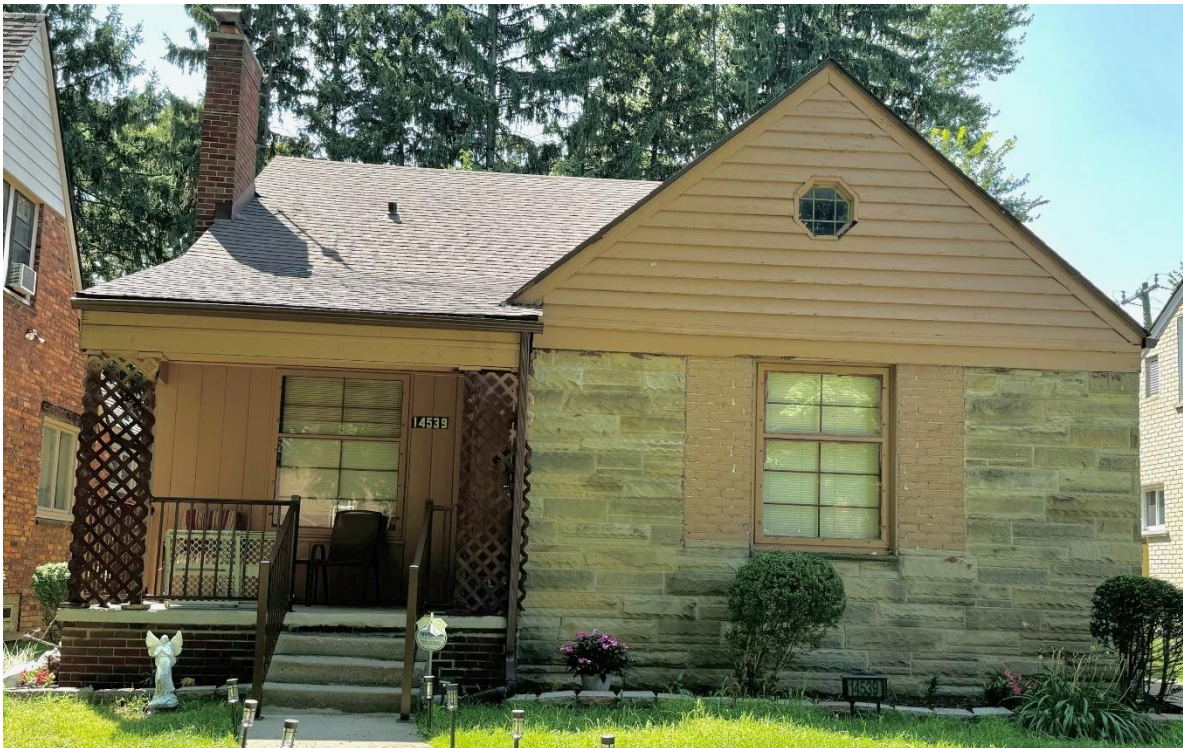
*Facade, east-facing wall. Staff photo, May 22, 2024.*

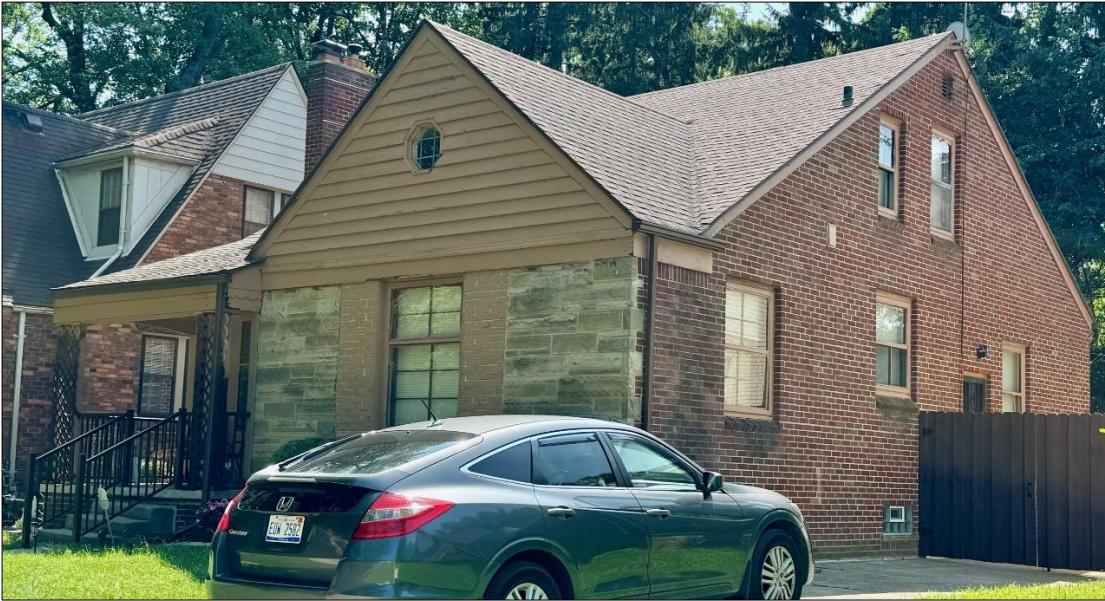
*View from Artesian sidewalk looking southwest. The third window with sub-divided sash is seen here on the north wall. Staff photo, July 26, 2024.*

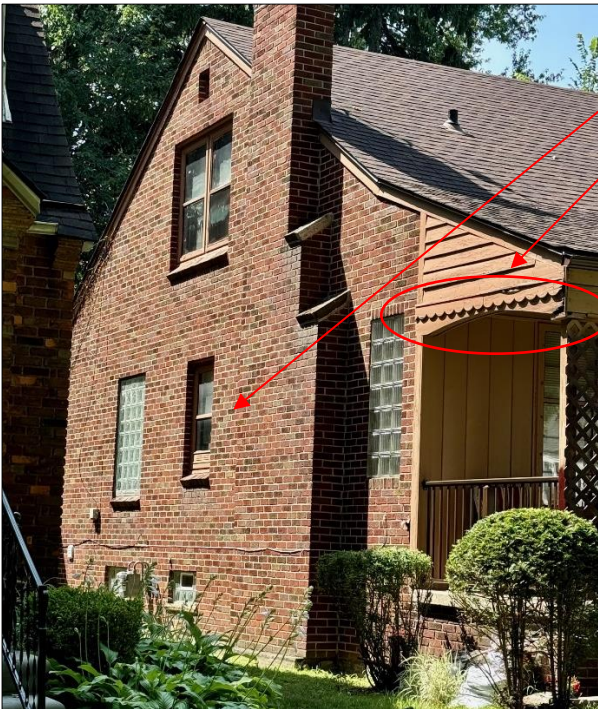
*Left: View of the south-side wall, taken from the Artesian sidewalk. Two glass block windows are visible at this location, one glass block window is hidden by the chimney. This view of the porch shows scalloped trim atop a curved trim board, which are historic details that are no longer in place on the front side of the porch.*

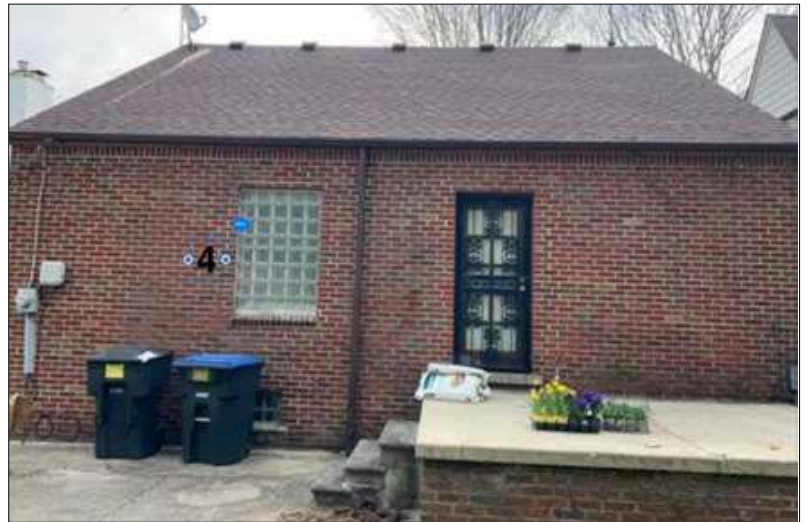
*Applicant photo of rear wall with third glass block opening.*

- Also, when windows are removed without Historic District Commission approval; based on the Standards, new windows should match all the details of the historic windows that were removed. Therefore, the replacement of the three glass block openings should be completed with wood (or aluminum-clad wood) one-over-one double-hung windows.

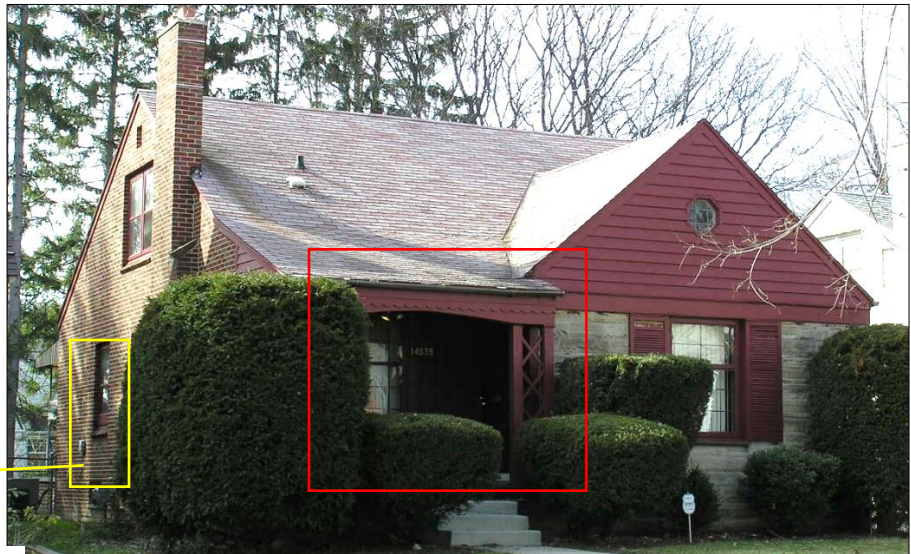
Above: Designation photo, 2007. HDAB. The original window near the rear was in place at designation. Porch components no longer present on the house are boxed in red.

- Staff confirmed that the south wall window opening near the rear still had the original window at the time of district designation. Staff assumes the other two openings that now have glass block likely had the original windows in place at time of designation. There is no approval on file for the glass block. Other details that are no longer present at the house include the removal of the decorative porch supports, and the scalloped trim and arched trim board facing Artesian. There is no record of HDC approval for the glass block installation as well as the removal of porch details.

- There is also no record of HDC approval for the removal of the shutters at the front window, which are seen in the above designation photo. As noted in the current condition, this wall surface is brick, rather than stone, and was not meant to be uncovered. The shutters are a distinctive character-defining feature and a common detail on this sub-type of mid-century dwelling within the Rosedale Park historic district, as demonstrated in the below photos.

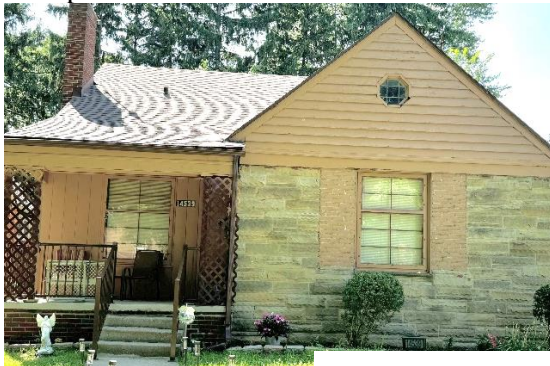
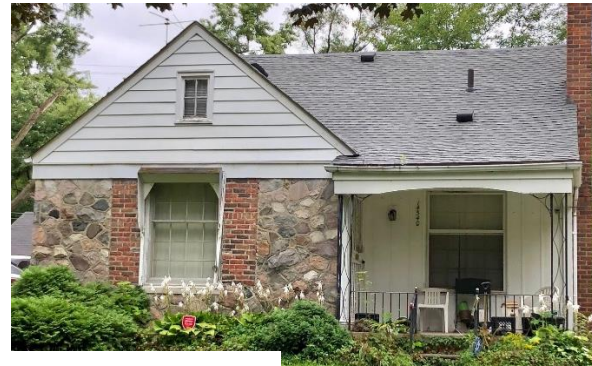
Top left: 14539 Artesian. Brick where missing shutters were located is painted to match siding. Top right: 14540 Greenview is also missing shutters and is more evident in unpainted condition.

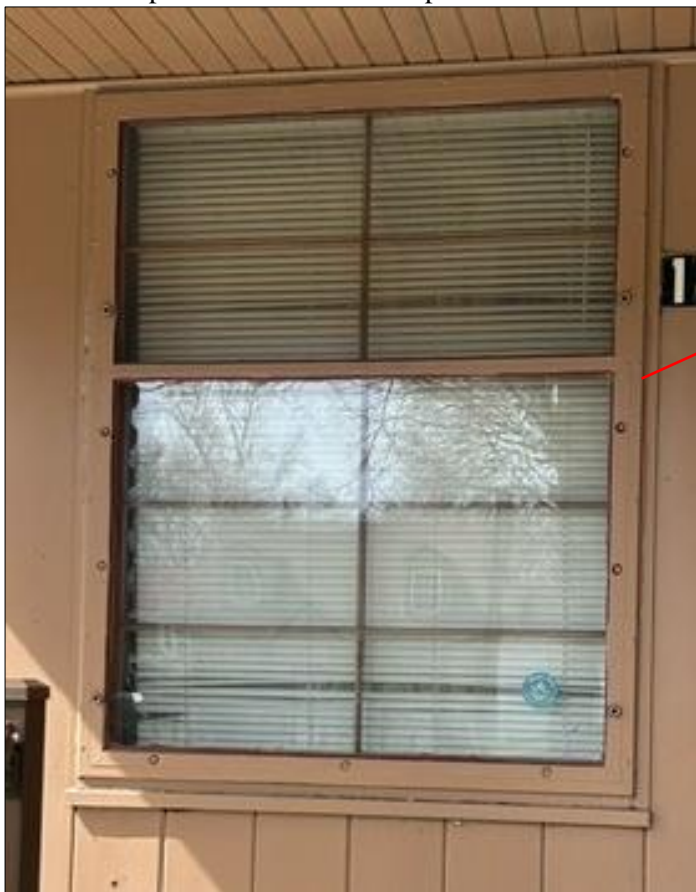
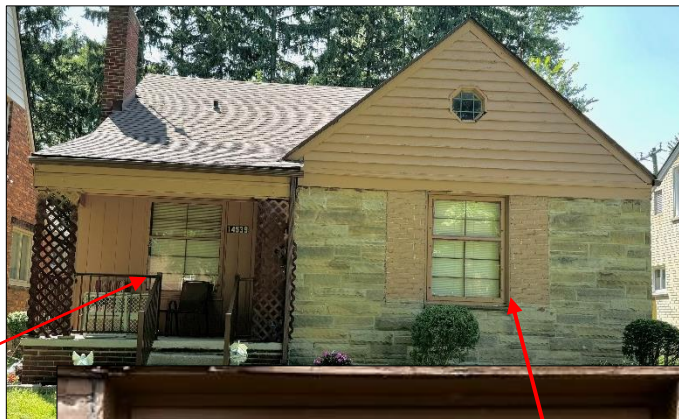
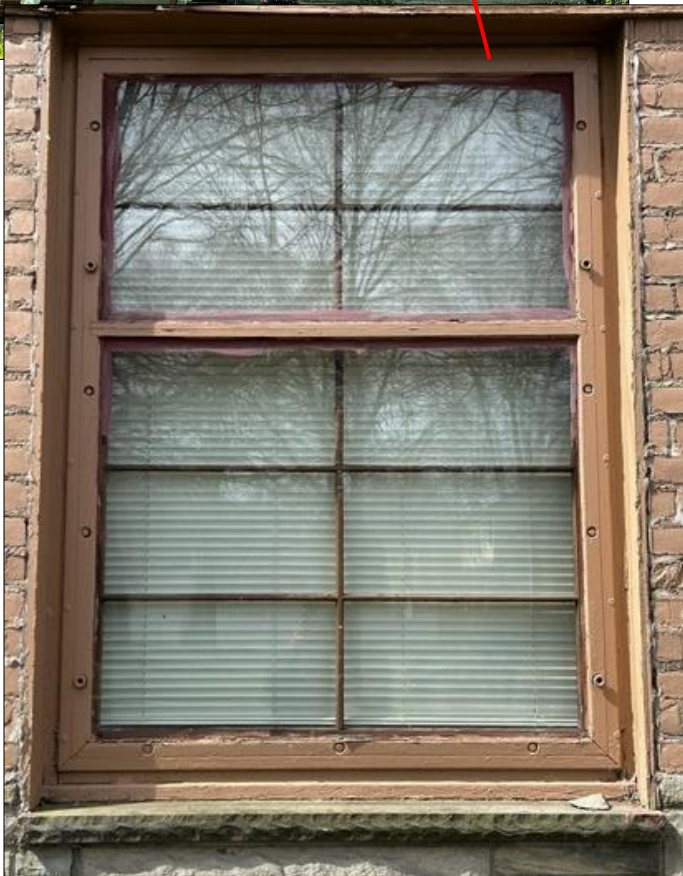
- The wood windows are covered with storm windows; these storm windows may be original to the house.
- The applicant states the windows don’t open, but didn’t offer any details as to why, nor close-up photos showing advanced deterioration.

- Based on staff’s view of the windows that are protected by storm windows, they do not appear to be heavily deteriorated. Therefore, operational problems can generally be easily repaired, and for a price less than the purchase of a new window. A property owner can look beyond companies that advertise as wood window repair companies; often tradespeople/carpenters who work with wood can assist in wood window repair. Also, contacting neighborhood hardware stores be helpful as some may offer window services or can direct owners to companies that repair windows. The applicant may submit a repair estimate provided by a person/company experienced in window repair. This estimate would detail the work needed as well as an estimated cost.

*Applicant photos of the front wall windows*

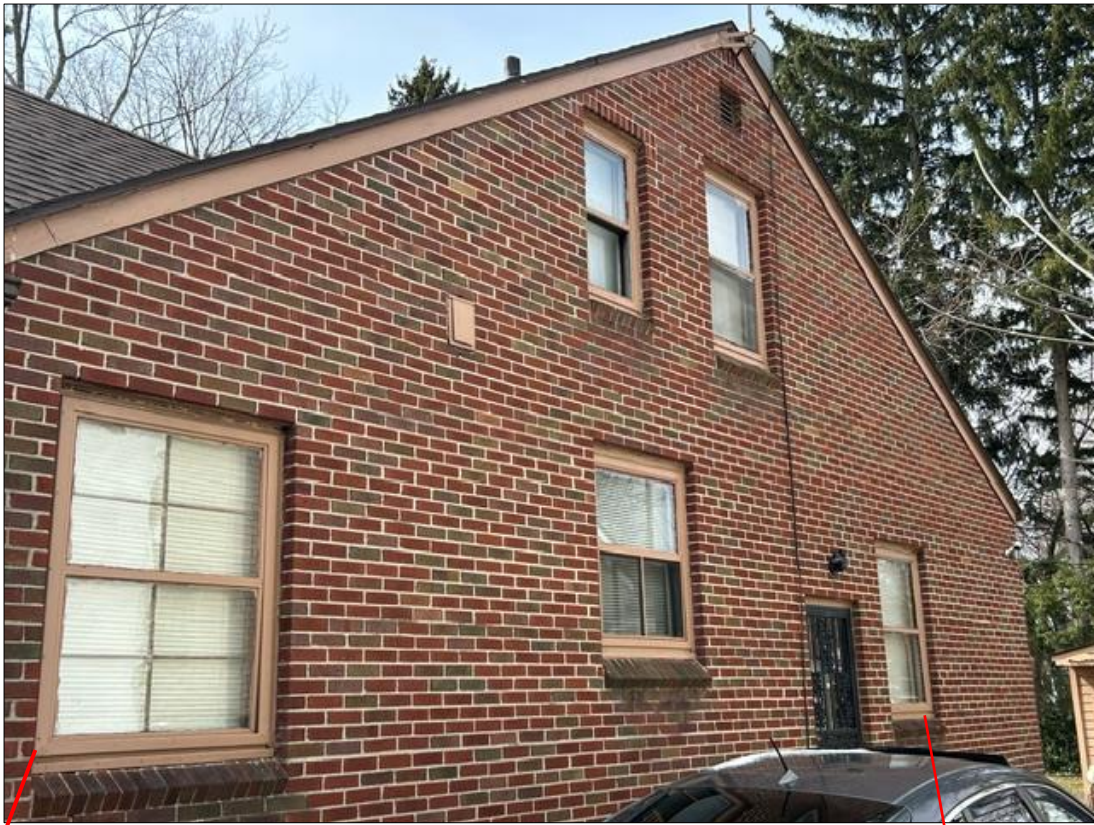
*North (side) wall. Applicant photos.*

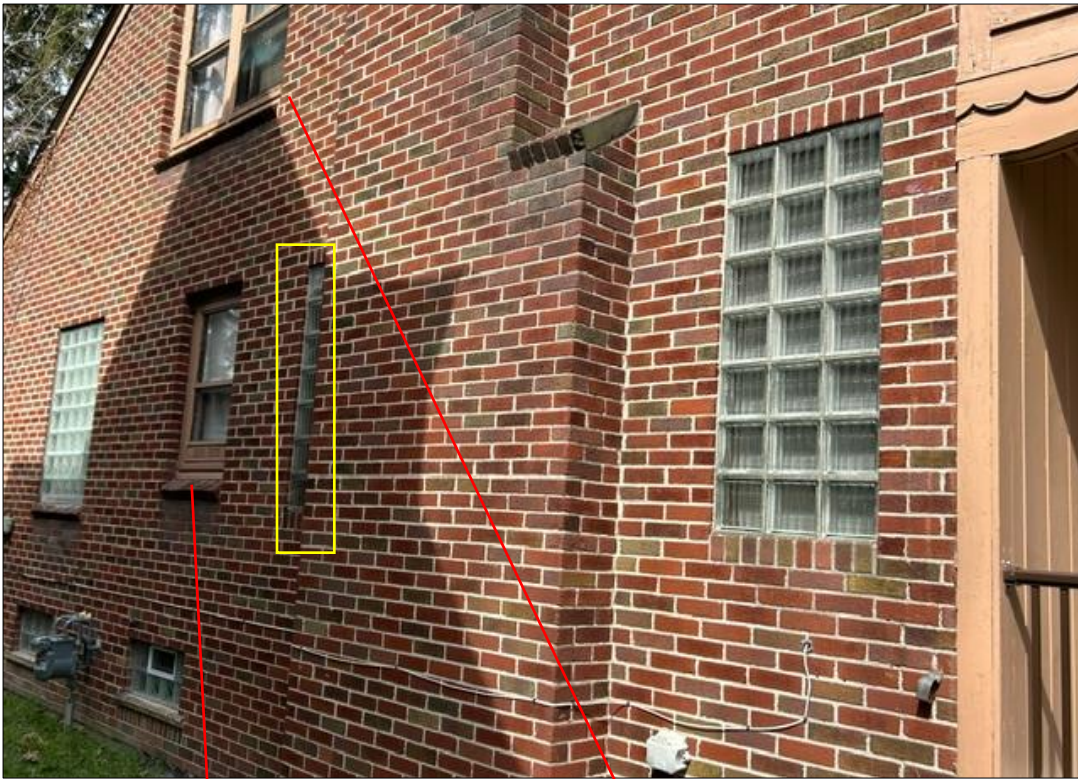
*South (side) wall. Applicant photos. This photo shows a little bit of the other glass block window (boxed in yellow) that flanks the chimney.*
