STAFF REPORT: AUGUST 14, 2024 MEETING – *Revised 8/14/24*

APPLICATION NUMBER: HDC2024-00421

ADDRESS: 2244 WABASH

SCOPE: DEMOLISH REAR OF HOUSE* (WORK COMPLETED WITHOUT APPROVAL);
ERECT REAR ADDITION

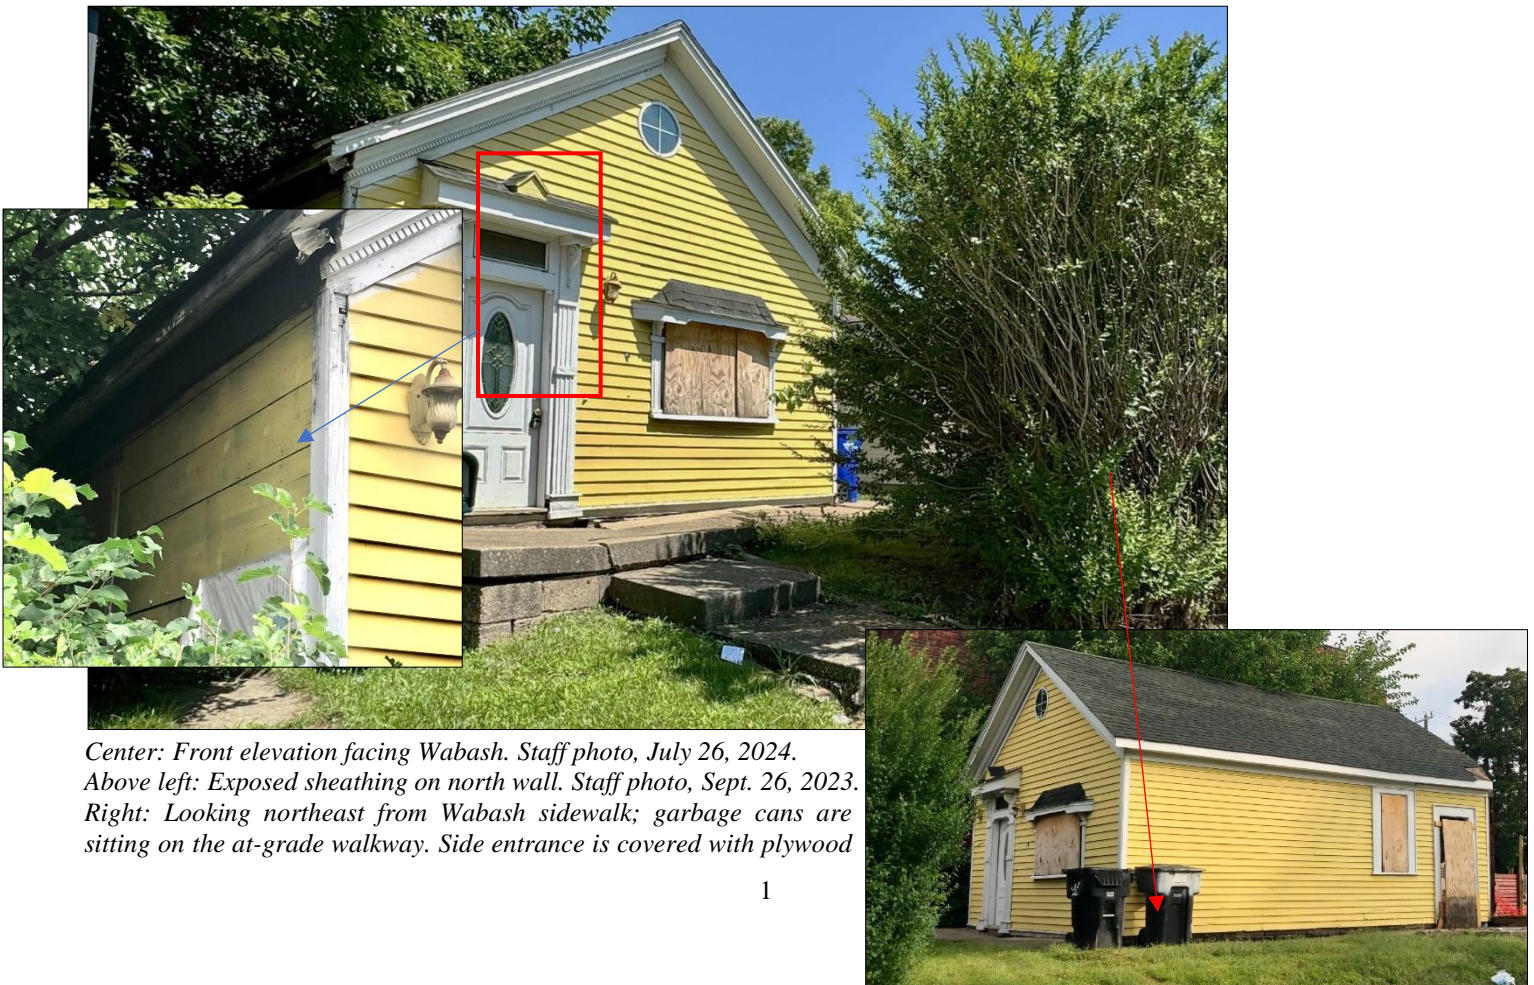
*Center: Front elevation facing Wabash. Staff photo, July 26, 2024.
Above left: Exposed sheathing on north wall. Staff photo, Sept. 26, 2023.
Right: Looking northeast from Wabash sidewalk; garbage cans are sitting on the at-grade walkway. Side entrance is covered with plywood*

panel. Staff photo, September 12, 2023.

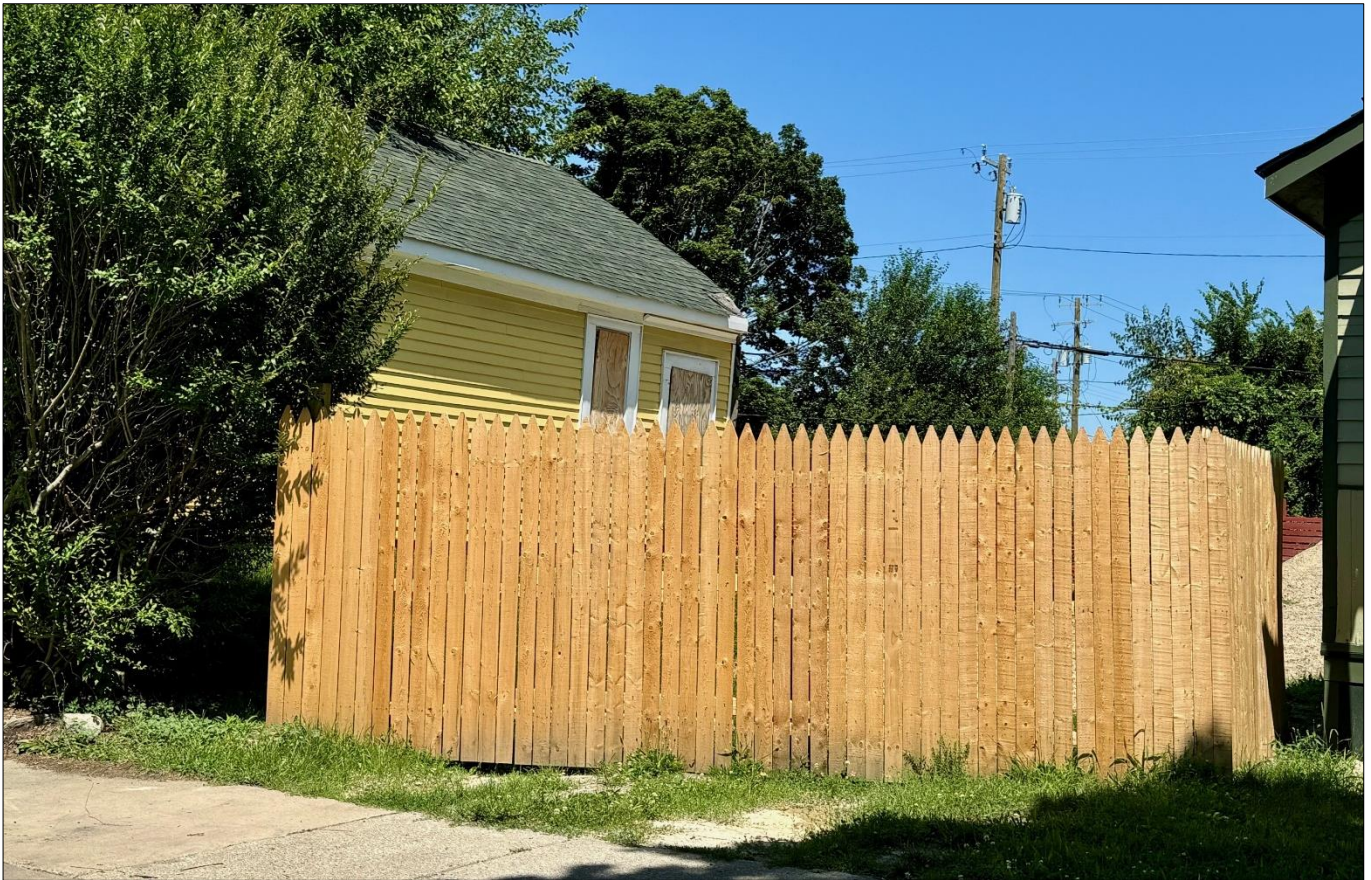
Current view from Wabash sidewalk looking northeast toward alley. Staff photo, July 26, 2024. The stockade fence was erected without HDC approval. Applicant states it was installed temporarily to enclose the lot which has an excavated and open foundation wall at the rear of the structure.

- The existing temporary fence will be removed and a temporary fence, that conforms with the Commission's Fence Guidelines, will be erected and placed in line with the front of the house (as shown on the applicant's submitted site plan) and will be removed no later than nine months from the date of the August 14, 2024 Commission meeting.

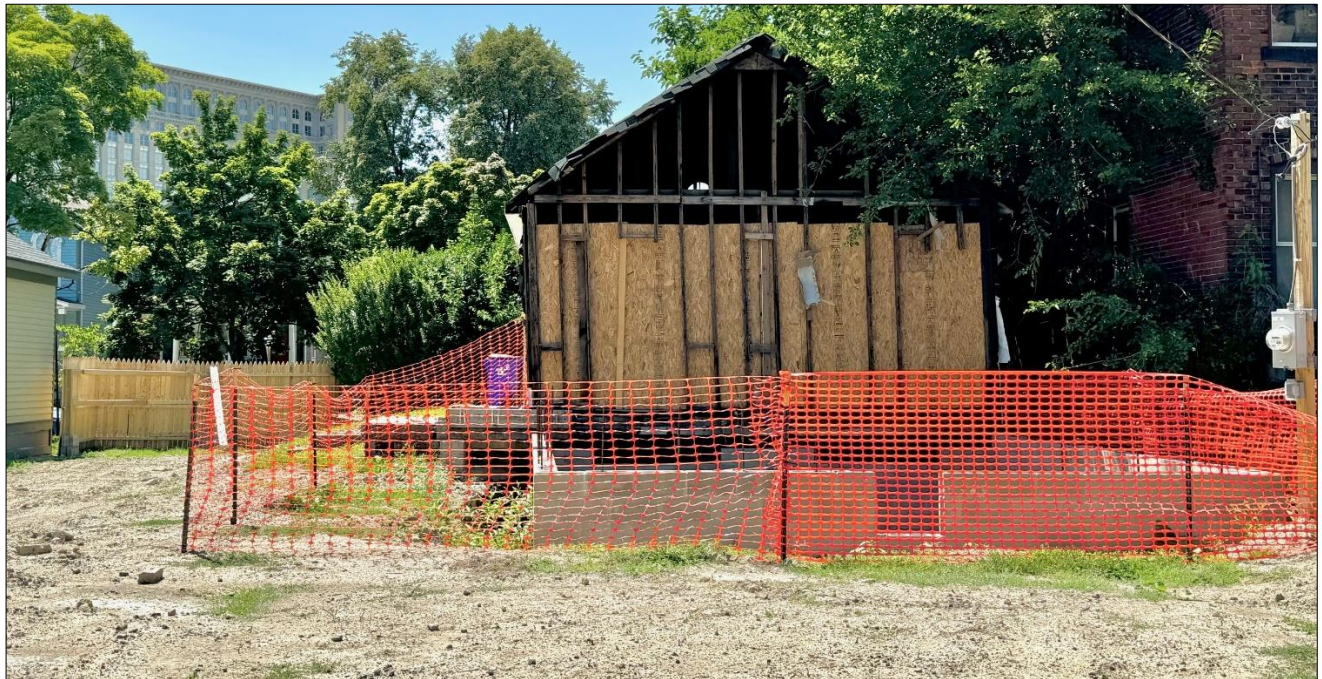
View looking west toward Wabash from alley. Staff photo, July 26, 2024. The erected concrete block foundation walls

(completed in 2023) are visible behind the plastic construction fencing.

In 2023, the property owner demolished the historic wing of the dwelling that extended from the south wall, as well as dug out the rear yard for a concrete block foundation (partially completed) for an addition. This work was done without HDC approval and a stop work order was issued by BSEED on October 27, 2023.

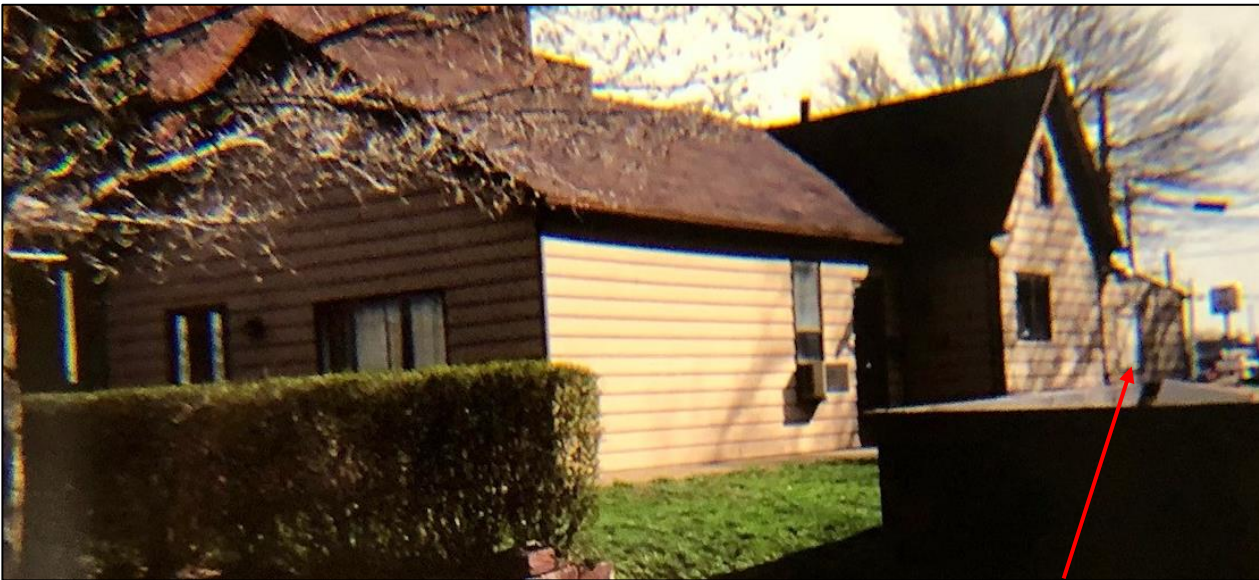
1984 designation photo – view from Wabash showing front and south-side elevations, HDAB. The pre-1921 rear addition, which had a shed roof, is partially visible in this photo (red arrow).

- Aluminum siding covered the house at time of designation. The front elevation's window opening appears to have a non-historic window. The pointed window in the side gable is a shape that was common on Gothic Revival structures. Staff doesn't know when this window was removed and replaced with a rectangular fixed window.

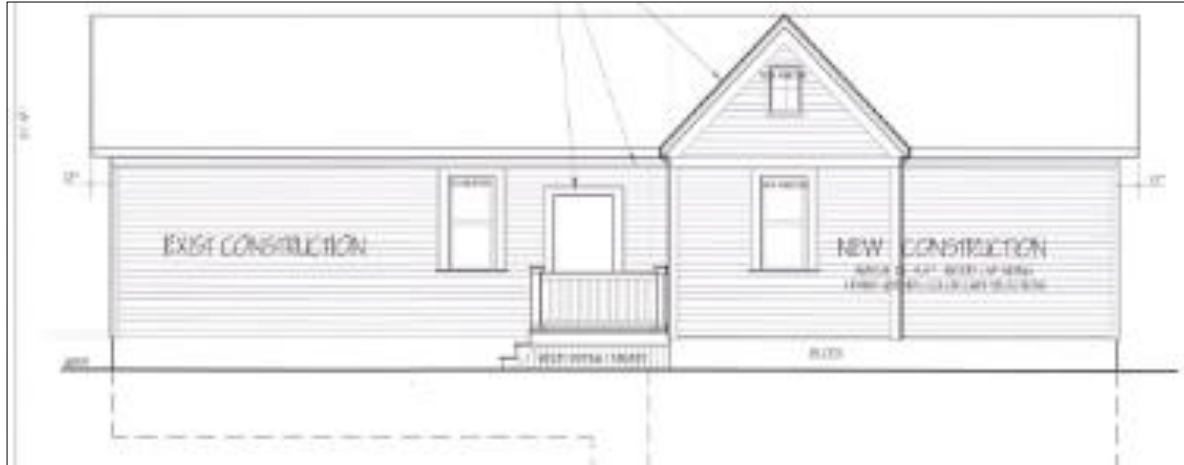
Applicant elevation view of south wall.

The above photos, copied from earlier in the staff report, show the side wing extended further than what is proposed, when compared with the elevation drawing and floor plan. The wing is indicated to extend 2' from the house's south wall.

It is staff's opinion the side wing should extend at least to the depth of the side porch, which is noted as four feet wide (area in red box) and closely in line with the historic footprint .

- The roof of the new construction addition will be slightly lower than the historic house's roof.
 - **The south wall of the side wing will extend 4' (not 2') from the main house.**

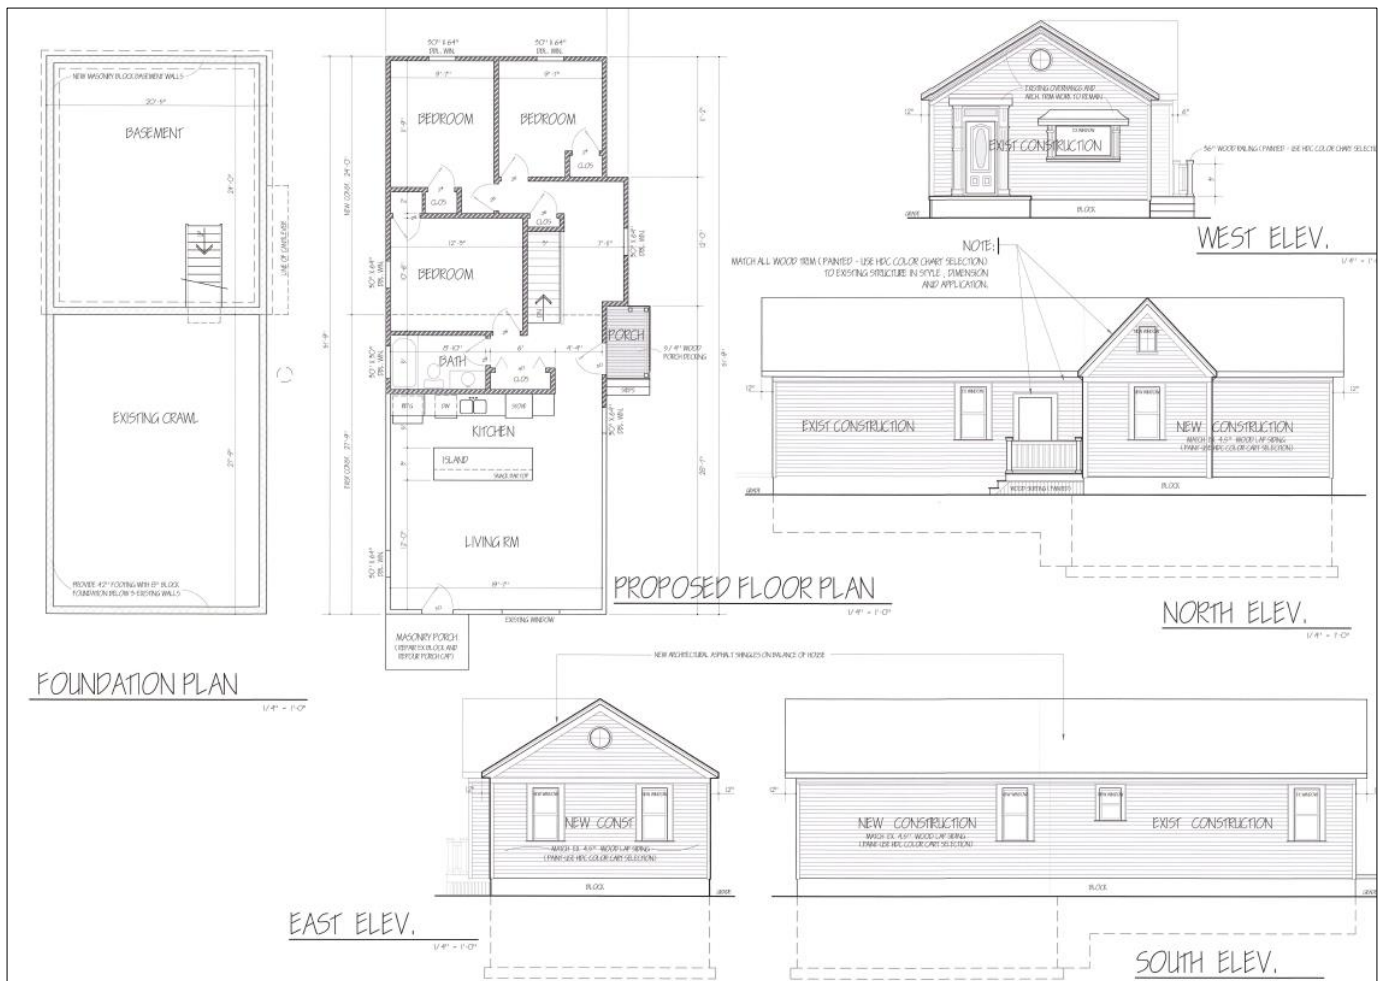
Applicant's current proposal. According to the National Park Service, the new construction addition should be deferential to the historic property, it should be compatible with, but distinguished from, the historic dwelling.

- As staff discussed under Staff Observations and Research, an addition should not be erected to create a single architectural whole. The historic building must be clearly identifiable, and its physical integrity must not be compromised by the new addition. The new structure should be subordinate in size and clearly differentiated and distinguishable so that the identity of the historic structure is not lost in a new and larger composition.

- To differentiate and be subordinate to the historic dwelling, the addition's new north wall should be recessed from the existing north wall 3" – 6". The roof height should be lowered a similar dimension to create an independent roof system for the new addition.

- The drawings must be revised to show how the new construction addition will be differentiated from and subordinate to the historic structure.
 - The north side wall will be recessed 3" – 6" inches from the historic dwelling's north wall.

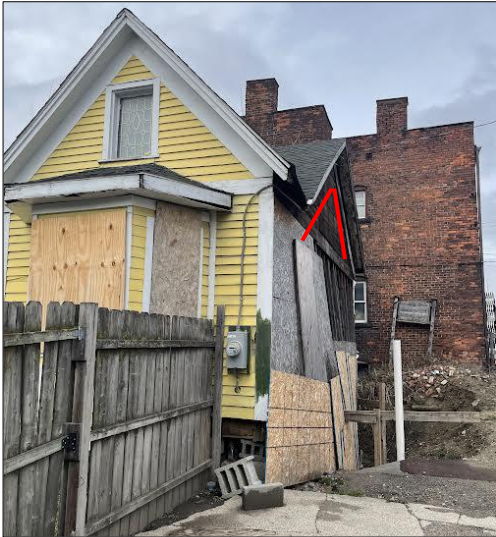
Undated applicant photo

- The undated applicant photo and a 2005 aerial photo of the rear of 2244 Wabash, before the shed addition was demolished (sometime between 2006 and 2009), shows how the side wing cross gable roof and the rear of the front gable roof came together. The rear gable wall should be replicated on the existing structure. This would allow the lower height roof of the new addition to easily and clearly meet the gable wall of the historic dwelling, as indicated by the red lines on both photos.

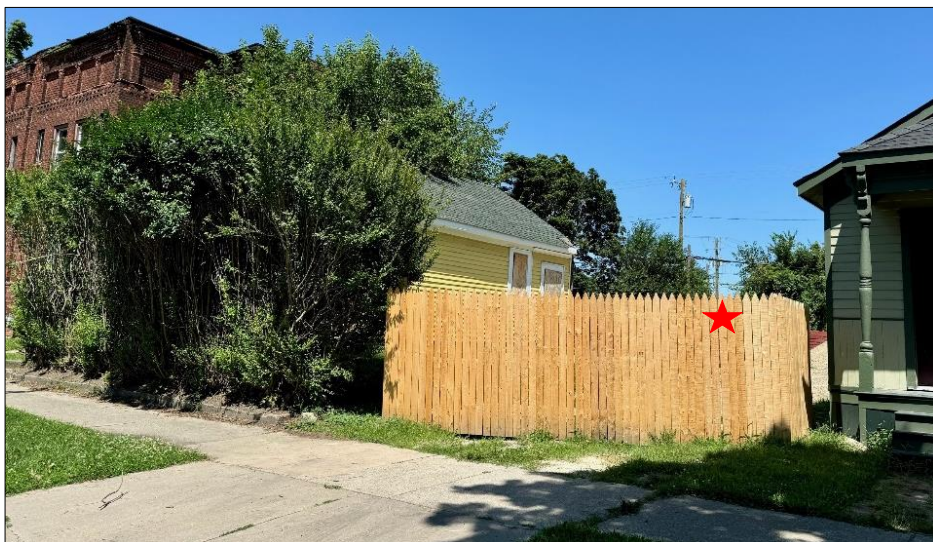
Staff photo, July 26, 2024.

- Regarding the temporary wood stockade fence, staff has authority to approve the installation of a temporary, chain link construction fence for a period that does not exceed nine (9) months. The narrow spear-like pickets used in the stockade fence is a design generally not approved by the Commission. The solid fencing disrupts the viewshed of the property within the Wabash streetscape and alters its physical relationship with the surrounding dwellings, and conflicts with the following Corktown Elements of Design:

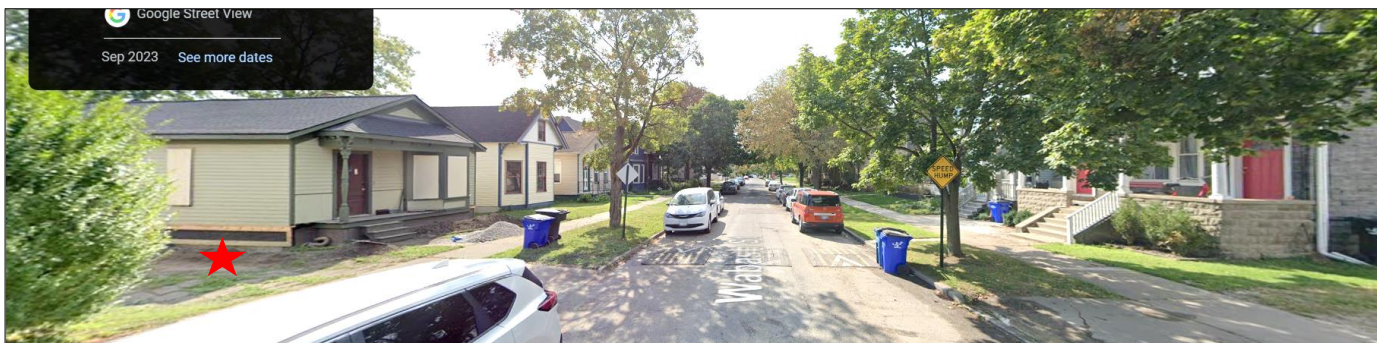
Wabash looking south. Google street view, September 2023. The lack of solid fencing at front and side yards allows for a broad view of densely placed buildings in this mixed-use, late-19th and early 20th-century neighborhood. The red star indicates the location of the recently-installed stockade fence shown above in-situ.
