**STAFF REPORT:** 10/09/2024 REGULAR MEETING

**APPLICATION NUMBER:** HDC2024-00520

**ADDRESS:** 15107 MINOCK

**SCOPE:** DEMOLISH GARAGE, ERECT GARAGE; REPLACE DOORS AND WINDOWS (WORK COMPLETED WITHOUT APPROVAL)

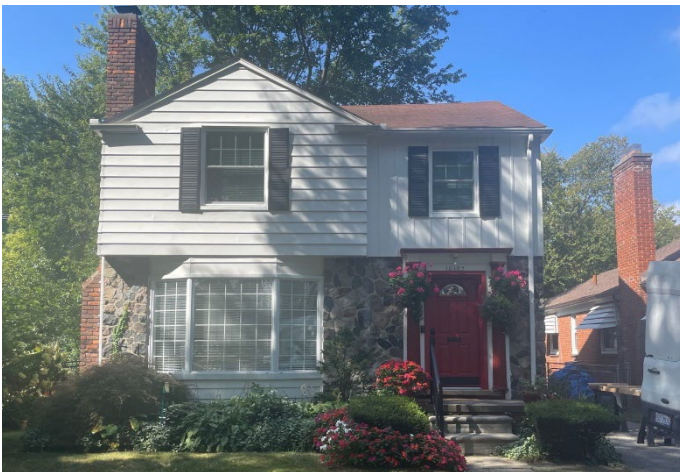
*Site Photo 1, by Staff Sept. 19, 2024: (East) front elevation of house showing replaced windows and door.*

- The front and the north side windows are particularly visible from the public right-of-way and were replaced with vinyl windows with grilles between the glass. Staff learned that all windows were replaced with vinyl windows without approval. It is staff’s opinion that the original true divided-light, wood windows with true divided light were distinctive character-defining features. Their loss substantially detracts from and destroys the historic appearance of the building. (See photos 1, 5-7, Fig. 1) All windows replaced true-divided light with grids between the glass, creating a flat surface and destroying the complexity and dimensionality that was historically present.

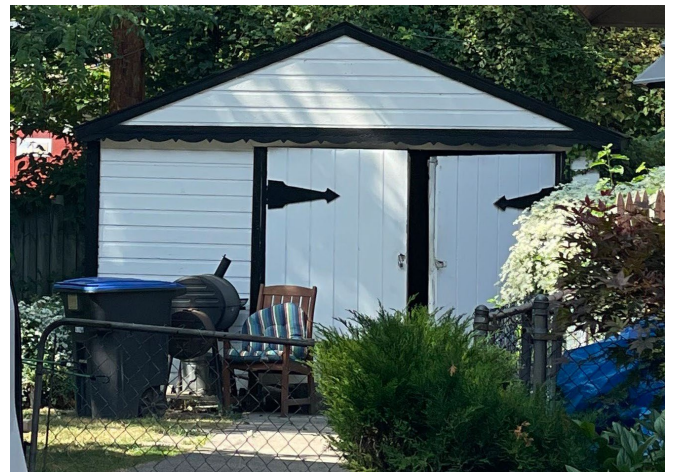
*Site Photo 2, by Staff Sept. 19, 2024: (East) front elevation of the existing garage.*

- From the applicant's photos, staff observed that the garage is stable and not in a state of deterioration that is beyond repair. Staff requested the applicant to provide interior photos and any description that shows the structure is beyond repair and/or a statement from a licensed architect or structural engineer. The applicant states that the wood siding, front swing doors, and asphalt shingled roof are in poor condition and beyond repair. However, when asked to supply information (interior photos, and a certified professional assessment) that proves that this condition is beyond repair, the applicant states that "even if the existing were repairable, it would not be large enough to satisfy the customer's needs... it is not so much that the existing garage is unrepairable, it's the existing size of the garage." At the time of this report, no interior photos have been provided. (See exterior site photos 2-4)

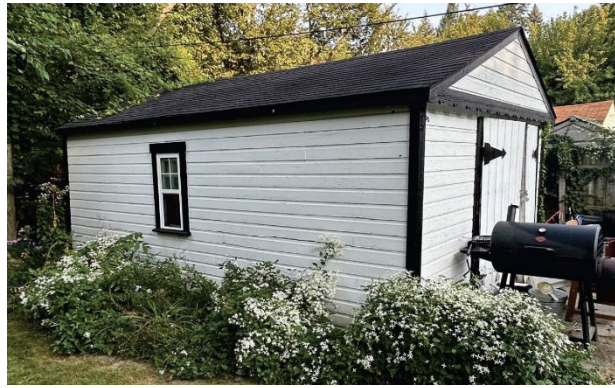
Site Photo 3, by Applicant, 2024 showing south (side) and east (front) of the garage and current conditions.

- The rear wood siding is damaged, but not irreparable, in staff's opinion. Staff also noticed that the south side window has been replaced with a vinyl, double hung window with grilles between the glass, which may have occurred at the same time the house had its windows replaced. (See site photo 3.) The structure retains its historic integrity, contributes to the historic district, and is not beyond repair, in staff's opinion.

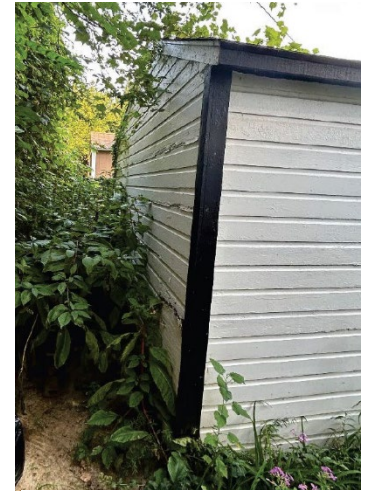
Site Photo 4, by Applicant, 2024 south (side) and west (rear) of the garage, showing some wood siding damage at the rear.

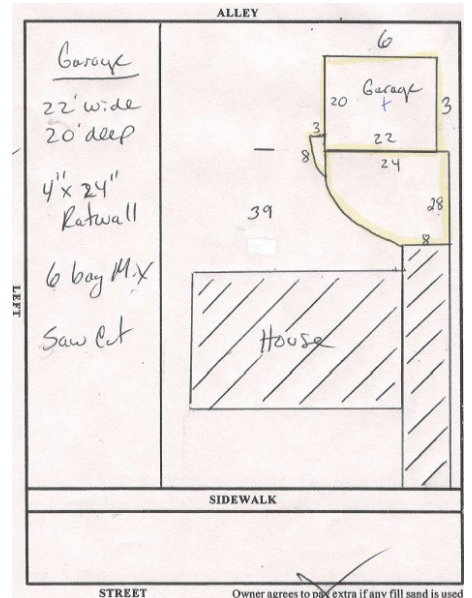
Figure 6, by Applicant: proposed site plan showing garage, driveway and service walk locations.

- Staff has no issue with the proposed concrete driveway and walkway should the Commission decide that the construction of new garage is appropriate. (See Fig 6.)

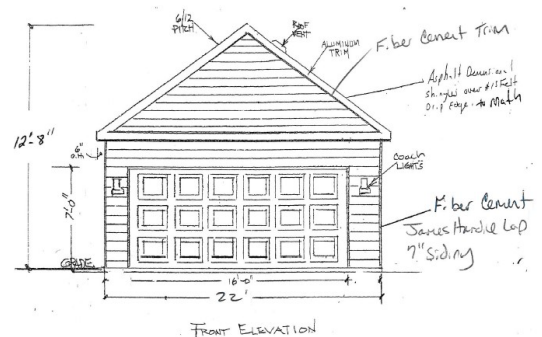
Figure 7, by Applicant: showing proposed front elevation of the garage.

primary structure, i.e., the house and meets the Elements of Design, i.e., “relates to the main dwelling”. Staff opines that a smooth finish cementitious board of a narrower reveal dimension and a color scheme that follows the HDC color guidelines for Color System C would be appropriate alternatives should the Commission decide that the construction of a new garage is appropriate.

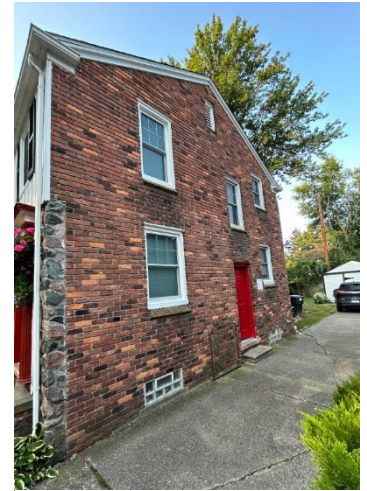
Site Photo 5, by Applicant, 2024 north (side) of the house, showing replaced windows and side door.

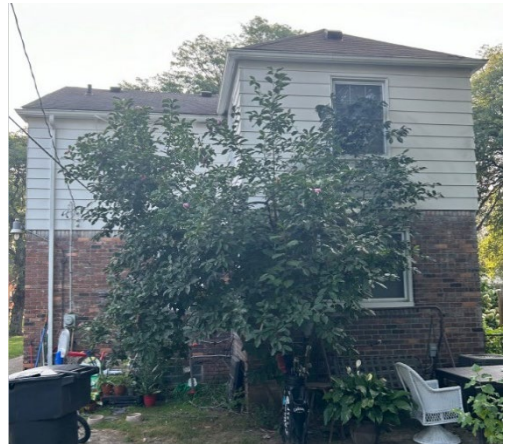
Site Photo 6, by Applicant, 2024 west (rear) of the house, showing replaced windows.

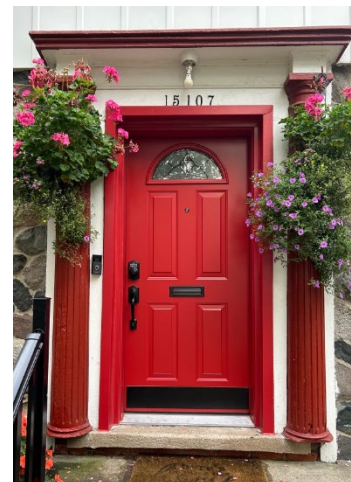
- Staff received confirmation that the front and side doors are steel. While staff has no issue with the side door, it is staff’s opinion that the vision panel for the front is inconsistent with the simplicity of the rectilinear fenestration of this Colonial Revival style and therefore not appropriate. A rectangular vision panel would suffice, in staff’s opinion. Finally, the red color of both doors not follow the HDC Guidelines and should conform to Color System C.

- The replacement of the front wood door with a steel door is inappropriate as it introduces a design and material that alters the historic character of the property: the half-moon vision panel of this door introduces a new form that is not compatible with the Colonial Revival style of the house.

- Red is not an appropriate color for front and side door trim as this is not compatible with HDC color guidelines, nor with the Colonial Revival style of the house.

*Site Photo 7, by Applicant, 2024 east (front) of the house, showing replaced front door.*

- The color of the door be selected from the HDC Color Guidelines, Color System C.
