STAFF REPORT: 10/09/2024 REGULAR MEETING

APPLICATION NUMBER: HDC2024-00542

ADDRESS: 3960 (3966) W. 7 MILE RD.

SCOPE: REPLACE DOORS, WINDOWS AND SIDING

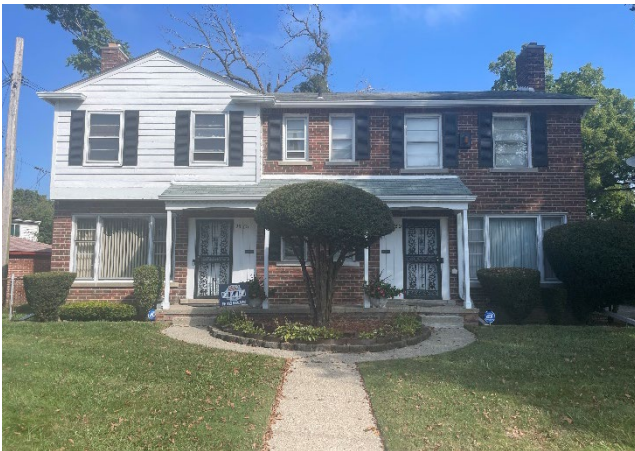
Site Photo 1, by Staff Sept. 19, 2024: (South) front showing dual entrances and current conditions.

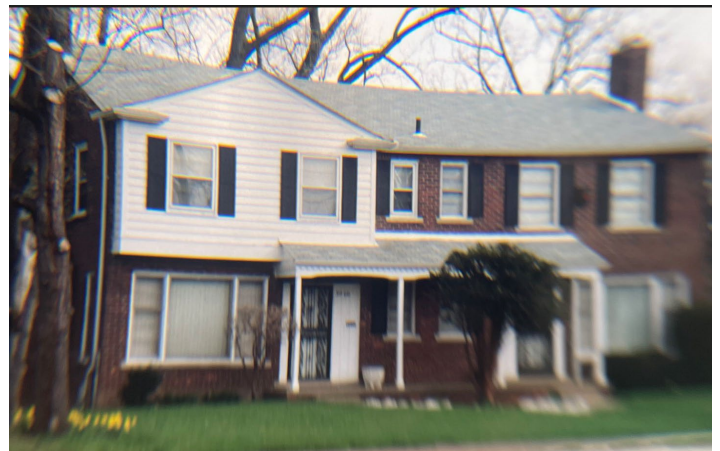
Fig. 1, Designation image 2001: (South) front showing original features that are still in place today.

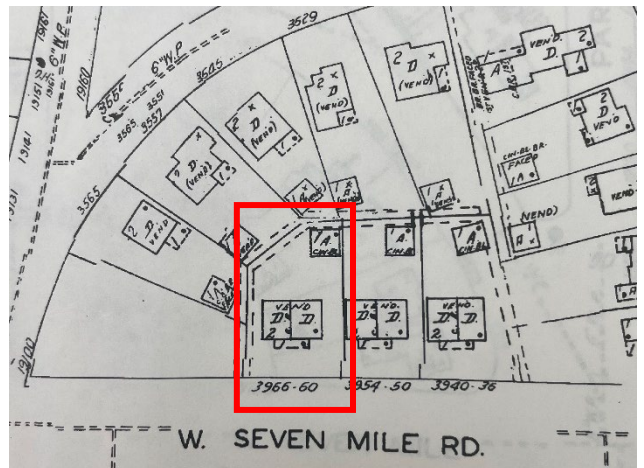
Sanborn, 1926 revised 1997, Vol 16.

- Staff observed from Sanborn maps that the front porch is shown. (See Sanborn image.)
- It is staff's opinion that the wood dentil molding, curved wood trim board, wood posts, and wood paneling by the front doors are historic, distinctive character defining features. Removal, covering and replacement of these features destroys and alters these features, introduces new materials and therefore does not meet the Standards.

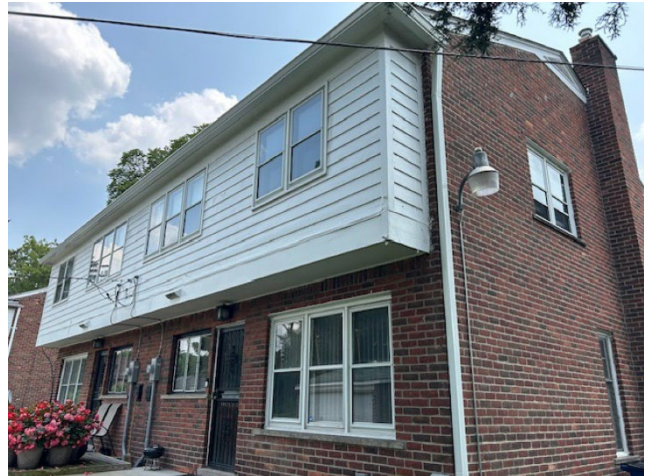
- The 2/2 true divided-light, double-hung wood windows with the horizontal muntins are historic distinctive character-defining features. Their loss would substantially detract from and destroy the historic appearance of the building.

- While the applicant states that the windows are "very old and cannot be repaired", no documentation was provided that shows the condition of the original windows are beyond repair.

Site Photo 2, by Applicant: (North) rear side showing original double hung wood windows and doors and clap board siding.

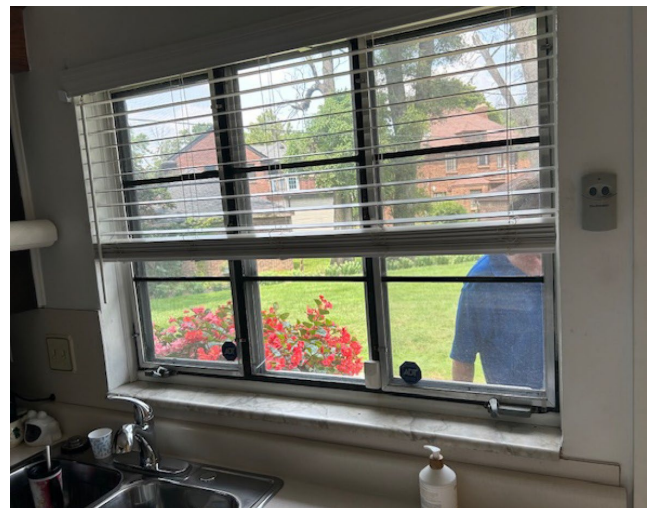
- Staff observed that the rear kitchen casement is steel but of similar design and light configuration with matching horizontal muntins. It is staff opinion that this casement appears to be repairable.

Site Photo 3, by Applicant: Interior kitchen window facing north, at (North) rear side showing casement windows with similar horizontal detailing of double-hung wood windows.

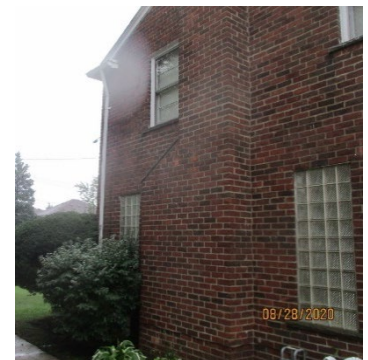
- Staff observed from Google Street Images that glass block windows have been installed at the building's east side since at least 2009. Staff has no record for this installation and may predate designation of the district in 2002. (See Site Photo 4.) Staff has the opinion that replacement of these glass block windows with the proposed double-hung aluminum-clad wood windows would be appropriate provided that no grilles between the glass are produced, the brick mould be reconstructed if no longer present, and no aluminum coil stock is used to cover the brick mould.

Site Photo 4, by Applicant: (East) side showing glass block windows on first floor and original windows on second floor.

It is staff's opinion that the replacement of the glass block windows with double-hung, aluminum-clad wood windows at the building's east side and replacement of the rear doors are appropriate. Staff therefore recommends the Commission issue a Certificate of Appropriateness for the work as proposed because it meets the Secretary of the Interior Standards for Rehabilitation and the District's Elements of Design.

- The side windows have no grilles between the glass.
- The brick mould be reconstructed if no longer present, and no aluminum coil stock is used to cover the brick mould.
- The rear steel doors have a simple rectangular vision panel.

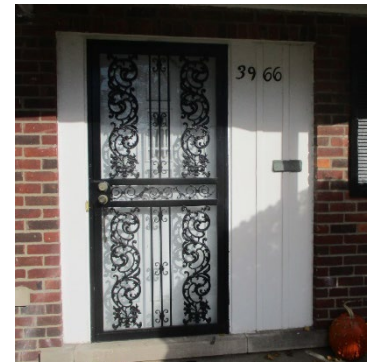
- The front doors feature a centered vision panel above wood paneling that complements the surrounding wood paneling, are historic

character defining features of the home. (See Site Photos 1,3 and 6.)

The replacement of these doors and the replacement of the wood paneling with Hardie board is inappropriate in Staff's opinion.

Site Photo 5, by Applicant: (South) Front door showing original wood panel features and side panel features.

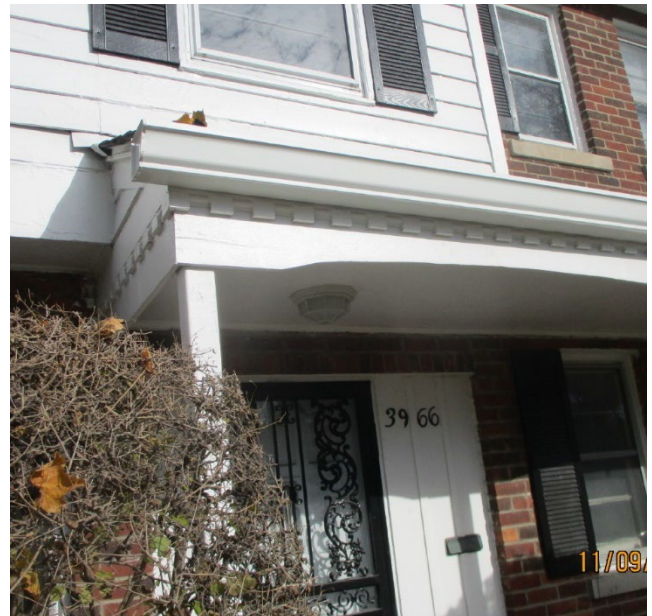
Site Photo 6, by Applicant: (South) front elevation showing detail of porch roof, front door side paneling, and second floor wood siding.
