ADDRESS: 1760 VAN DYKE

APPLICATION NO: HDC2024-00517

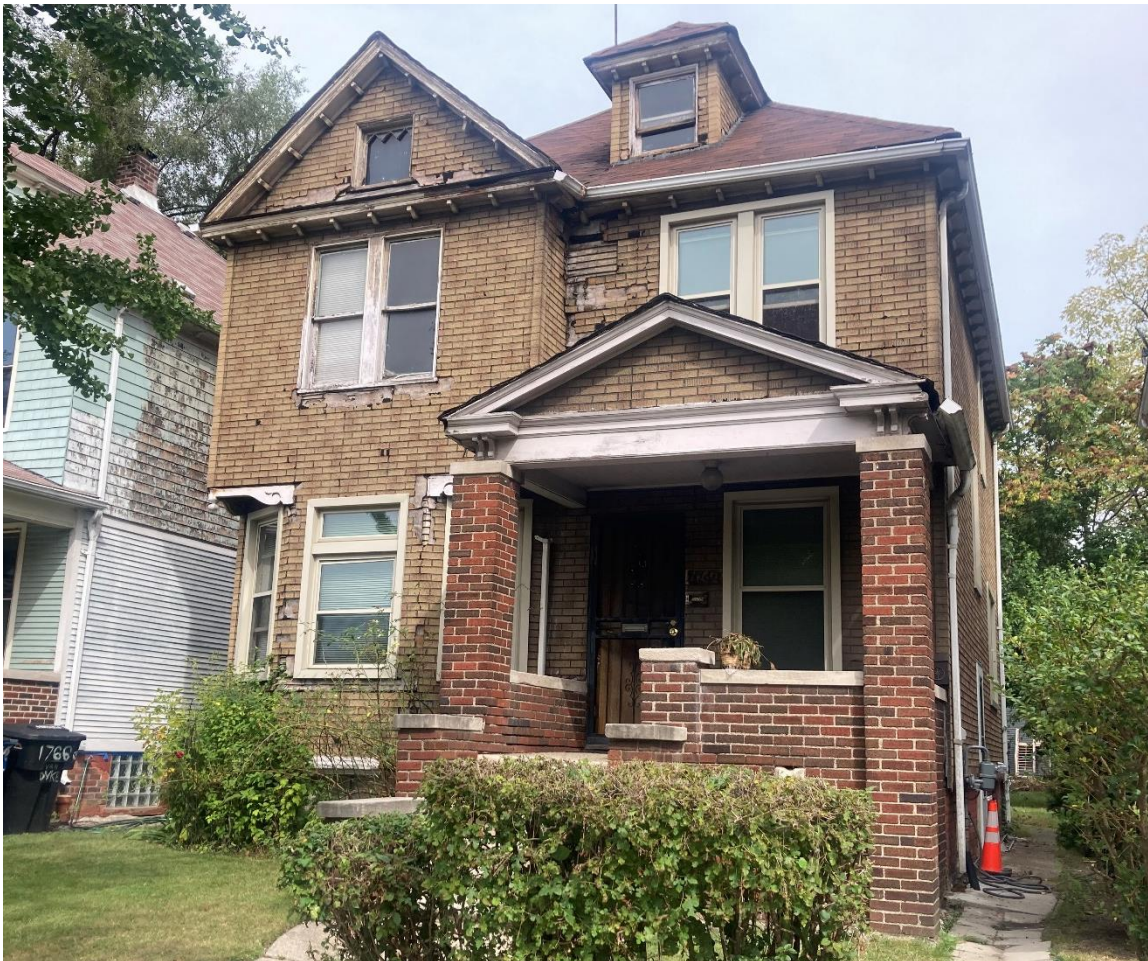
1760 Van Dyke, current appearance (staff photo taken 11/30/2023)

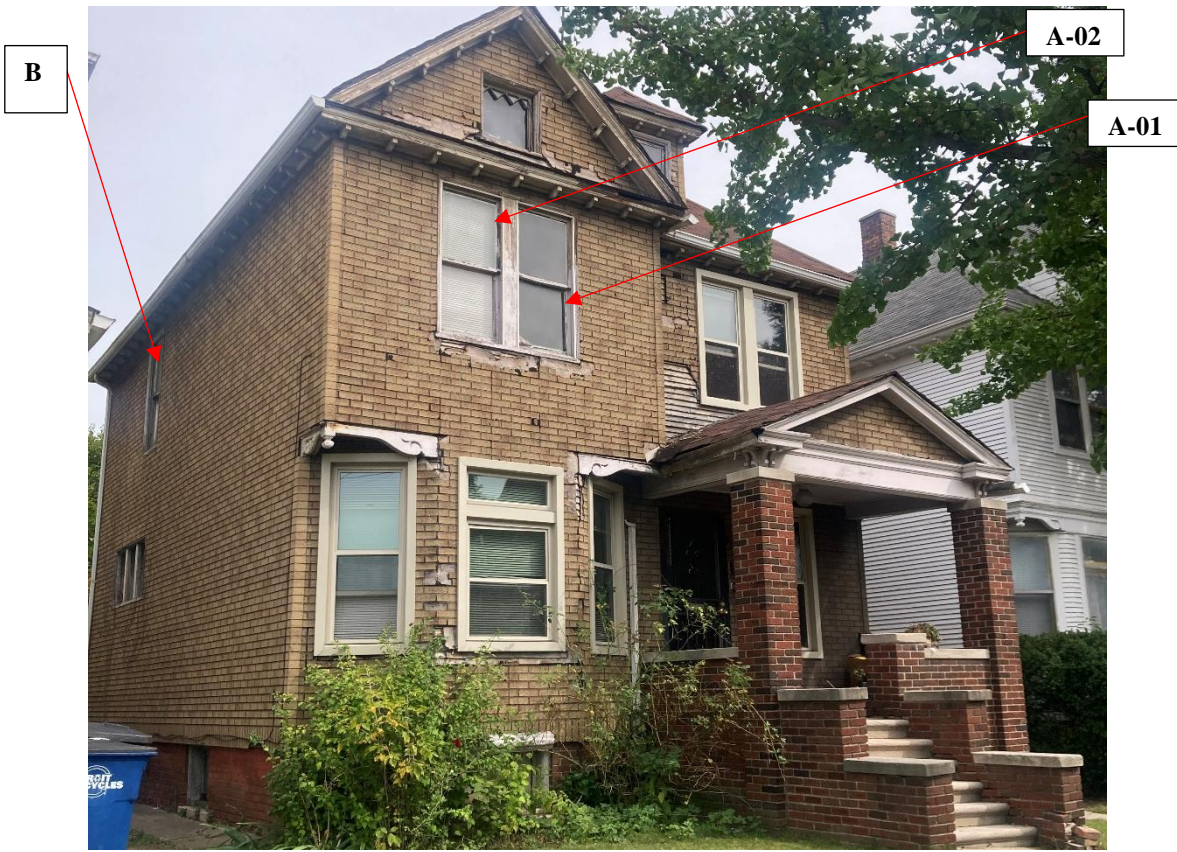
Staff photo taken on 10/3/2024. Front and side wall

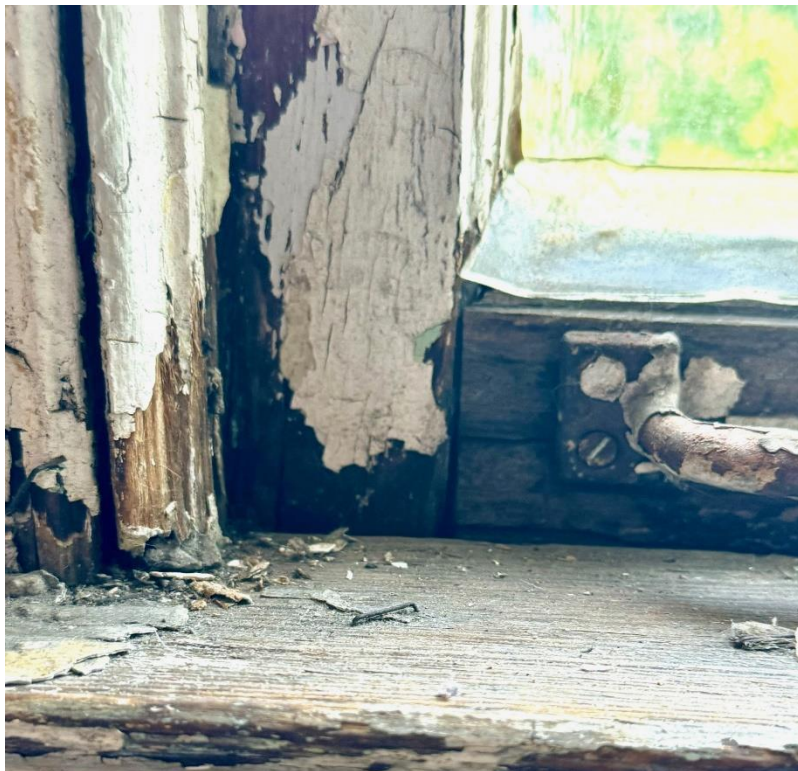
Deterioration at corner of WINDOW A-01. 10/30/2024 HDC staff

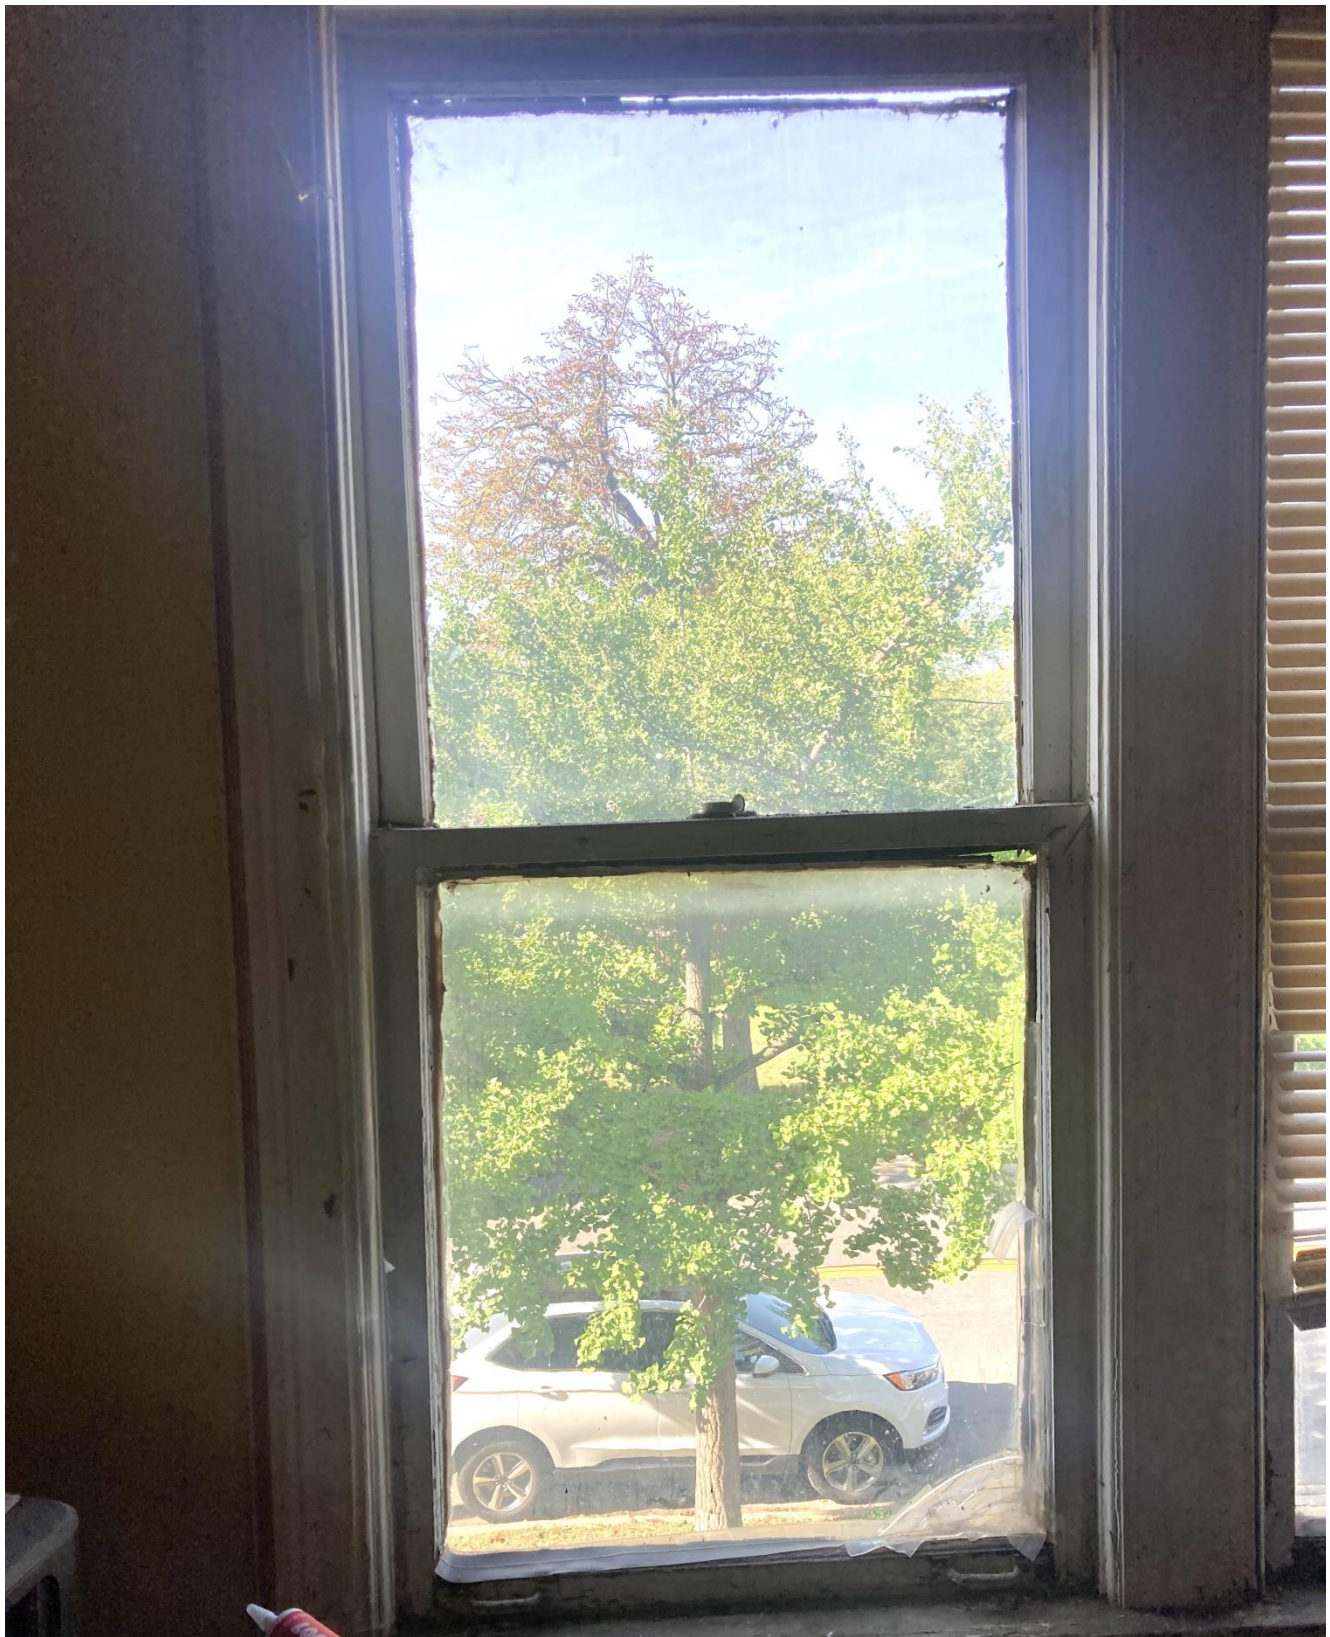
WINDOW A-01 –Gaps at top and sides glass pane in both bottom and top sash; large hole at the corner of the glass pane at the bottom sash. Wood components appear to be in repairable condition 10/3/2024 HDC staff

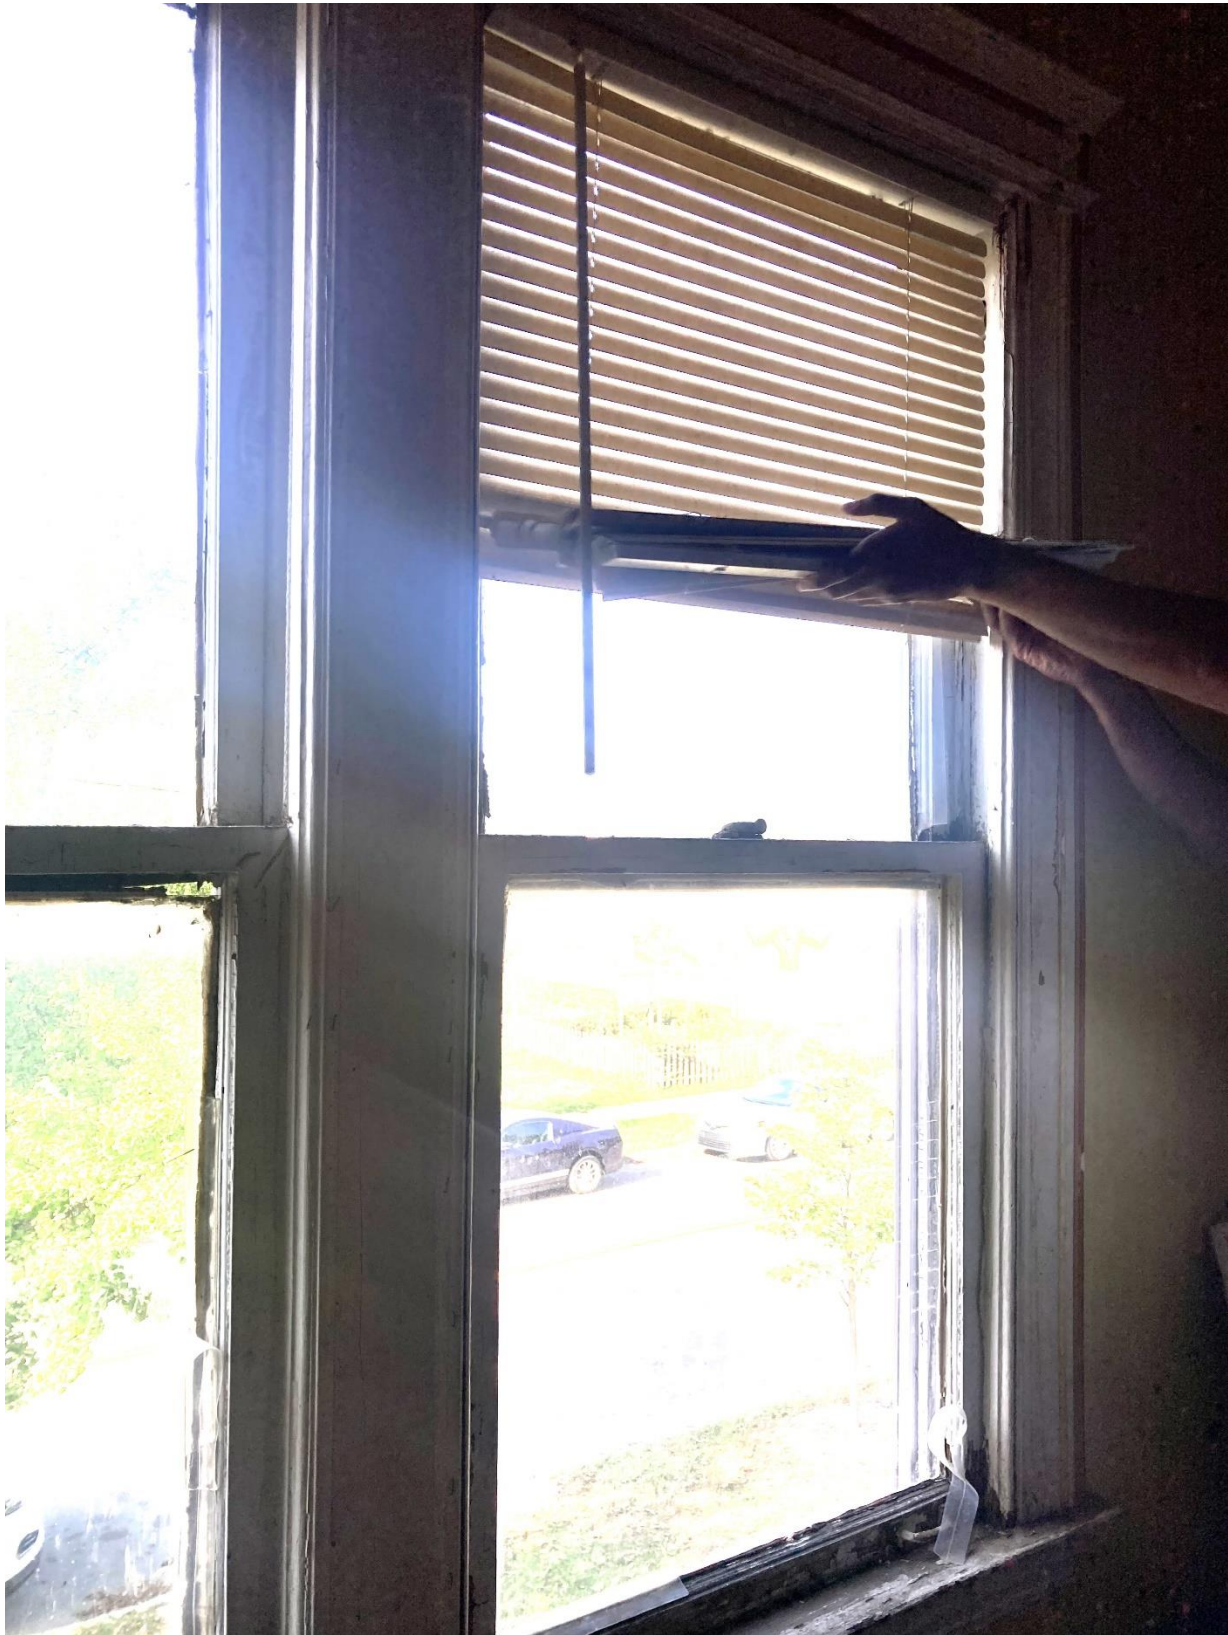
WINDOW A-02 – Gaps at sides of glass pane in both bottom and top sash; large hole at the corner of the glass pane at the bottom sash. Wood components appear to be in repairable condition. 10/3/2024 HDC staff

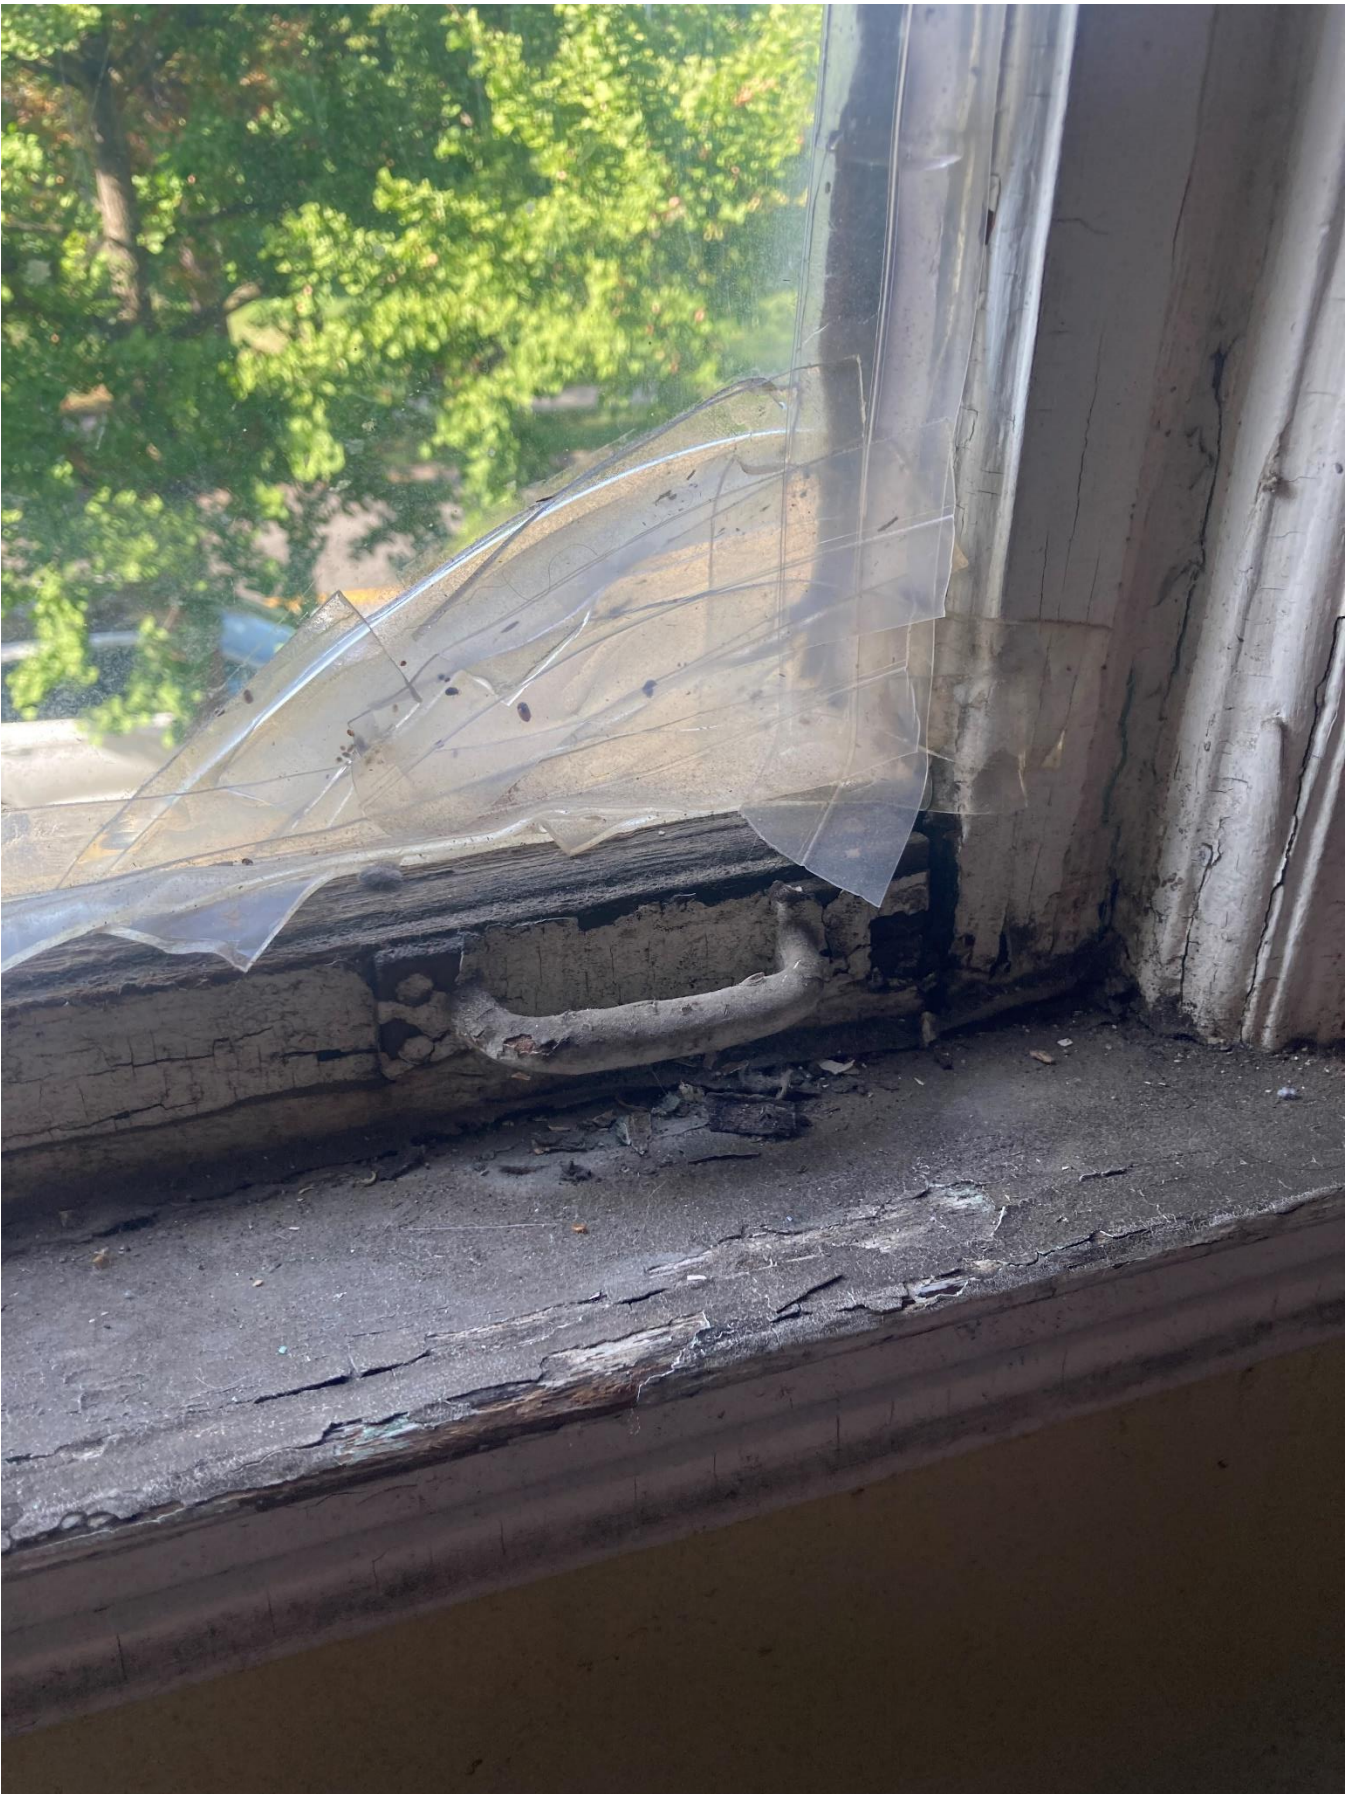
WINDOW A-01 – Large hole at the corner of the glass pane at the bottom sash. 10/3/2024 HDC staff

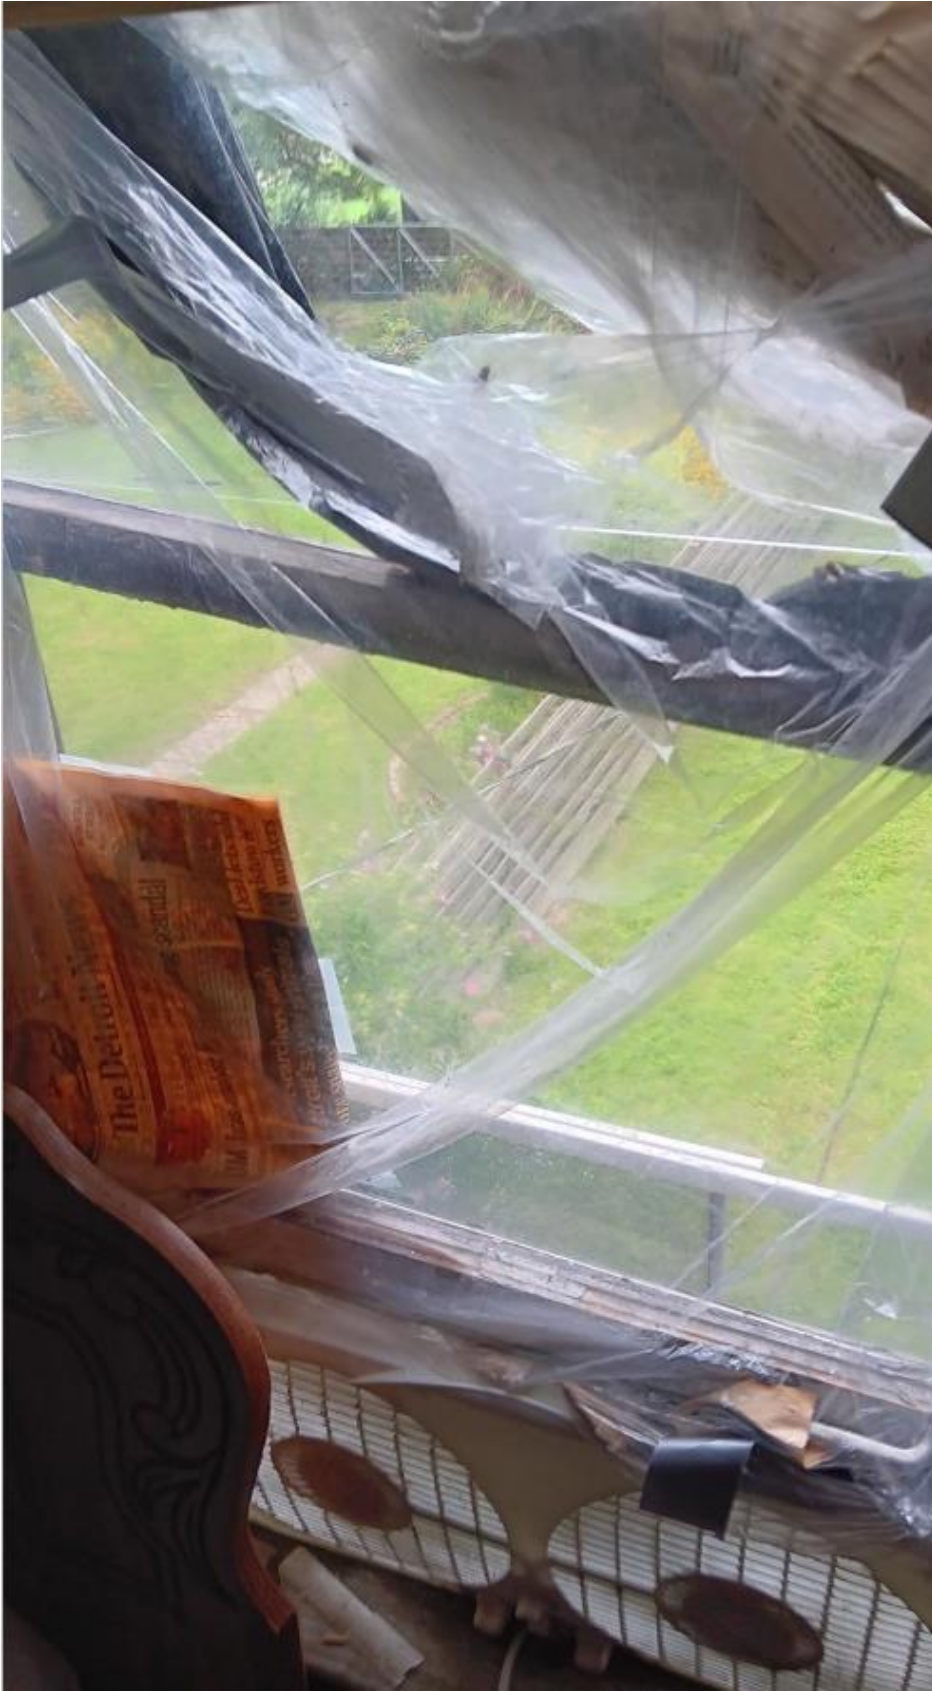
WINDOW D – Covered with plastic due to extreme air infiltration/gaps in glass panes at top and bottom sash; bottom rail at top sash is failing/about to fall off. Other wood components appear in fair/repairable condition. Photo by applicant

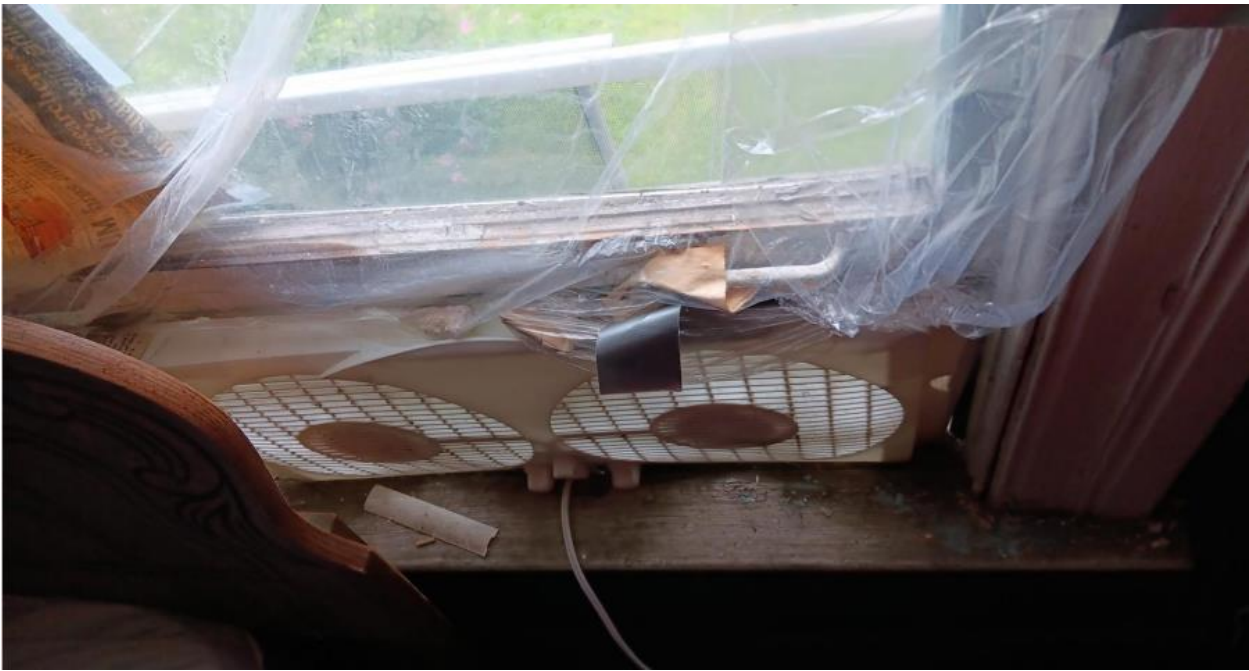
WINDOW D – Covered with plastic Photo by applicant

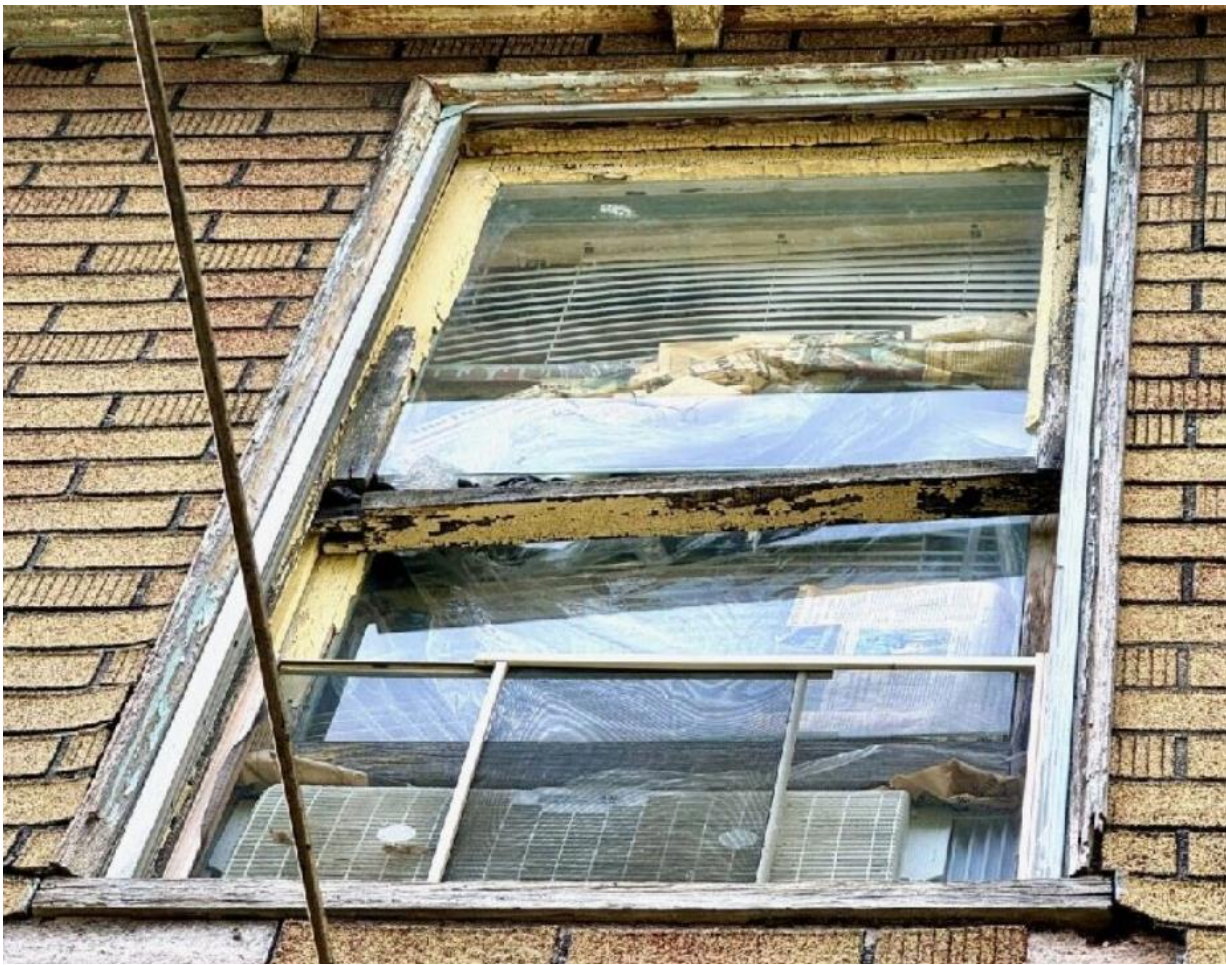
WINDOW D – Note poor/deteriorated condition of the bottom rail of the upper sash. 10/3/2024 photo by HDC staff

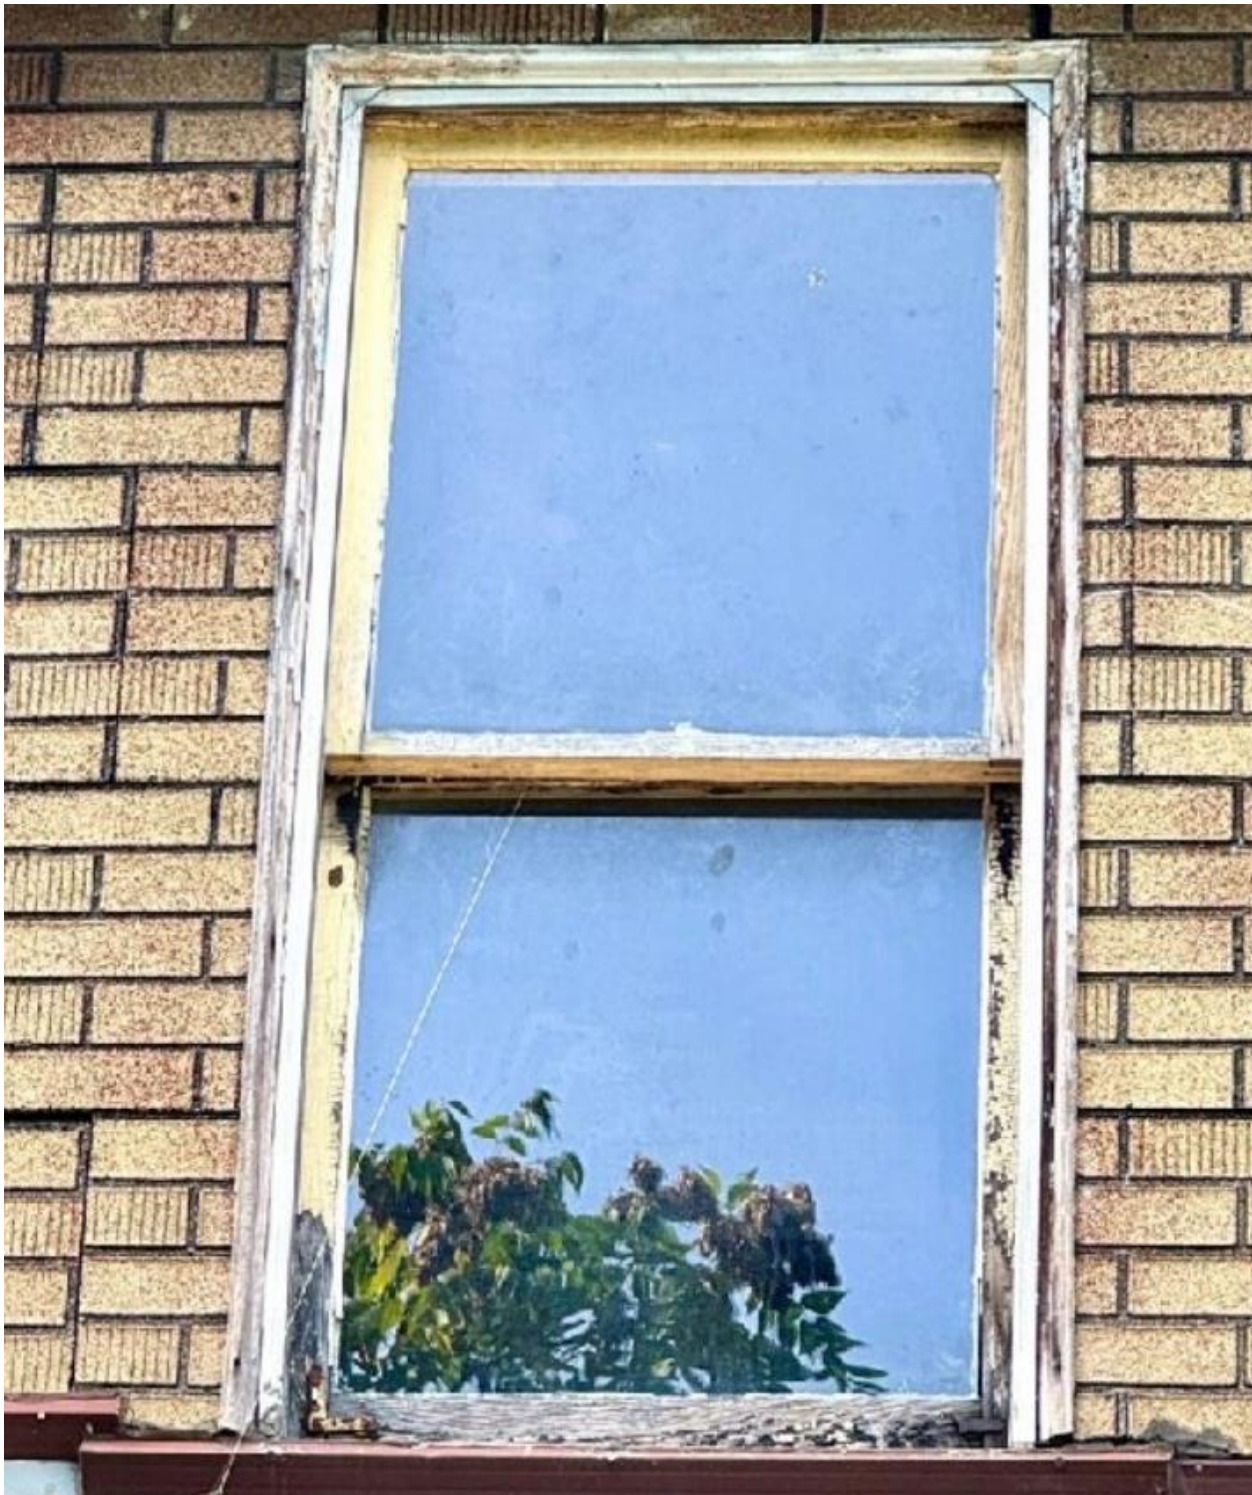
Window E- Photo by HDC staff, 10/3/2024

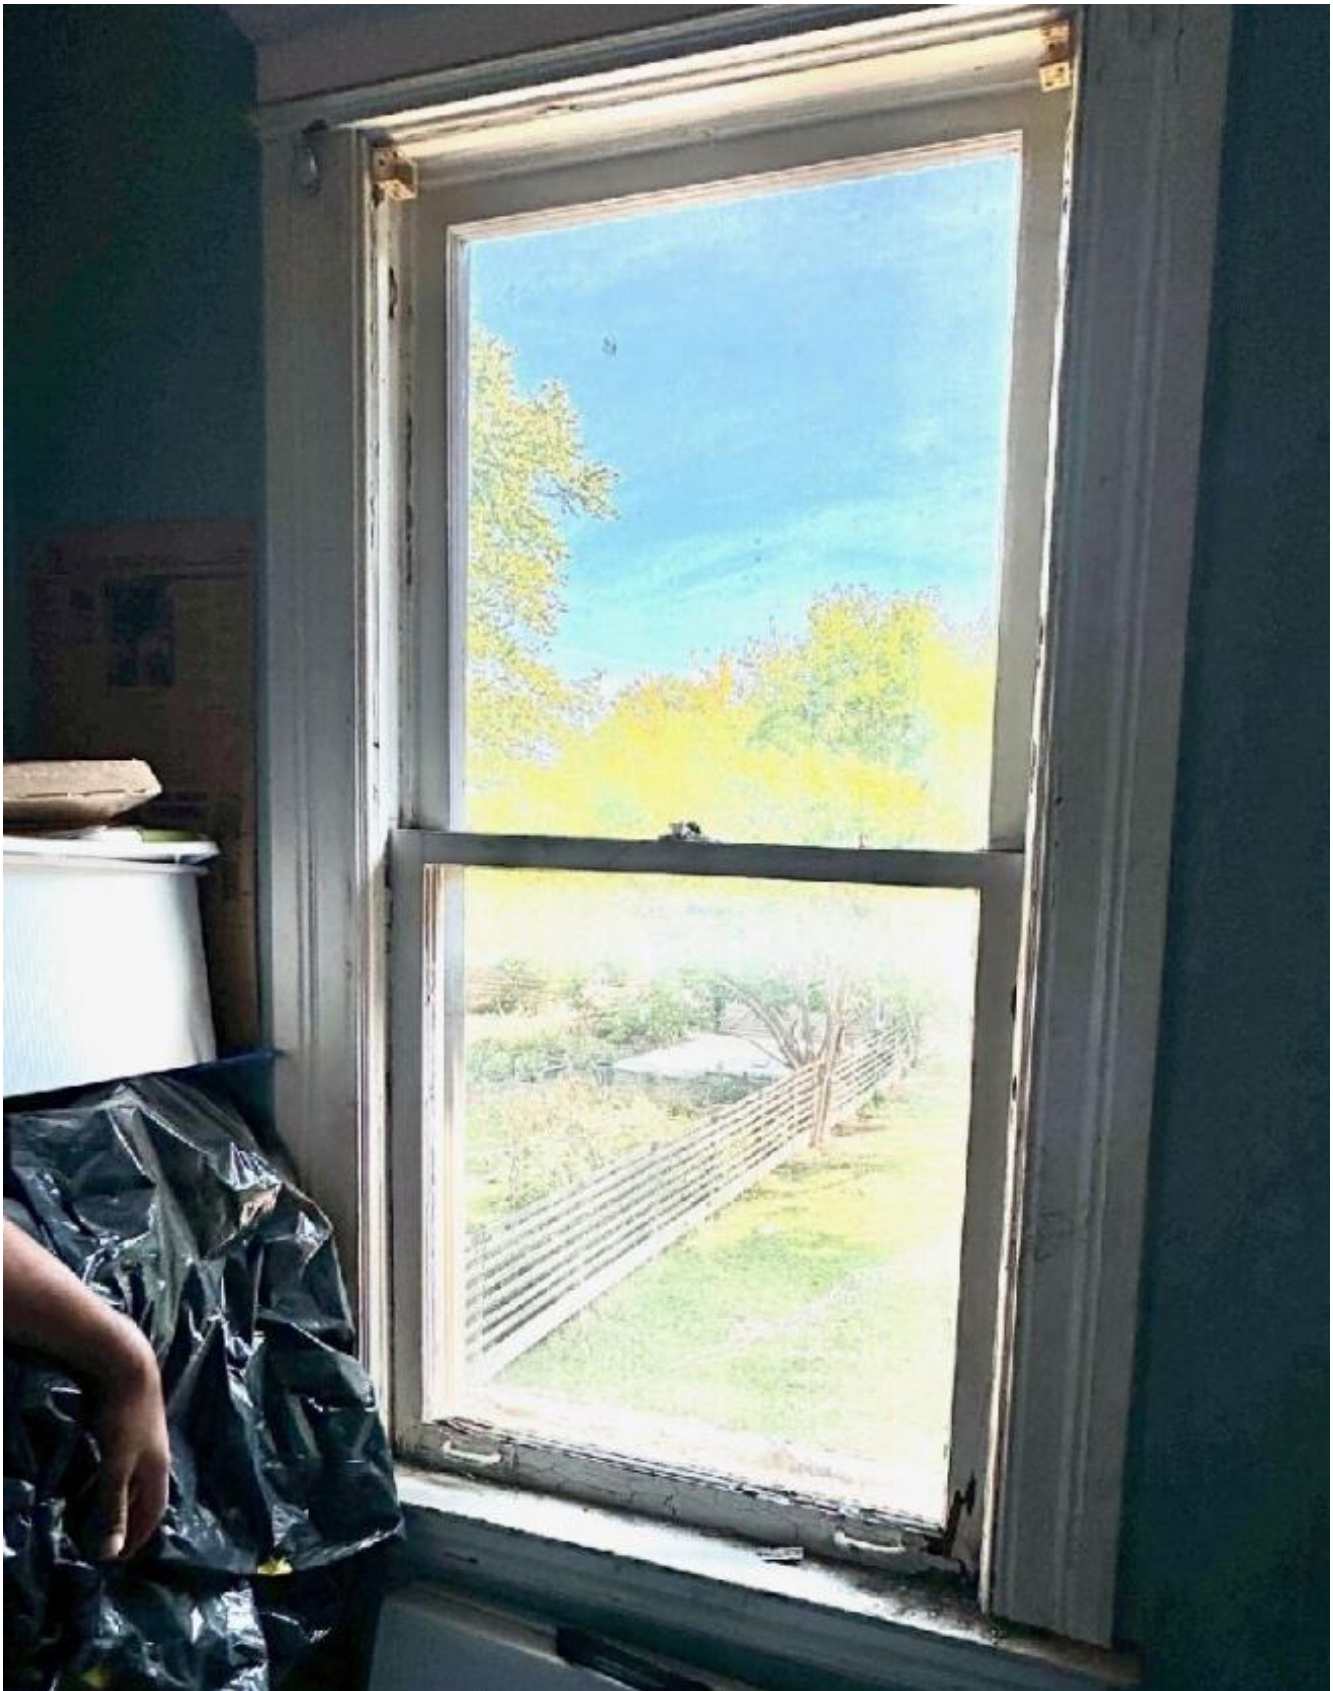
WINDOW E- Photo by HDC staff, 10/3/2024. Wood components in repairable condition with the exception of some rot at bottom rail

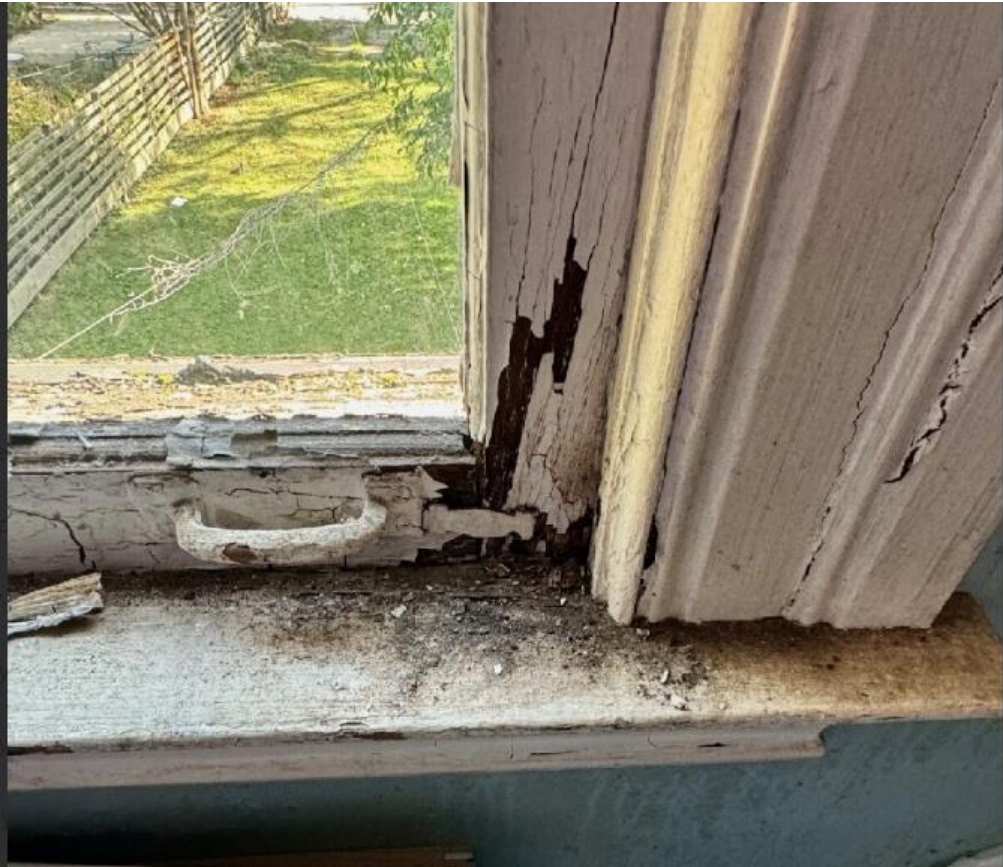
WINDOW E- Photo by HDC staff, 10/3/2024. Area of rot at bottom rail, showing previous repair

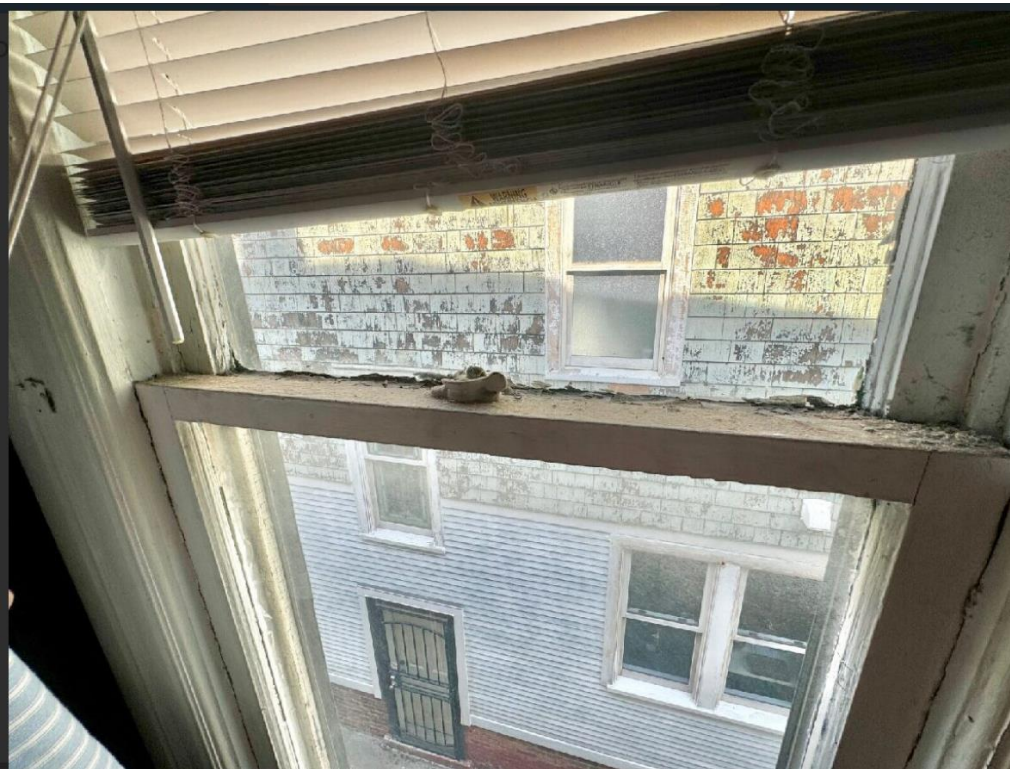
**WINDOW B – Wood components in repairable condition with the exception of “spongy” bottom rail
HDC staff, 10/3/2024**

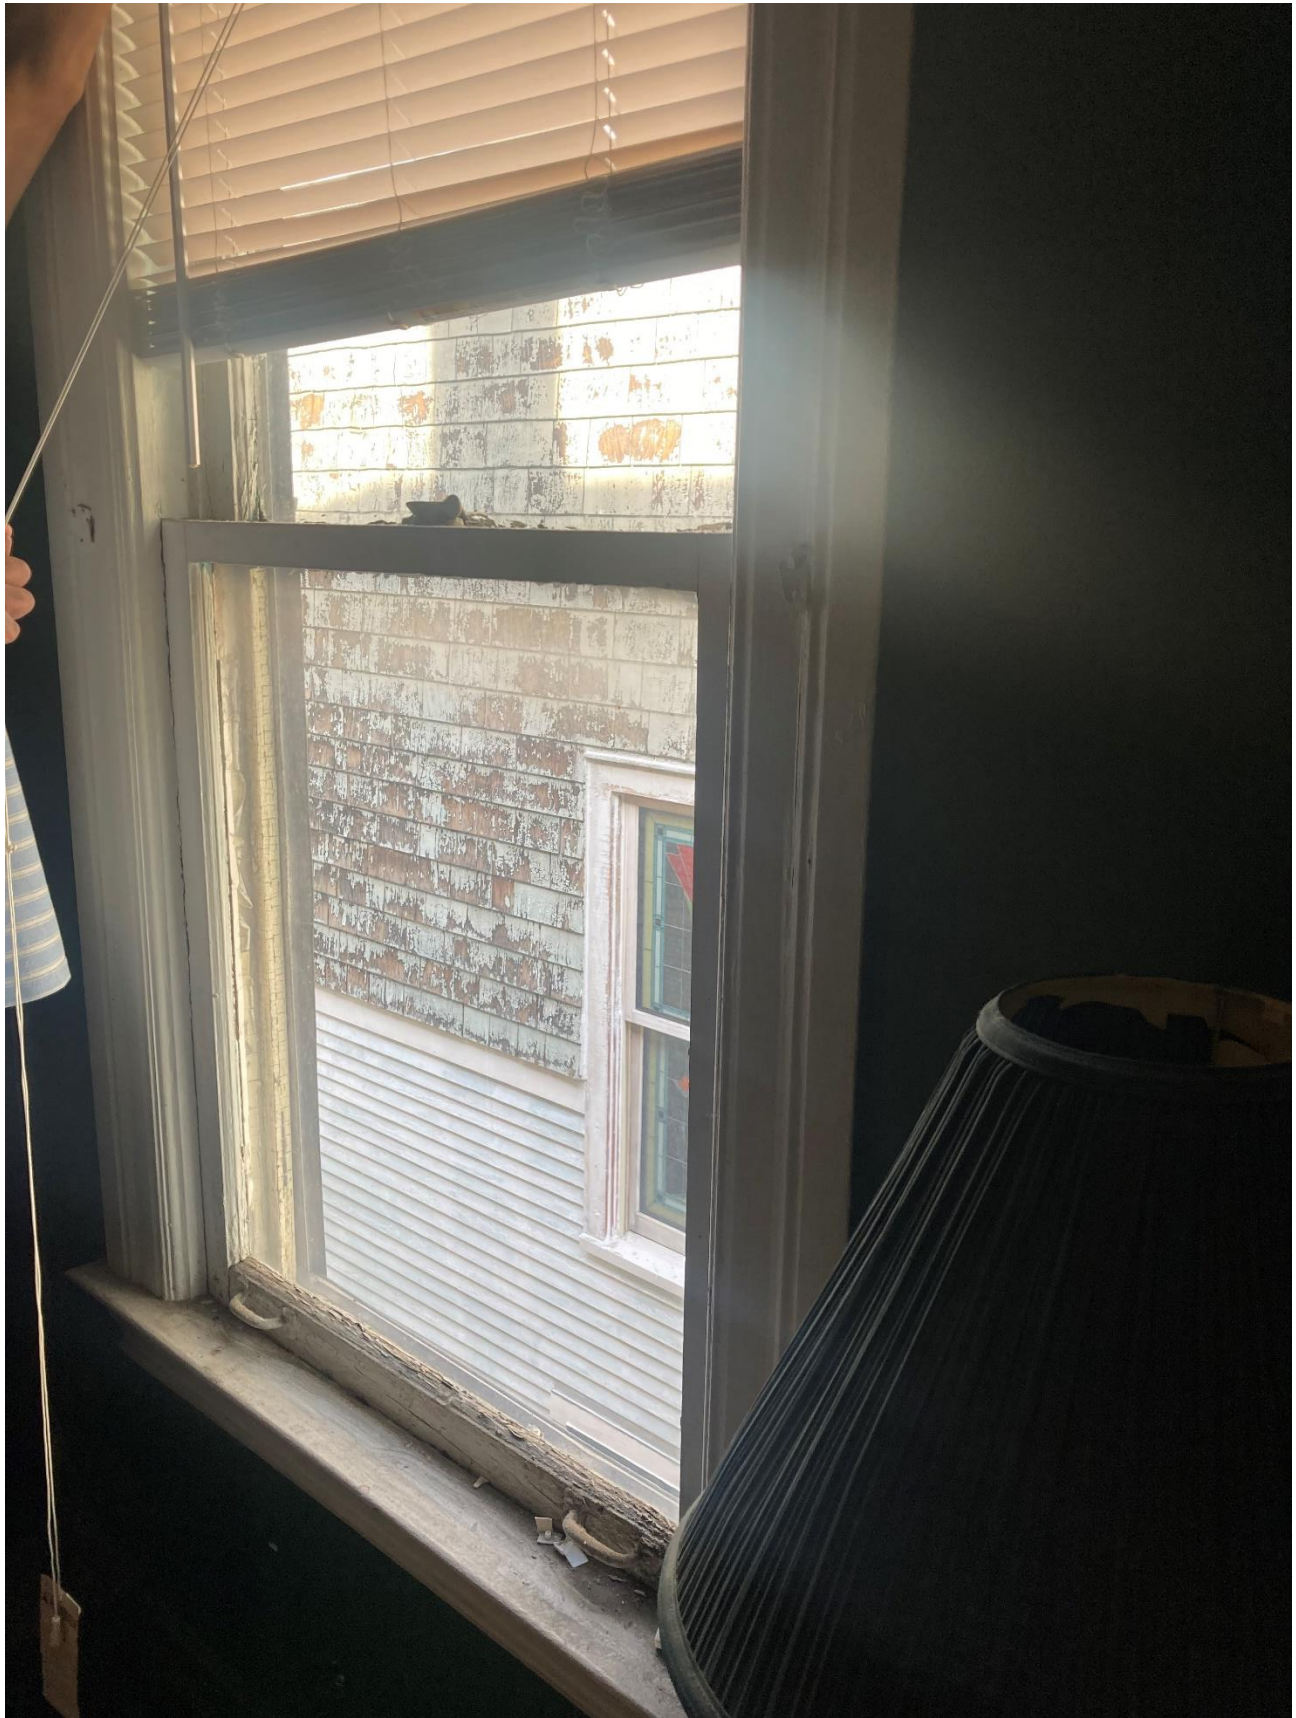
**WINDOW B – Wood components in repairable condition with the exception of “spongy” bottom rail
HDC staff, 10/3/2024**

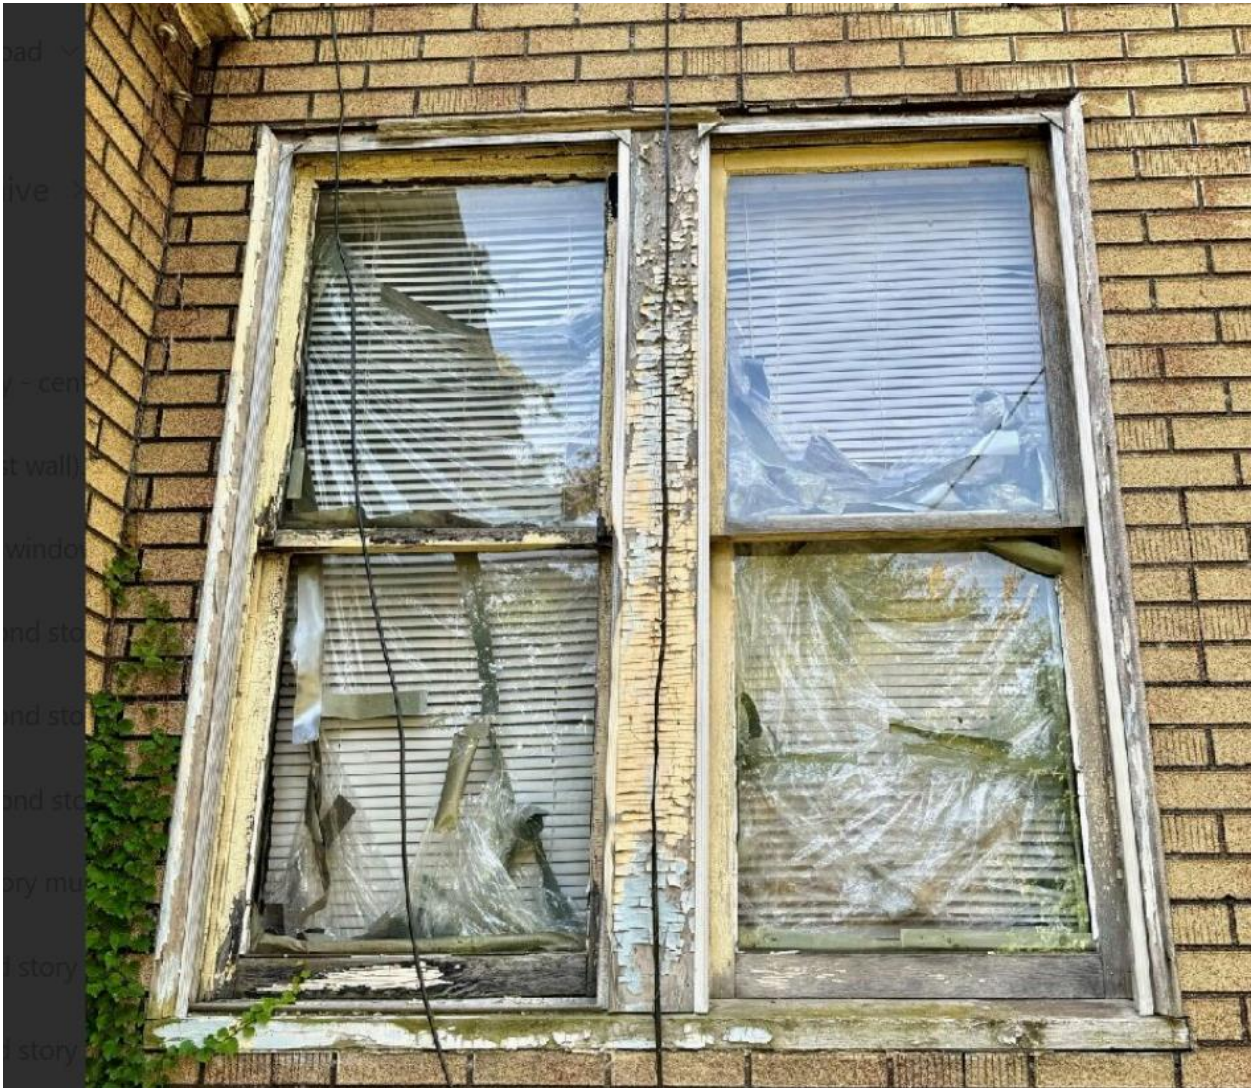
WINDOW C – No interior photos taken due to plastic covering, Staff noted that the wood components at these windows are in good condition.
