**ADDENDUM: OCTOBER 09, 2024 MEETING**  
**APPLICATION NUMBER: 22-8012**  
**ADDRESS: 1556 BAGLEY**  
**HISTORIC DISTRICT: CORKTOWN**  
**APPLICANT: BROOKE SCHWARTZ**  
**PROPERTY OWNER: BROOKE SCHWARTZ**

**SCOPE: REPLACE WINDOWS AND TRIM, INSTALL SIDING, REMOVE PORCH DETAILS (WORK DONE WITHOUT APPROVAL)**

### **Historic District Commission Review – Rehabilitation of House**

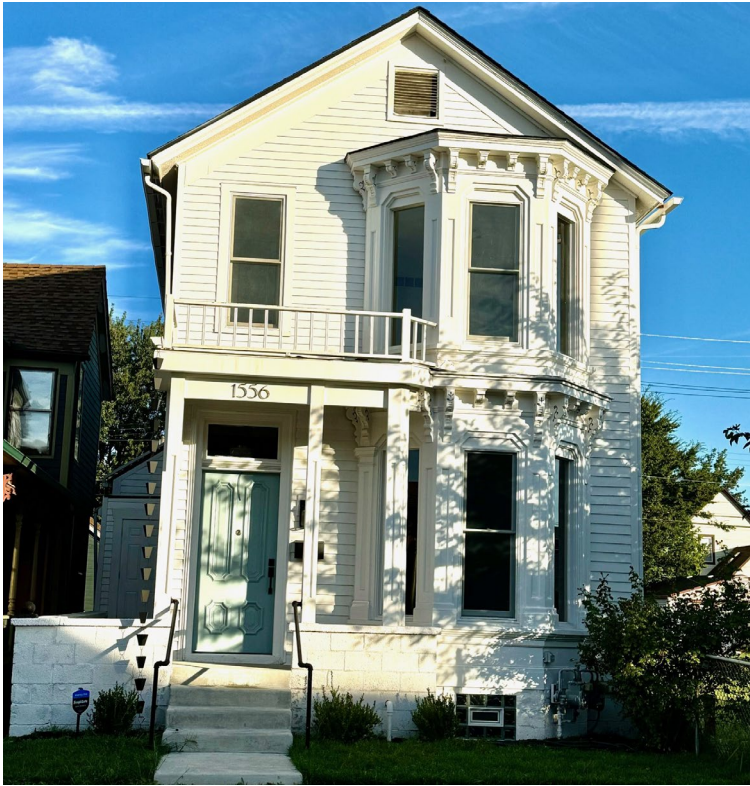
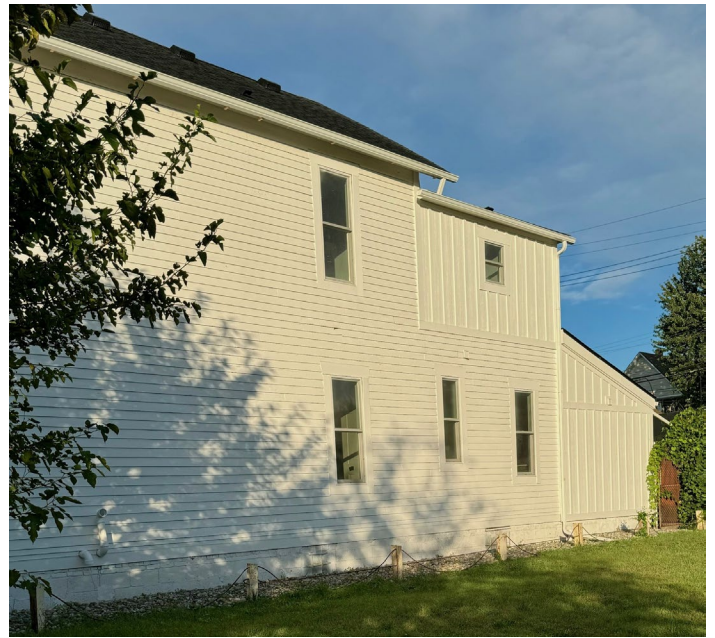
*Staff photos, October 2, 2024*

On October 2, staff visited the property to document current conditions and noticed that the historic double-hung windows in the two-story bay had been replaced. Therefore, the current work items before the Commission include:

- Installation of board-and-batten siding at rear
- Removal of the 19<sup>th</sup> century window casings and installation of uniform flat window casings
- Removal of decorative element to the left of the front door.
- Removal of decorative brackets at the front porch
- Removal and replacement of historic wood double-hung windows in front, two-story bay window

The only item staff recommends for approval is the installation of the board-and-batten siding. Installation of wood siding that would identically match the 19<sup>th</sup> century lap siding, as well as being seamlessly in plane with the historic siding, would have been difficult to complete. The vertical siding offers a compatible design which also identifies these wall surfaces as new work.

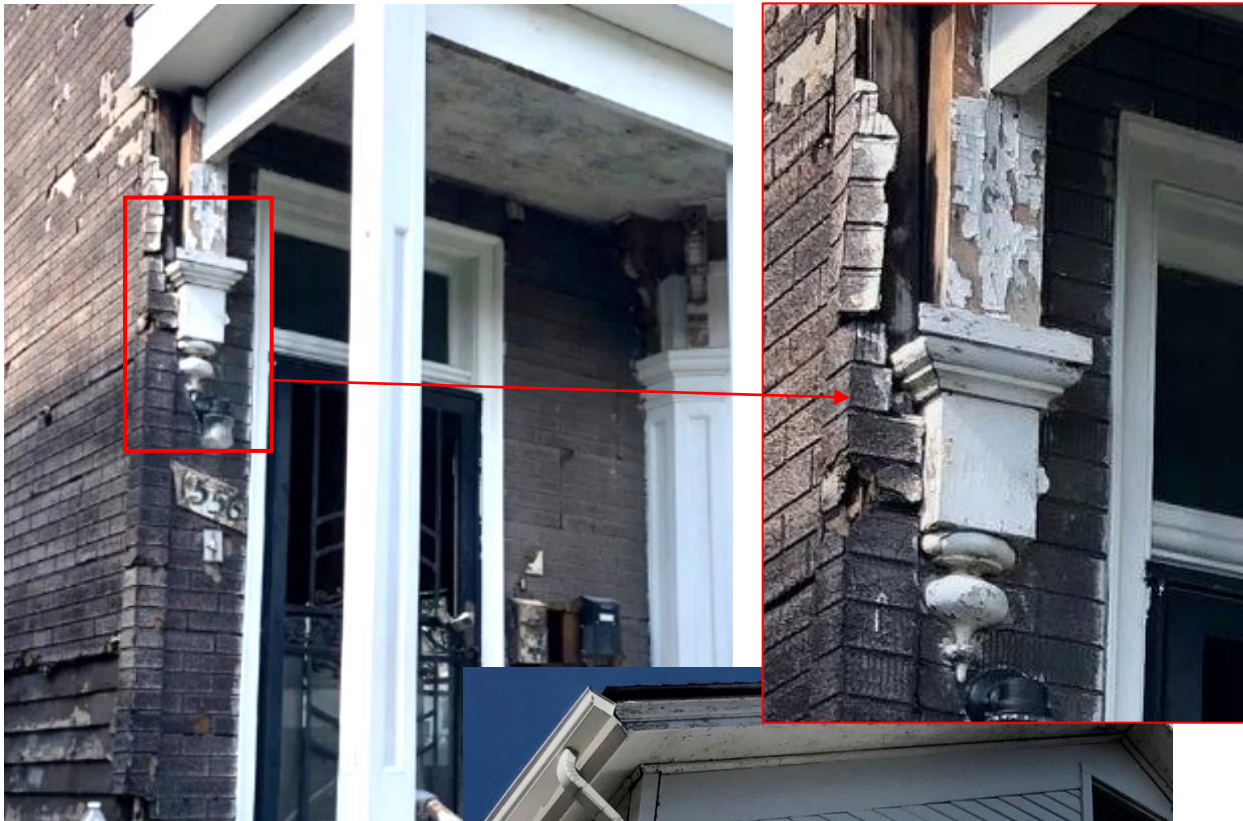
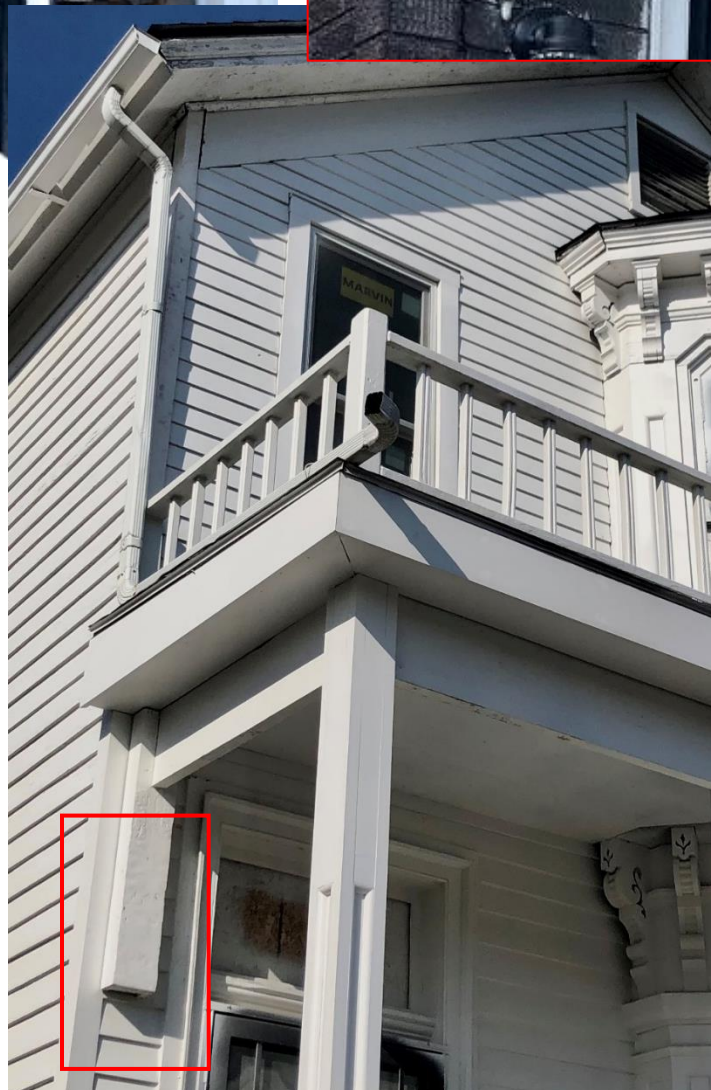
Above: Aug 2023

- Removal of “corbel-like” detail – from a distance this element looks like a corbel, but is comprised of applied trim to create a top and a separate rounded piece was installed at the bottom of the wood board. The height appears to match the height and general design of the bay window corner column and was in place at time of designation.

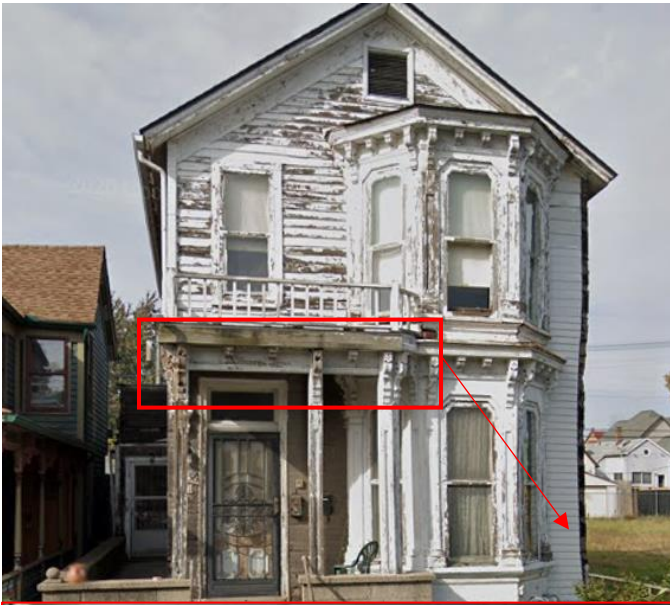
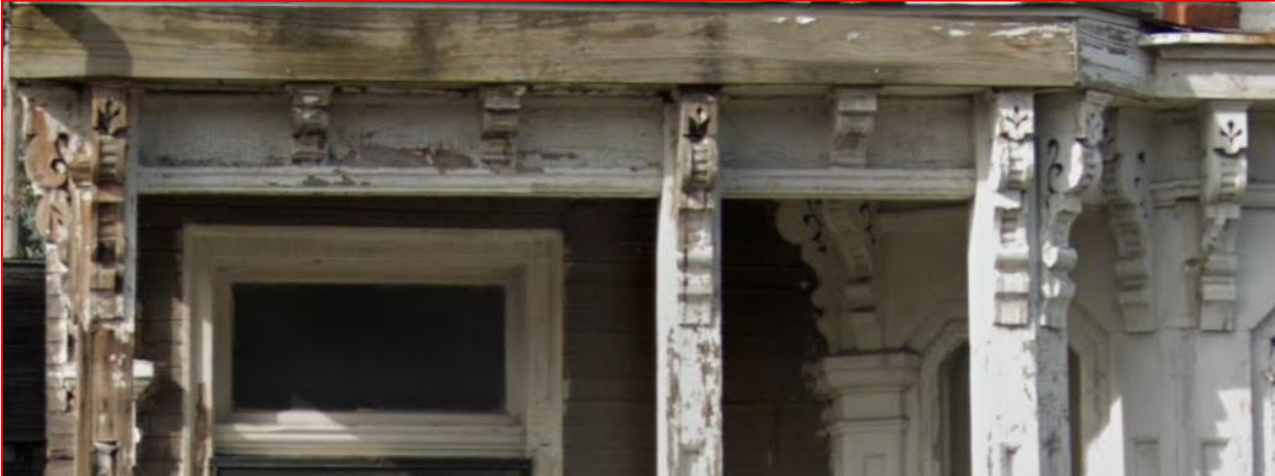
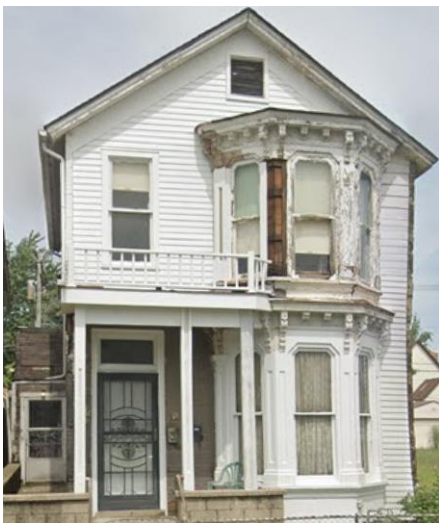
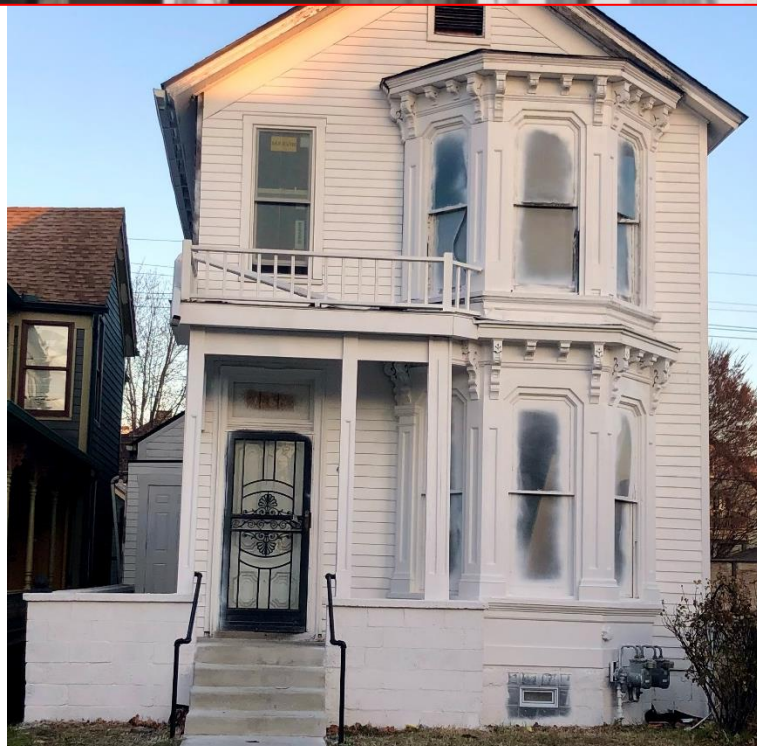
Left and middle: Oct 2020, Google street view  
Below left: August 2021, Google street view  
Below right: Dec 2023

- Decorative brackets at the porch were removed between October 2020 and August 2021. The current owner/applicant was notified of this violation at the time of their September 2022 application.

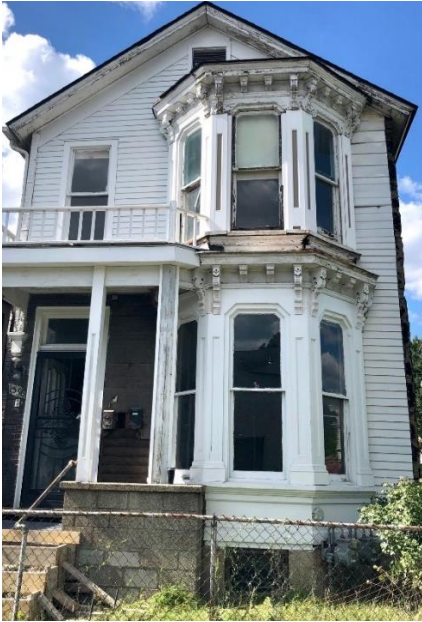
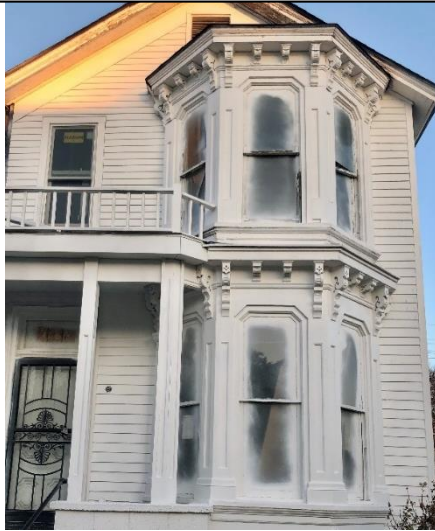
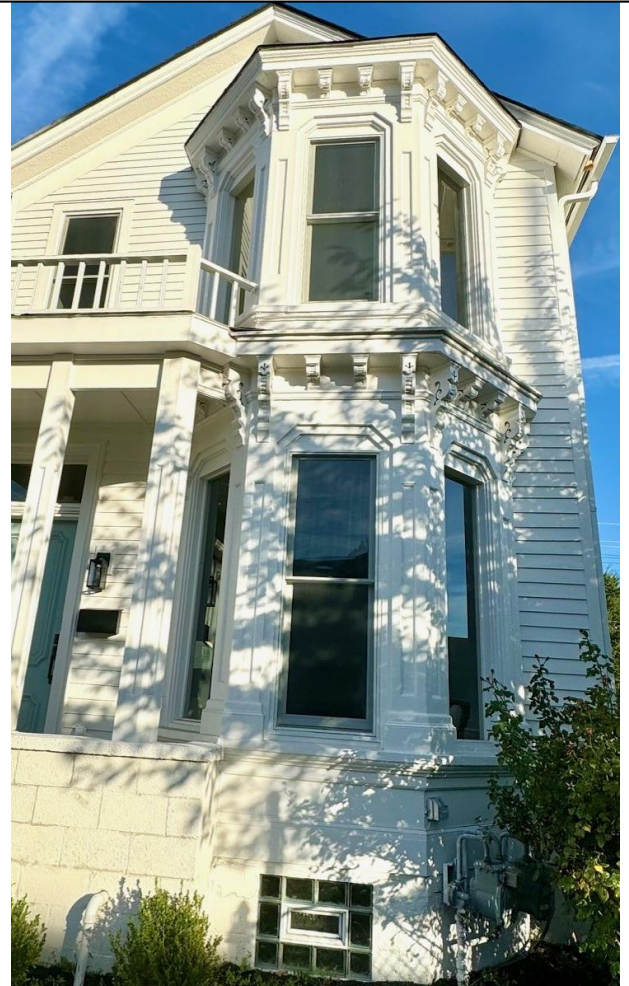
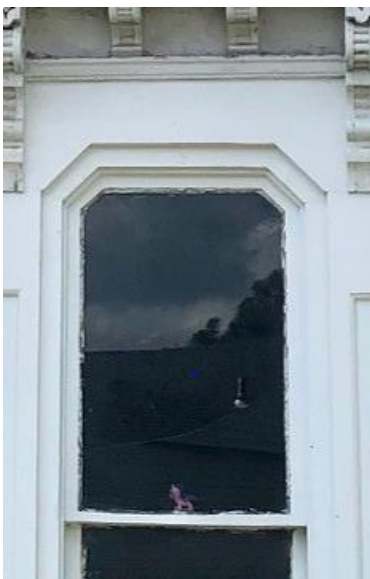
Top left: August 2022 – existing conditions of house at time of HDC September 2022 review

- The historic double-hung windows in the bay were replaced between February and October 2024). Central bay windows are single or double-hung; angled openings have fixed full-glass windows. Standard rectangular windows were installed, and wood framing installed to fill the remaining window openings.
- The September 2022 application stated the windows and doors on the front elevation would be “refurbished”. The applicant requested (and received HDC approval for) the replacement of the remaining windows on the house, including the single double-hung opening on the façade (above the front door).
- Glass block windows were installed.

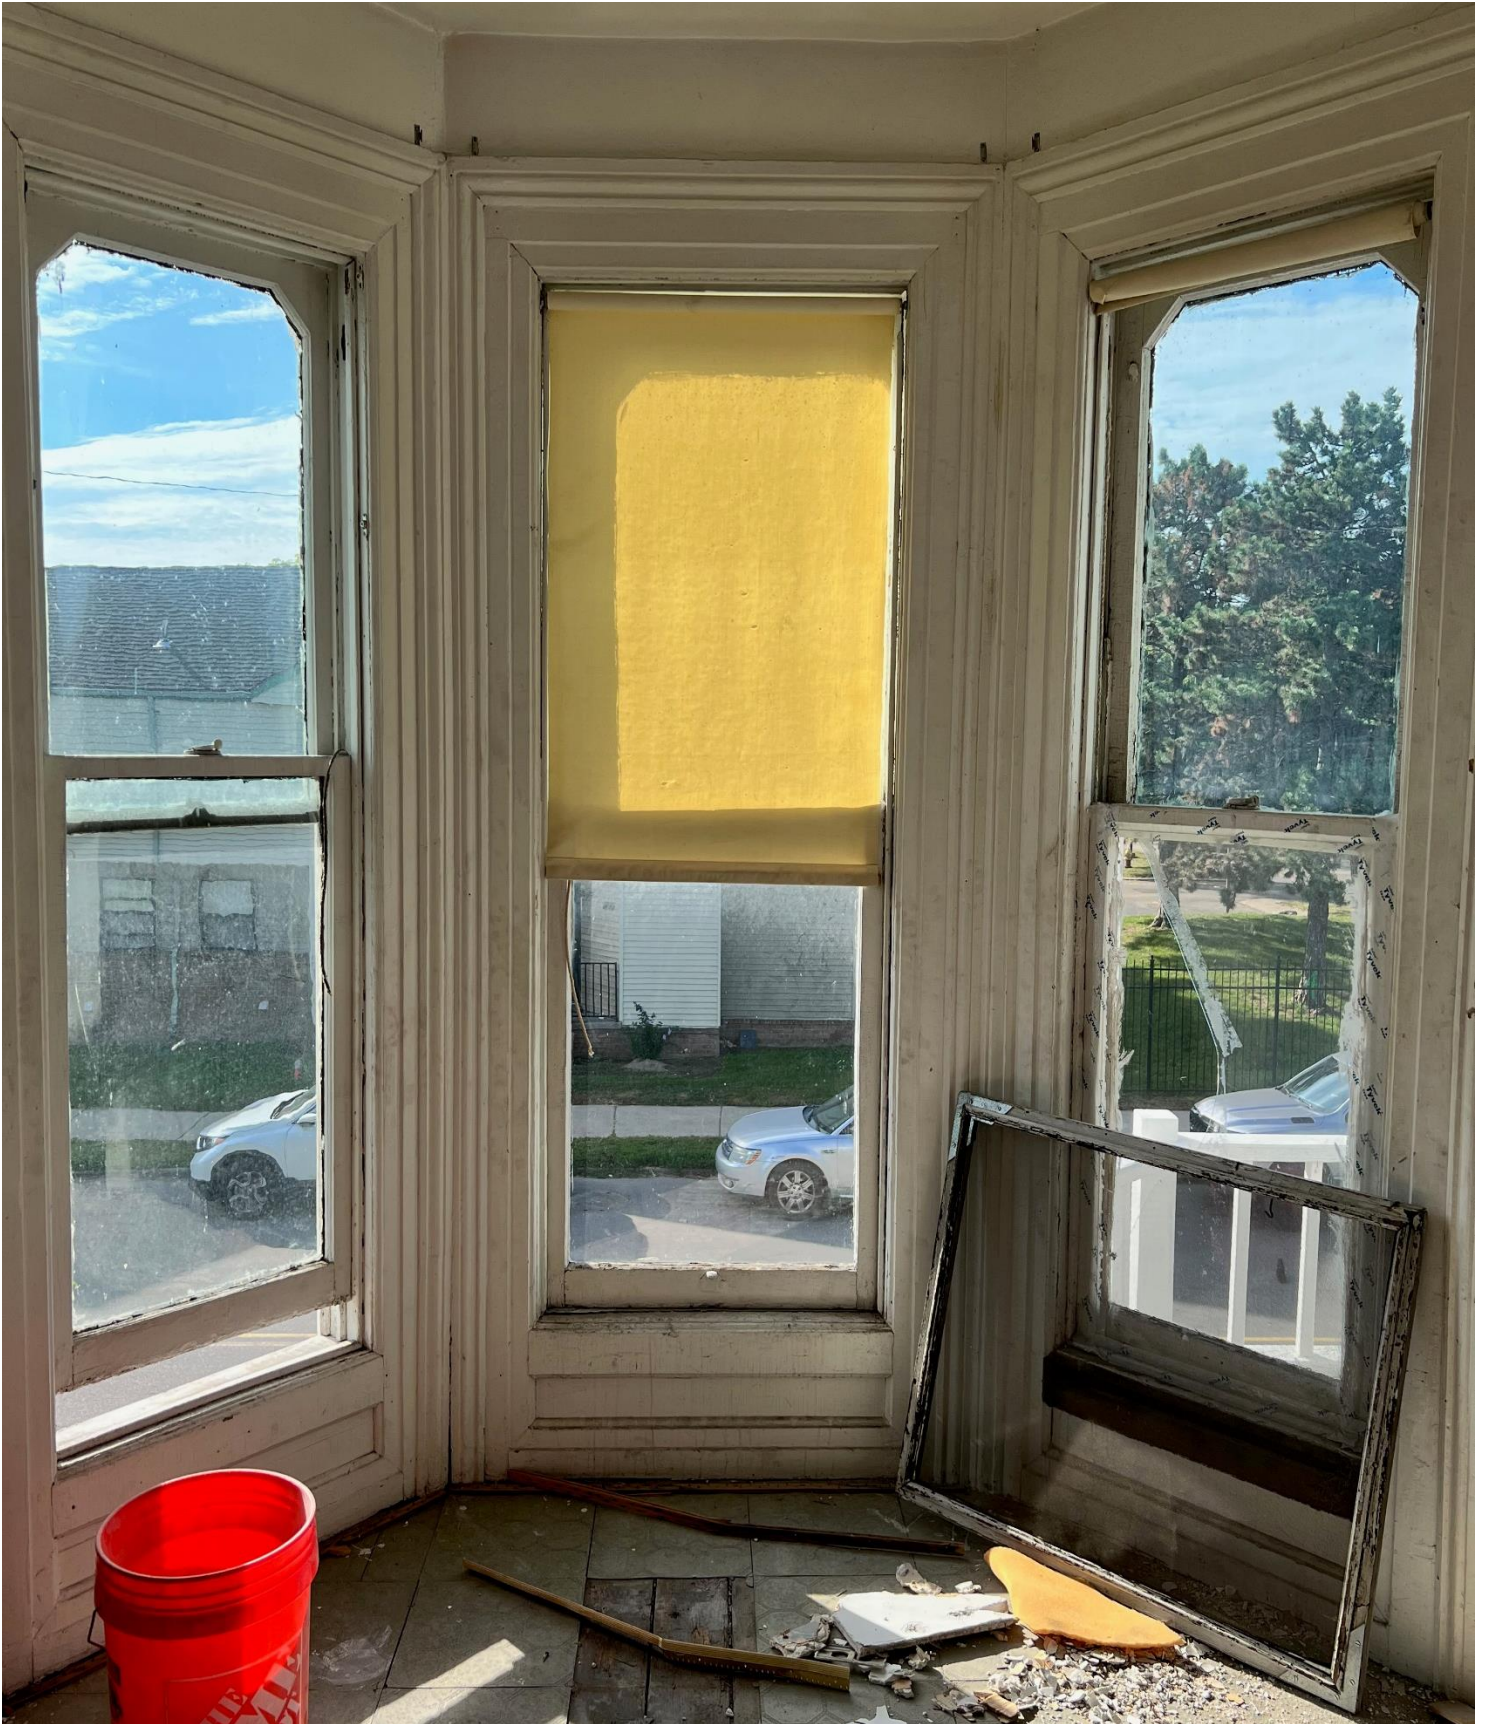
First floor bay windows – interior – historic windows

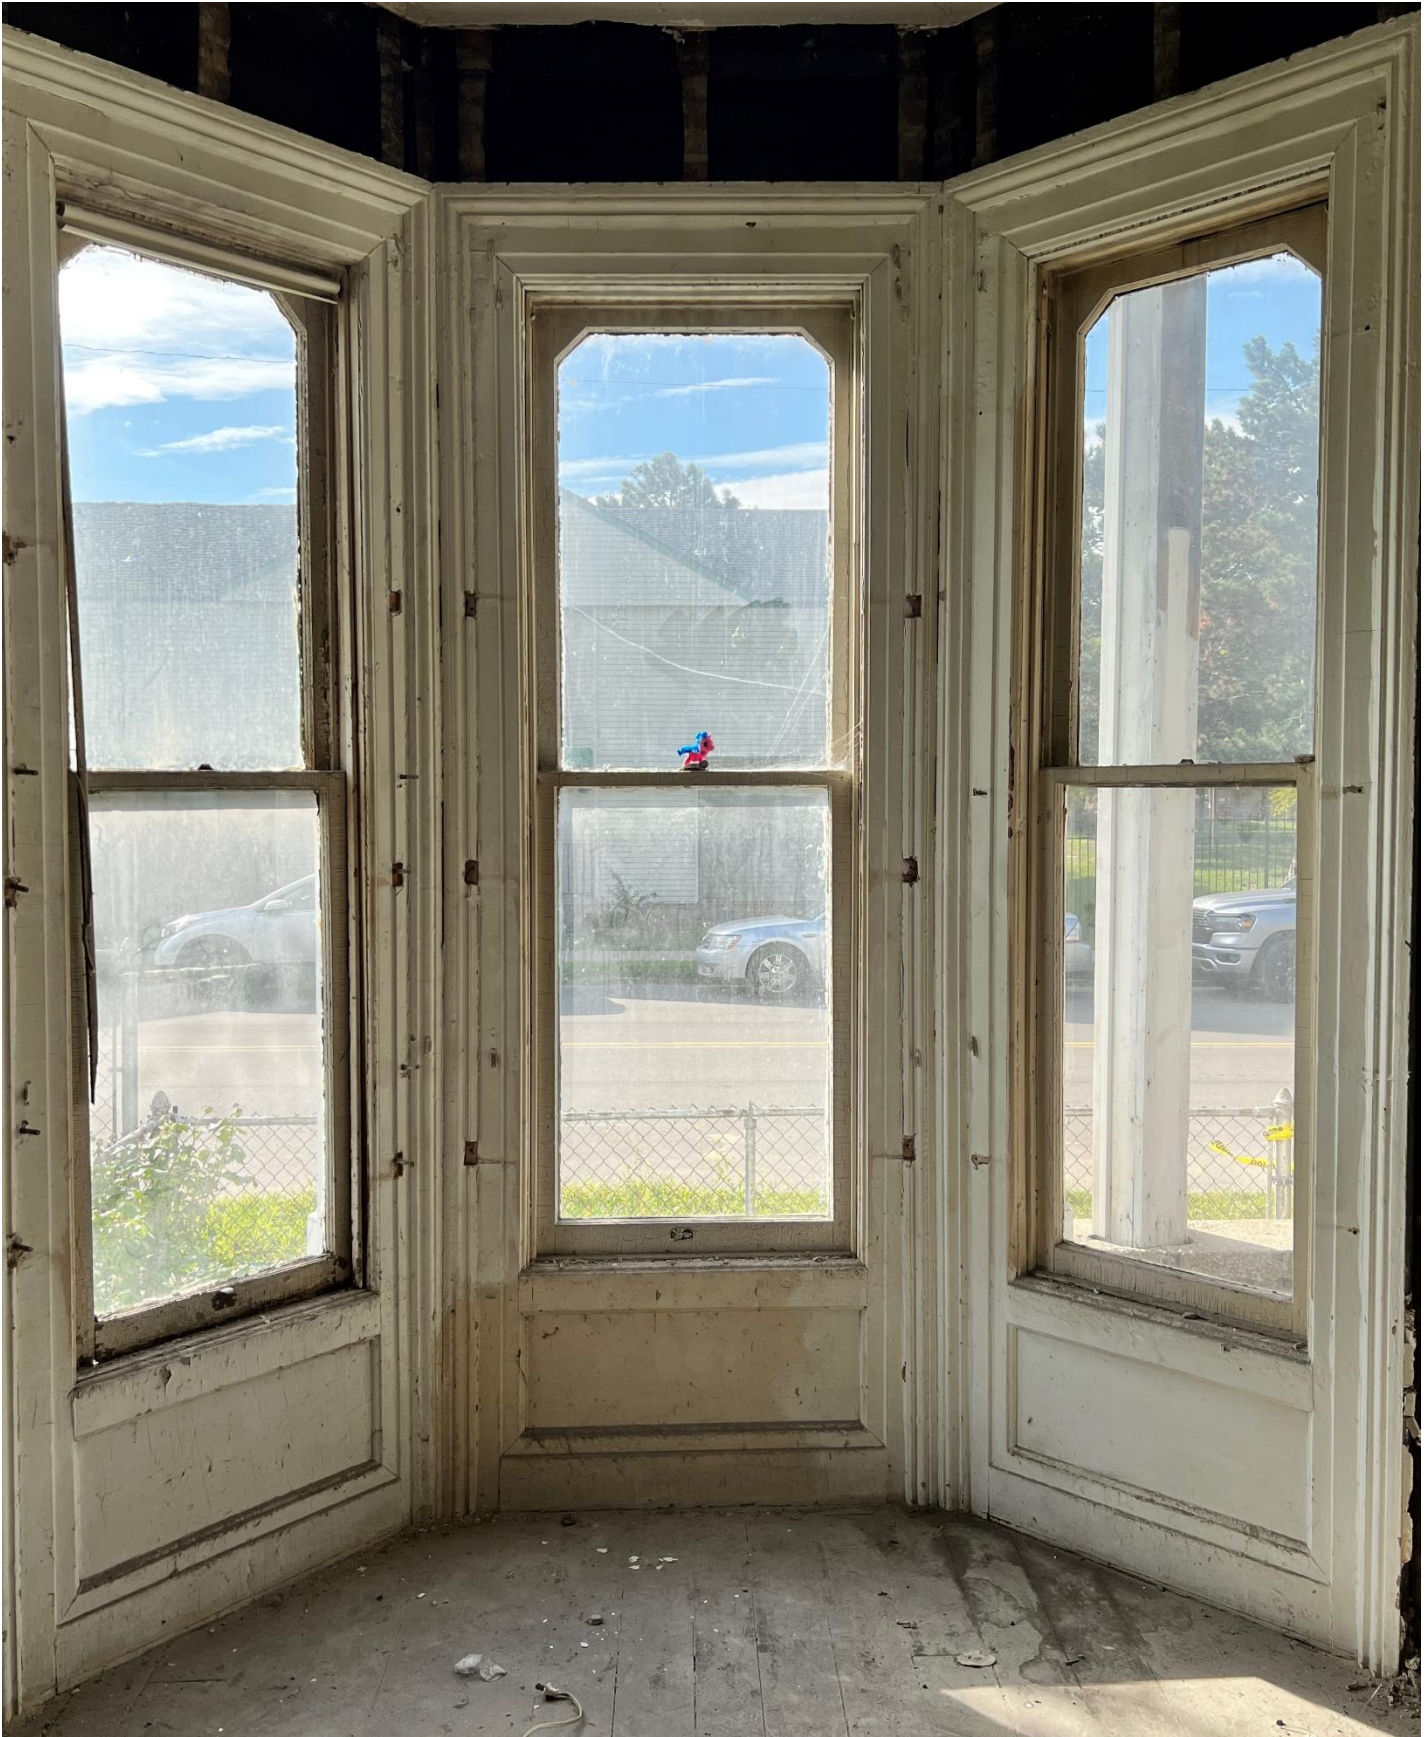
First floor bay windows – interior – historic windows

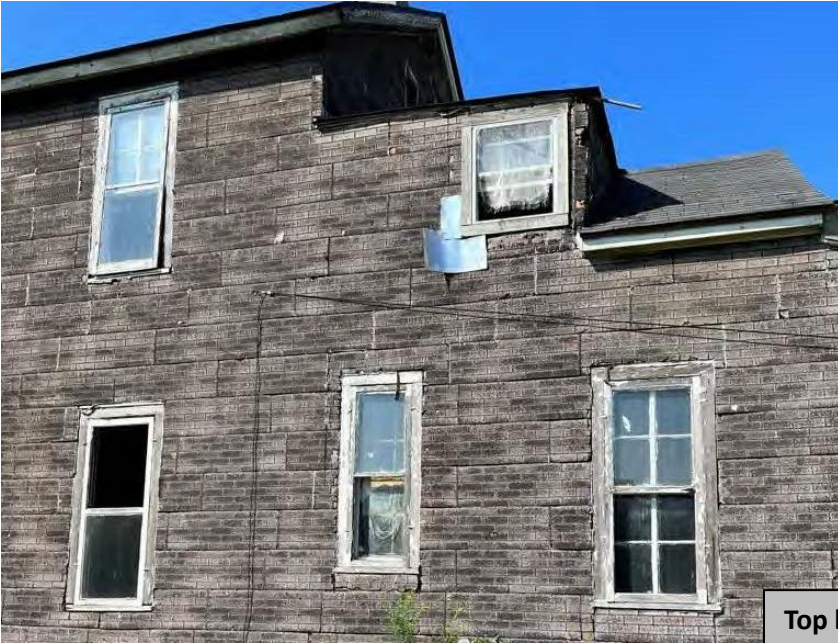
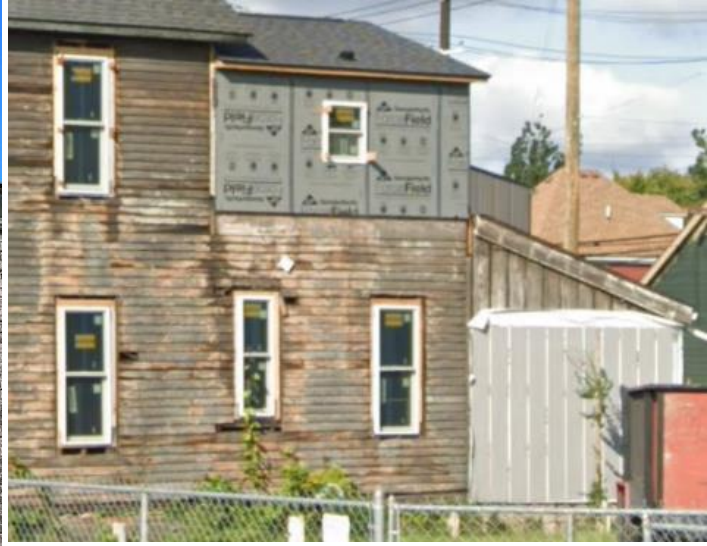
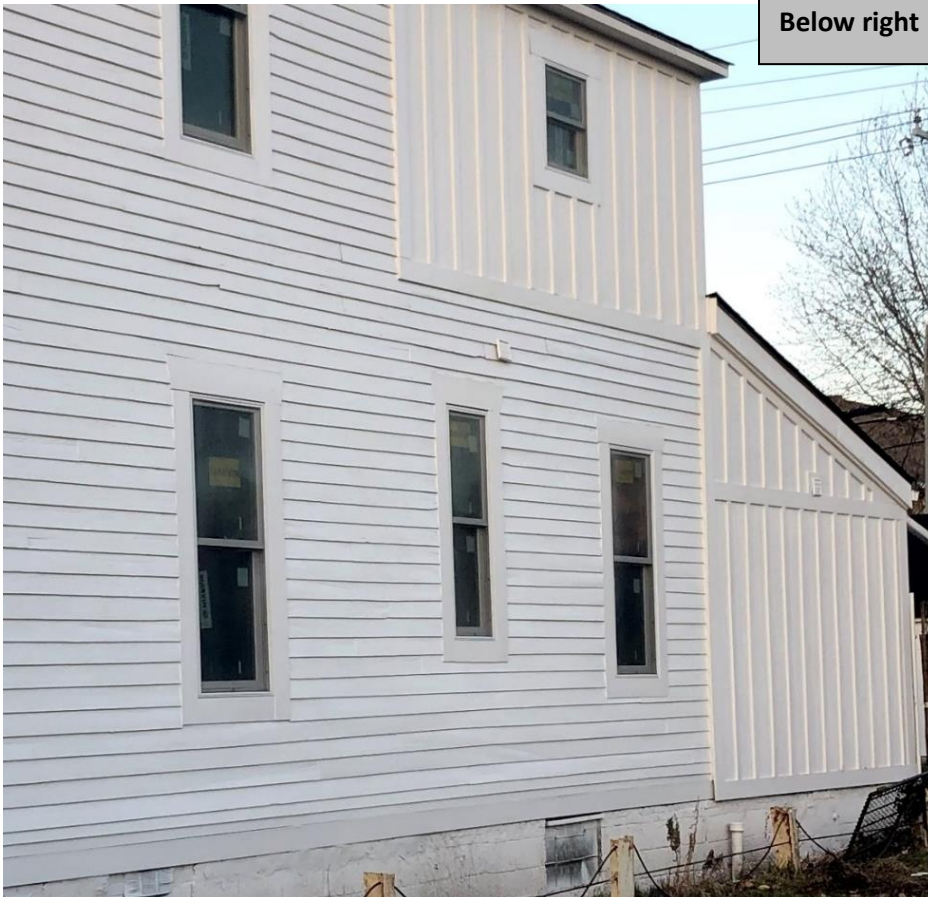
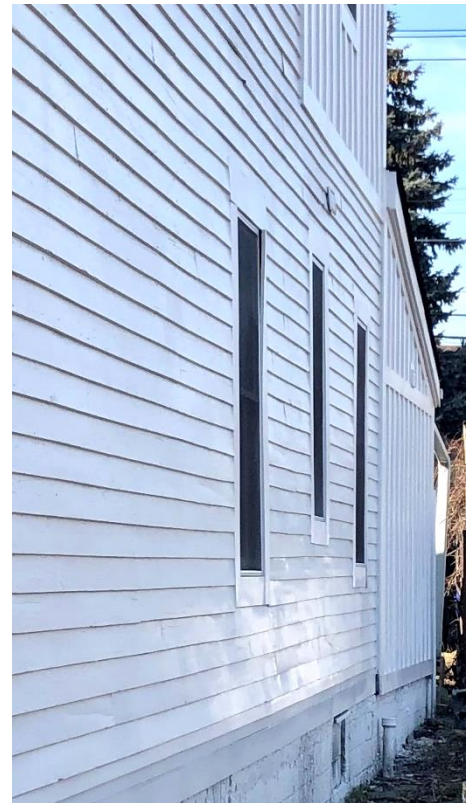
Top left: Aug 2022 – historic window openings/casings in place

- Installation of Board and Batten Cementitious Siding – covering new construction/rehabilitation work at rear
- Removal of historic 19<sup>th</sup> century wood window casings and sills – installation of flat (cementitious?) casings

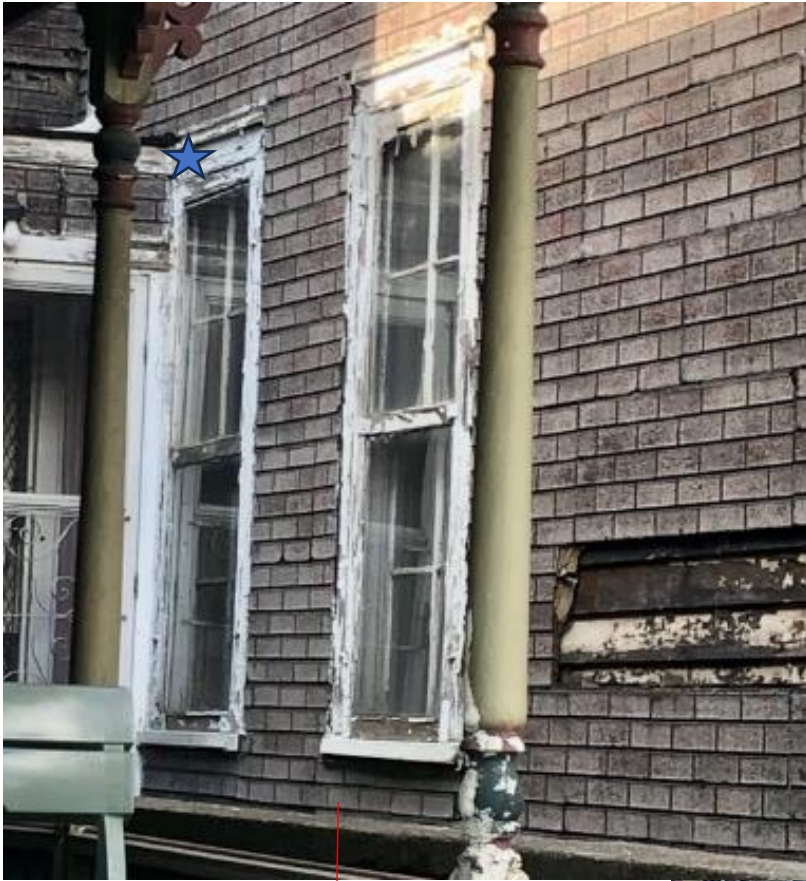
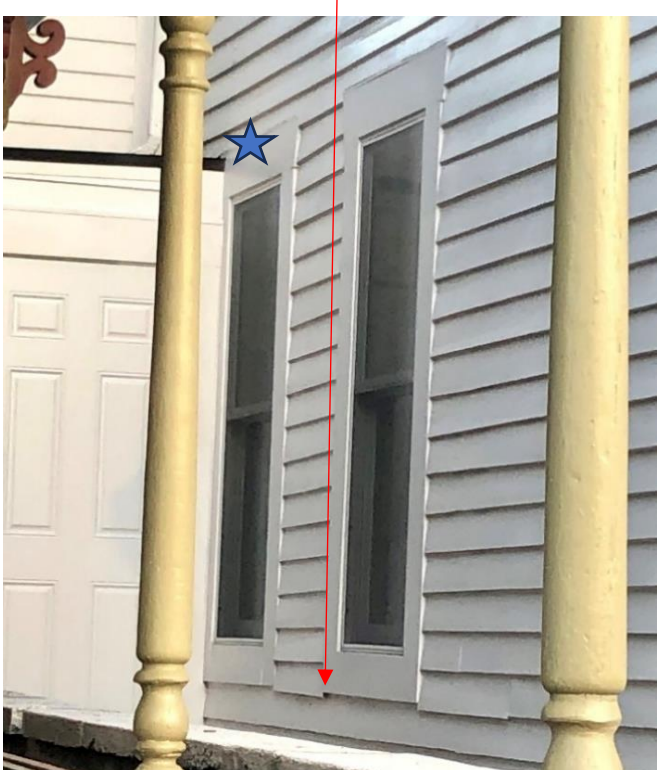
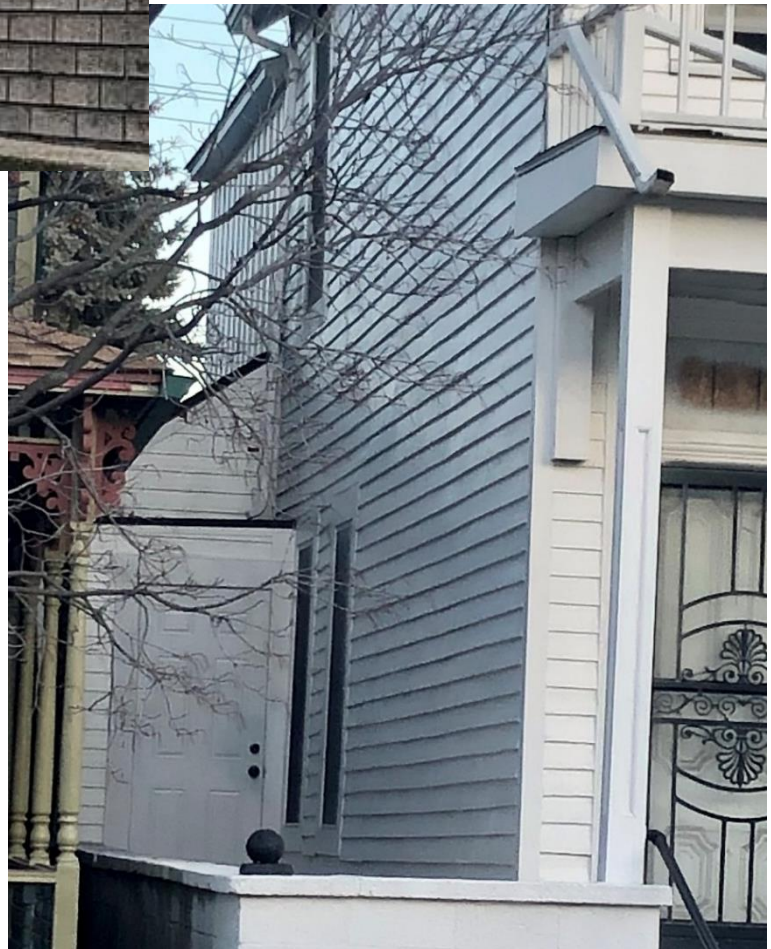
Left: Aug 2023

- Installation of Board and Batten Cementitious Siding – covering new construction/rehabilitation work at rear
- Removal of historic 19<sup>th</sup> century wood window casings and sills – installation of flat (cementitious?) casings – these two openings also had wood hoods (additional dimensional trim above the window openings)

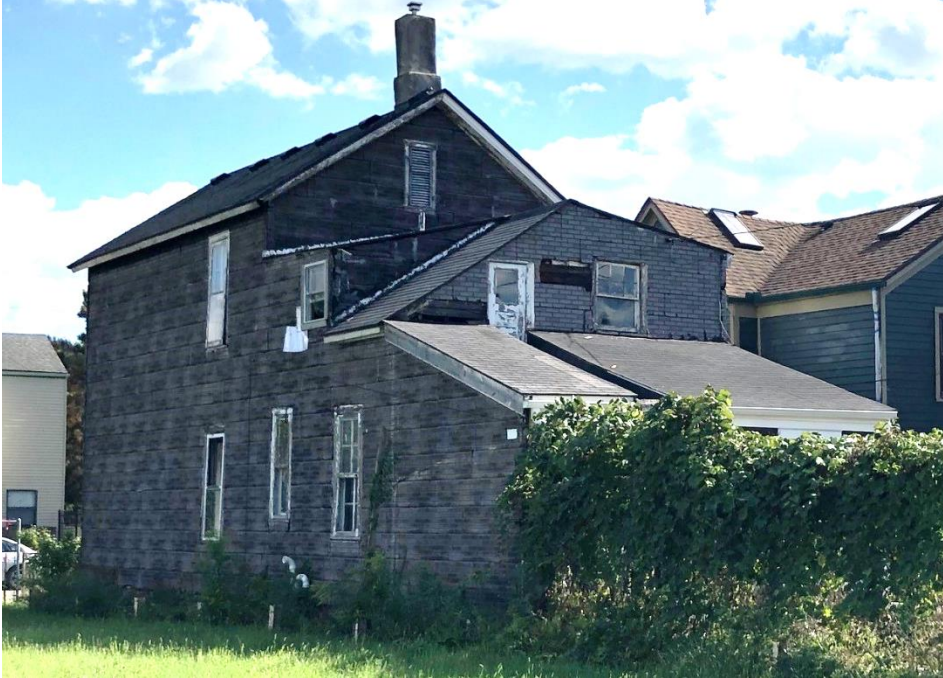
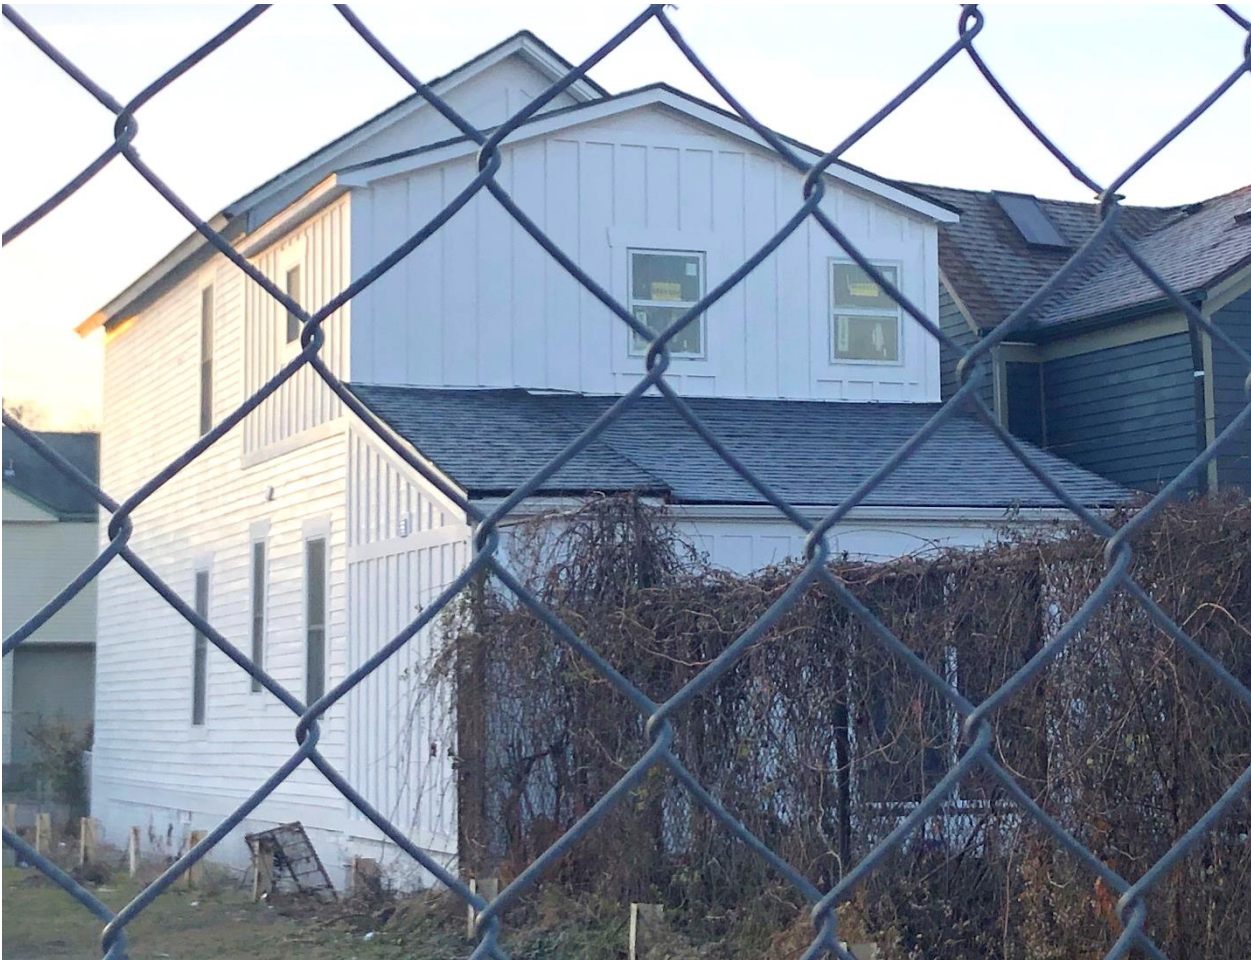
Left: Aug 2022 (applicant photo)

- Installation of Board and Batten Cementitious Siding – covering new construction/rehabilitation work at rear
