STAFF REPORT: OCTOBER 9, 2024 MEETING

APPLICATION NUMBER: HDC2024-00514

ADDRESS: 2906 CASS

SCOPE: ALTER PARAPET AND CORNICE

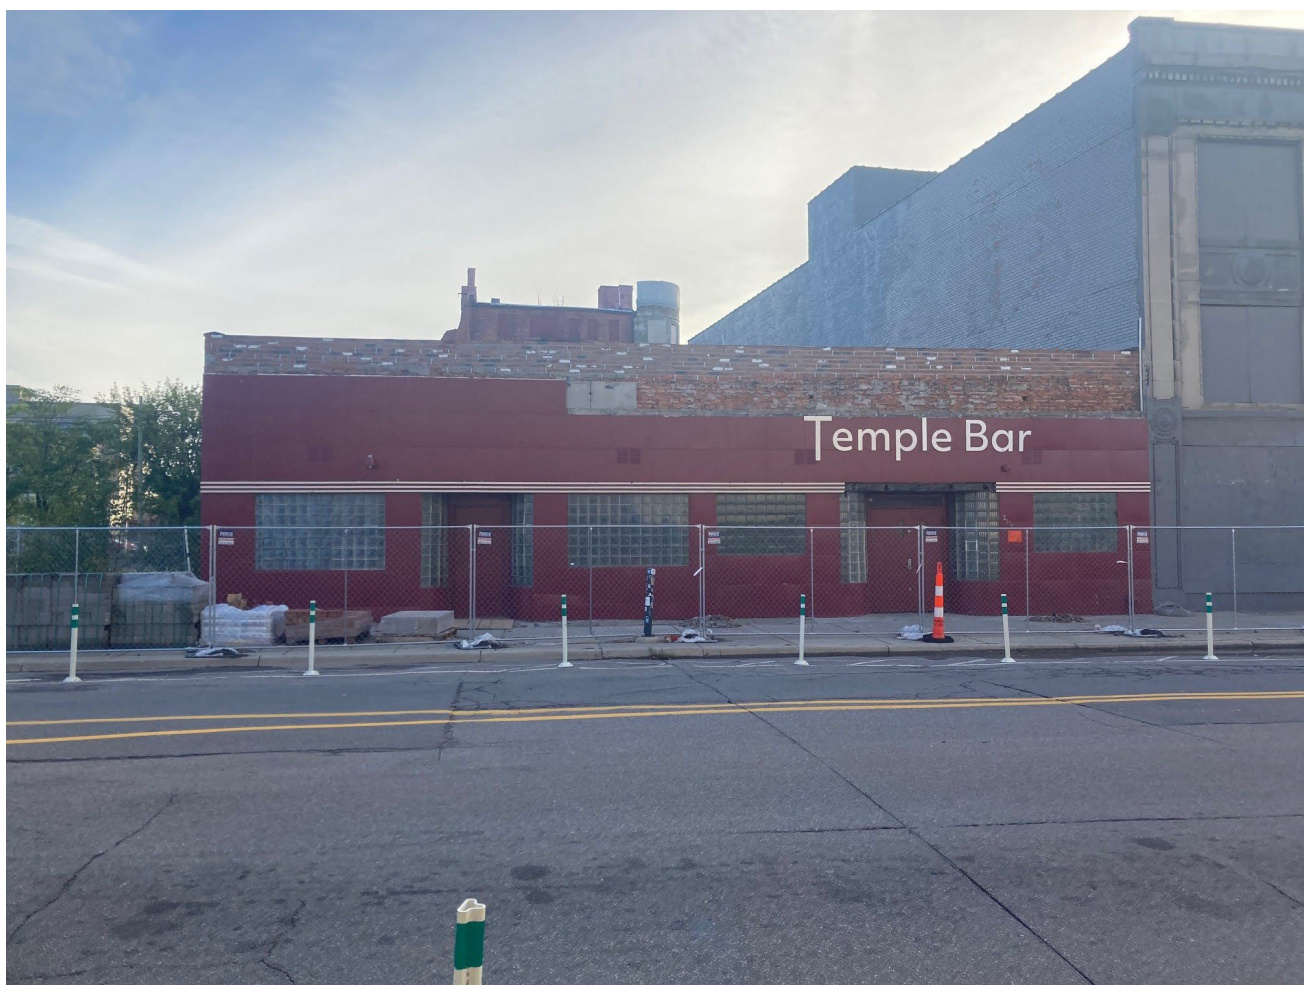
Figure 1: Current view of 2906 Cass, looking east.

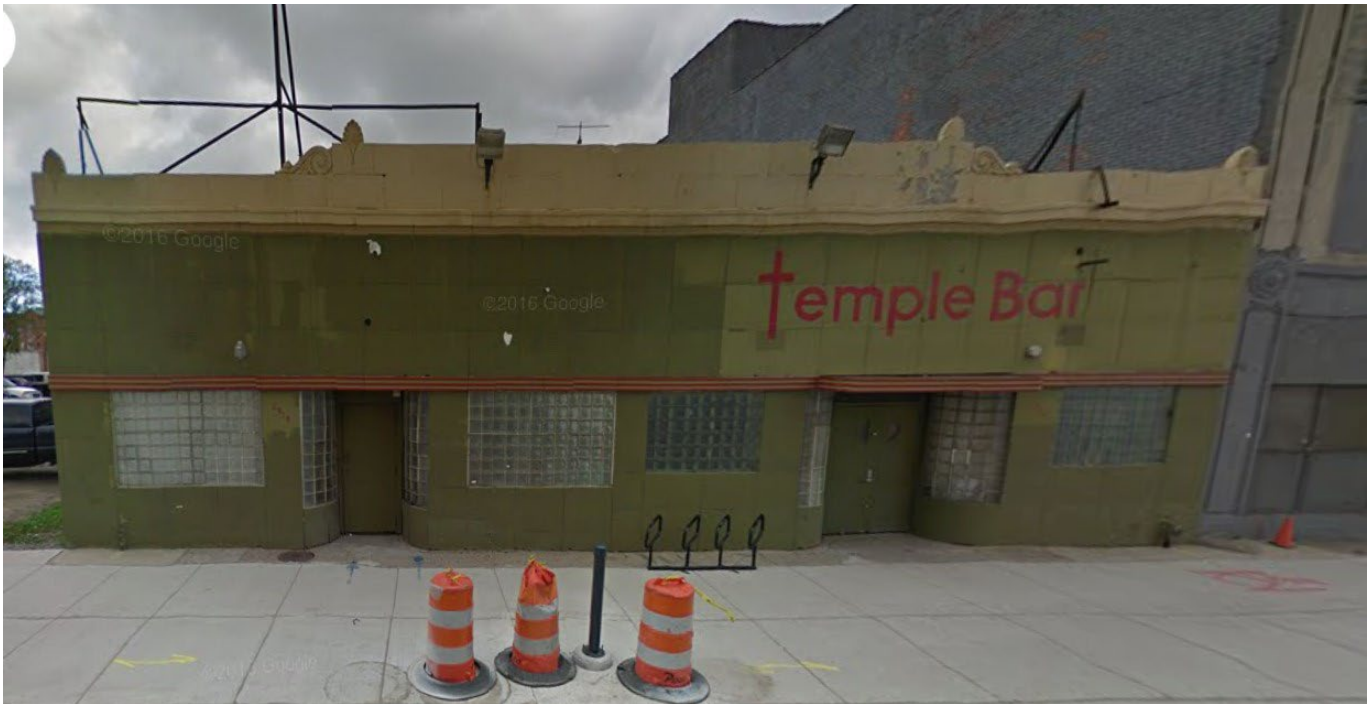
Figure 2: Image of 2906 Cass from 2016 (date of designation). Image from Google Street View.

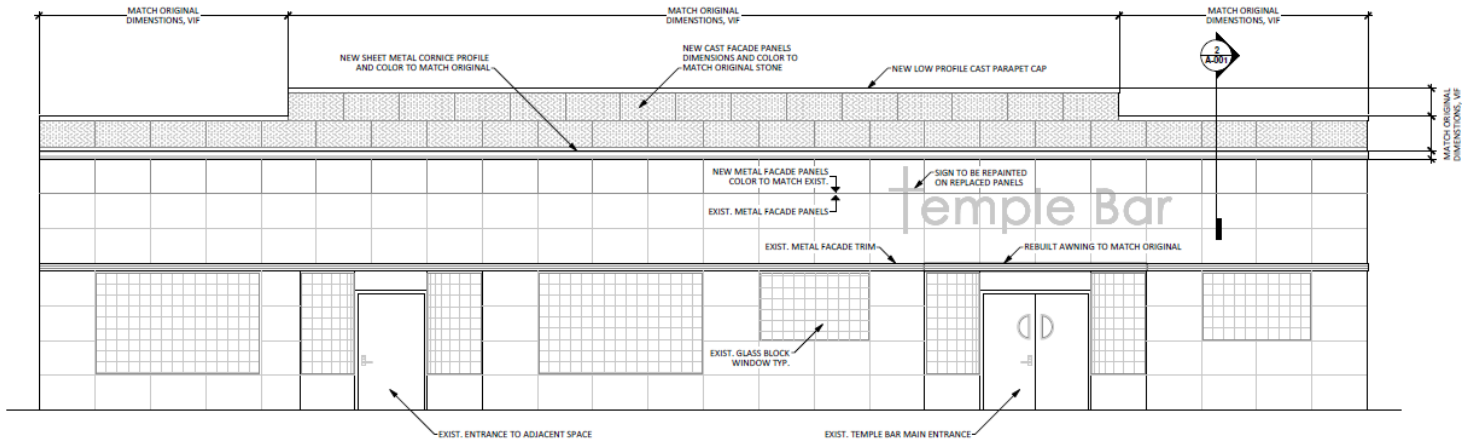
1 CASS AVENUE FAÇADE ELEVATION
1/4" = 1'-0"

Figure 3: Elevation showing the proposed parapet.

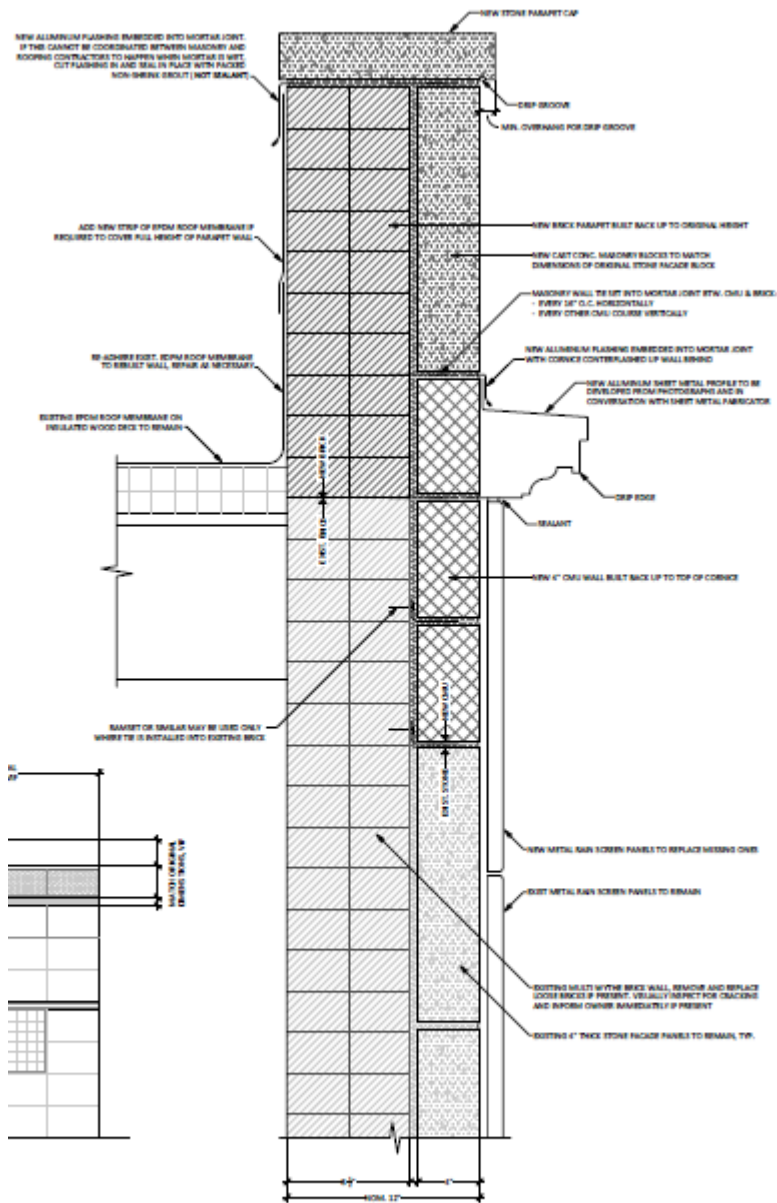
2 PARAPET RECONSTRUCTION SECTION DETAIL
3" = 1'-0"

Figure 4: Section detail of the proposed parapet and cornice.

- Staff also has concerns regarding the longevity of the formed aluminum cornice. While the proposed cornice may initially be a visually acceptable substitute for the original stone, it is probable that as the replacement feature ages and weathers that dents and scrapes will reveal the true material of the cornice.

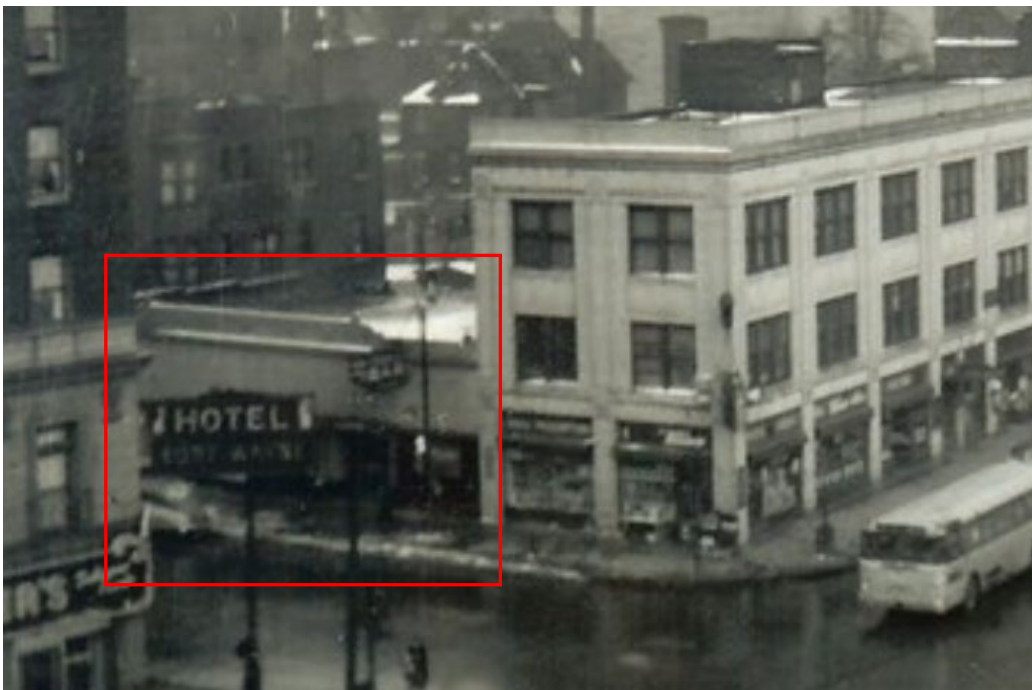
Figure 6: Image of 2906 Cass showing the original storefront ca. 1935. Image via Old Detroit website. <https://olddetroit.tumblr.com/post/4324190538/temple-bar-detroit>

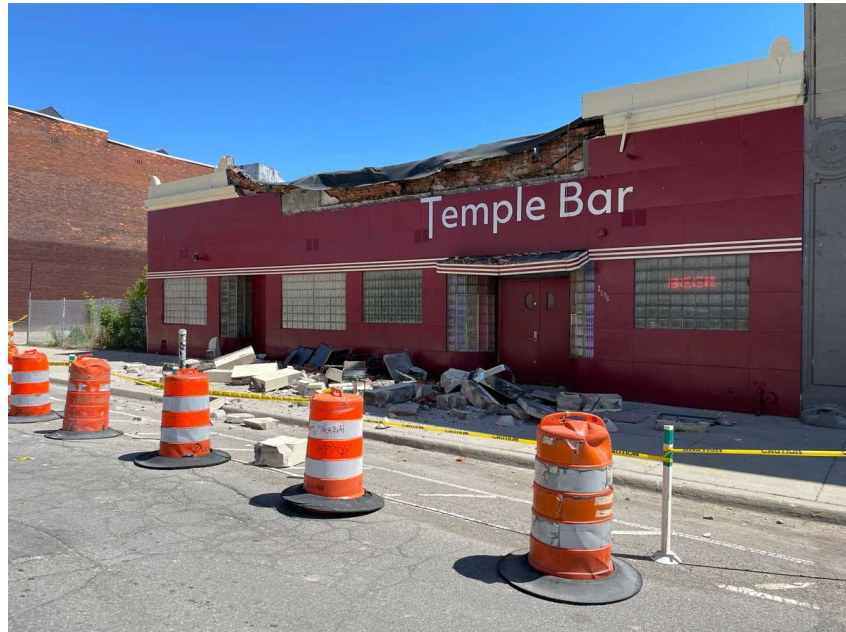
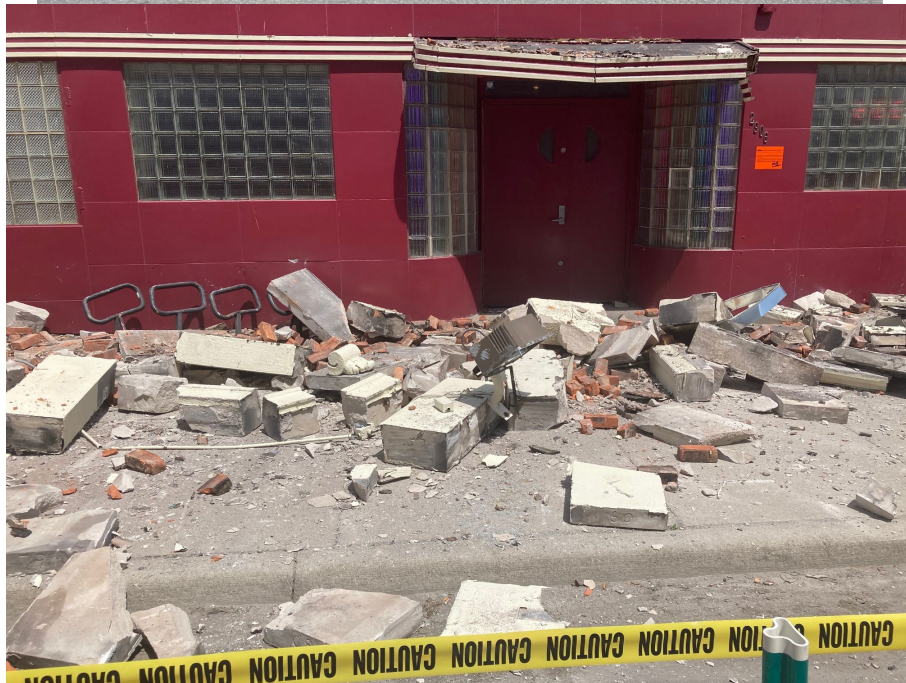
- On May 24, 2024, a portion of the original cornice and parapet of the building collapsed onto the sidewalk of Cass Ave. The 1941 awning was damaged by the collapse, and some of the painted metal panels were lost.

- During the time between the initial parapet collapse and the current application. The remaining portions of parapet were removed from the façade and disposed of. A new brick backing for the proposed parapet has been constructed without HDC review.
- The applicant claims the stone parapet pieces were damaged from the collapse and unable to be reinstalled. Photographs from the time of the collapse do indicate pieces of the parapet were damaged, however substantial portions remained on the building, including three of the carved stone pieces.

Figures 7,8: Images of the collapsed stone parapet.
