STAFF REPORT: 11/13/2024 MEETING

ADDRESS: 899 EDISON

APPLICATION NO: HDC2024-00572

SCOPE: REPLACE TWO WINDOWS

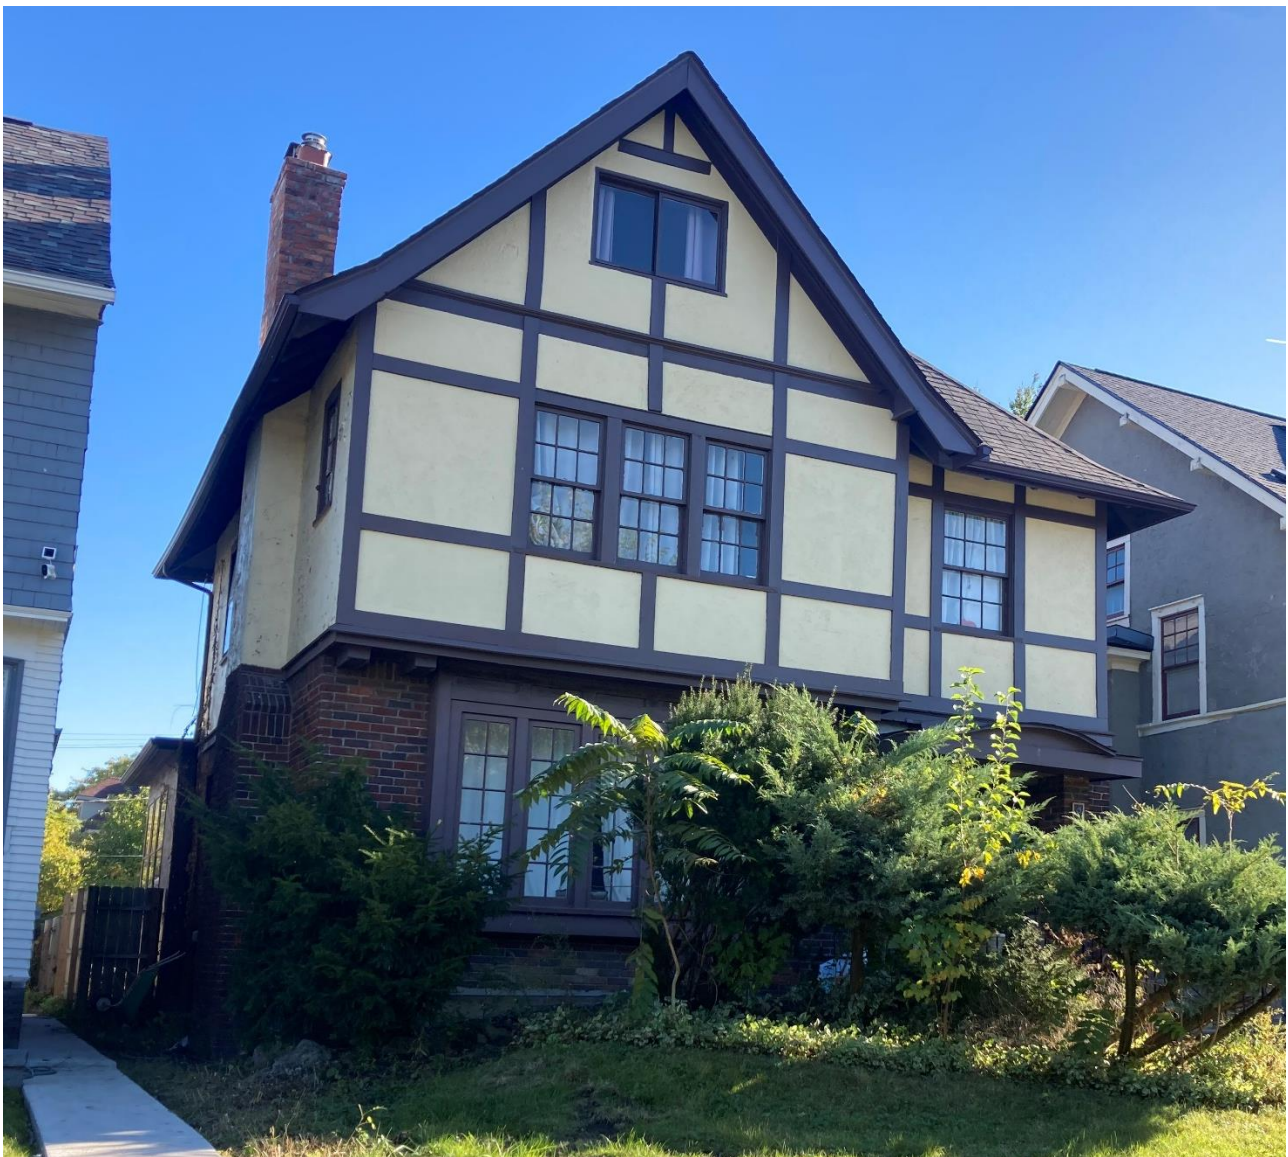
Current condition, staff photo taken on 10/16/2024

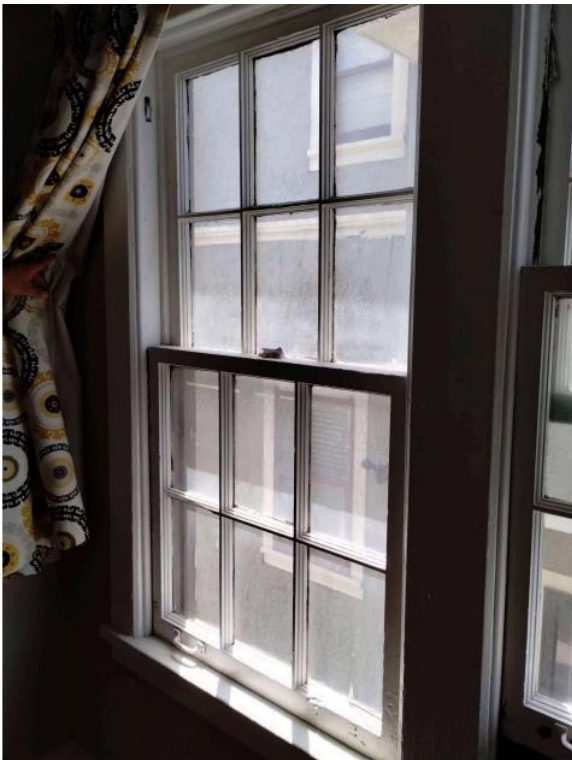
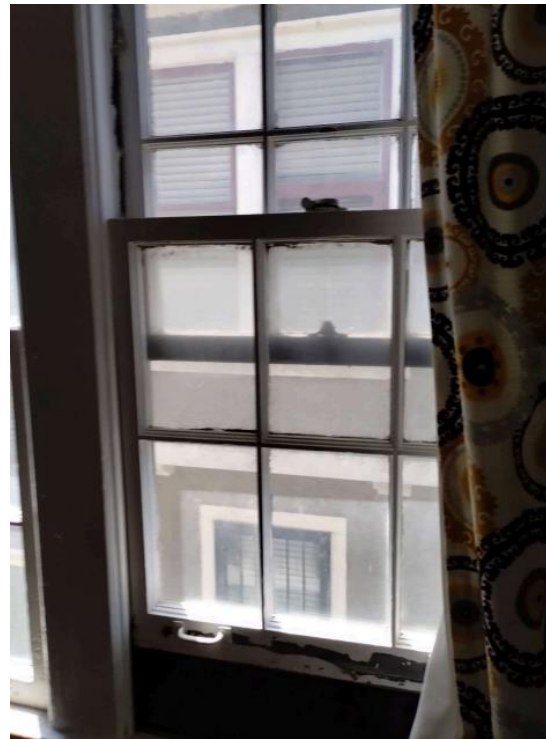
- The Boston-Edison Historic District was designated in 1973
- The application includes interior and exterior photos of the two windows proposed for replacement. Staff reviewed these photos and concluded that the windows and associated brickmould/trim do not appear to be deteriorated beyond repair. Specifically, staff has not observed widespread rot to an extent that merits replacement. As it is staff's opinion that these windows are distinctive character defining features of the house, staff concludes that this scope item is inappropriate because the work does not meet the Standards. Please see the below photos of the two windows proposed for replacement. Also, please note that the current application does not include dimensioned drawings of the new windows to include the casing/brickmould/trim

Windows proposed for replacement, interior. Photos provided by applicant

Staff therefore recommends that the Commission issue a Denial for the replacement of the two wood windows and associated brickmould at the building’s east side wall’s second story bay.

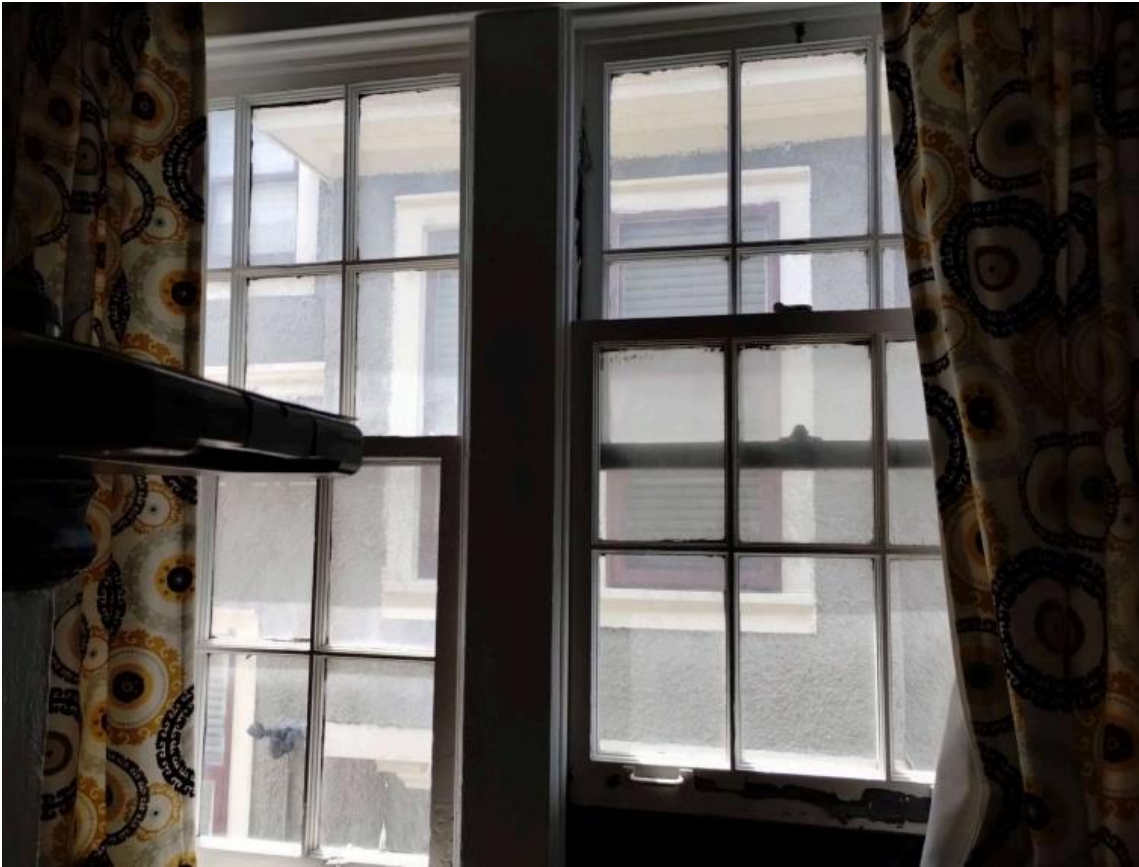
Windows proposed for replacement, interior. Photo provided by applicant

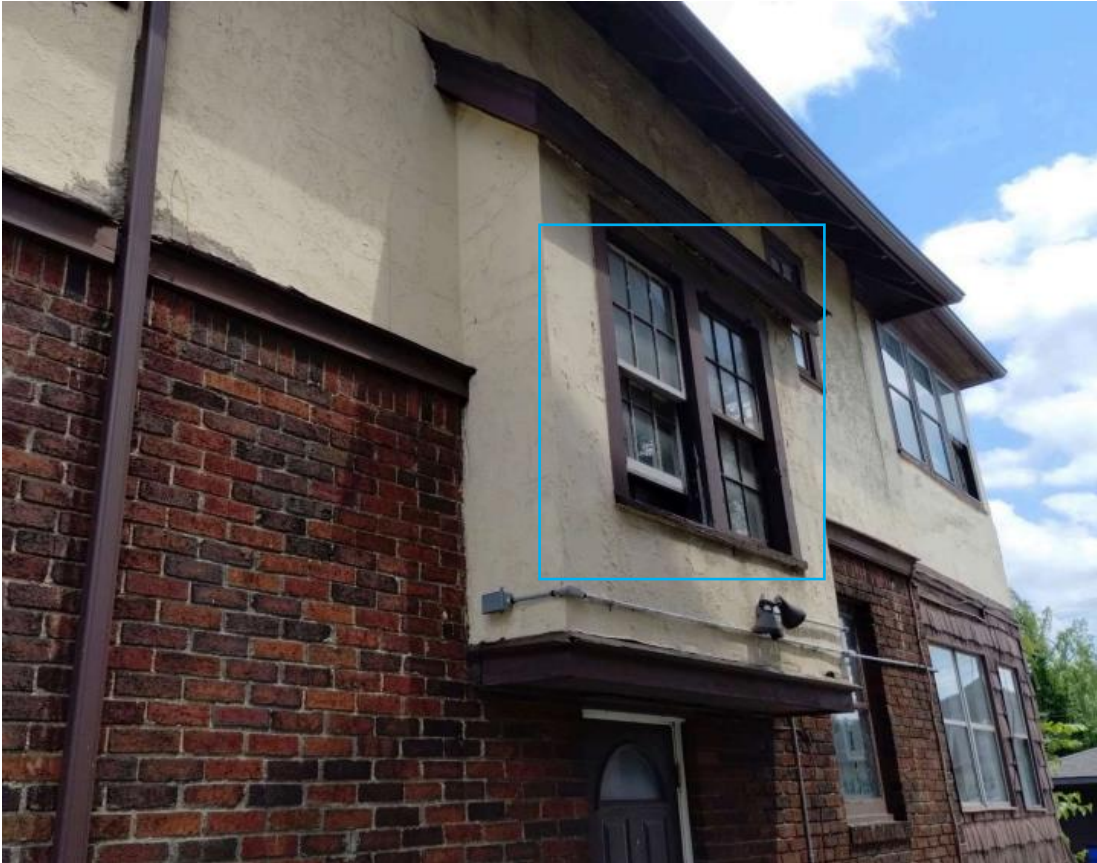
Windows and associated brickmould proposed for replacement, outlined in blue. Photos provided by applicant

- The windows and associated brickmould/trim which are proposed for removal are distinctive character defining features of the home. The current application has not provided documentation that the subject windows and brickmould are deteriorated beyond repair. Therefore, the work does not meet Secretary of the Interior’s Standards for Rehabilitation, specifically Standard #6, which states the following:

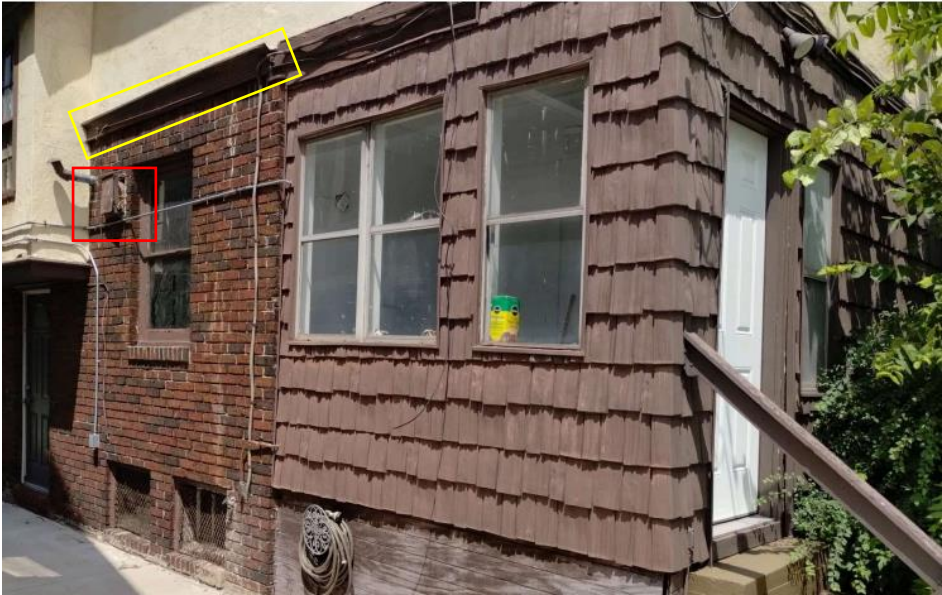
- The application also proposes to replace a small area of rotted wood trim to the south of the bay in kind. A vent at this location will also be removed and the opening will be infilled with brick to match adjacent. Please see the below photos. Staff supports this approach as the vent is not a distinctive character-defining feature of the house and the area of rotted wood trim proposed for replacement is small and will be replaced in kind.

Area of trim proposed for in kind replacement (outlined in yellow) and vent proposed for removal (outlined in red). Photo by applicant

It is staff’s opinion that the proposed replacement of trim and enclosure of vent opening at the east side wall will not alter the features and spaces that characterize the property. Staff therefore recommends that the Commission issue a Certificate of Appropriateness for the work, as it meets the Secretary of the Interior’s Standards for Rehabilitation and the elements of design.

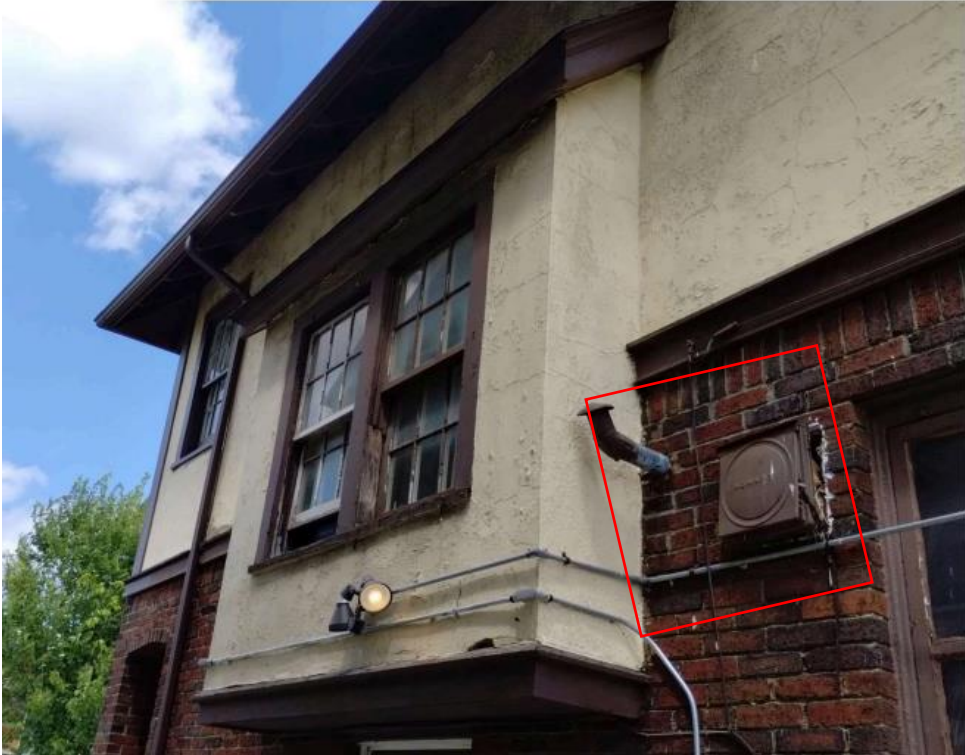
Vent proposed for removal (outlined in red). Photo provided by applicant
