**ADDRESS: 264 WATSON**

**APPLICATION NO: HDC2024-00660**

**HISTORIC DISTRICT: BRUSH PARK**

**SCOPE: ERECT COVERED DECK AND STAIR AT REAR**

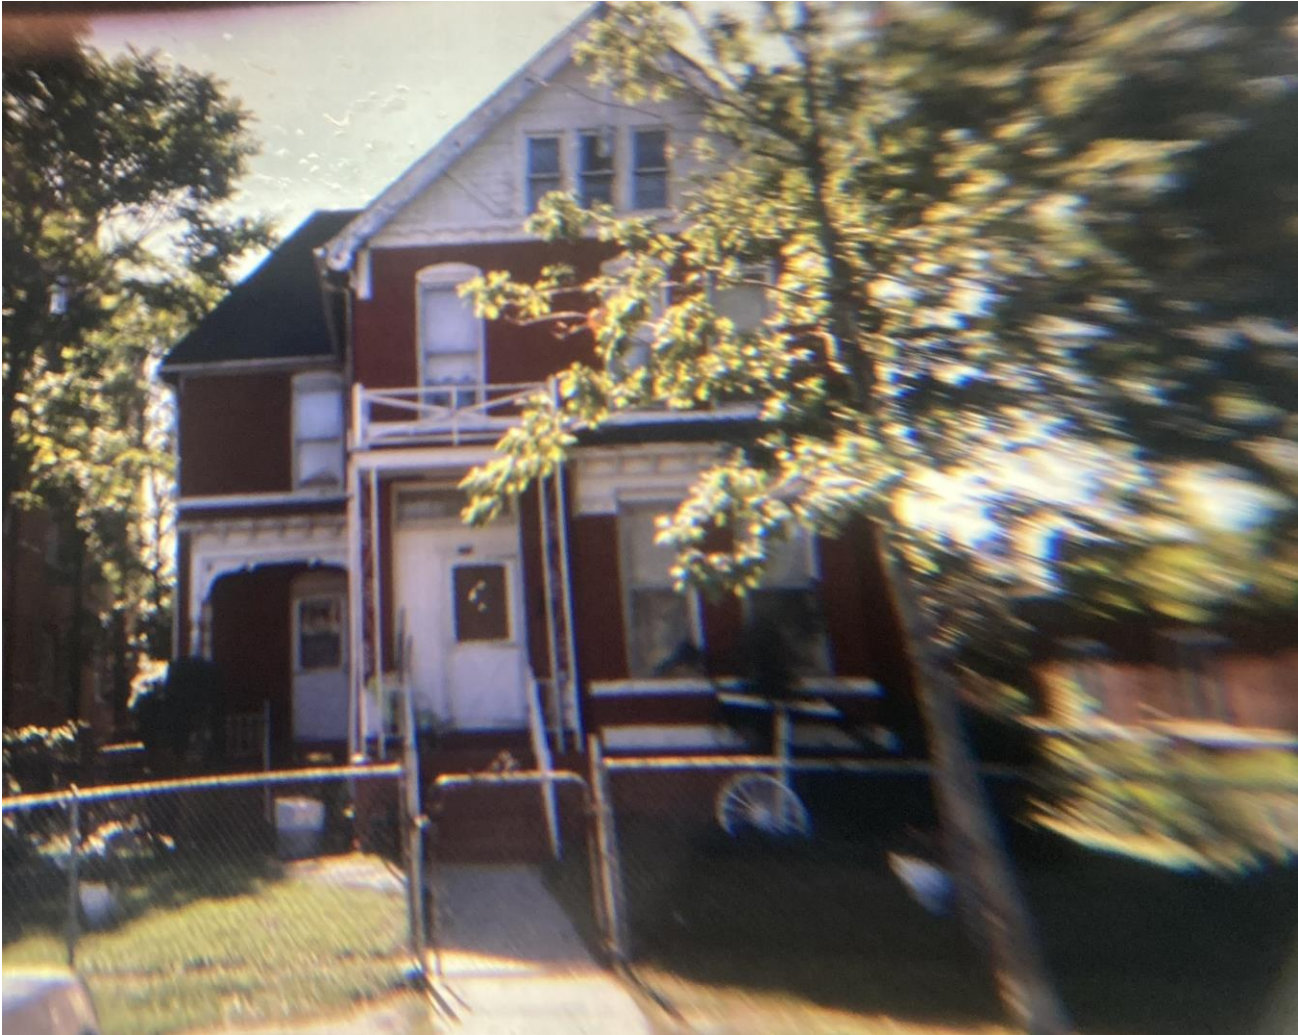
- The Brush Park Historic District was designated in 1980
- See the below designation photo of the house to note the following:
  - The side porch which is proposed for demolition was present and appears to be of historic age/original to the date of the house's construction
  - The front porch has ca. 1960s metal posts and does not appear to be of historic age

- The front doorway has a transom and appears to have been partially infilled with plywood.

**264 Watson, designation slide dating from 1980.**

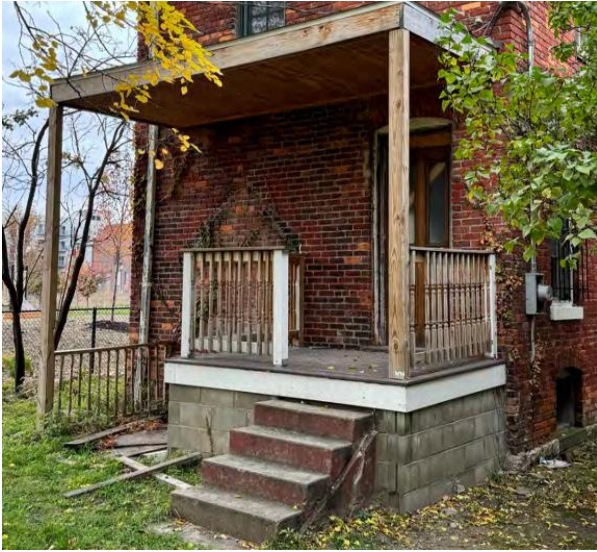
- Erection of the rear wood porch sometime after 1981 - The 1981 drawings indicate the presence of a deck with a small, shed-roof overhanging canopy on brackets over the rear door. Also, a gabled roof enclosure was located at steps which led to the basement was present. Sometime after 1981, the basement door enclosure was removed and the current large wood canopy was erected. The current application proposes to replace the current wood porch and non-character-defining masonry deck with a new wood deck with wood handrails and guardrails and composite floor. Staff supports this approach

**Current rear porch proposed for removal.**

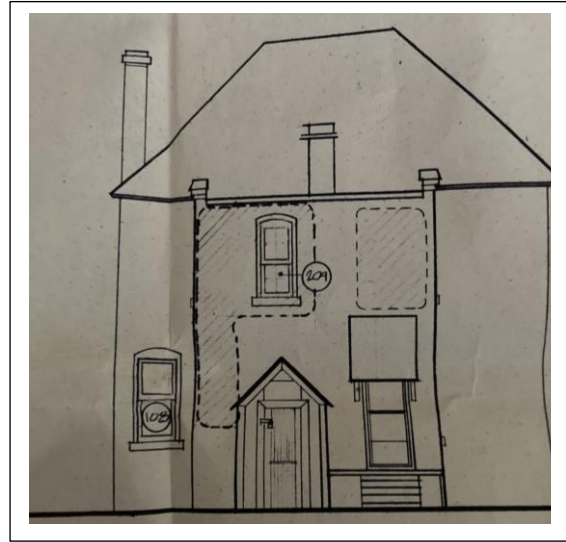
**Conditions at rear in 1981**

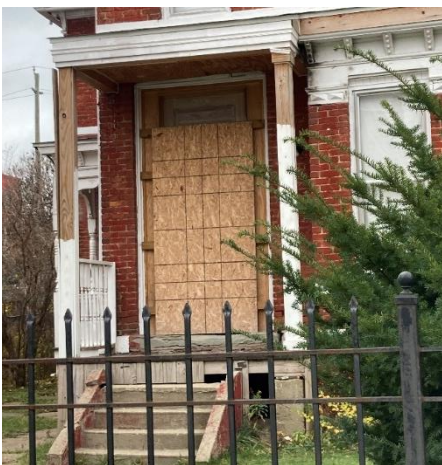
- Removal of the front porch and erect a new porch – Google Streetview images indicate the front porch was removed sometime between 2011 and 2013, leaving the masonry deck and steps. The current wood porch was erected 2021. The current application proposes to replace this non-historic front porch with a new wood porch, modeled on the details present at the existing historic-age side porch. Staff generally supports this proposal, although the applicant is seeking to demolish the historic east side porch and wrap the porch around to the east wall, which staff does not support. As noted above, the side porch appears to date from the building’s original date of construction. Also, the porch displays significant ornamental features which are illustrative of the building’s vintage/period of construction and Queen Anne style. As such, the porch is a distinctive, character-defining feature which should be retained.

**Front porch, current conditions, Staff, 11/25/2024**

- As stated above, the front porch columns were installed in 1981. At that time, only the historic age roof and masonry deck remained. Neither feature was character-defining, in staff’s opinion. By 2013, the wood porch had been removed, leaving only the masonry deck. The installation of a new front porch in the style of the proposed meets the Standards, in staff’s opinion

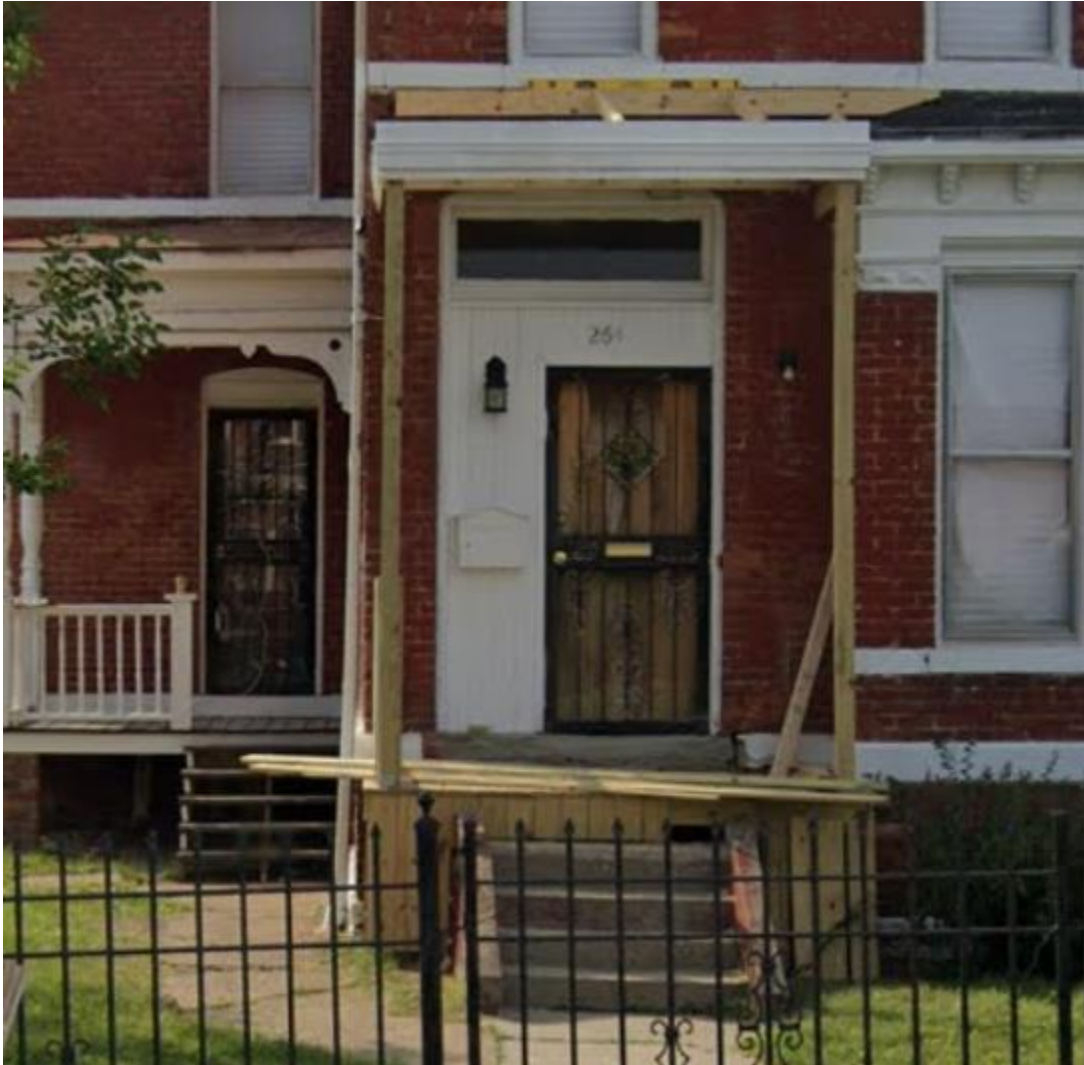
- Remove transom at front door and install new door which fills rough opening – Per the above designation slide, the front door opening was partially infilled with plywood and a non-historic age door. A transom topped the door. The doorway retained this configuration until 2022, when the transom, door, and plywood infill was removed and replaced with a new wood door. The current application does not propose to restore the transom. Rather, it seeks to install a new wood door and trim in the current round opening. As the transom was historic age and removed without HDC approval, staff recommends that it be restored.

**Front door, 2022. Google Streetview. Per the above photo taken by staff on 11/25/2024, the transom, wood infill, and door depicted in this image are now gone. A new wood door which fills the entire opening is current present. The applicant is seeking to install a new door and trim in the opening**

- As noted above, the historic front door wood transom was removed recently without HDC approval by a previous owner. The current application does not propose to restore the transom. Staff recommends that it be restored as it was a distinctive character-defining feature.

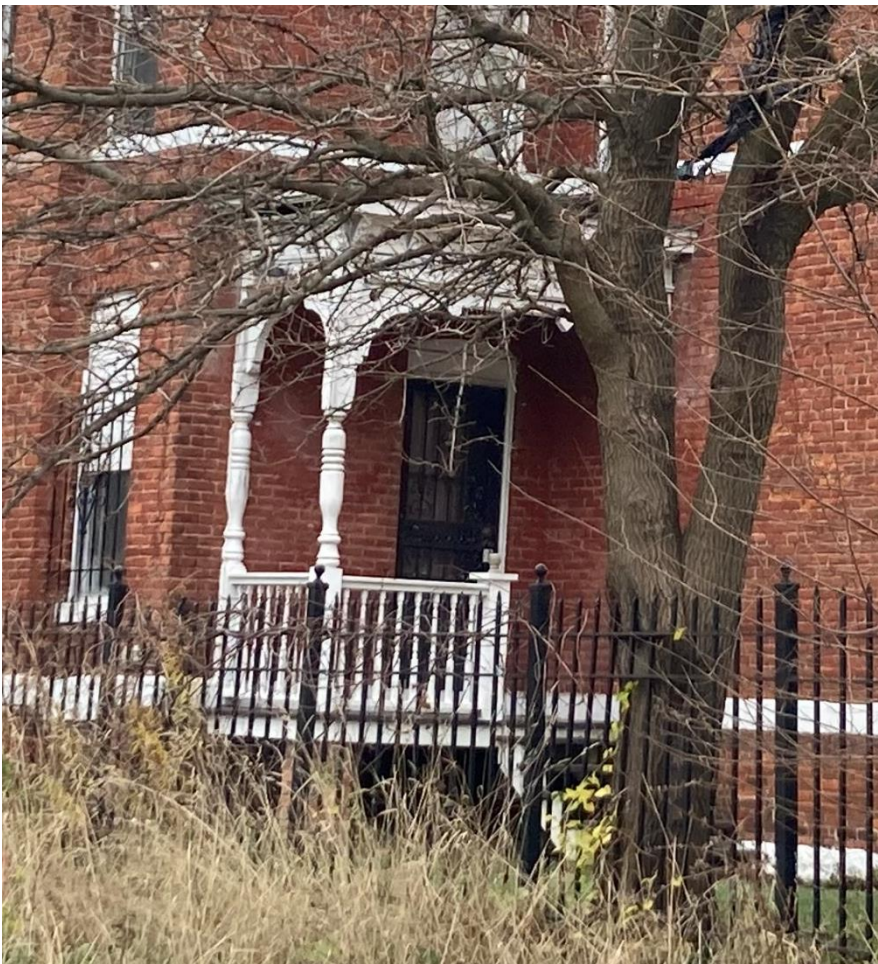
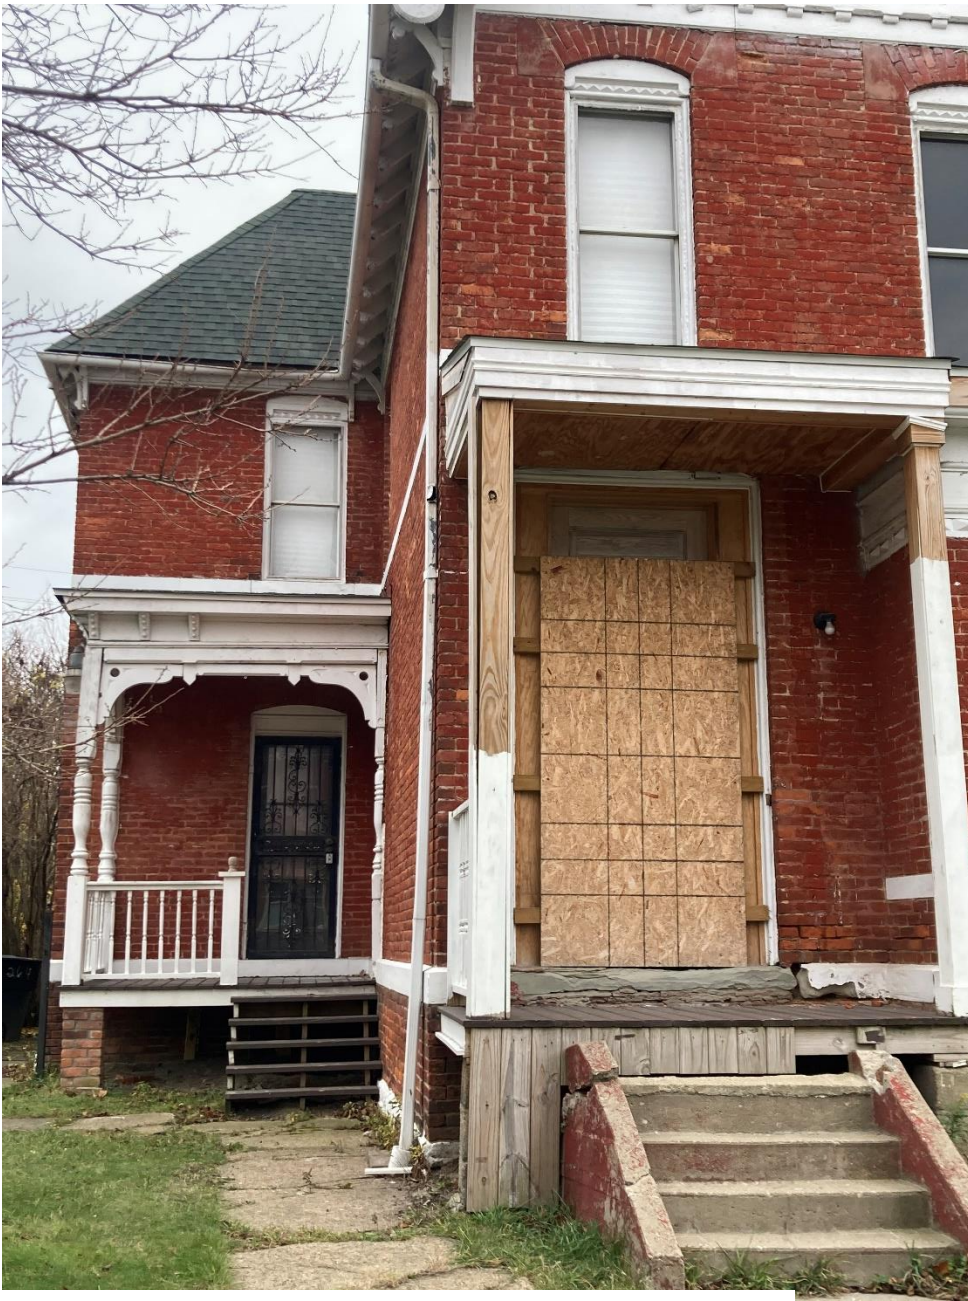
- However, the project proposes to demolish the side porch and replace it with a wrap around wood porch. It is staff’s opinion that this proposal does not meet the Standards as the application does not provide documentation that shows that this character-defining porch is deteriorated beyond repair. Also, if the side porch was shown to be deteriorated beyond repair the new porch the Standards require an exact replication. While the new porch appears to borrow design cues from the historic, it does not exactly replicate the existing. The applicant has stated that the owner wishes to demolish the side porch because it is poor condition. The applicant has committed to providing additional information re: the condition of the porch prior to the HDC’s 12/11/2024 meeting. Staff will forward the information on to the Commission for review upon our receipt of the documents.

**East side porch proposed for demolition, HDC staff 11/25/2024**

- The east side porch proposed for removal is a distinctive, character-defining feature of the property because it appears to date from the building's original date of construction and displays significant ornamental features which are illustrative of the building's vintage/period of construction and Queen Anne style.

- The application does not provide documentation that shows that the distinctive character-defining east side porch is deteriorated beyond repair. Also, if the porch was shown to be deteriorated beyond repair the new porch the Standards require an exact replication. While the new porch appears to borrow design cues from the historic, it does not exactly replicate the existing.
