**STAFF REPORT:** DECEMBER 11, 2024 REGULAR MEETING  
**APPLICATION NUMBER:** HDC2024-00625  
**ADDRESS:** 1670 EDISON  
**HISTORIC DISTRICT:** BOSTON-EDISON  
**APPLICANT:** JMM SINGLE FAMILY HOLDINGS LLC  
**PROPERTY OWNER:** JMM SINGLE FAMILY HOLDINGS LLC  
**DATE OF PROVISIONALLY COMPLETE APPLICATION:** OCTOBER 22, 2024  
**DATE OF STAFF SITE VISIT:** NOVEMBER 25, 2024

**SCOPE:** REPLACE WOOD WINDOWS WITH VINYL WINDOWS, ADD VINYL SIDING, ALTER ROOF

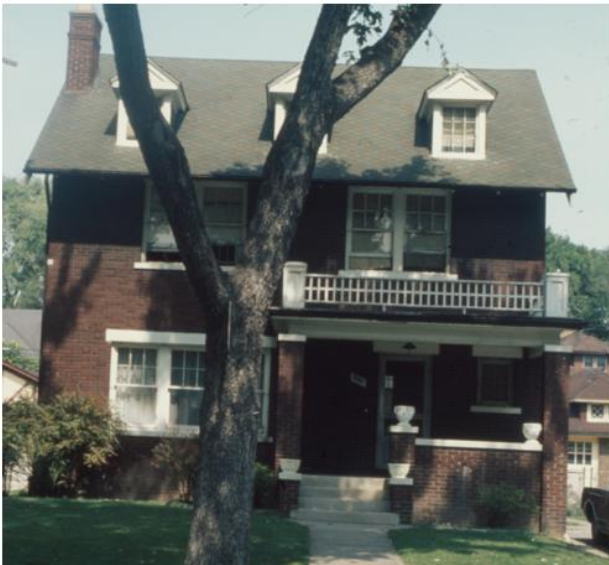
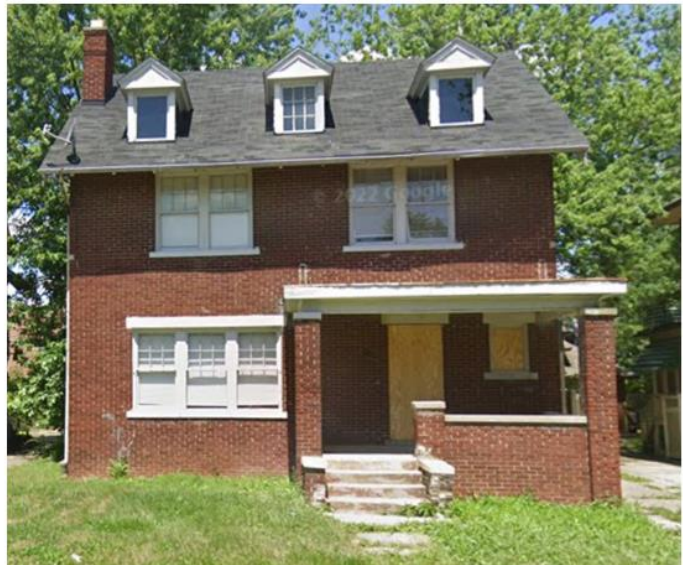
*Left: 1974 photo by the Historic Designation Advisory Board. Right: 2022 Google photo showing the building before the unapproved work.*

- Staff was unable to inspect the prior windows as they no longer exist. However, they appear to have been original, historic windows that were important to the character of the building. Further, they were present at the time the Boston-Edison Historic District was established, as seen in photos from that time. The Secretary of the Interior’ Standards for Rehabilitation, particularly Standard #2 (quoted below) direct that they be retained.

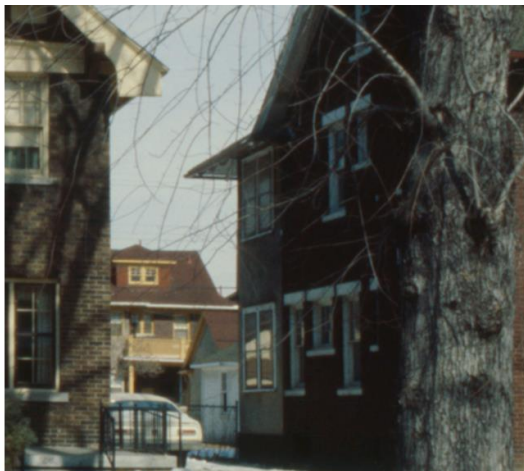
*Sun porch with stucco cladding. 1980 photo by the Historic Designation Advisory Board.*

- The sun porch is an important, character-defining feature of the building, as the prevalence of sun porches, in general, is highlighted in the Elements of Design, as is the importance of the contrast between stucco and brick that was formerly provided.

- The proposed work removes historic materials that have not been shown to be beyond repair.
- The proposed work eliminates the important contrast of stucco and brick that was formerly present on this building and specifically highlighted in the Elements of Design.
- The proposed work greatly alters the texture and appearance of the character-defining sun porch.

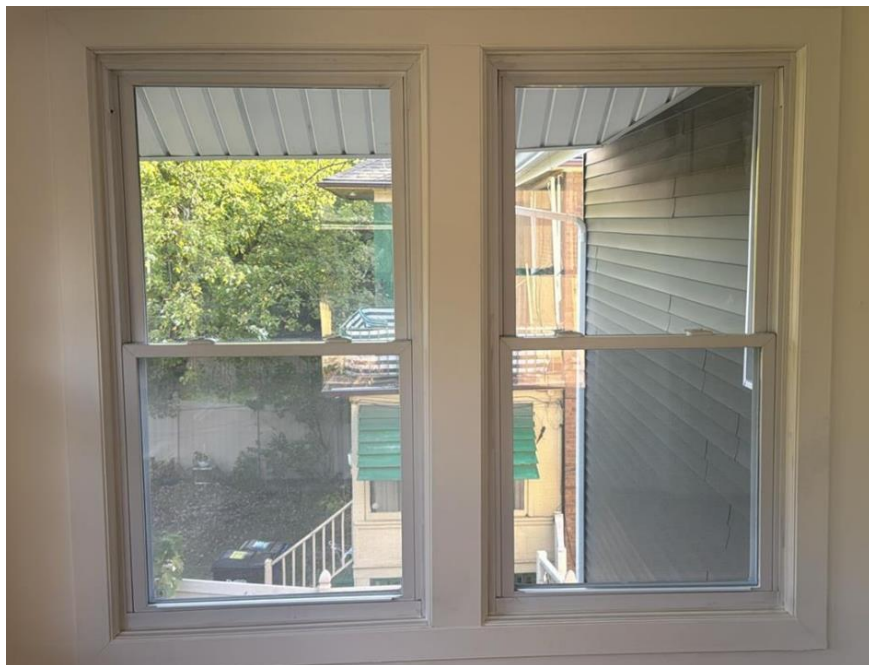
*Image, from application documents, showing proposed (already installed) vinyl windows, vinyl siding, vinyl soffit panels, and vinyl gutters and downspouts.*

- If a replacement window were to be warranted (for instance, if the existing windows had deteriorated beyond feasible repair), staff notes that an appropriate replacement window would be a wood sash window with similar dimensions, subdivided upper sashes, and an appropriate color. The proposed (already installed) windows feature the thinner profile commonly found on vinyl windows, are not subdivided, and are an inappropriate pure white color.

- The aluminum wrap surrounding the windows and obscuring the brickmould, and the addition of vinyl siding onto the character-defining sun porch, and the addition of vinyl soffit panels, gutters, and downspouts, constitute an “alteration of features and spaces that characterize the property,” also contrary to Standard #2.

- The loss of rafter ends and vergeboards eliminates distinctive features that formerly contributed to the character of the property.
- The installation of vinyl soffit panels, gutters, and downspouts adds non-historic materials and incompatible new features to the building.

Therefore, staff recommends that the Commission issue a Denial as the proposed work fails to meet the Secretary of the Interior's Standards for Rehabilitation, in particular:

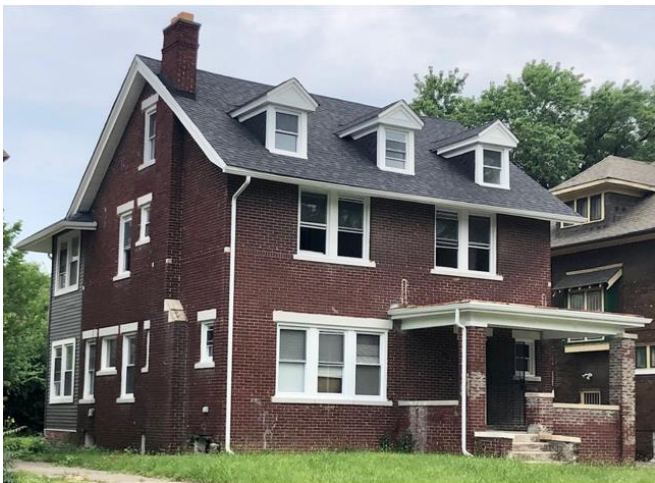
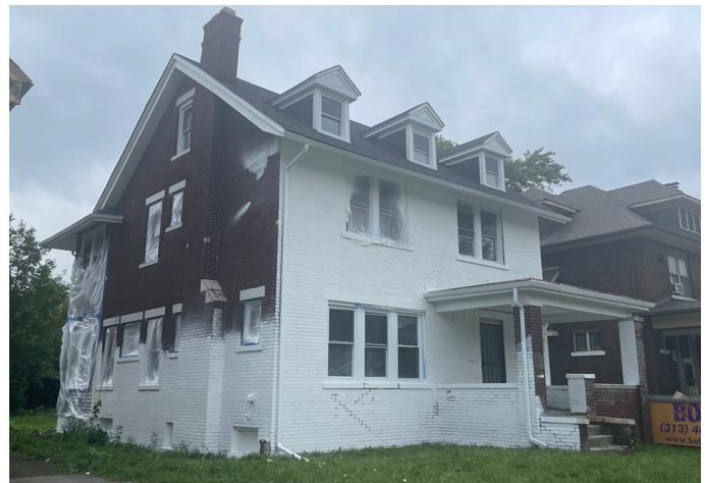
- On June 21, 2024, staff observed the new vinyl siding on the sun porch (to the extent that it was visible from the street), new vinyl windows, vinyl soffits, and the removal of vergeboards and rafter ends.
- On August 6, 2024, staff observed painting in progress.
- According to Historic District Commission records, the Buildings, Safety Engineering, and Environmental Department commenced enforcement, including a Stop Work order, on August 19, 2024.

*Left: June 21, 2024, staff photo. Right: August 6, 2024, staff photo.*
