STAFF REPORT: OCTOBER 9, 2024, REGULAR MEETING
APPLICATION NUMBER: HDC2024-00522
ADDRESS: 19566 CANTERBURY
HISTORIC DISTRICT: SHERWOOD FOREST
APPLICANT: JUSTIN BERCHENY, MAX BROOCK REALTORS
PROPERTY OWNER: WOLCOTT LAND DEVELOPMENT LLC
DATE OF PROVISIONALLY COMPLETE APPLICATION: SEPTEMBER 10, 2024
DATE OF STAFF SITE VISIT: DECEMBER 6, 2024

PREPARED BY: T. BOSCARINO
Revised December 11, 2024

SCOPE: REPLACE STEEL WINDOWS WITH ALUMINUM WINDOWS

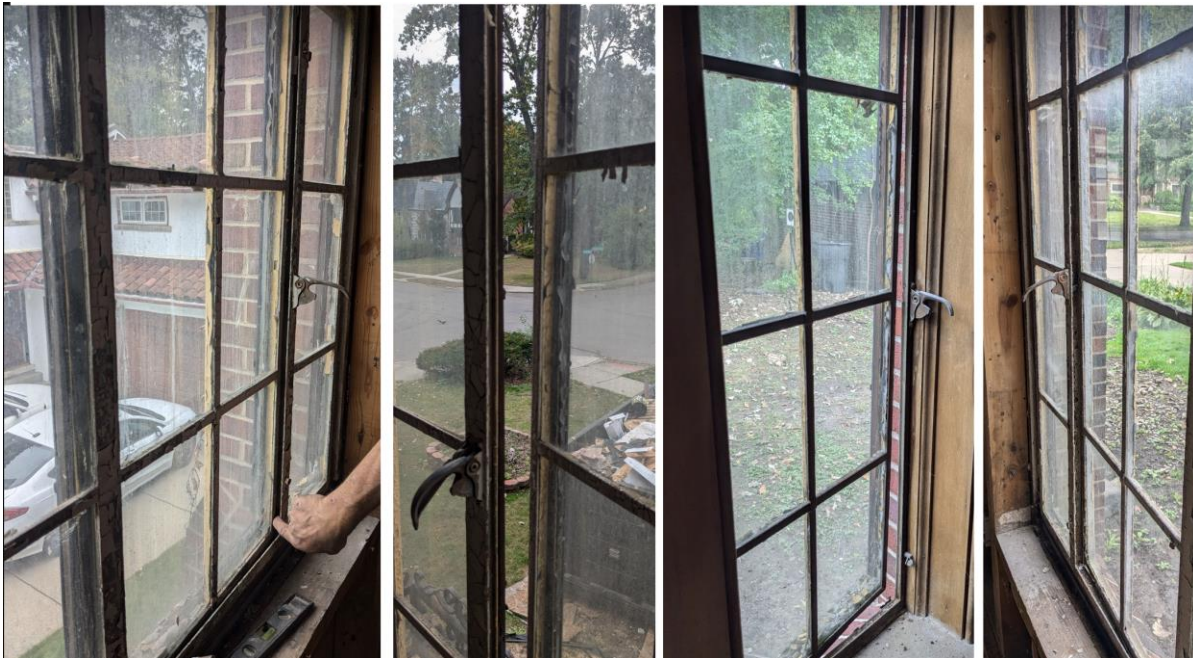
October 2024 staff photos showing warped casements.

- Staff was invited (see photos above) to view the windows in person at the time of the October 2024 staff report. As is common with steel windows, they consist of an outer row of fixed panes, with operable casement panels set within. Staff observed that the outer panes generally appeared to be in need of sanding, painting, and reglazing. These conditions are not beyond repair. However, staff also observed that the inner casements were visibly warped or racked to the extent that they are misaligned and do not close, often leaving a gap of about an inch or more at the top or bottom. This condition was clearly visible on about half of the windows on the property.

- *Preservation Briefs 13* describes a repair process for bent casements:

“Bent or bowed metal sections may be the result of damage to the window through an impact or corrosive expansion. If the distortion is not too great, it is possible to realign the metal sections without removing the window to a metal fabricator’s shop. The glazing is generally removed and pressure is applied to the bent or bowed section. In the case of a muntin, a protective 2 x 4 wooden bracing can be placed behind the bent portion and a wire cable with a winch can apply progressively more pressure over several days until the section is realigned. The 2 x 4 bracing is necessary to distribute the pressure evenly over the damaged section. Sometimes a section, such as the bottom of the frame, will bow out as a result of pressure exerted by corrosion and it is often necessary to cut the metal section to relieve this pressure prior to pressing the section back into shape and making a welded repair.”

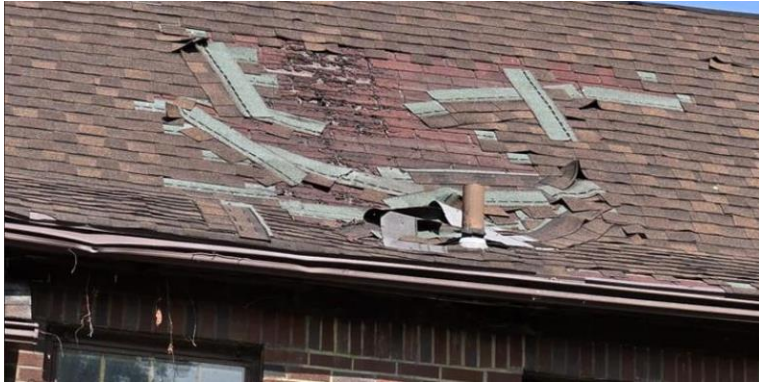
- *Preservation Briefs 13: The Repair and Thermal Upgrading of Historic Steel Windows*, notes “since moisture is the primary cause of corrosion in steel windows, it is essential that excess moisture be eliminated and that the building be made as weathertight as possible before any other work is undertaken.” Extensive roof damage, formerly visible, has recently been repaired.

Area of prior roof deterioration. Image from August 22, 2024, application documents for roof repairs.
