STAFF REPORT: MARCH 25, 2025 MEETING

APPLICATION NUMBER: HDC2024-00599

ADDRESS: 1610 EDISON

SCOPE: INSTALL WINDOWS AT REAR PORCH

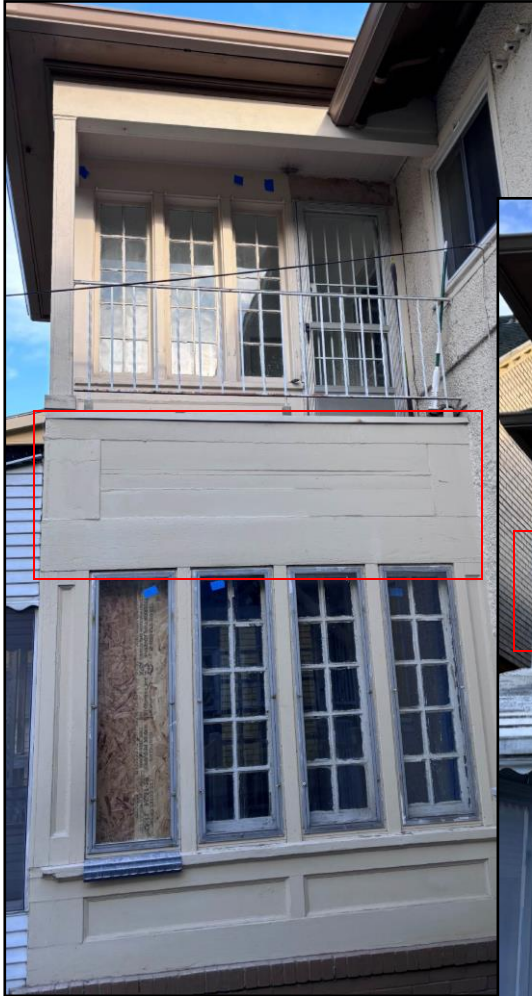
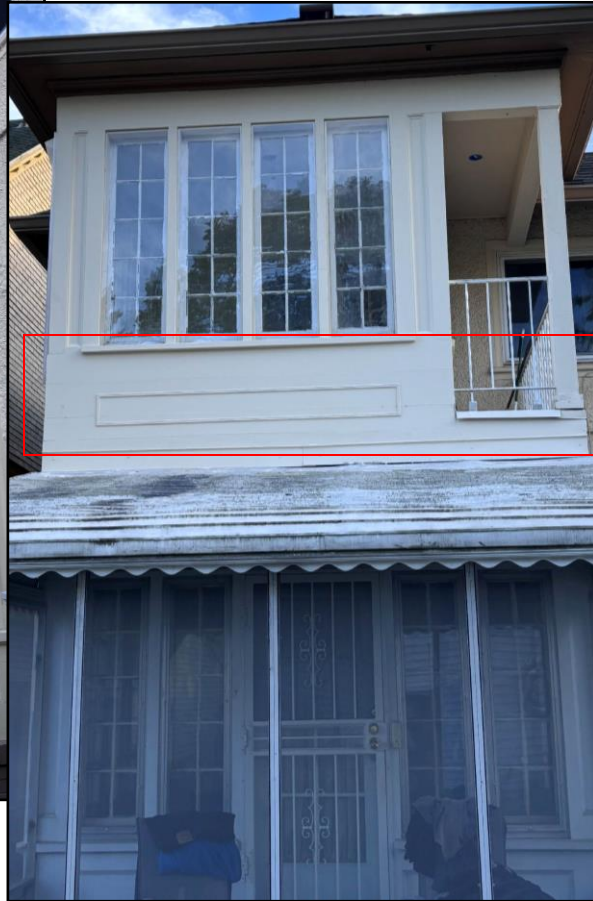
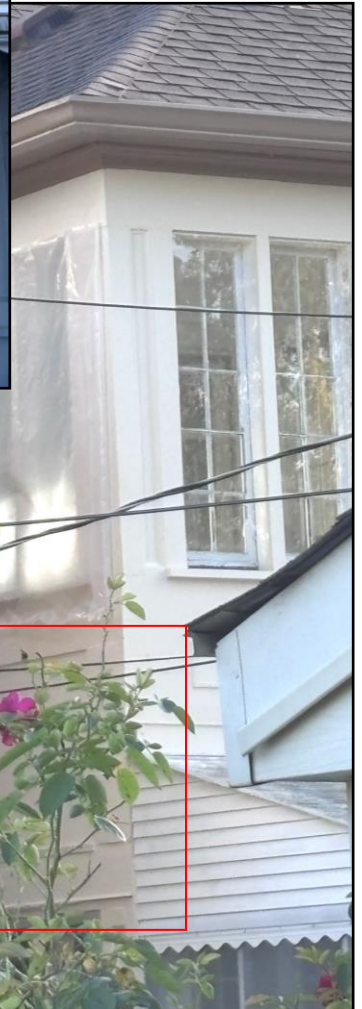
- The dissimilar design treatment to the half-walls below the grouped windows, and the small open porch suggest the exterior walls were modified at some point in time. The white aluminum railing matched the design of the 1970's-era aluminum railing at the front porch (a photo comparison of the front and rear porch rails is on page 8), so it is possible these walls were changed at that time.

Comparison of the three walls of the rear extension. Each lower wall is finished in a different manner. Applicant photos.

Left: West-side wall

Middle: North-rear wall

Right: East-side wall

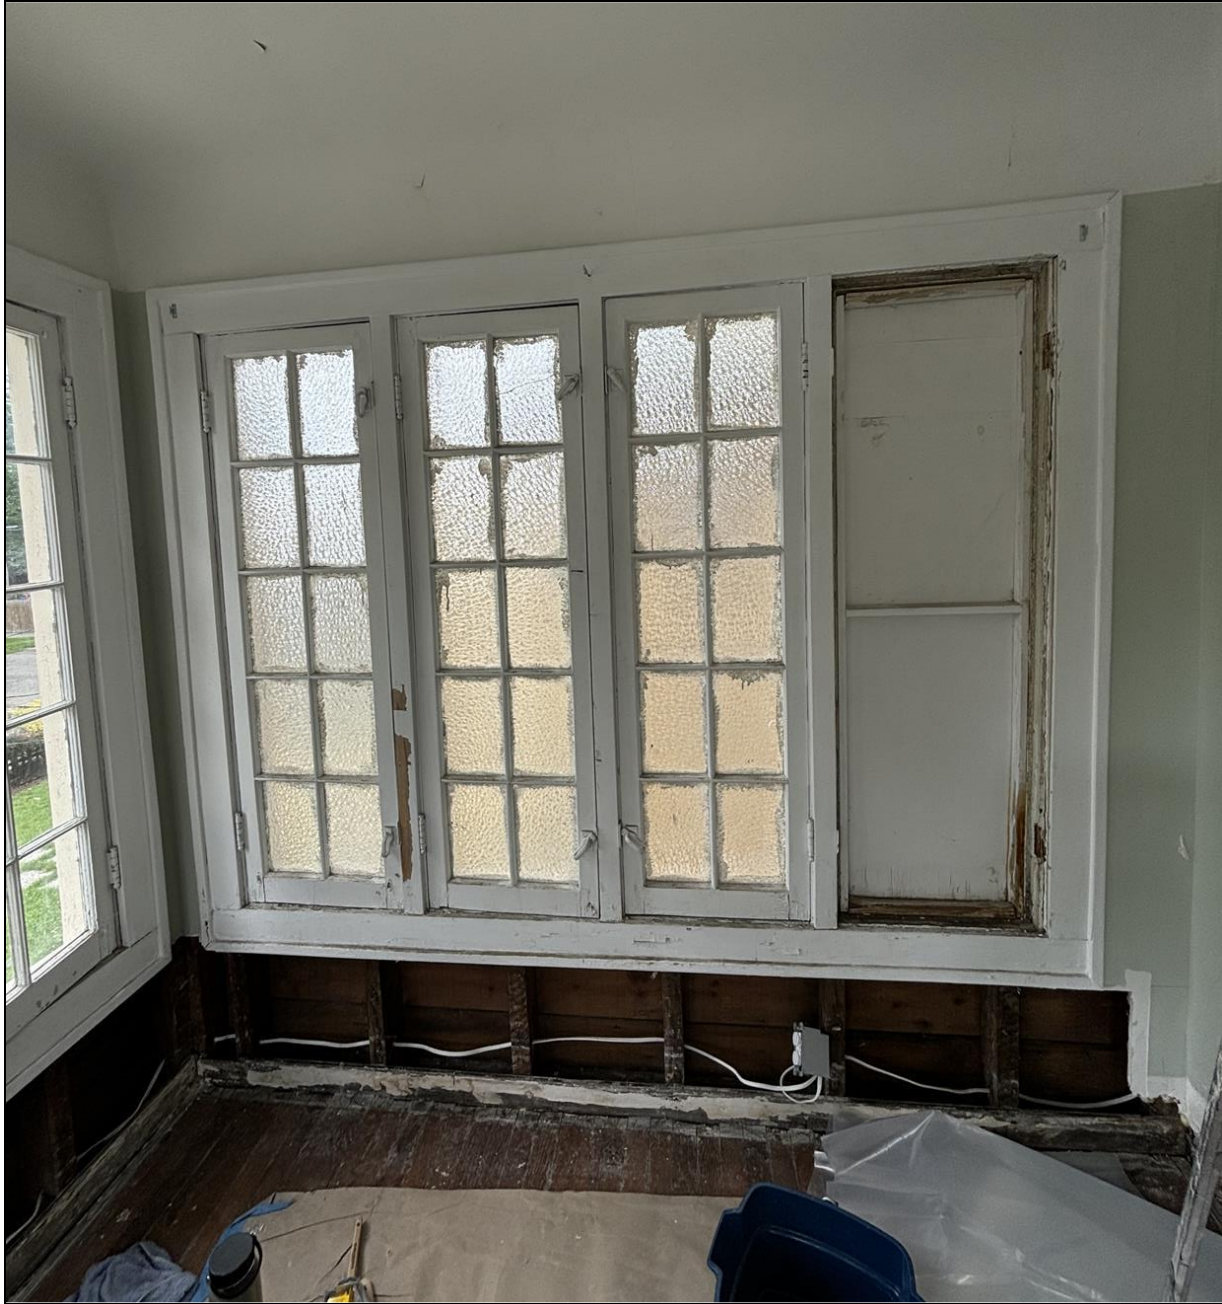
- The interior and exterior photos submitted by the applicant show the windows to be intact (with the exception of one missing window on the east wall) and in repairable condition.
- The applicant mentions in the “Description of Existing Conditions” part of the application form, that the water problems which caused deterioration to the interior porch walls are directly related to the current sills and how they were constructed. It is possible to fabricate new sills (and mullions, if needed) and reinstall the existing casements after the windows are repaired.

Interior view of the east-side wall. Applicant photo.

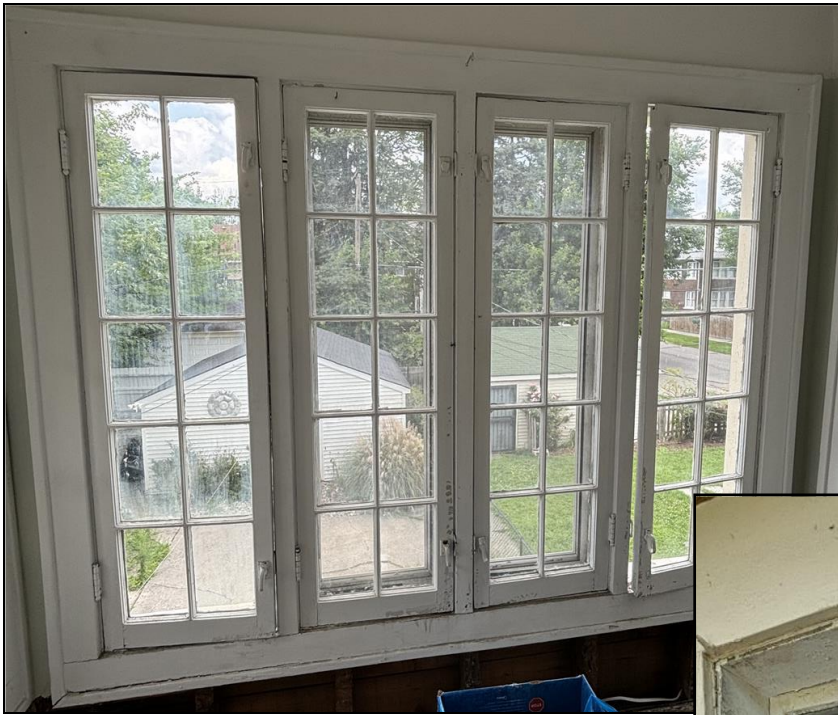
- The close-up exterior views of this set of windows, as shown below, confirm their deep placement within the walls.
- The existing exterior wood wall treatment may have been in place at the time of designation and is a compatible material and wall finish for the house; therefore, staff does not consider this a violation.

Interior and exterior views of the rear-north wall and windows. Applicant photos.

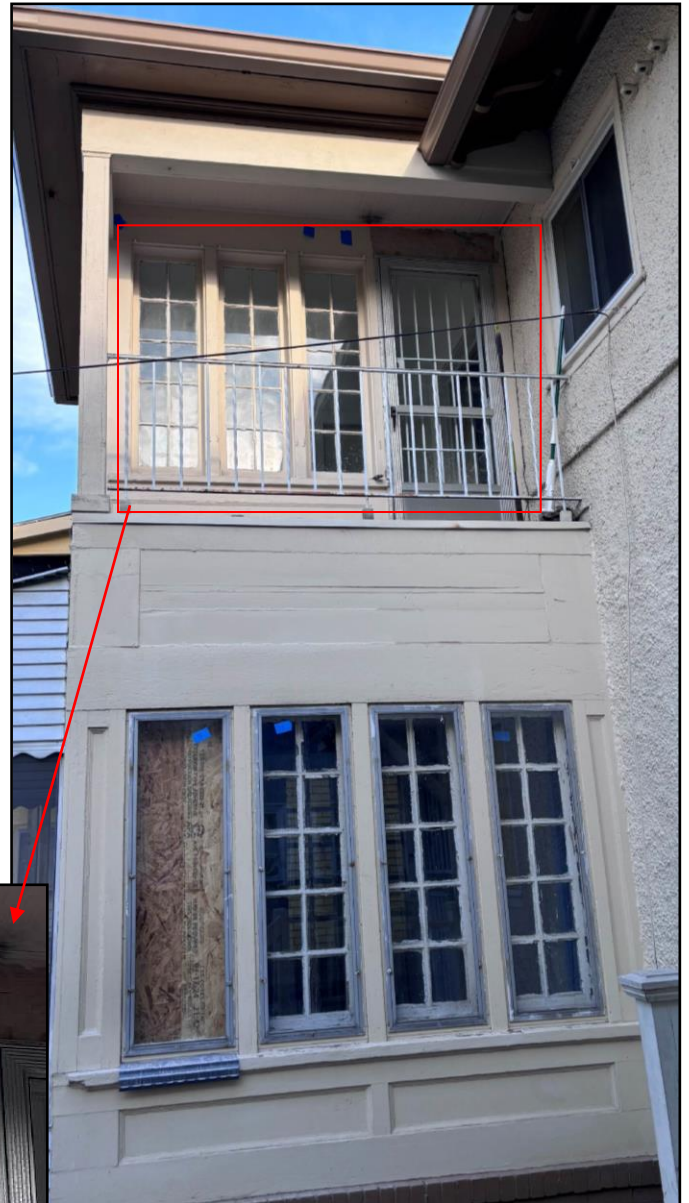
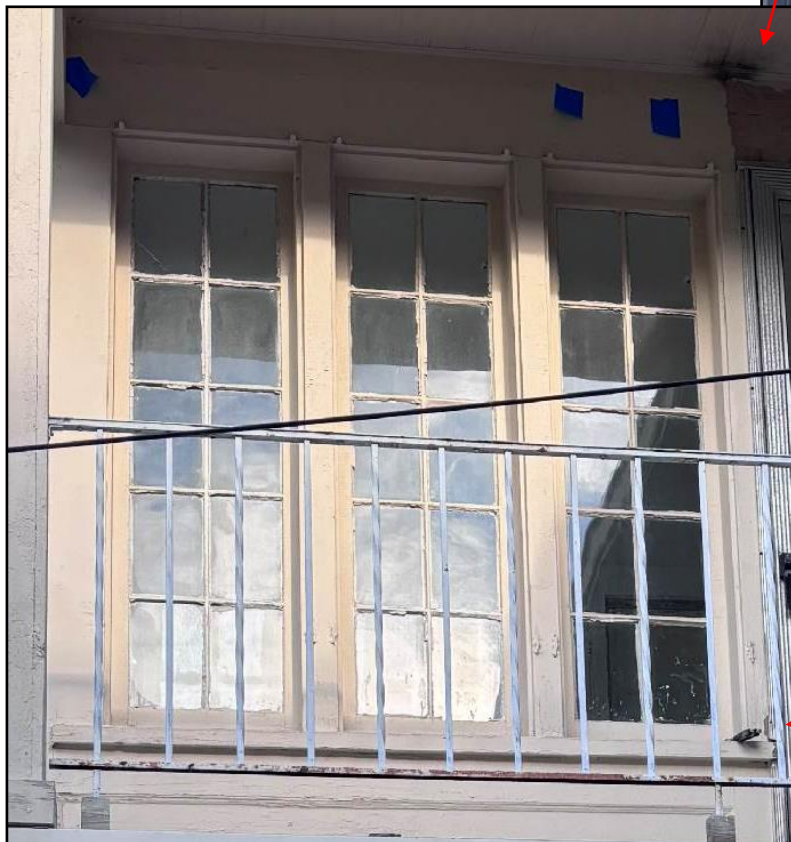
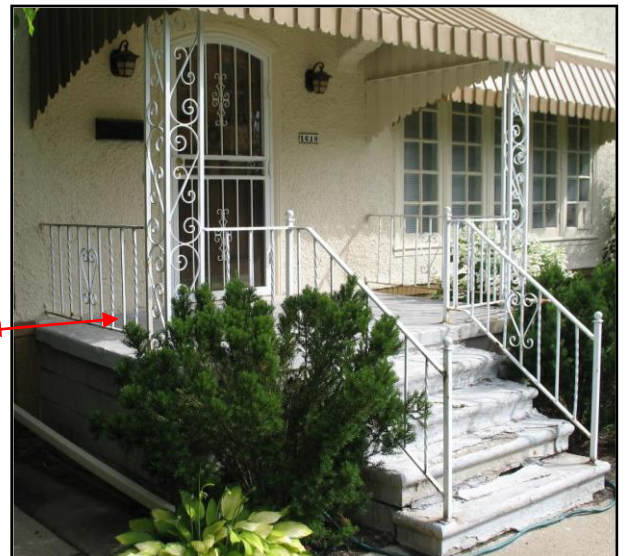
Interior and exterior views of the side-west wall and windows. The white aluminum railing has alternating twisted and straight simples, identical to the railing that had been installed at the front porch. Applicant photos. Bottom right photo is circa 2018.

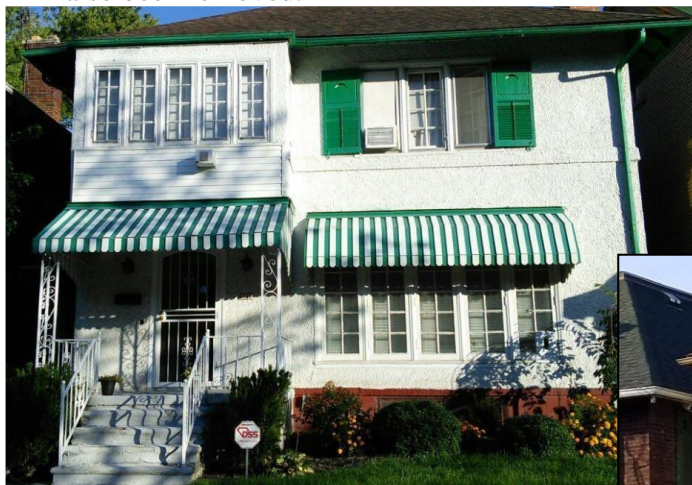
Above: This 2016 photo shows the conditions of the front facade prior to the 2018 – 2019 rehabilitation of the front porches.

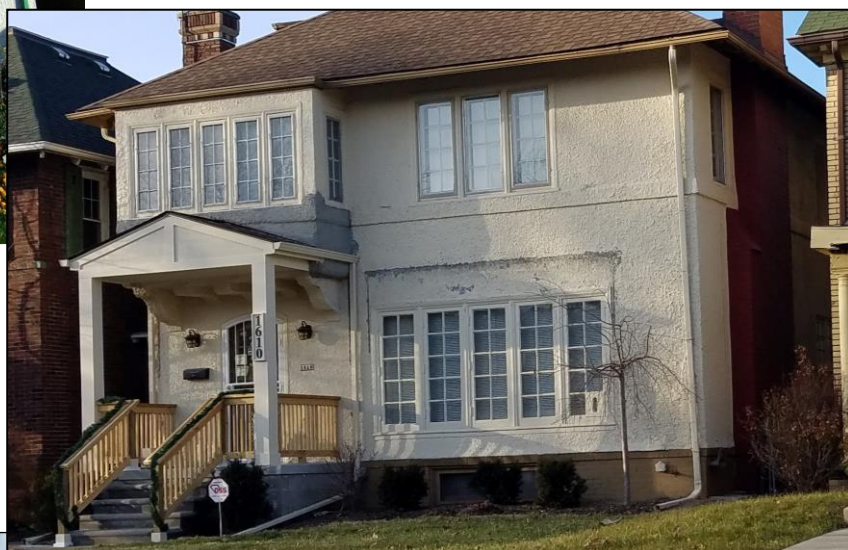
Above: This 2019 photo shows the lower wall of the upper porch has been rebuilt, and evidence of the awning at the first floor grouped window opening is still visible. Staff photo, January 6, 2019.

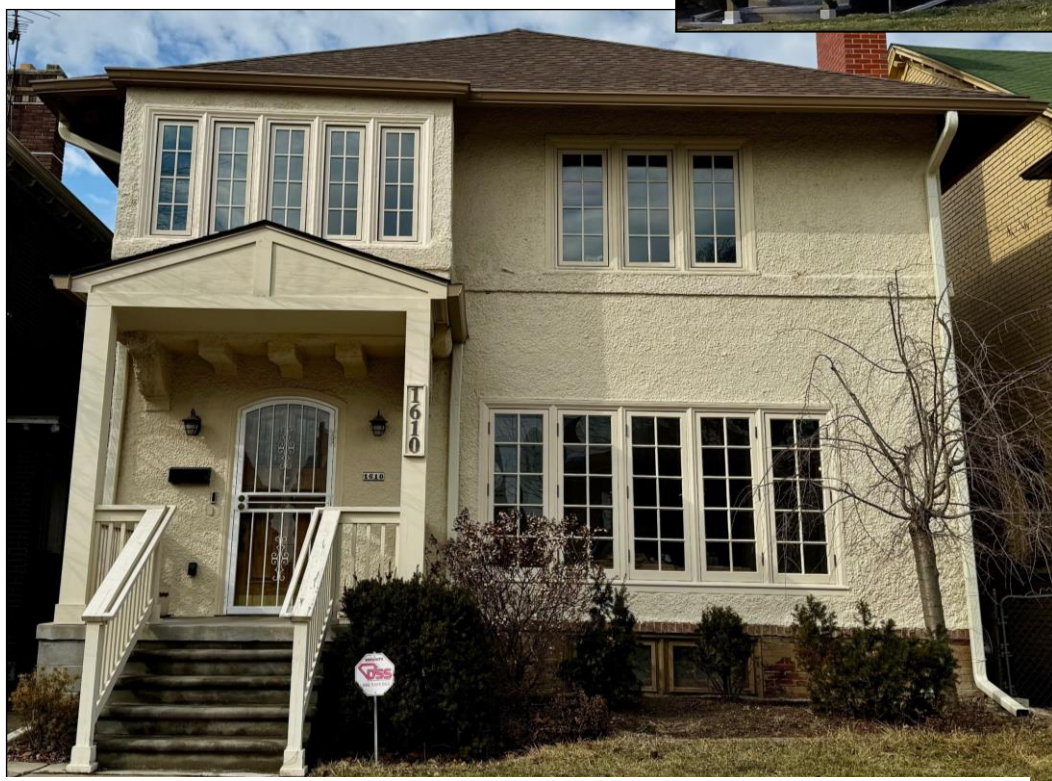
Above: Current conditions - The repair and finish work to the stucco at the bottom of the box bay, as well as the area above the grouped window shows minimal, if any, evidence of the former awnings.
