STAFF REPORT: MARCH 25, 2025 MEETING

APPLICATION NUMBER: HDC2025-00032

ADDRESS: 8101 ST. PAUL

SCOPE: INSTALL ALUMINUM SIDING AND TRIM

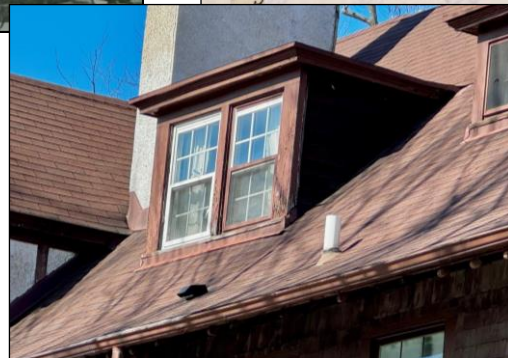
During staff's recent site visit, work completed at other units, such as vinyl windows and aluminum trim covering wood window casings, were identified on the facade. Staff did not find approvals on file for this work. The respective owners will be notified that their properties will receive violations and that applications for this completed work will need to be submitted for the Commission's review at an upcoming meeting.

Left: Vinyl windows installed at 8107 St. Paul.

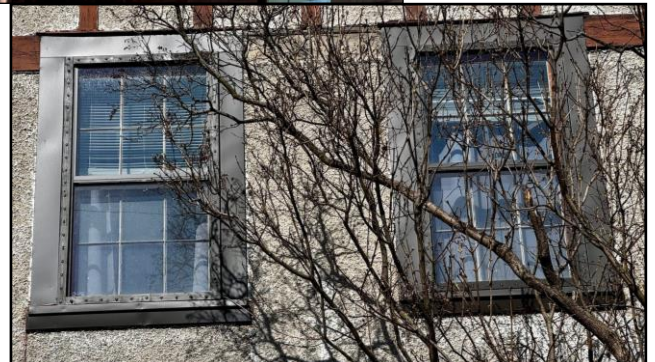
Below: Aluminum trim applied over wood trim at 8129 St. Paul.

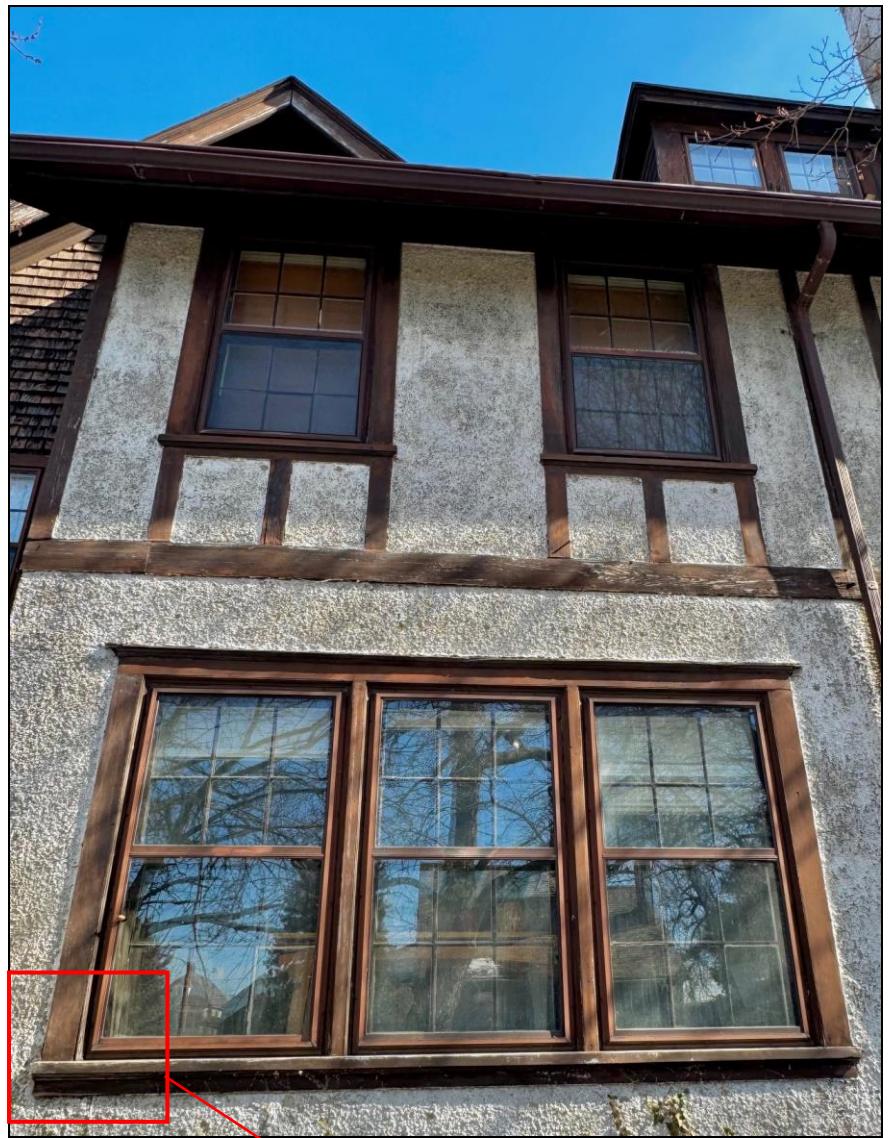
- The applicant and staff's photos document the dimensionality and highly detailed profiles of the existing, historic window casings and mullions. These details are distinctive character-defining features of the building.

- The photographs also confirm the wood window trim is in good, repairable condition. Standard Six states, "Deteriorated historic features shall be repaired rather than replaced."

Top: HDC staff photo, February 2025.

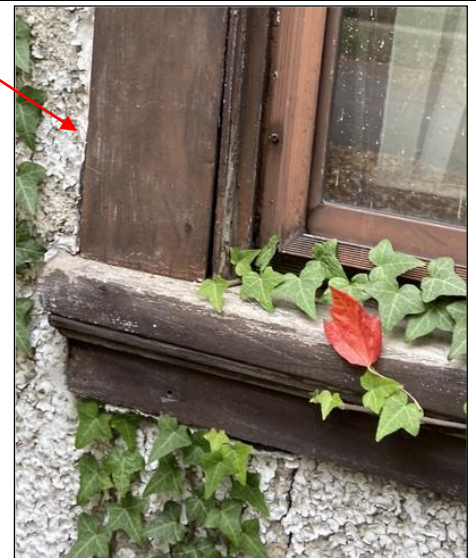
- The proposed wood trim is flat with square edges and doesn't match the details, dimensions and profiles of the historic wood trim.
 - Wrapping wood trim with aluminum emphasizes the flatness of a contemporary trim, as well as imparting a sheen which is incompatible with historic buildings.

Above: Applicant drawing of proposed window trim that will be wrapped in aluminum.

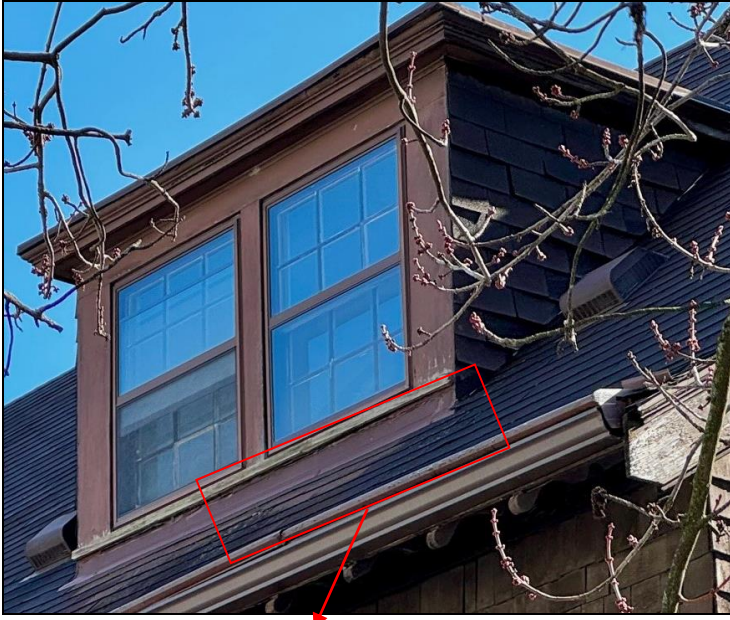
Above left: Rear wall dormer. The only area that shows any level of deterioration is near the bottom where water may pool due to the horizontal surface. Sanding, priming and repainting these surfaces is possible.

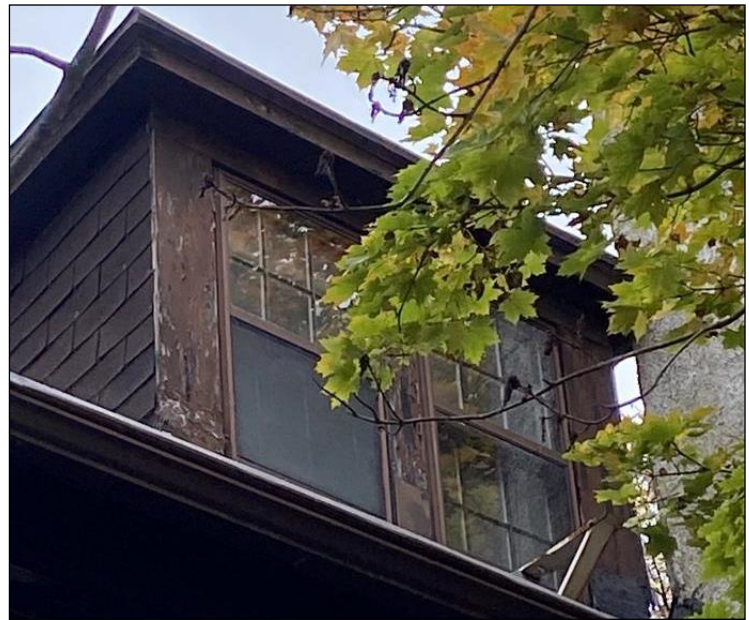
Above right: West-side dormer. The wood surfaces around the windows appears to have more flaking paint, likely due to its exposure to the sun. Again, repair can consist of surface prep, filler if necessary, and repainting.
