ADDRESS: 801 EDISON**APPLICATION NO: HDC2025-00037****HISTORIC DISTRICT: BOSTON-EDISON****APPLICANT/CONTRACTOR: BRENDAN MCGLINCH/MCGLINCH AND SONS****OWNER: AMANDA CONNOLLY & MICHAEL GIBB****DATE OF STAFF SITE VISIT: 2/25/2025****DATE OF PROVISIONALLY COMPLETE APPLICATION: 02/18/2025****SCOPE: REPLACE WINDOWS, GUTTERS, AND DOWNSPOUTS****EXISTING CONDITIONS**

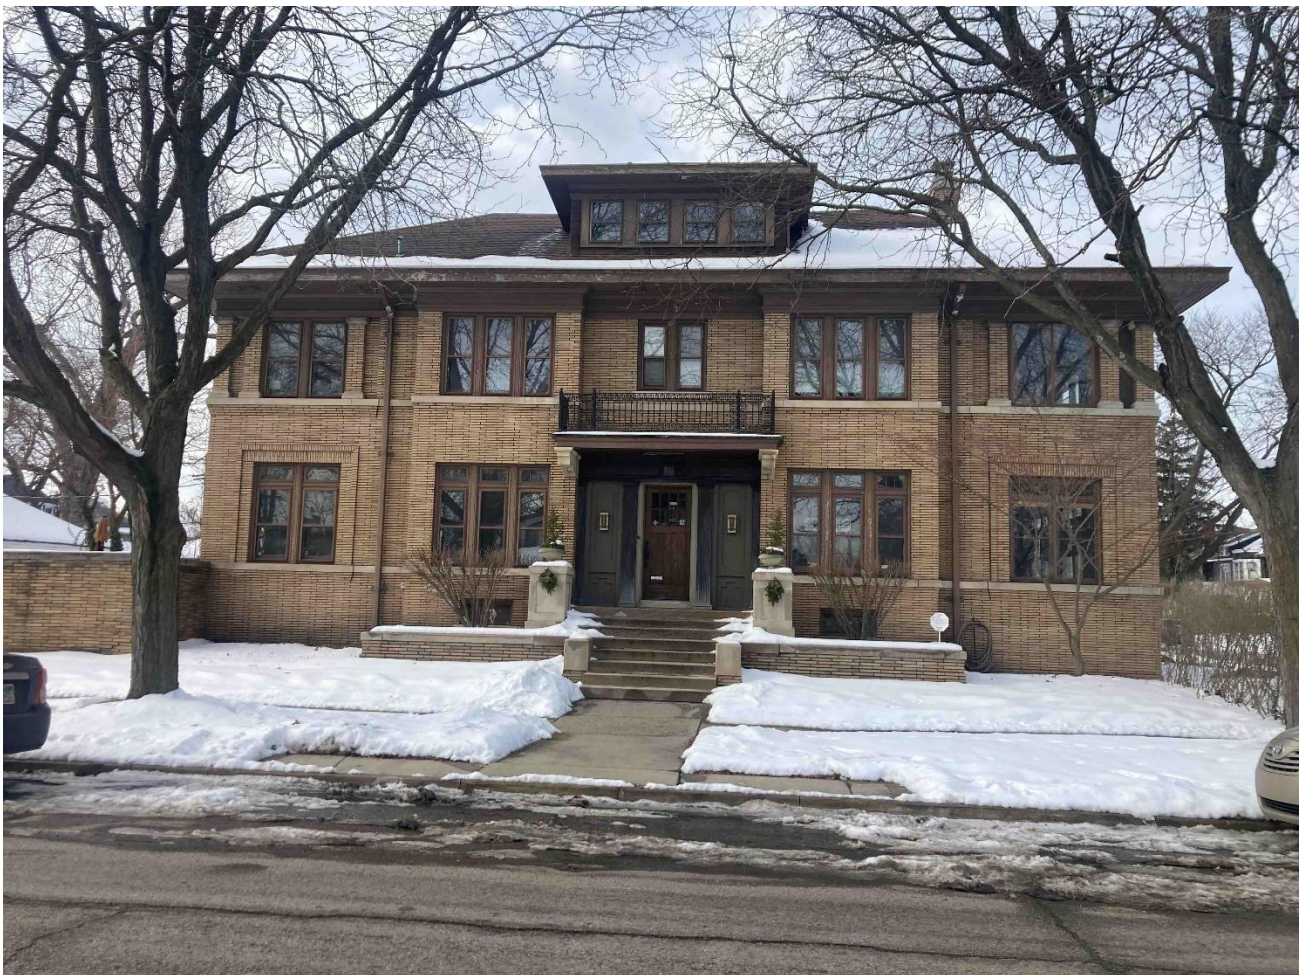
801 Edison, current conditions. Photo by HDC staff, 2/25/2025.

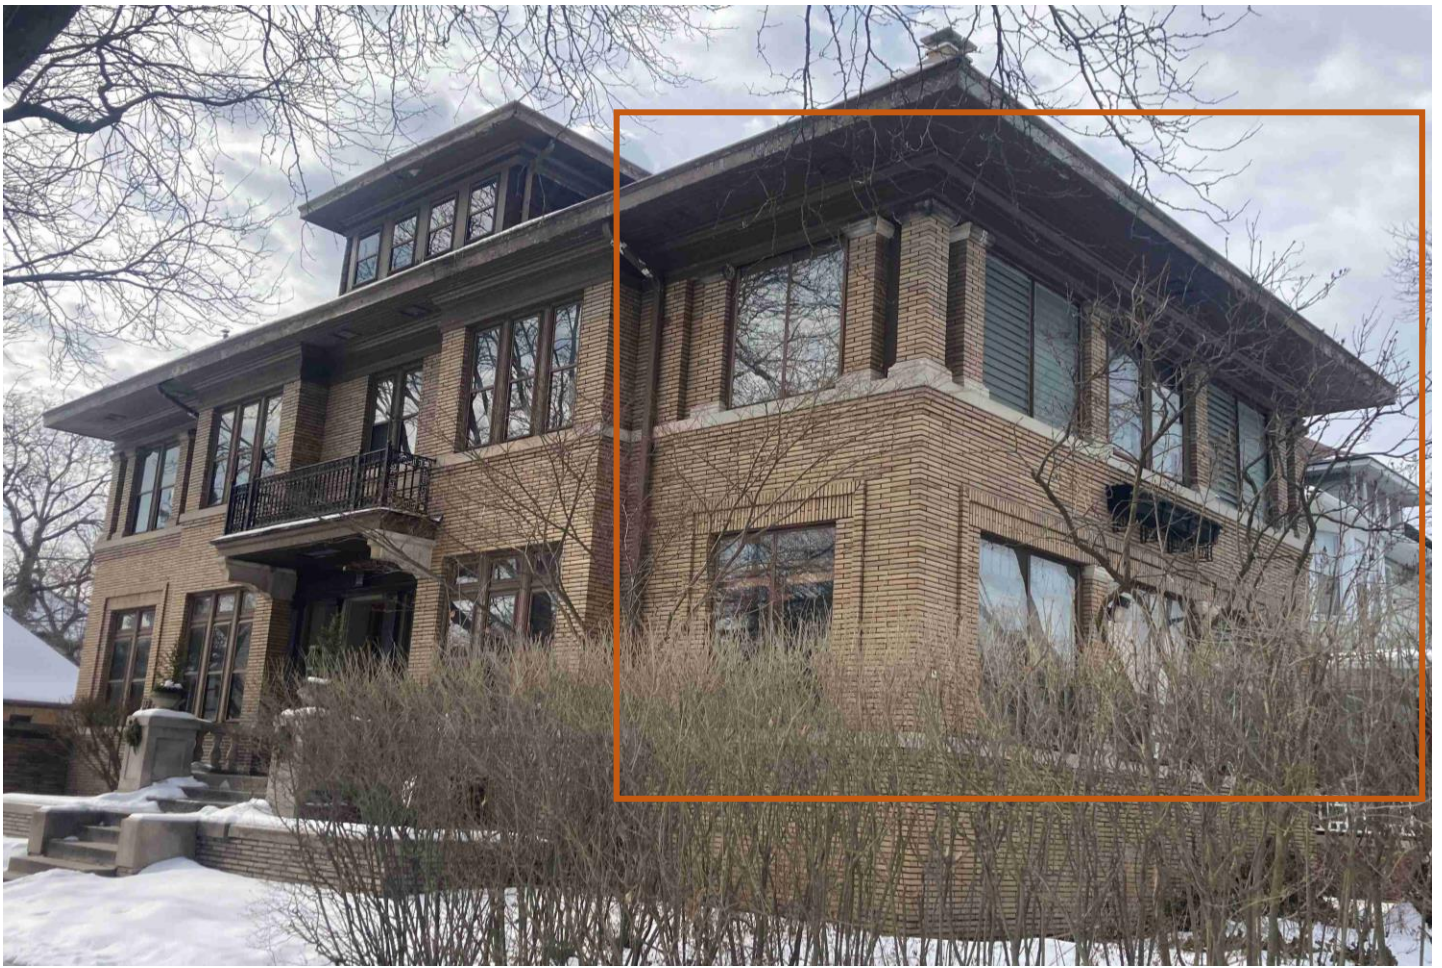
801 Edison, current conditions. Photo by HDC staff, 2/25/2025. North side porch outlined in orange

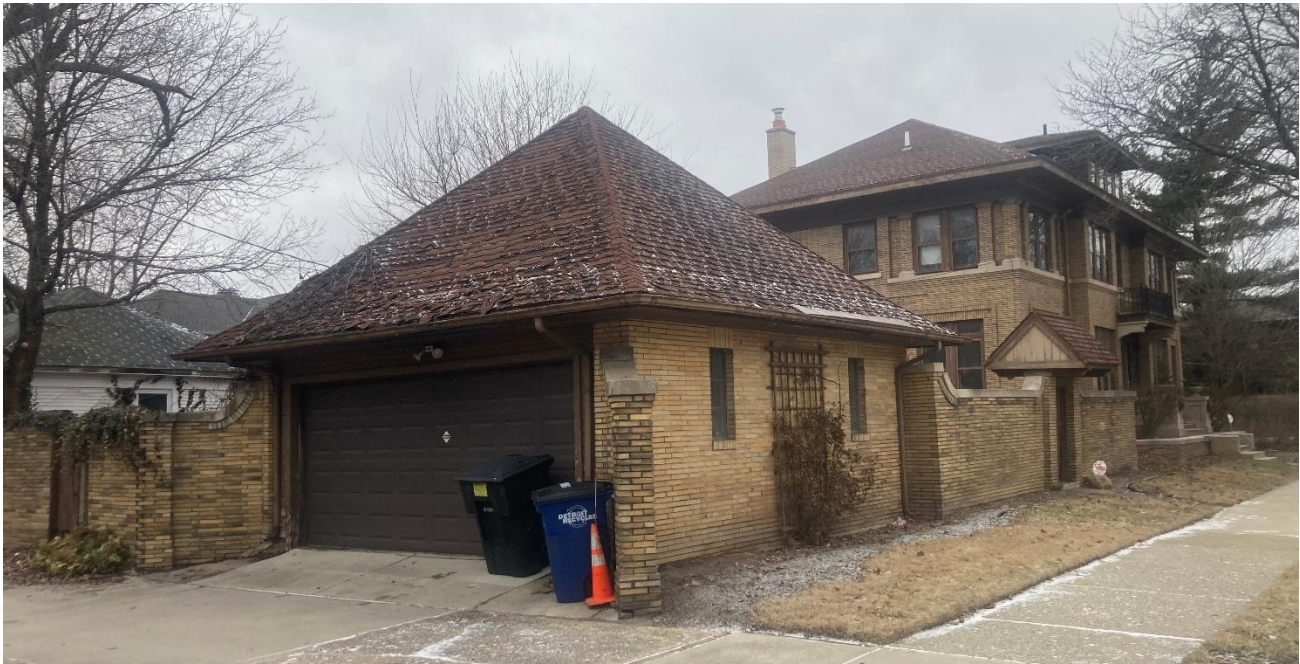
801 Edison garage, current conditions. Photo by HDC staff, 3/6/2025.

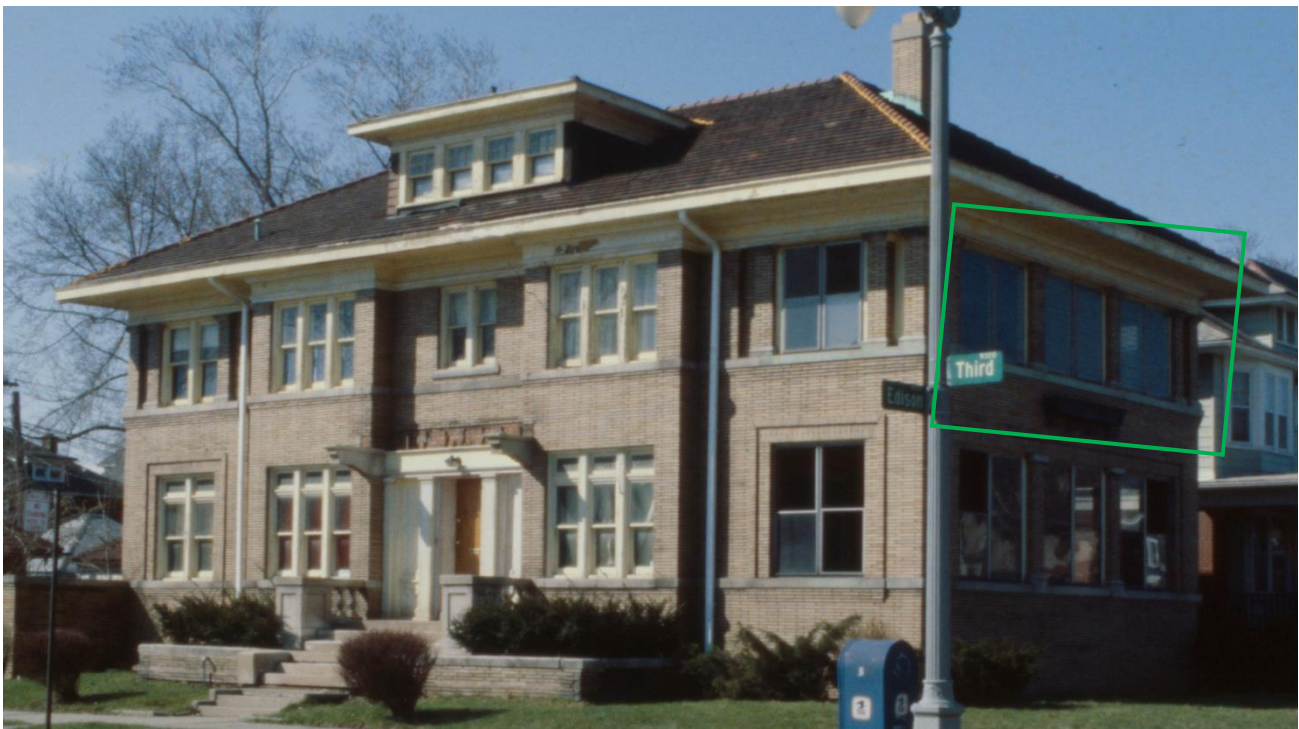
801 Edison, photo taken in 1980. See the side porch wing. The windows at the porch outlined in green are jalousie windows. All other windows at the porch appear to be 1/1 storm windows

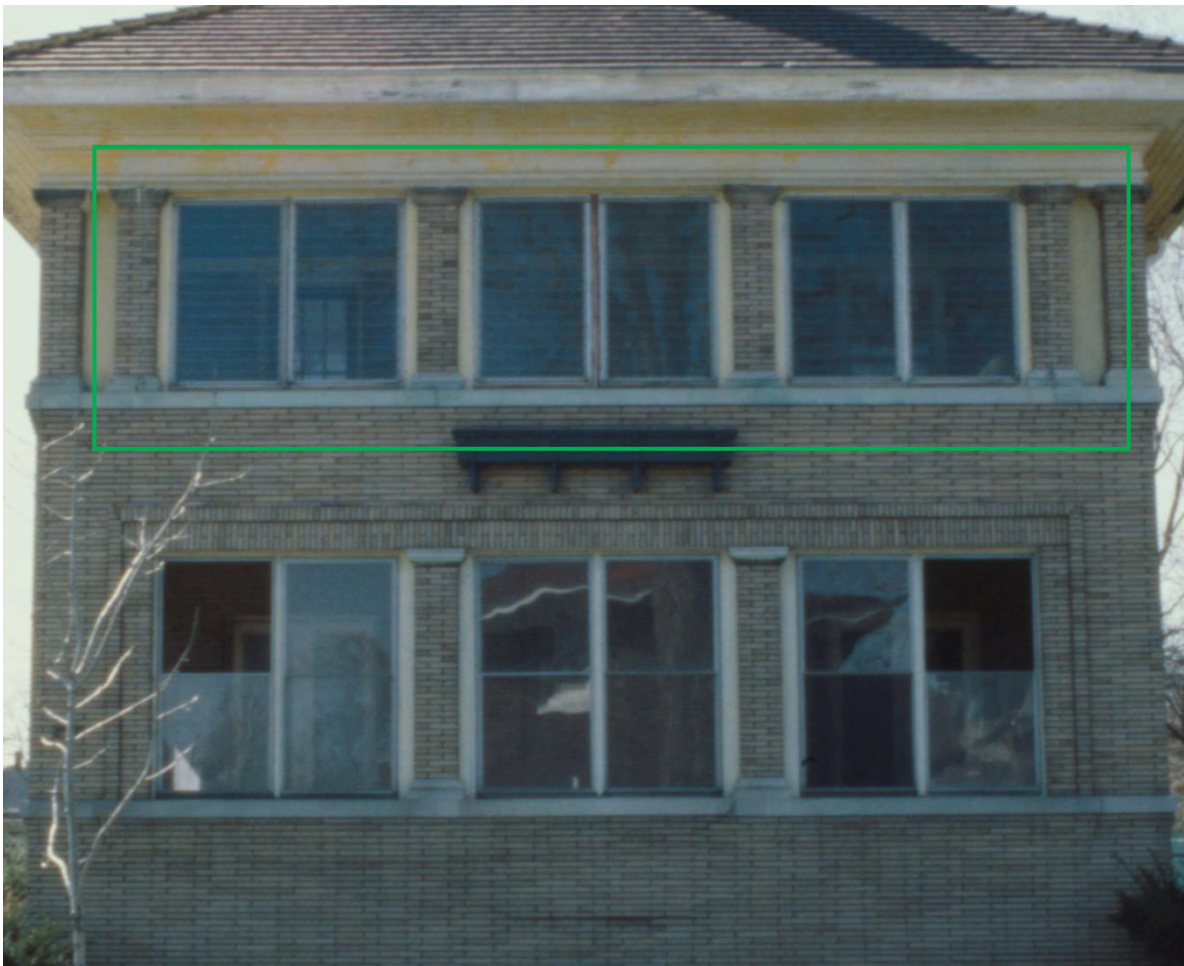
801 Edison, photo taken in 1980. See the side porch wing. The windows at the porch outlined in green are jalousie windows. All other windows at the porch appear to be 1/1 storm windows

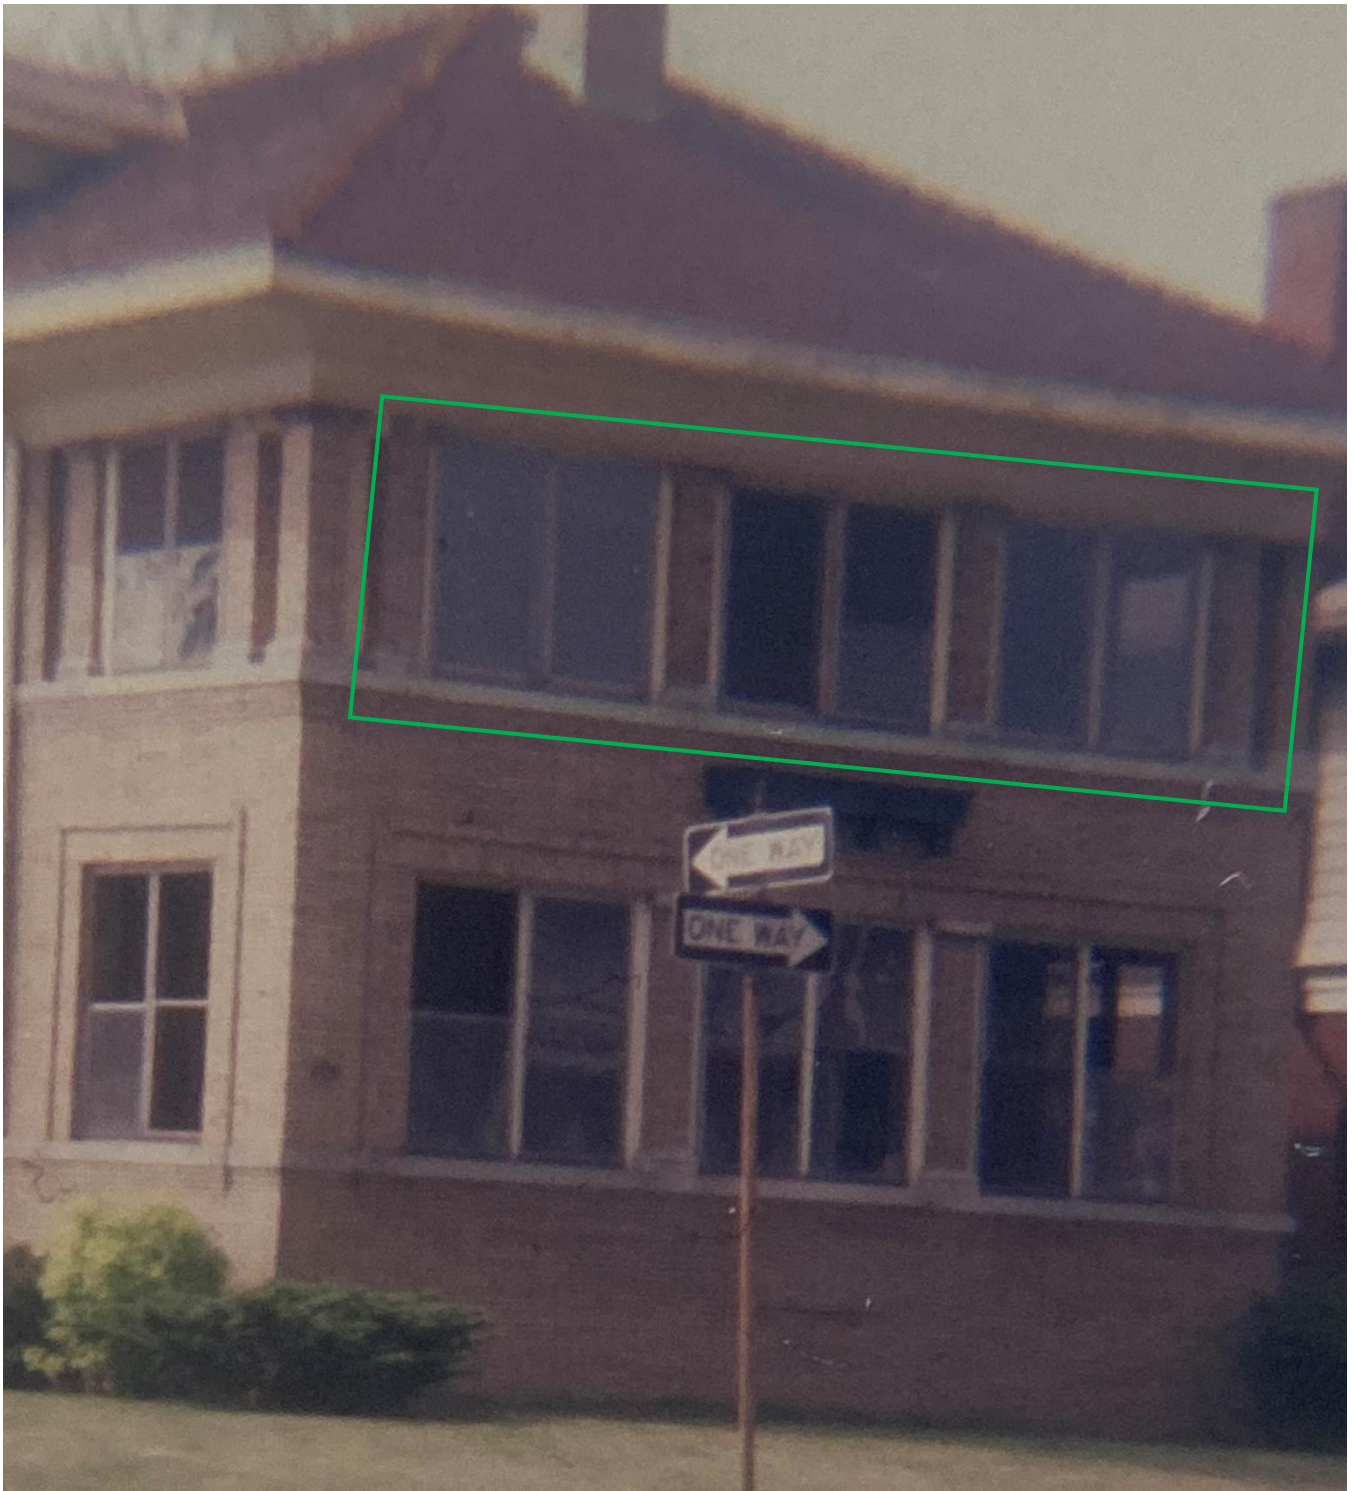
801 Edison, photo taken in 1980 showing north side porch, the location of the proposed new windows. The windows outlined in green are jalousie windows. All other windows appear to be 1/1 storm windows

- It is staff's opinion that the windows that were present at the side porch at the time of the district's designation were not original to the property's date of construction. Specifically, the porch was likely open when the house was built, and the jalousie and storm windows were likely installed post 1950s. Also, in 1974, the storm windows at the side porch appeared to be in poor condition. It is therefore staff's opinion that the windows present at the porch in 1974, at the time of the district's designation, were not distinctive character-defining elements of the house.

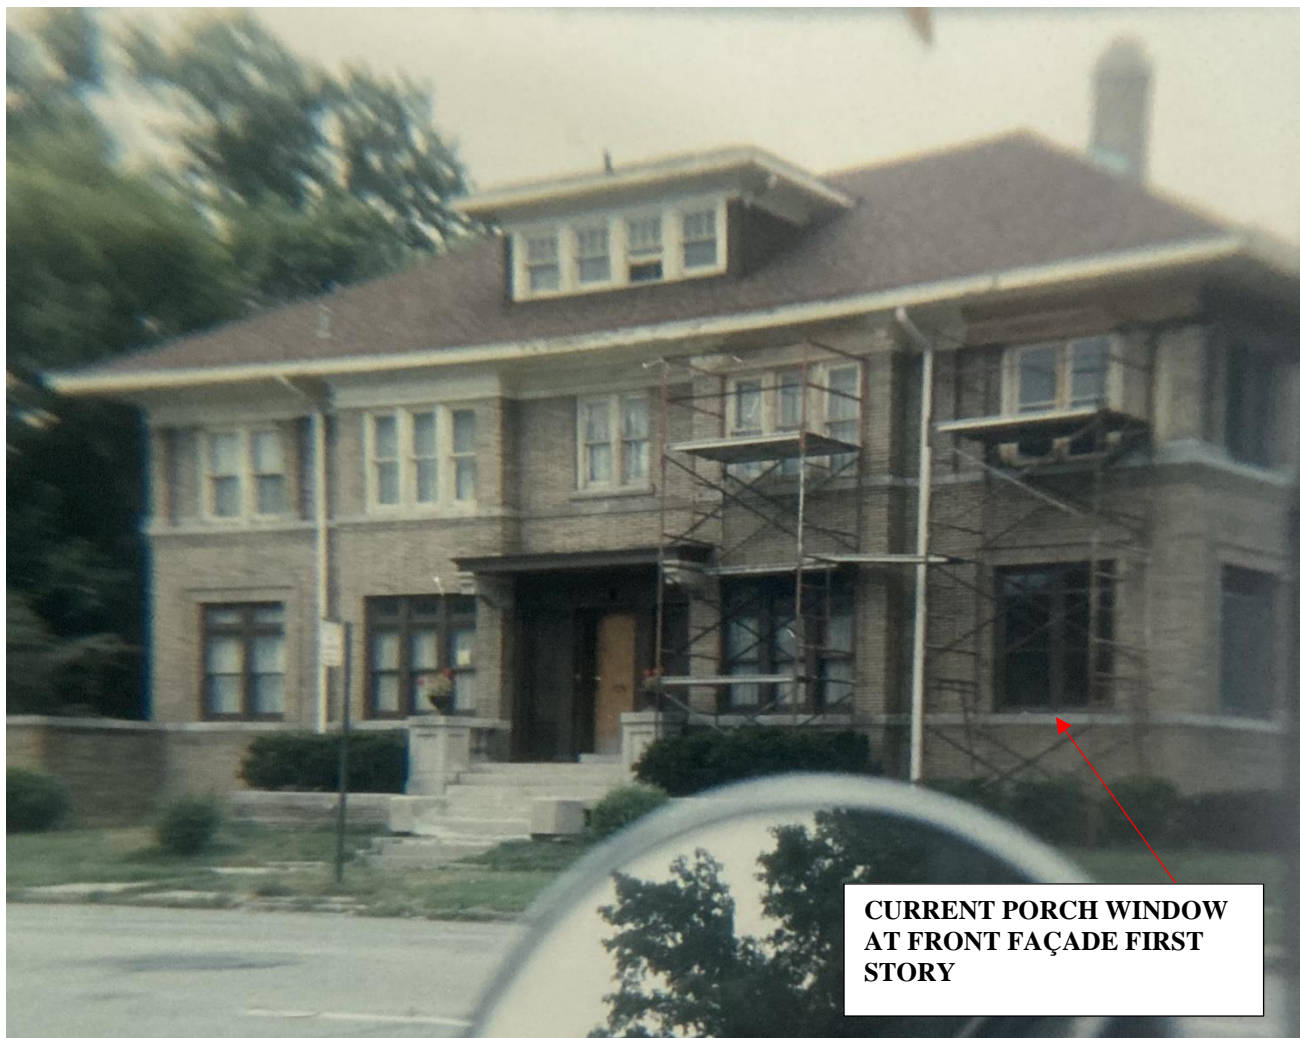
- The clay tile roof had been removed and replaced with asphalt shingles per the 1980 COA.
 - The window and front door trim were in the process of being painted brown

- The aluminum storm windows which were approved by the 1984 COA had not yet been installed at the house's main body. Likely, the wood windows had to be painted brown prior to the installation of the storms

- The owner had begun to install the current wood windows at the north side porch. Staff was unable to locate a COA for the replacement of the porch's storm windows. Nevertheless, as noted above, the windows which were present in 1974 and removed ca. 1984 were not distinctive character-defining features of the house, in staff's opinion.

Ca. 1984 photo. Note that the owner was in the process of replacing the side porch windows per the above note. See the below photos to note the window conditions in 1974 and 2025.

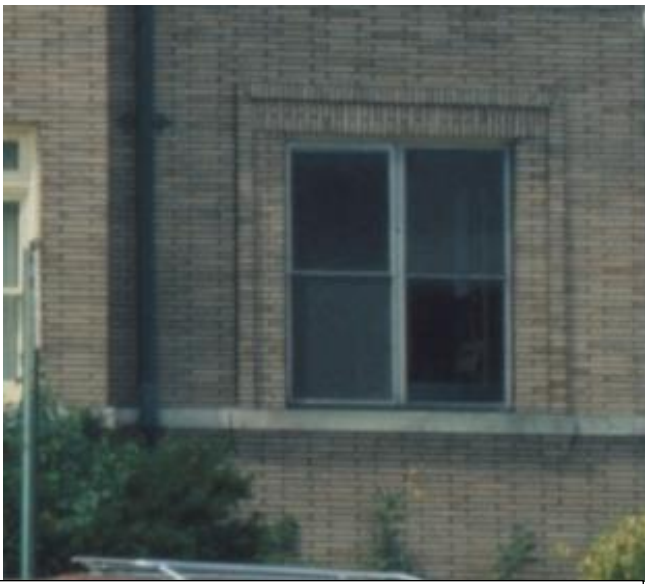
Above referenced porch window opening at front façade, first story, condition in 1974, prior to ca. 1984 replacement

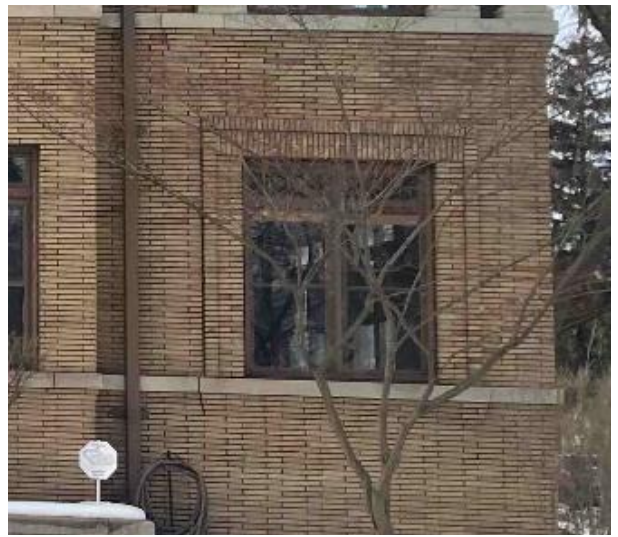
Above referenced porch window opening at front façade, first story, current condition. This window was installed ca. 1984

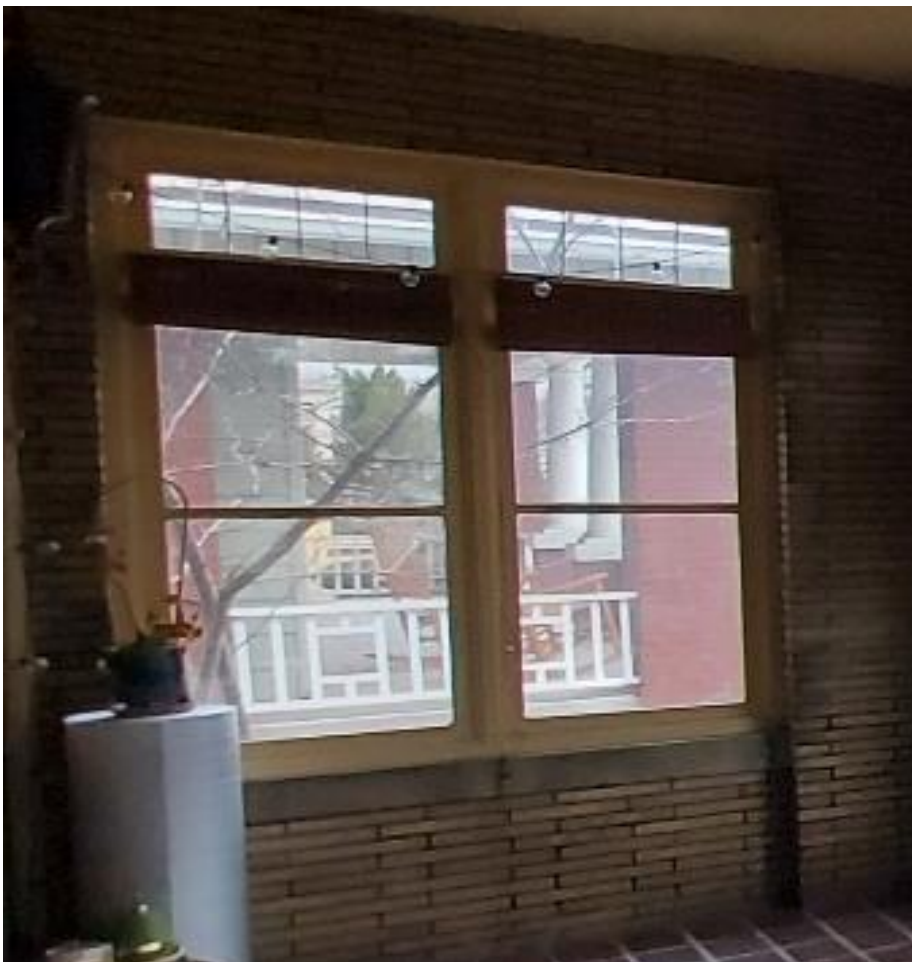
Window type that is present at the porch, front façade, first story. This window was installed ca. 1984. The window type is a wood 1/1 unit with what appears to be a fixed transom with metal casing

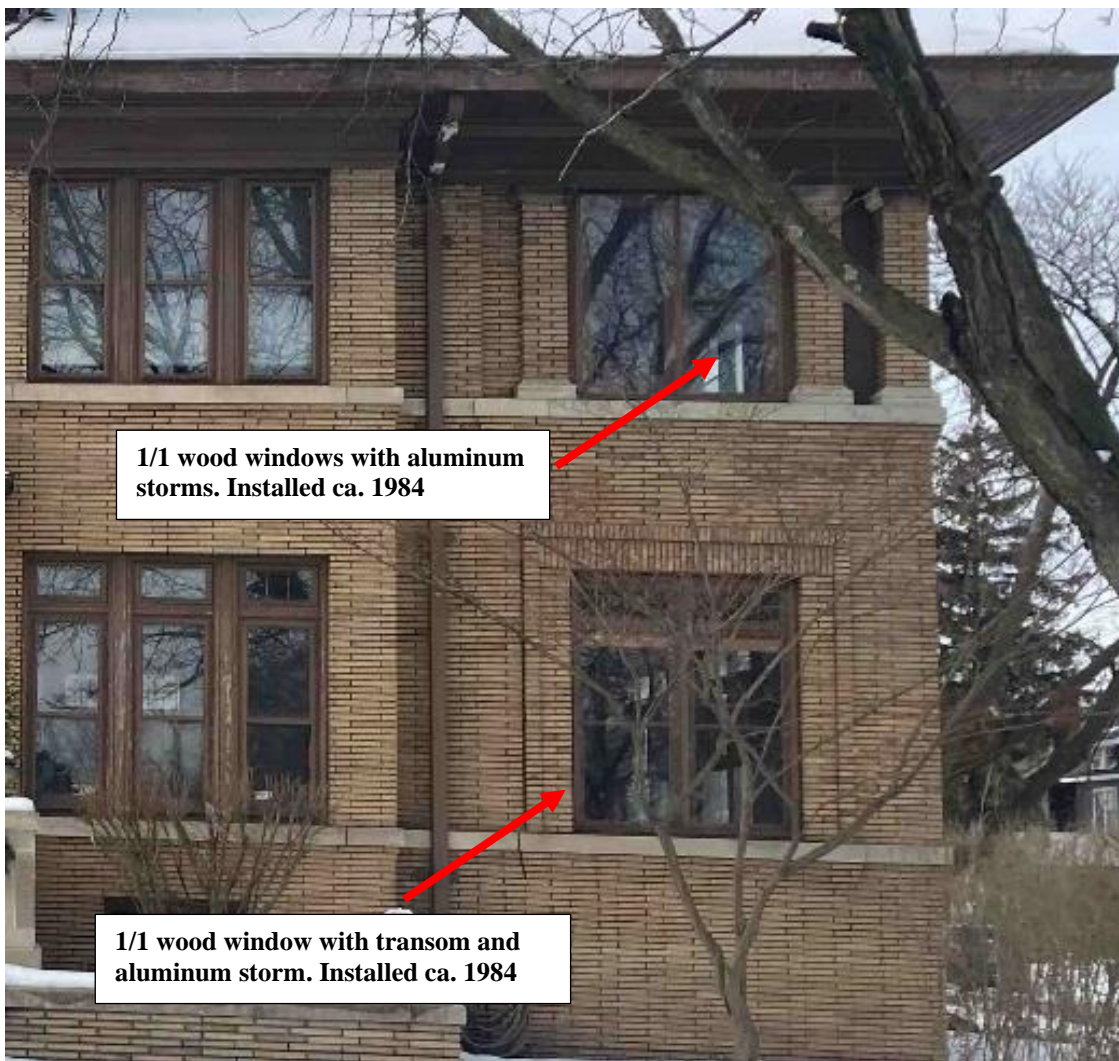
East/front façade, showing windows at porch which are proposed for replacement. Staff photo taken on 2/25/2025

1/1 wood windows with aluminum storms. Installed ca. 1983

1/1 wood windows with transoms and aluminum storms. Installed ca. 1983

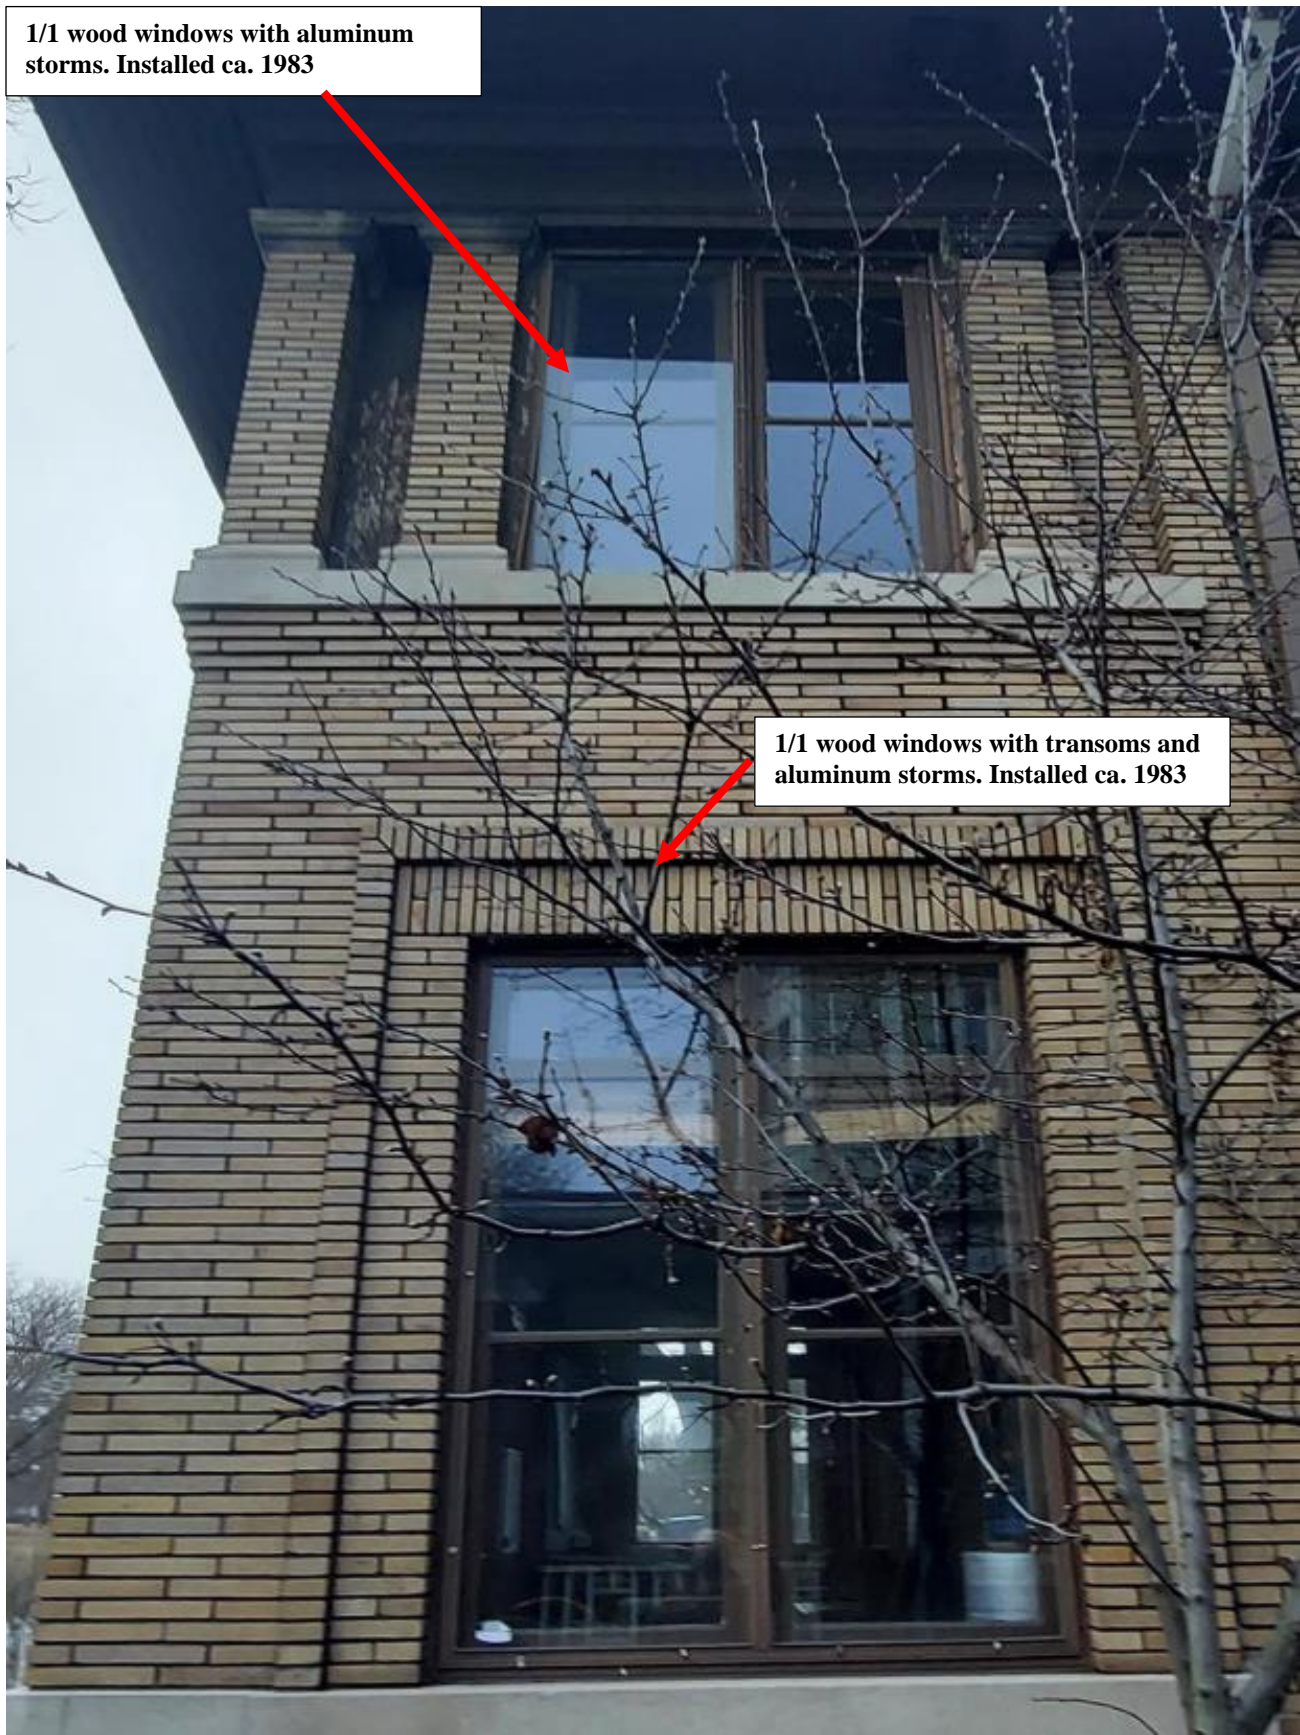
West façade of porch, showing ca. 1983 window proposed for replacement. Photo by applicant

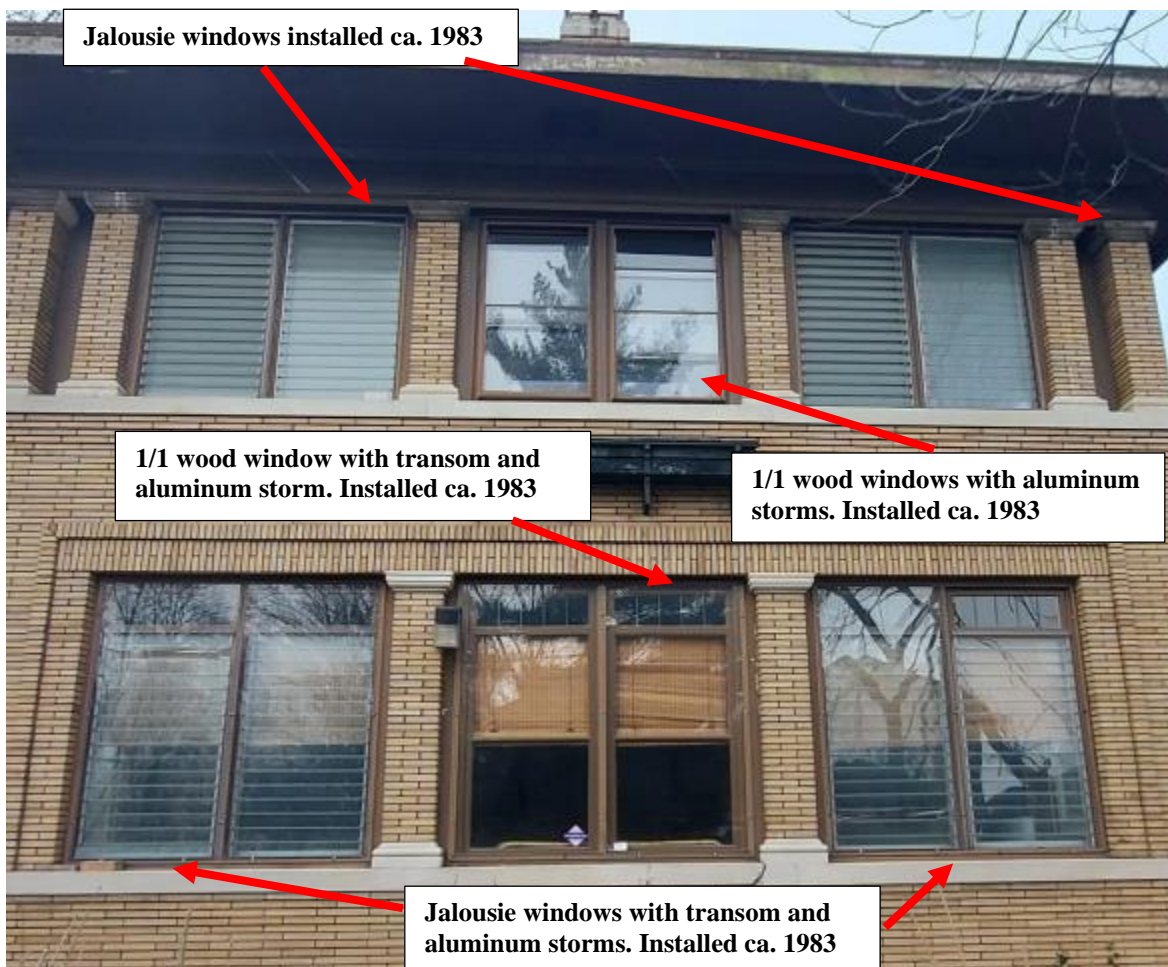
North/side façade, showing windows at porch which are proposed for replacement. Staff photo taken on 2/25/2025

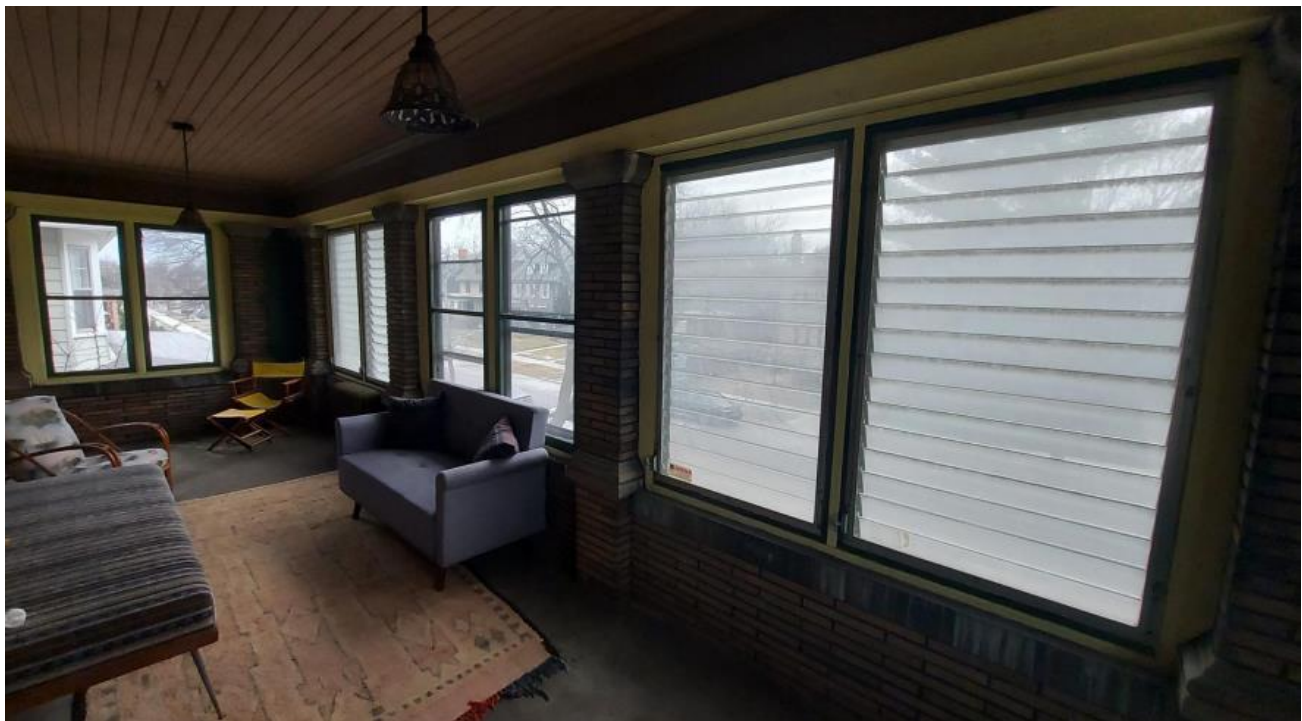
Interior of porch, second story. Facing northwest, showing windows installed ca. 1983. Photo provided by applicant

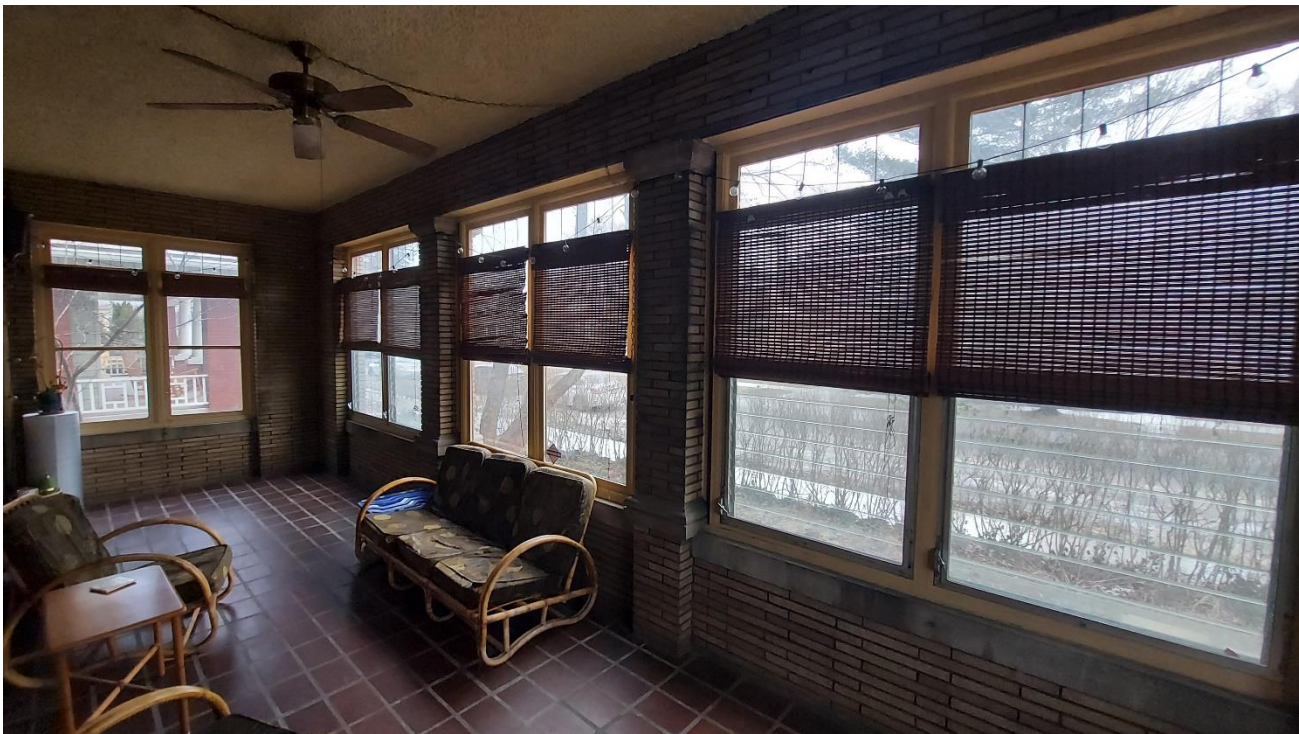
Interior of porch, first story. Facing northwest, showing windows installed ca. 1983. Photo provided by applicant
