# THE CARRIAGE HOUSE

HISTORIC DISTRICT COMMISSION // MAY 22, 2020

2827 JOHN R STREET  
STRUCTURAL REUSE EVALUATION

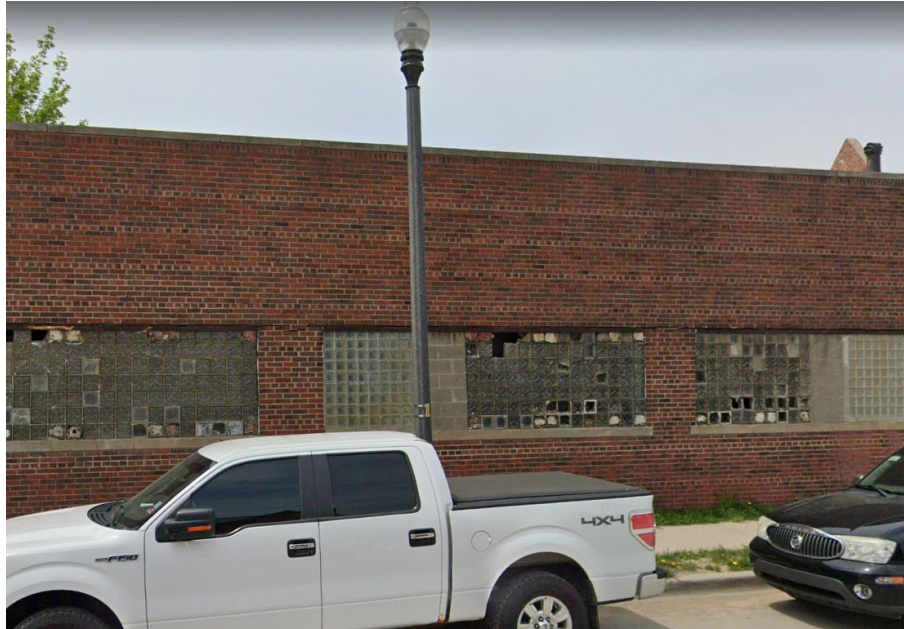
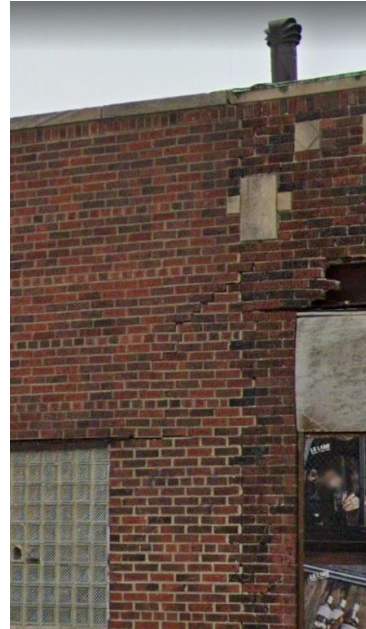
## 1-STORY STRUCTURE

The one-story building does not appear original with the carriage house. Part of the walls are CMU and do not match the period of the brick of the carriage house (Photo 4). Similar to the carriage house, part of the roof has collapsed. The existing brick is in very poor condition. The existing steel lintels above the windows and doors have rusted and caused the brick to crack around the steel (Photo 5). In addition, there are several large step cracking around the corners and several other locations around the building (Photo 6).

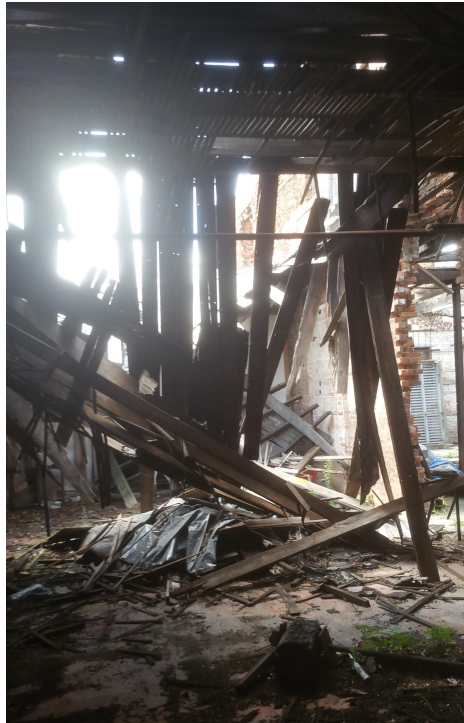
INTERIOR LOOKING EAST  
(COMPROMISED STRUCTURE)

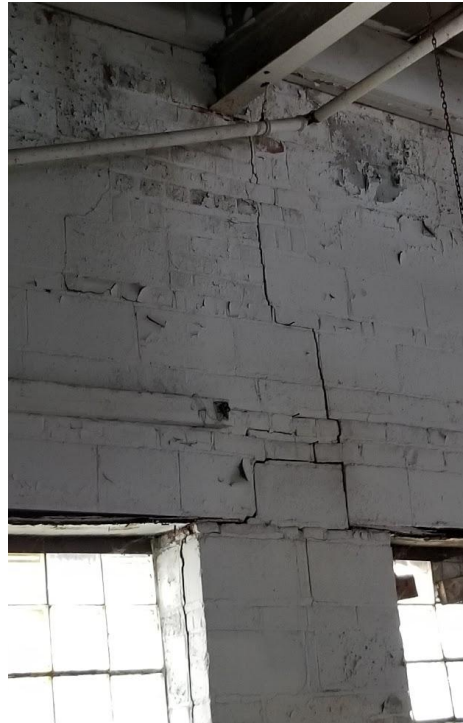
INTERIOR LOOKING EAST  
(COMPROMISED STRUCTURE)

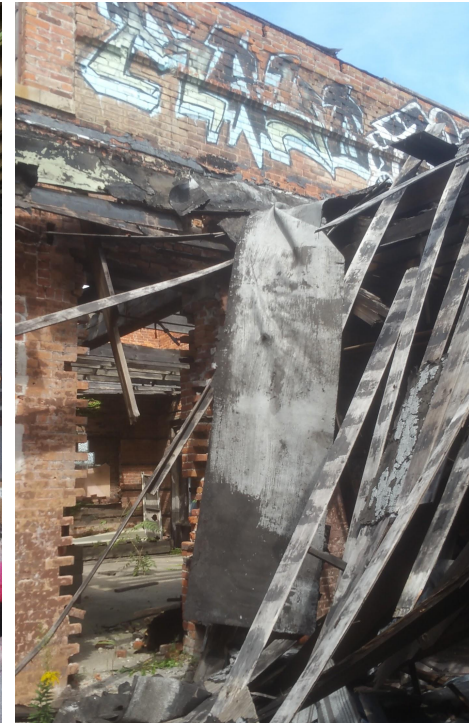
FROM 1-STORY INTO CARRIAGE  
(ROOF COLLAPSED)
