Marquez Residence
1948 Chicago Blvd
Window and Facade Submission

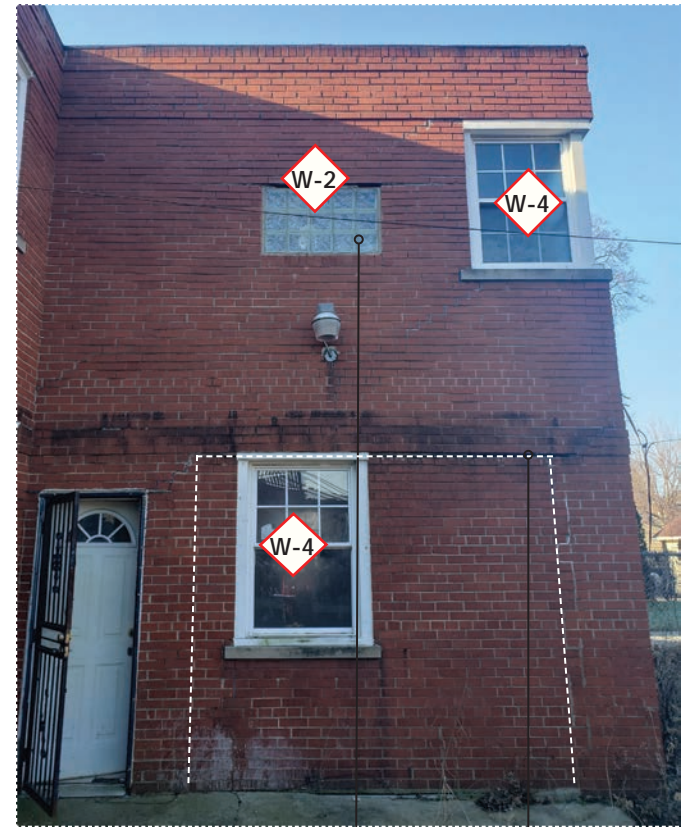
Fig. 1 | East Facade (Former Garage)

Original home had one car garage.

The original garage opening left the steel lintel in place.

Original Glass Block

It will get removed.

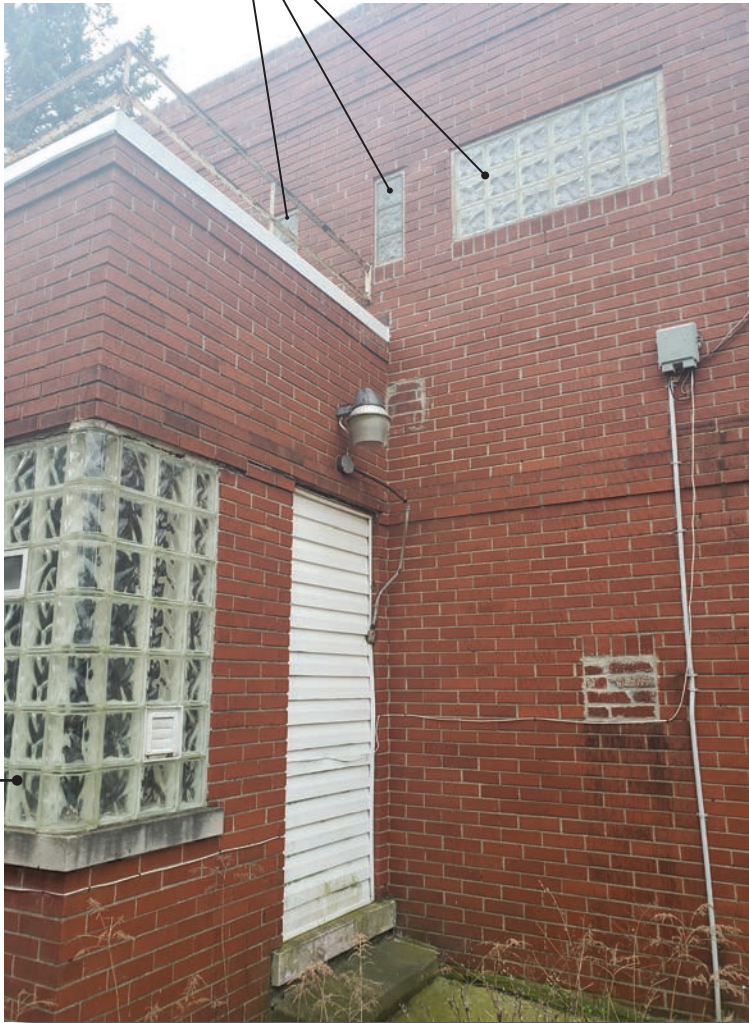
Fig. 2 | Looking SW at East Facade (Former Rear Entry)

Glass Block is not original to home according to historic photos

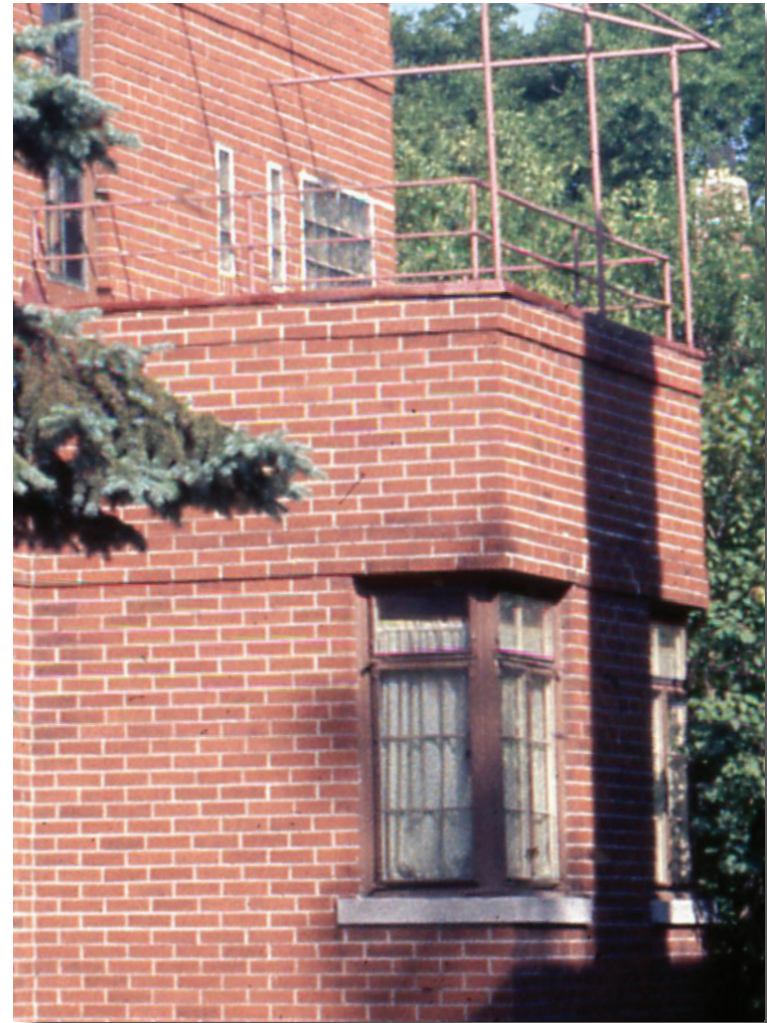
Fig. 3 | Historic 1974 Boston Edison photo references existing glass block windows on 2nd Floor with metal railing and fabric canopy structure.

On the first floor are long rectangular metal windows w/ upper transom and horizontal battens.

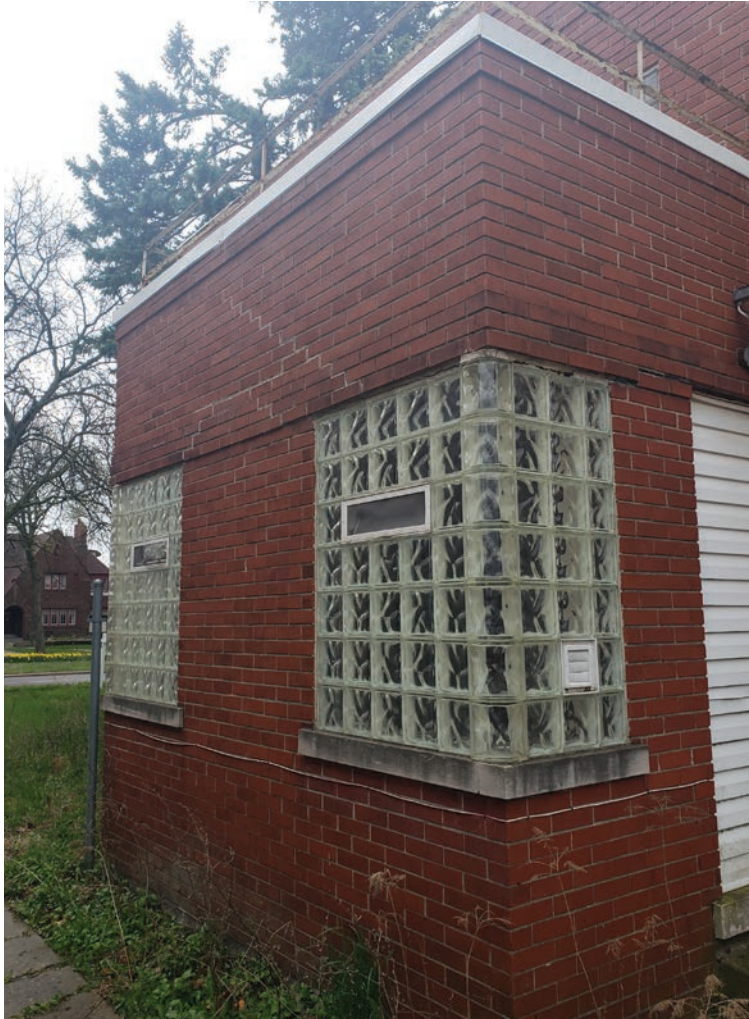
Fig. 3A | Today, the windows have been replaced with glass block. See window type (W-3) for more informaton

We propose a historic preservation retrofit with Anderson Windows. Anderson's E-Series are advertised as an architectural low-profile solution for this style of home. We will remove existing glass block and spec the original window to casement

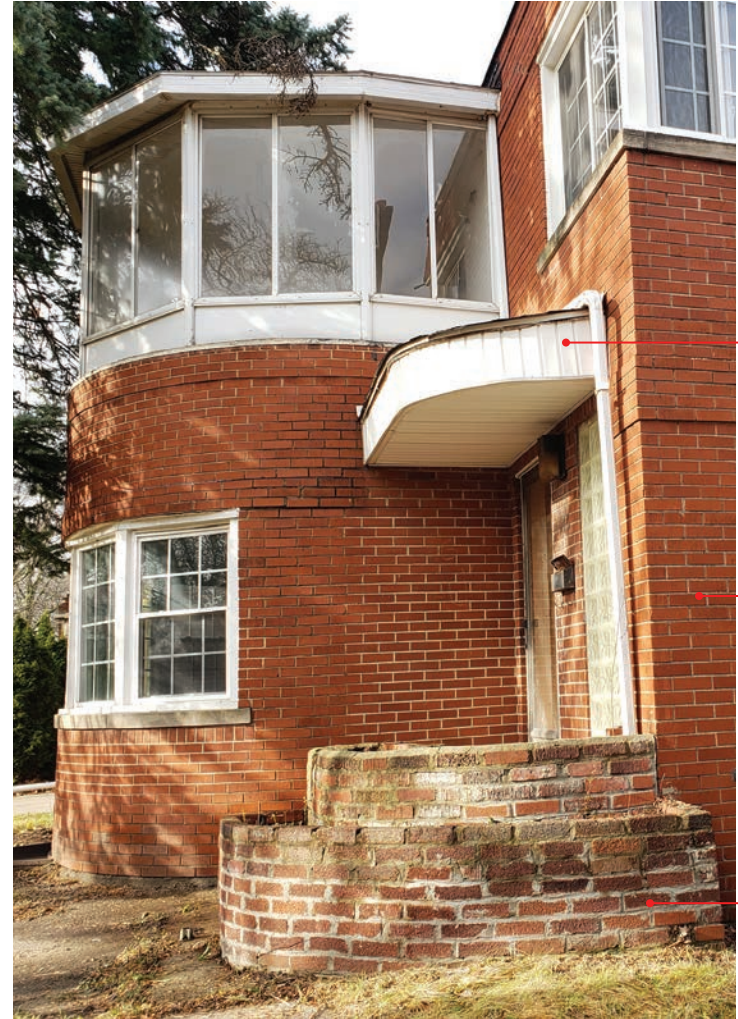
Fig. 5 | Looking west at East facing facade - Front entry area.

Existing Planter is not original.

Bricks do not match.

Remove overhang and repair framing. Reroof and clad w/ metal paneling to match windows.

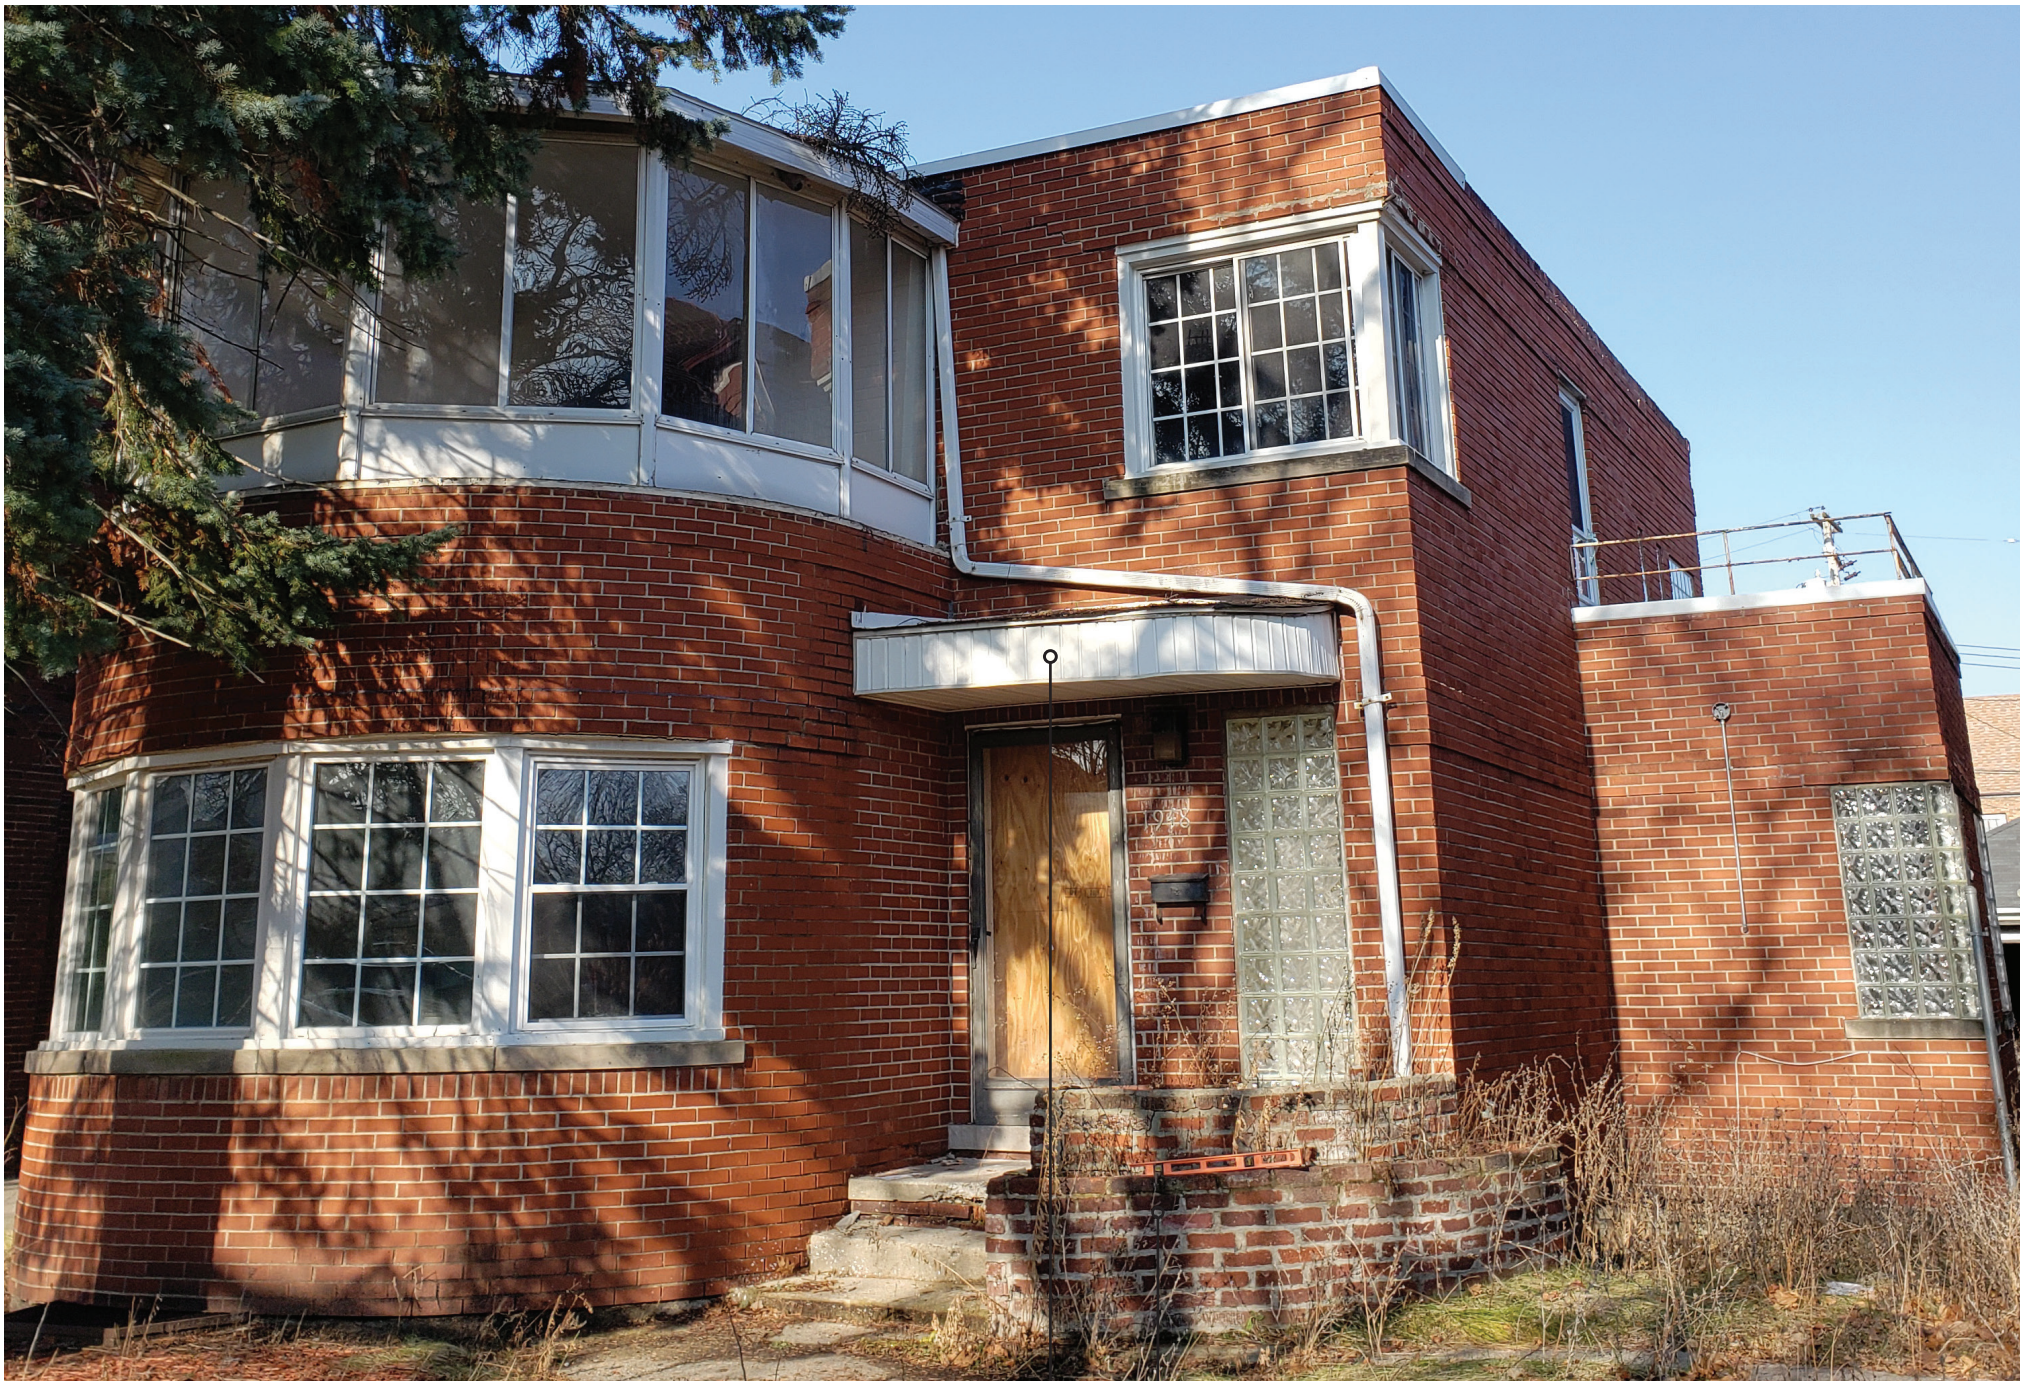
Fig. 6 / South Facade (Street View). See 1974 and 1980 Historic Photos

Planters were constructed between 1975-1979

Repair existing entry awning w/ metal composite

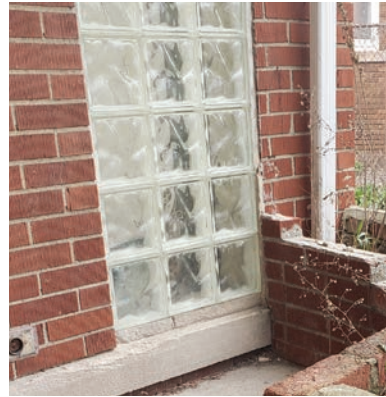
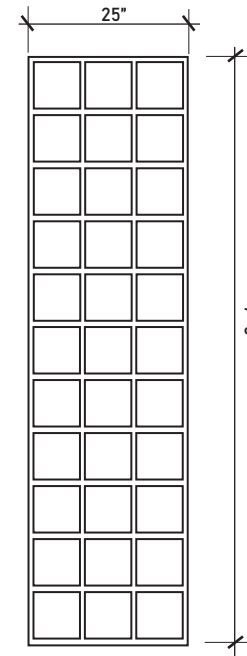
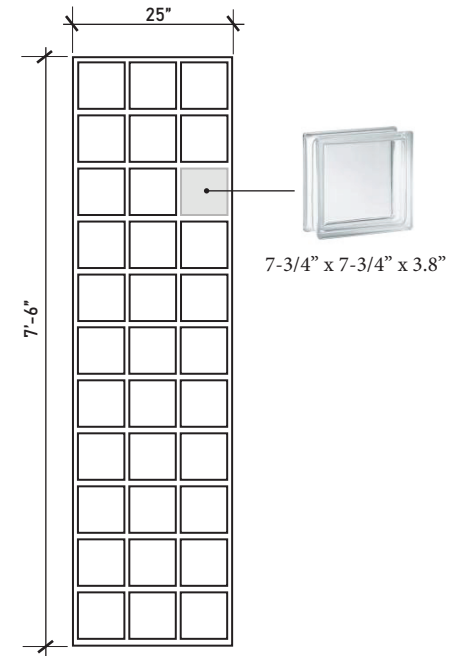
W-6

The existing glass block windows are original to the home. The windows mortar has aged and is brittle. The glass block is now 74 years old and has shown signs of fogging and mild deterioration.

We propose a historic preservation retrofit with glass block windows. We want to be good stewards to the homes architecture and will not alter the size or original intent.

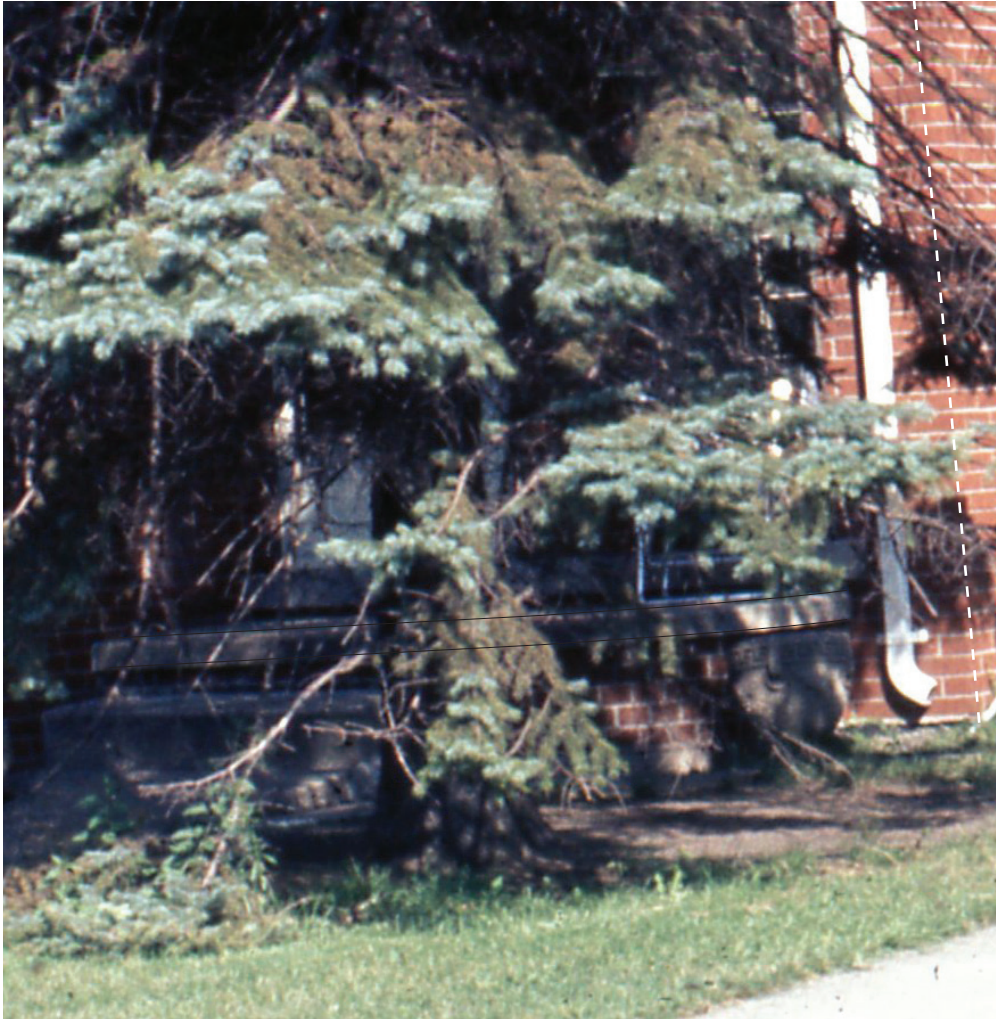
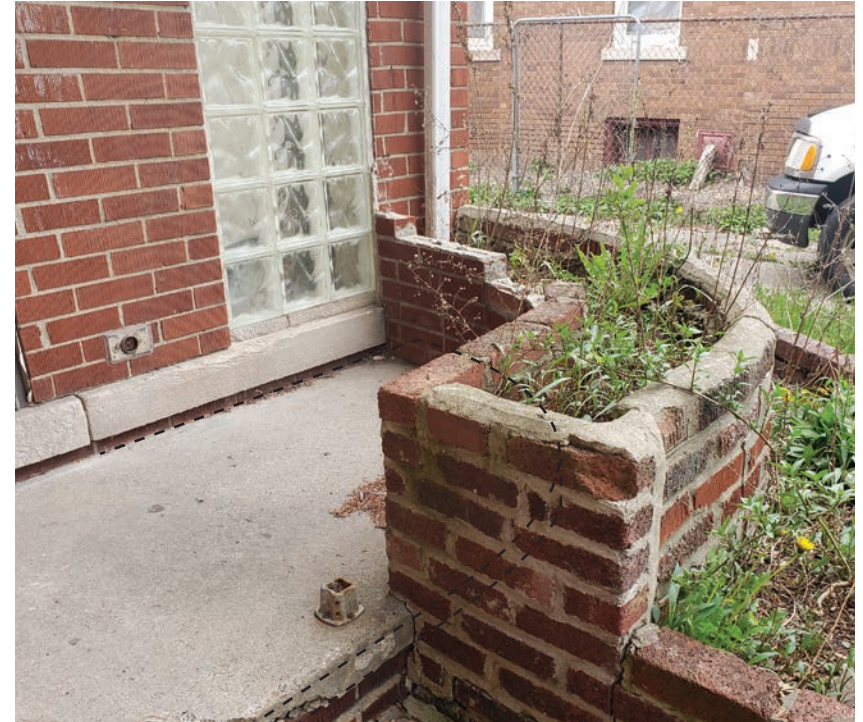
Fig. 7 | Above: 1974 Boston Edison Photo shows a front porch with a arched edge, but no raised planters. Right: Diagram shows where original porch location (in dashed).

add brick to bring windows to suitable proportions

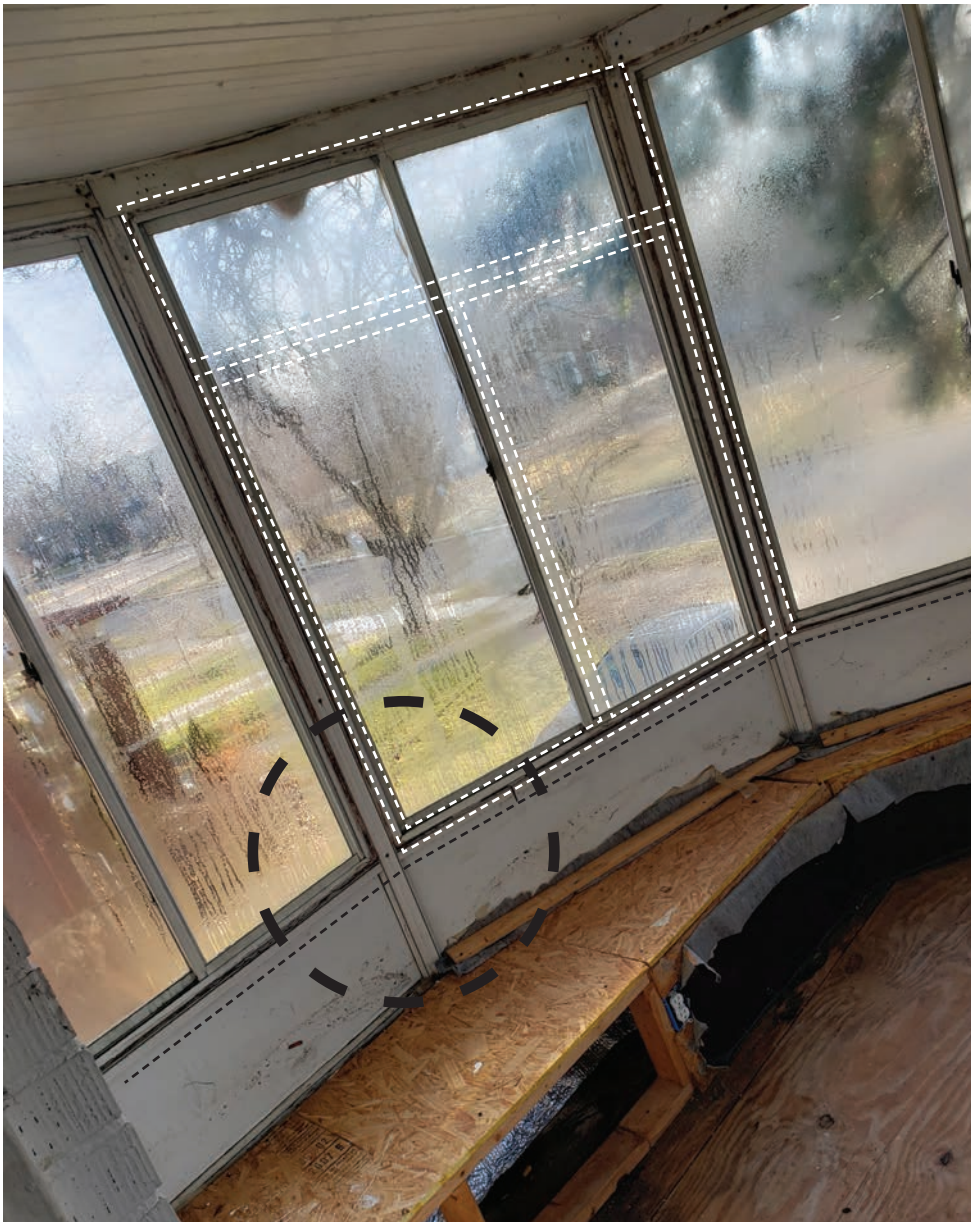
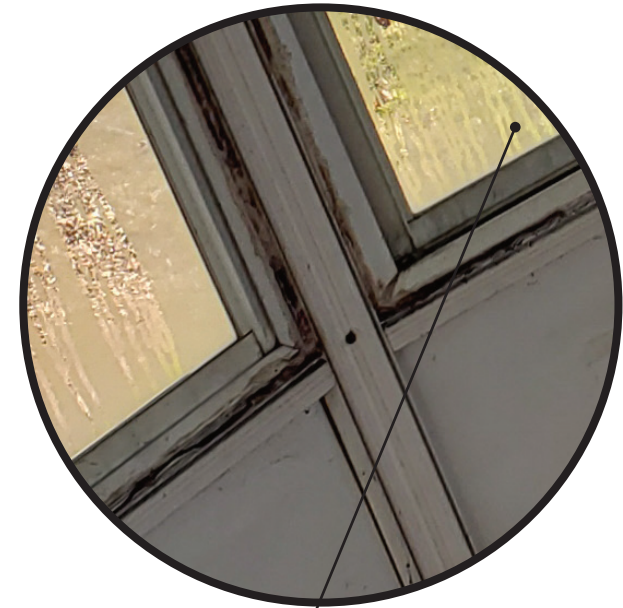
Fig. 9| Above: 2020 Interior photo shows existing Sunroom. To the left you can see the brick exterior wall that is now enclosed w/ 180 degree window view from the bow of the "boat." The dashed white lines highlight the proposed new window proportions.

- Single Pane Glazing
- Installed between 1958-1974
- Existing seals have deteriorated. Plastic frames have become brittle.
- Existing interior space is non insulated. Existing glazing system life cycle has expired.

Stack new brick to bottom of existing windows. Frame and insulate interior walls.

***Note: New masonry will match existing brick and mortar should match the original composition in color, texture, and tooling.*

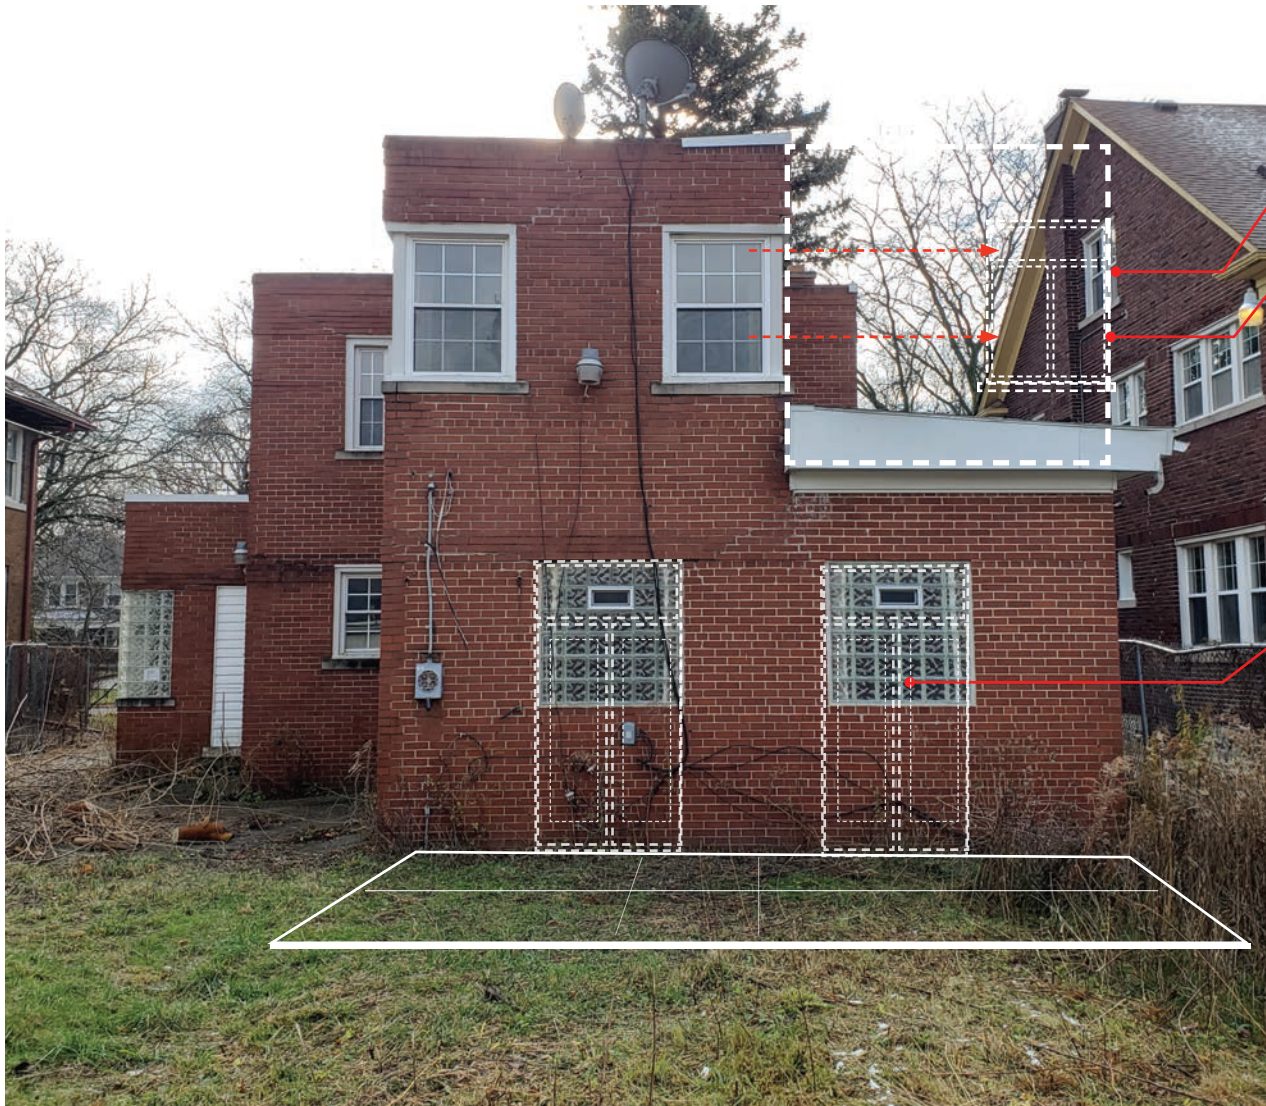
Fig. 11 | The backyard of 1948 Chicago Blvd. - South Elevation

Remove deteriorated "corner"
style vinyl windows and replace
with similar casements.

Existing Glass Block is not
original to home.

Add 175 sqft brick addition.
Match brick, mortar, and tooling
to existing brick of home.

Use a corner window in new
addition to preserve balace &
symmetry.

Remove glass block and cut
openings for exterior doors.
