**JASON M. FLIGGER**  
 LICENSED ARCHITECT  
 130 W. PARKHURST PL.  
 DETROIT, MI 48203  
 (313) 409-7108  
 fligger65@comcast.net  
 4JARCHITECTURE.COM

**Alvarez-Klecha Residence**  
 1535 Leverette Detroit  
 Michigan 48216

**EXISTING CONDITIONS**

**HDC-1**

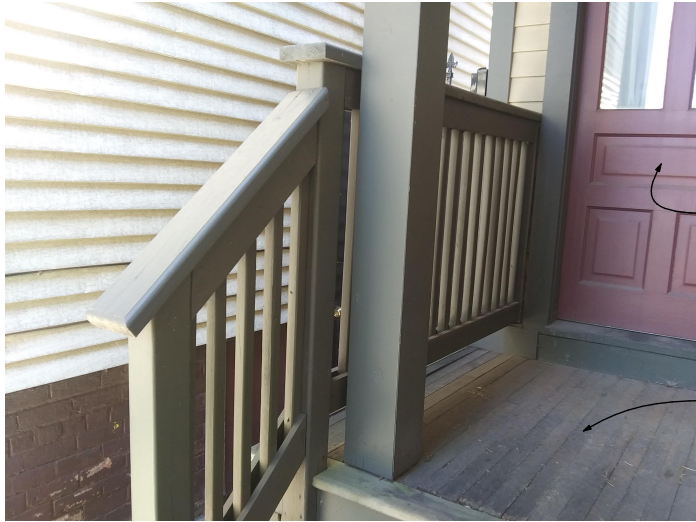
SAND AND APPLY CLEAR WATERPROOF COATING

North (Front)-Facing, East Side Porch: Existing wood floor requires minor repairs, sanding and clear waterproof coating.

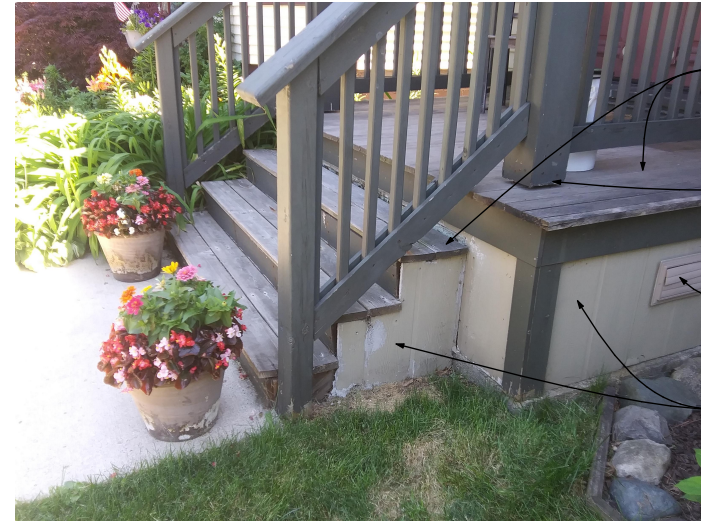
SAND AND APPLY CLEAR WATERPROOF COATING

ADD MISSING TRIM AT COLUMN BASE

VINYL VENT TO BE REPLACED WITH METAL VENT

REPLACE PLYWOOD SIDING WITH CEDAR VEE SIDING

North (Front) Porch: Existing wood porch floor and steps require repair, sanding and clear waterproof coating. Stair risers to be repainted. Plywood siding to be removed and replaced with new cedar vee siding. Column base trim to be reconstructed.

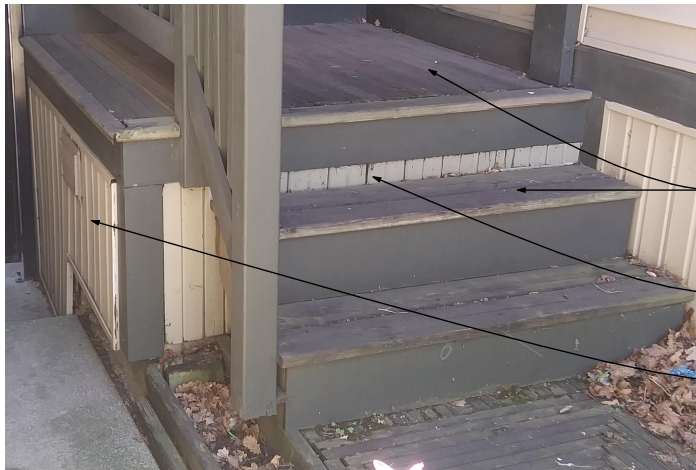
SAND AND APPLY WATERPROOF COATING

REPAIR VEE SIDING

REPLACE VINYL WITH VEE SIDING

North (Front)-Facing, East Side Porch: Existing north vee siding to be repaired. East vinyl cladding to be replaced with new cedar vee siding. Step risers to be repainted, step treads to receive new clear waterproof finish.

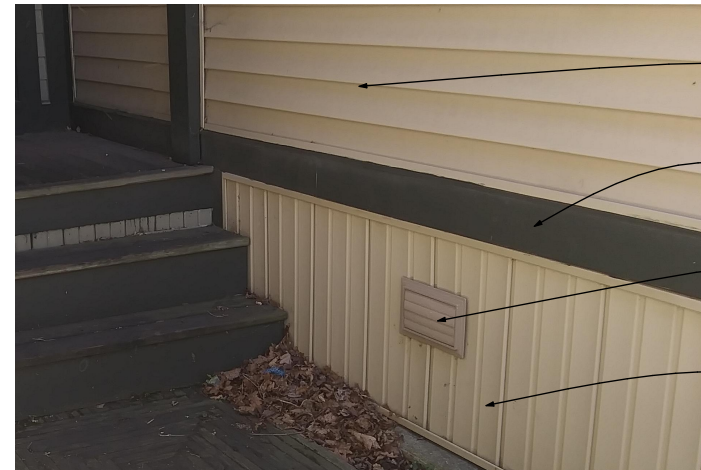
REPAIR AND REPAINT WOOD TRIM

VINYL VENT TO BE REPLACED

VERT. VINYL SIDING TO BE REPLACED

East Elevation: Remove all horizontal and vertical vinyl siding. Replace horizontal siding with new beveled cedar siding to match existing north elevation siding exposure. Replace vertical vinyl siding with new cedar vee siding to match crawlspace cladding at north elevation. Any existing wood siding discovered upon removal of vinyl siding will be repaired if possible. Replace vinyl crawlspace vents with new metal vents painted to match crawlspace vertical siding. See materials.

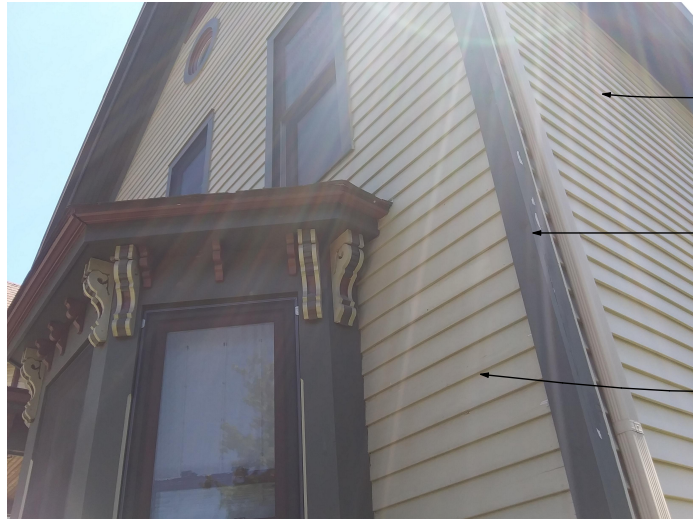
EXIST. VINYL SIDING TO BE REPLACED

EXIST. WOOD TRIM TO BE REPAIRED WHERE NECESSARY

EXIST. WOOD SIDING TO BE REPAIRED WHERE NECESSARY

Northwest house corner showing wood siding and italianate detailing on north elevation, wood corner trim with peeling paint and west vinyl-sided elevation. All wood trim to remain in place and be repainted. All vinyl siding to be removed and replaced with cedar bevel siding to match north elevation.

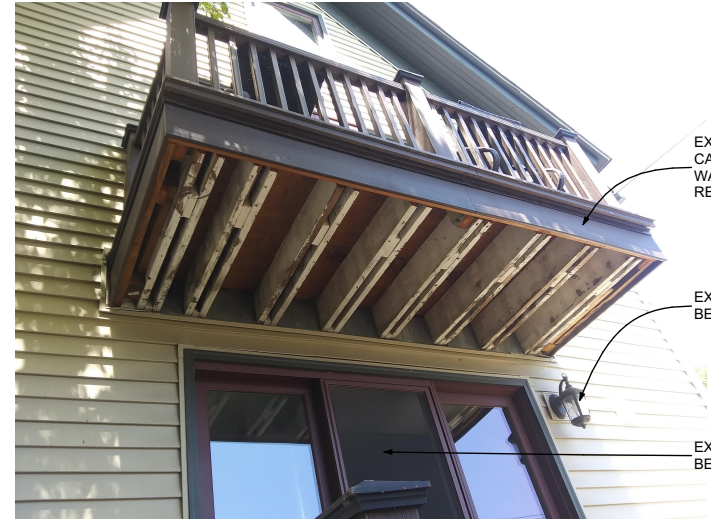
EXIST. SECOND FLOOR CANTILEVERED WALKOUT TO BE REMOVED

EXIST. EXT. LIGHT TO BE REMOVED

EXIST. DOORWALL TO BE REMOVED

South Elevation: Second floor cantilevered walkout to be removed. This walkout is accessed from the second floor master bedroom. The walkout is a recent addition and the deck and railing systems are clad with plastic composite lumber. The recently-added rear porch light shown in this photo will be removed and replaced with a flush-mount ceiling light when the new rear porch is constructed.

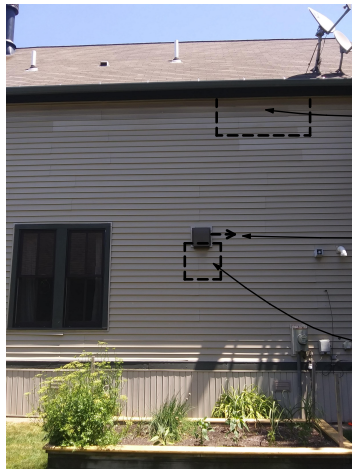
NEW MASTER BEDROOM WINDOW LOCATION

RELOCATE TOILET ROOM EXHAUST OUTLET AS NECESSARY TO ACCOMMODATE NEW WINDOW.

NEW TOILET ROOM WINDOW LOCATION

West Elevation at location of new master bedroom and first floor toilet room windows. Horizontal and vertical vinyl siding to be removed and replaced with cedar bevel and vee siding materials respectively

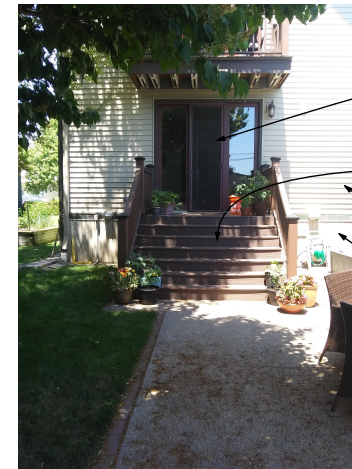
EXIST. DOORWALL TO BE REMOVED

EXIST. DECK AND STEPS TO BE REMOVED

EXIST. VINYL SIDING TO BE REPLACED

South Elevation: Rear porch to be removed. The relatively new rear porch and railing systems are clad with plastic composite lumber. All horizontal and vertical (crawlpace) vinyl siding to be removed and replaced with cedar bevel and vee siding respectively to match existing materials at the north (front) elevation.
