Front Porch Project 715 Van Dyke:

Description or project.

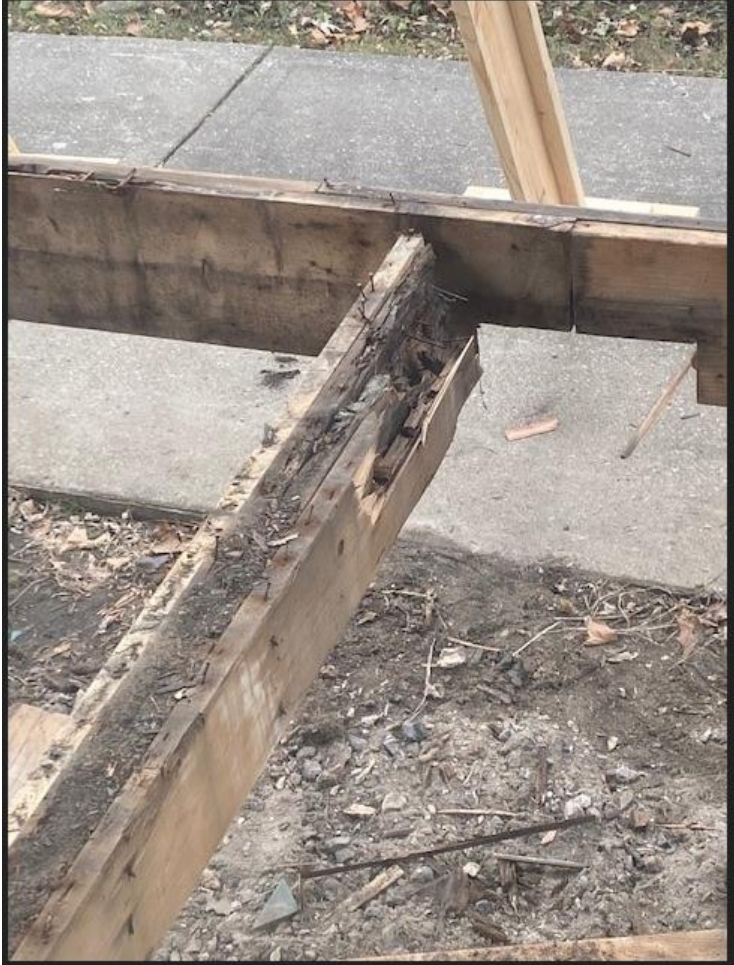
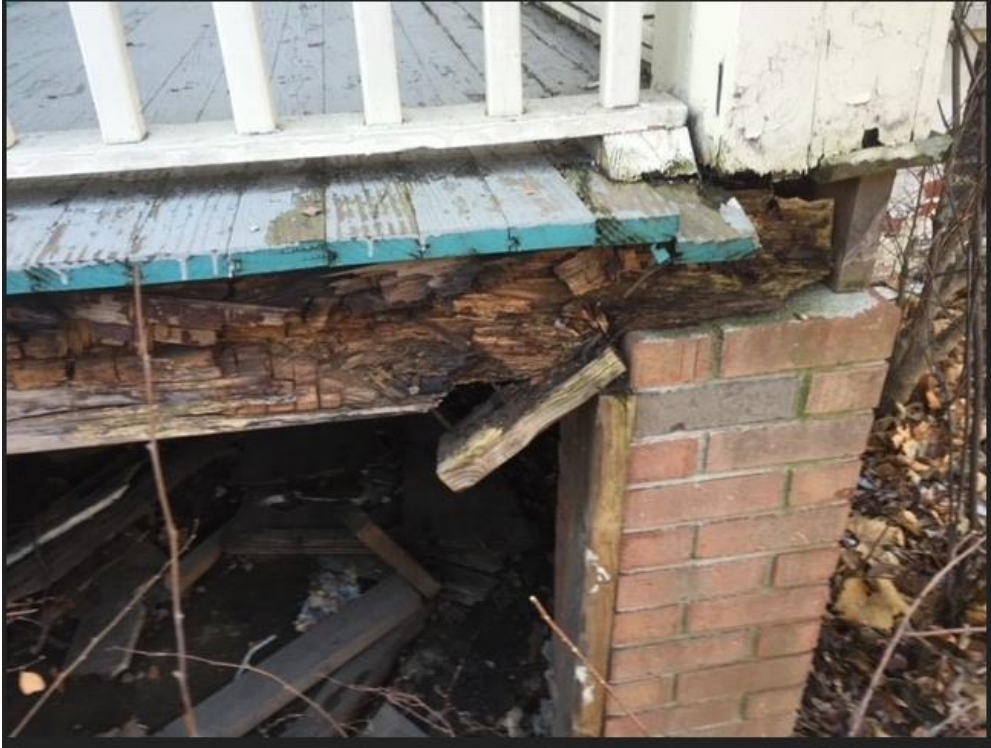
Condition of original porch: Rotten Wood / Missing Footing

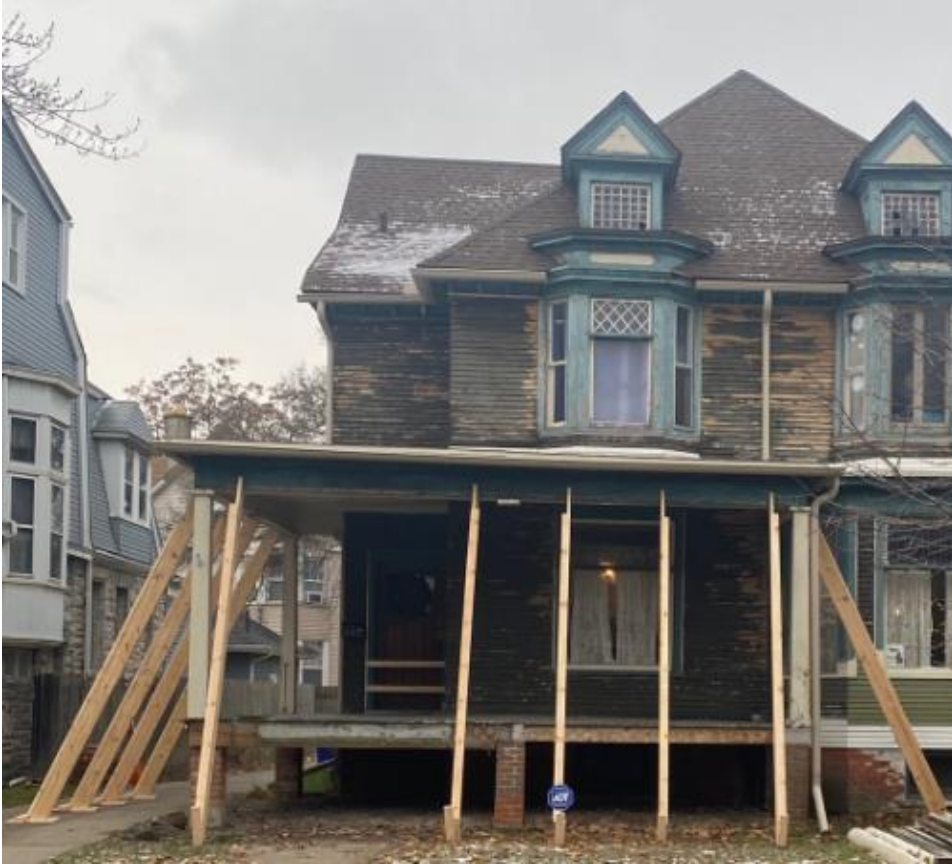
Porch braces:

Before we purchased the house the porch was rebuilt (we think in the 90's)– it was not to code, not historically accurate, and structurally unsound. The lumber they used was untreated and built the columns using 1" x 4" wood without supports inside the columns. Due to the deterioration for the wood and the weight of the ceiling we braced the porch in case of a heavy snow / wind.
