## 1556 BAGLEY OVERVIEW - UPDATED VERSION 9/1

### SCOPE OF WORK

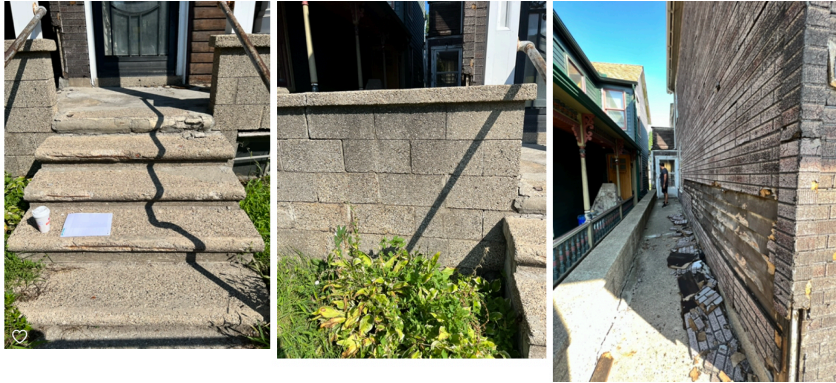
## FRONT PORCH

The existing front porch is built from cinderblock for the walls with a cement cap and also with a cement floor. This porch is suffering structurally and is sinking and cracking causing a hazard. After further consideration we decided this will be made structurally sound from underneath by getting access in the basement, then the floor will be re poured in cement. The original footprint of the porch and stairs will remain as it is now. The cinderblock walls of the porch will be tuck pointed and repaired. This will all be painted white to match the exterior. The stairs up onto the front porch from the street are also currently cement with exposed wires and cracks. We will re build these steps with 13 inch steps and 7.5 inch risers and these will be poured with new cement as well. The existing railing is wrought iron and is solidly attached to the footings and the house. We will keep this in place and paint it to match exterior.

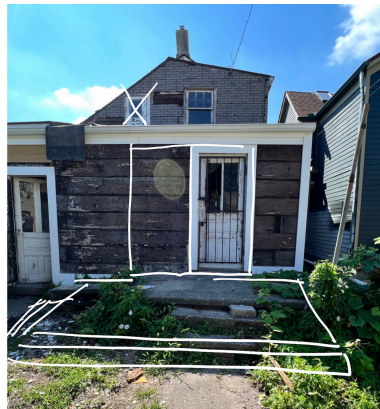
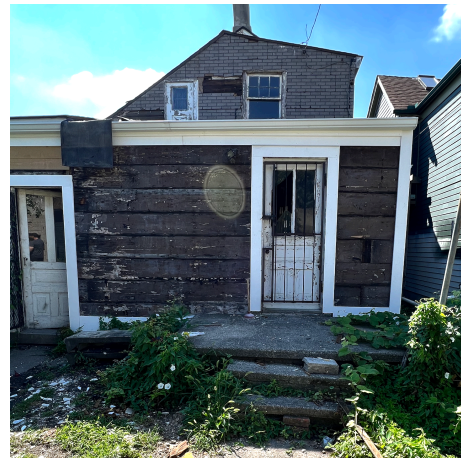
## REAR ELEVATION

The rear of the house as mentioned prior, will have a new door wall from the breakfast room onto a new deck. Currently there is a 5' x 7' cement patio that is in disrepair with insecure steps down onto the lawn. This patio will be demolished. A new 10' x 13' deck will be erected with proper footings and clad in pressure treated wood stained in a clear coat to maintain a natural modern look. A small railing on the west side of the deck will be erected for safety. Stairs down to the lawn will be erected for safety.
