**RE: Dr. Ossian Sweet House, 2905 Garland Avenue DHDC 22-8036 Update**

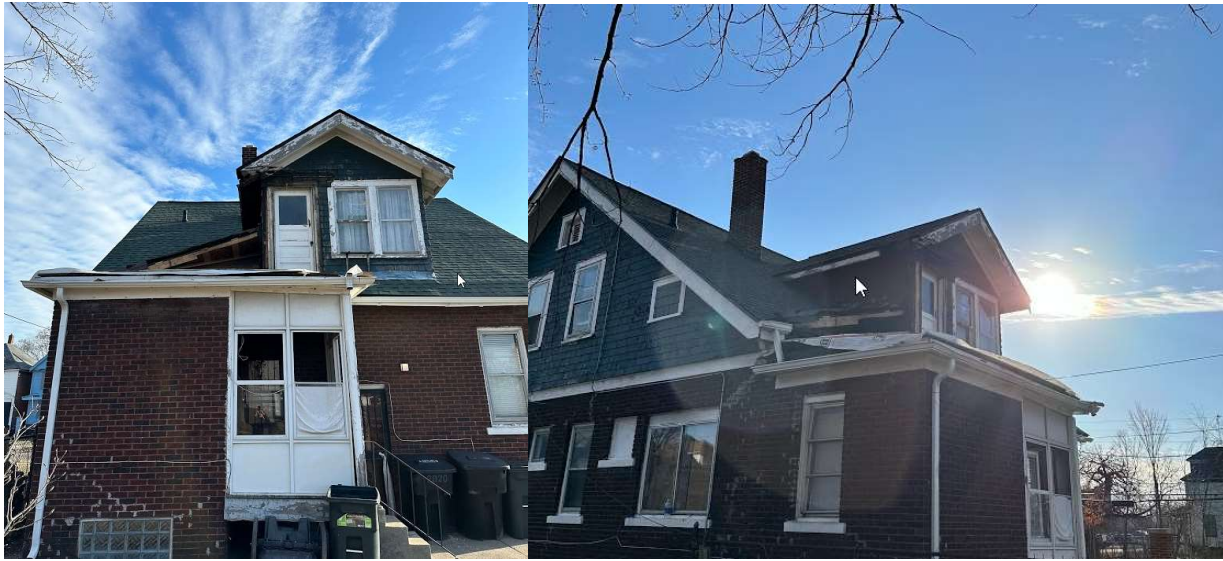
**Back Porch Current Conditions:**

A small brick framed one-story back-room projects off the core block of the house on the west façade and is original. A small porch is located directly adjacent to this back room and provides covered access from the backyard into the first-floor kitchen. In December of 2022, there was an enclosed upper porch that sat atop the one-story brick framed back room and the wooden porch below. This upper porch was enclosed at an unknown date although trial testimony indicates the upper porch was open and not enclosed in 1925. The upper enclosed porch was in poor condition with extensive water damage evident on the ceilings and walls while the windows are in poor condition with broken panes and damaged seals. Although there are no extant historic photos that show the west (rear) façade, because of the trial testimony, we believe the historic condition was likely an open upper porch with a low railing.

During the removal of non-historic materials from the framed back room under the porch, the upper porch structure began to fail. The structure was removed to ensure safe working conditions. We are proposing to return the rear façade to its historic configuration at the time of Ossian Sweet's arrest and trial by retuning to an open porch. The open porch would be accessed by the existing door on the second floor dormer and have iron railing and membrane roofing.

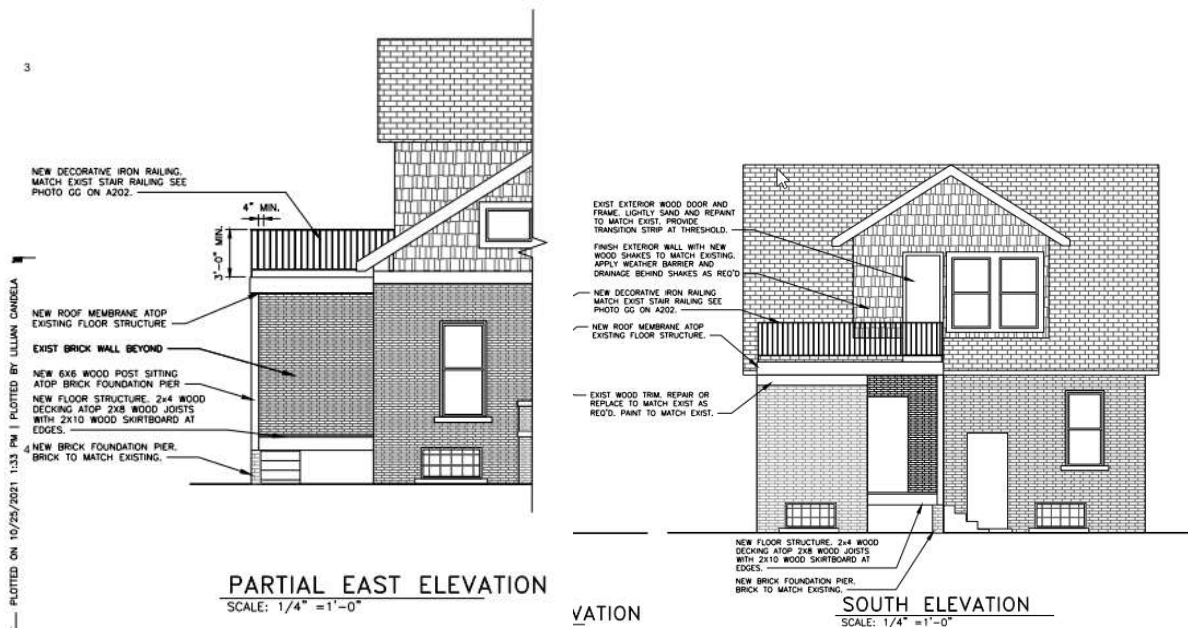
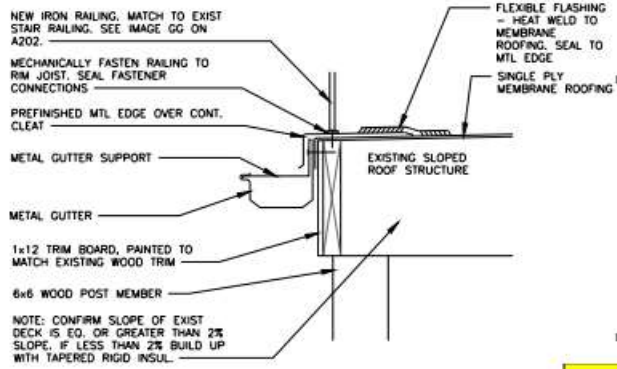
**Back Porch Proposed Condition:**

**ROOF DECK EDGE DETAIL**  
SCALE: 1/4" = 1'-0"

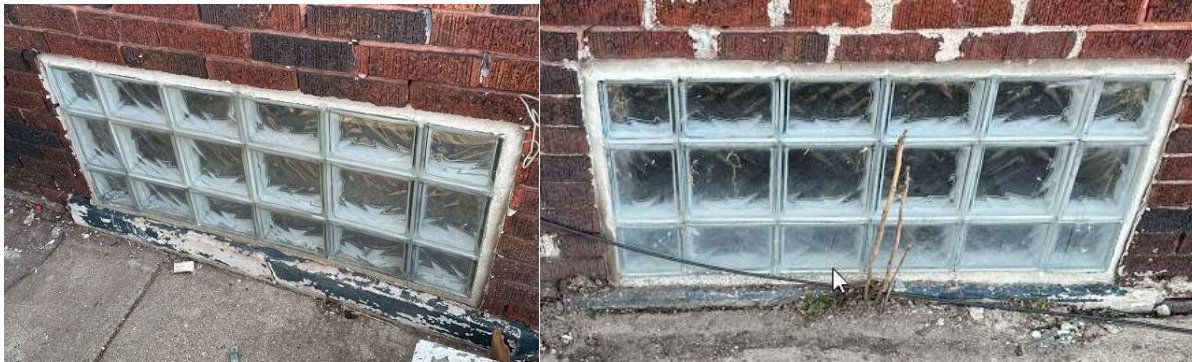
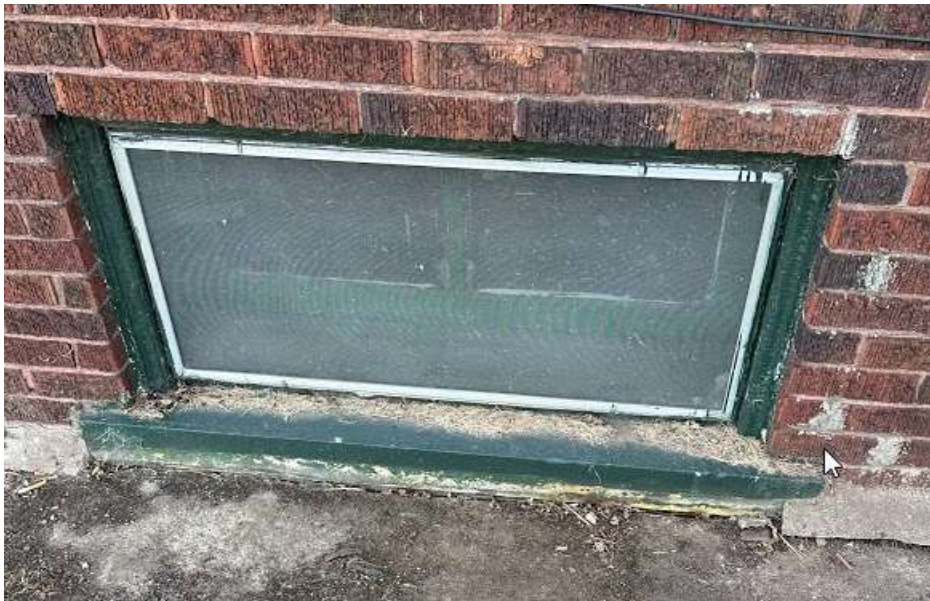
**Basement Window Current Conditions**

There are ten basement window openings around the perimeter of the basement. Multiple openings have been improperly filled with poorly fitting glass block windows. Frames on the existing inswing hopper windows are rotted and masonry requires repair. The foundation features three layers of brick and each opening is approximately one foot deep. We are proposing to appropriately repair the masonry, repair or rebuild in kind the exterior moldings, create period correct wood screens and build recessed 3 inch glass block windows in each opening. All glass block would be concealed behind screens and would not be visible from the exterior.
