## EXISTING WOOD WINDOW DETAILS (DOUBLE-HUNG)

## PROPOSED REPLACEMENT WINDOW DETAILS (DOUBLE-HUNG)

## 8022 KERCHEVAL RENOVATION HDC PROPOSED BRICKMOULD

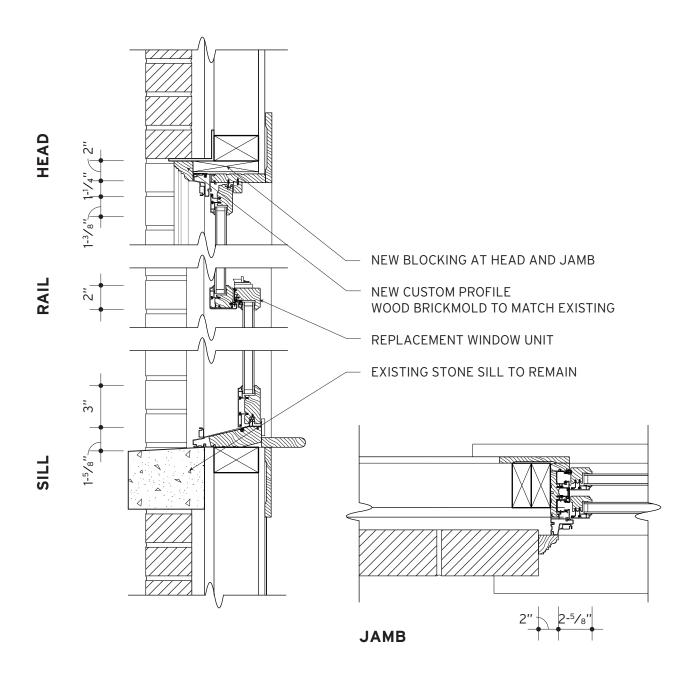
## HEAD INTERIOR HEAD TRIM, MOLDINGS, SILL AND APRON EXISTING ON 14 WINDOWS (MOSTLY SECOND LEVEL) AND MISSING ON 14 WINDOWS (MOSTLY FIRST LEVEL) RAIL STOPS MISSING ON MAJORITY OF WINDOWS EXISTING BRICKMOLD IS DETERIORATED ON MAJORITY OF WINDOWS RAIL PULLEY, ROPE, AND COUNTERWEIGHT BROKEN OR MISSING IN MAJORITY OF WINDOWS SILL 2" 2-3/8" **JAMB**

- MARVIN ULTIMATE G2
- ALUMINUM-CLAD WOOD FRAME AND SASH
- NEW CUSTOM WOOD BRICKMOLD TO MATCH EXISTING PROFILE
