## HDC PROJECT REVIEW

2405 BURNS AVE DETROIT MI, 48214

### Existing Conditions

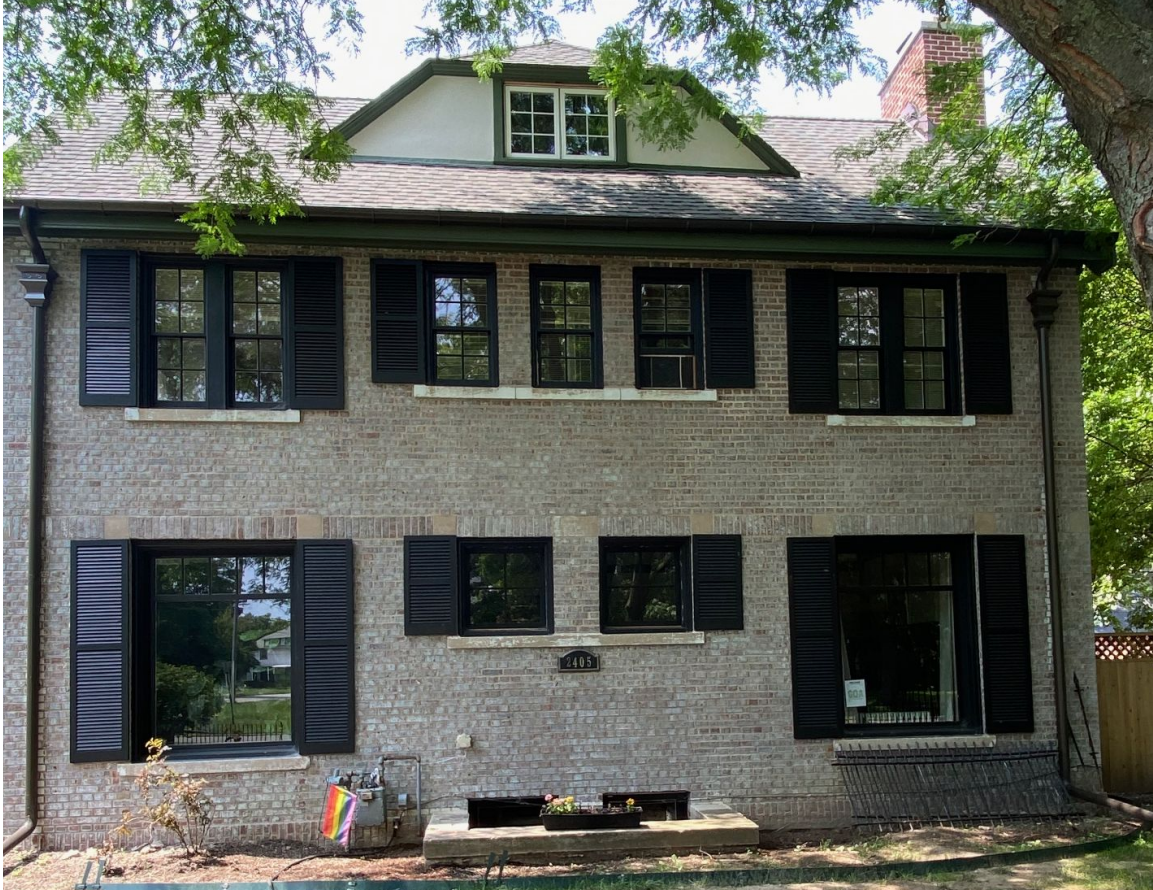
Northeast Elevation

*-First floor: replacement of vinyl picture windows with wood picture windows. Replacement of two smaller outswing casement with new wood inswing(utilizing original hinge placement)*

*-Second Floor: All restored double hung sash(done by Mary Dindas)*

*-Third floor: vinyl window to be replaced with wood inswing*

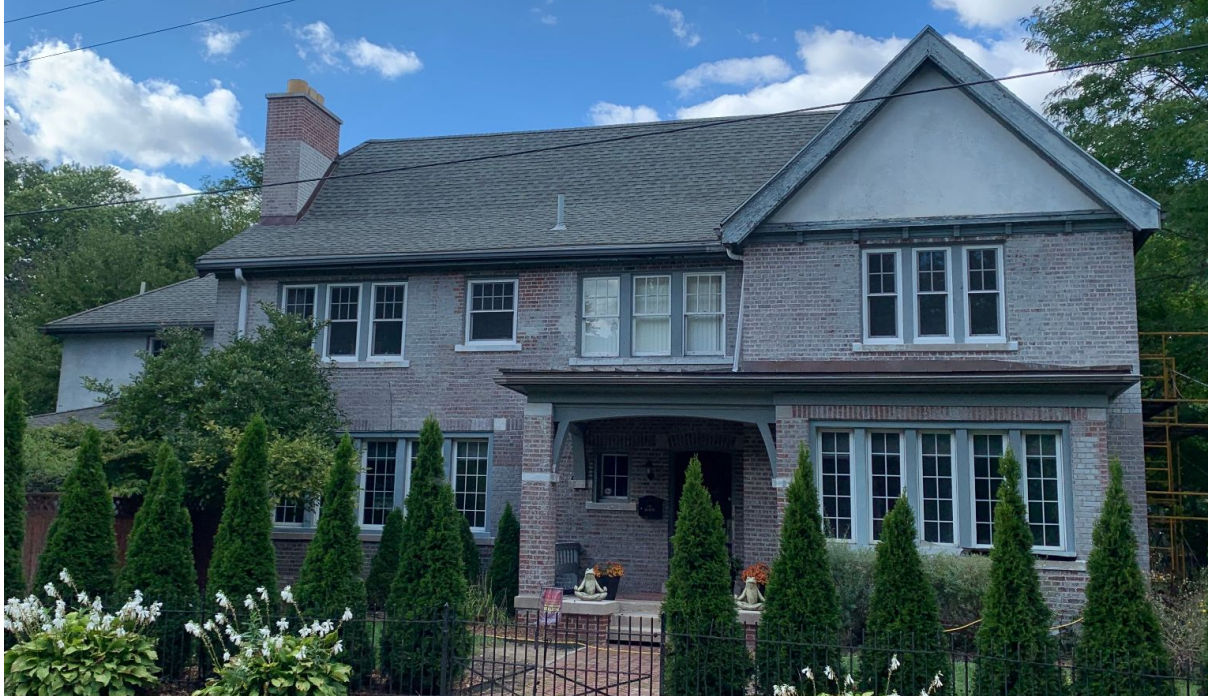
Southeast Elevation

-First floor: (Rightside) series of 5 vinyl casement style to be replaced with wood inswing(utilizing original hinge locations). Small fixed vinyl window under porch to be replaced with wood fixed window(closest window) (leftside) series of 5 to be replaced with inswing casement.

-Second floor: (Rightside) series of 3 vinyl double hung to be replaced with wood sashes(keeping the 4 over 1 lites) middle series of 3 double hung to be restored by Mary Dindas. Vinyl Single 8 over 1 to be replaced. (Leftside) series of 3 vinyl windows to be replaced(keeping the 6 over 1 lites)

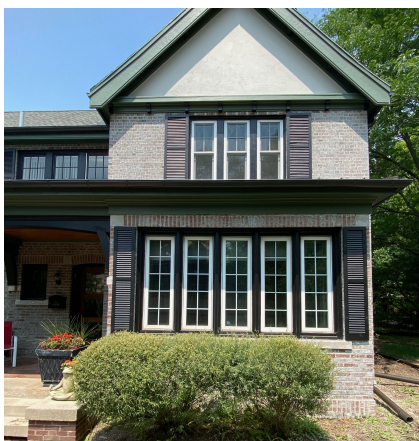
Current state of facade (showing restored brick moulding & gable)

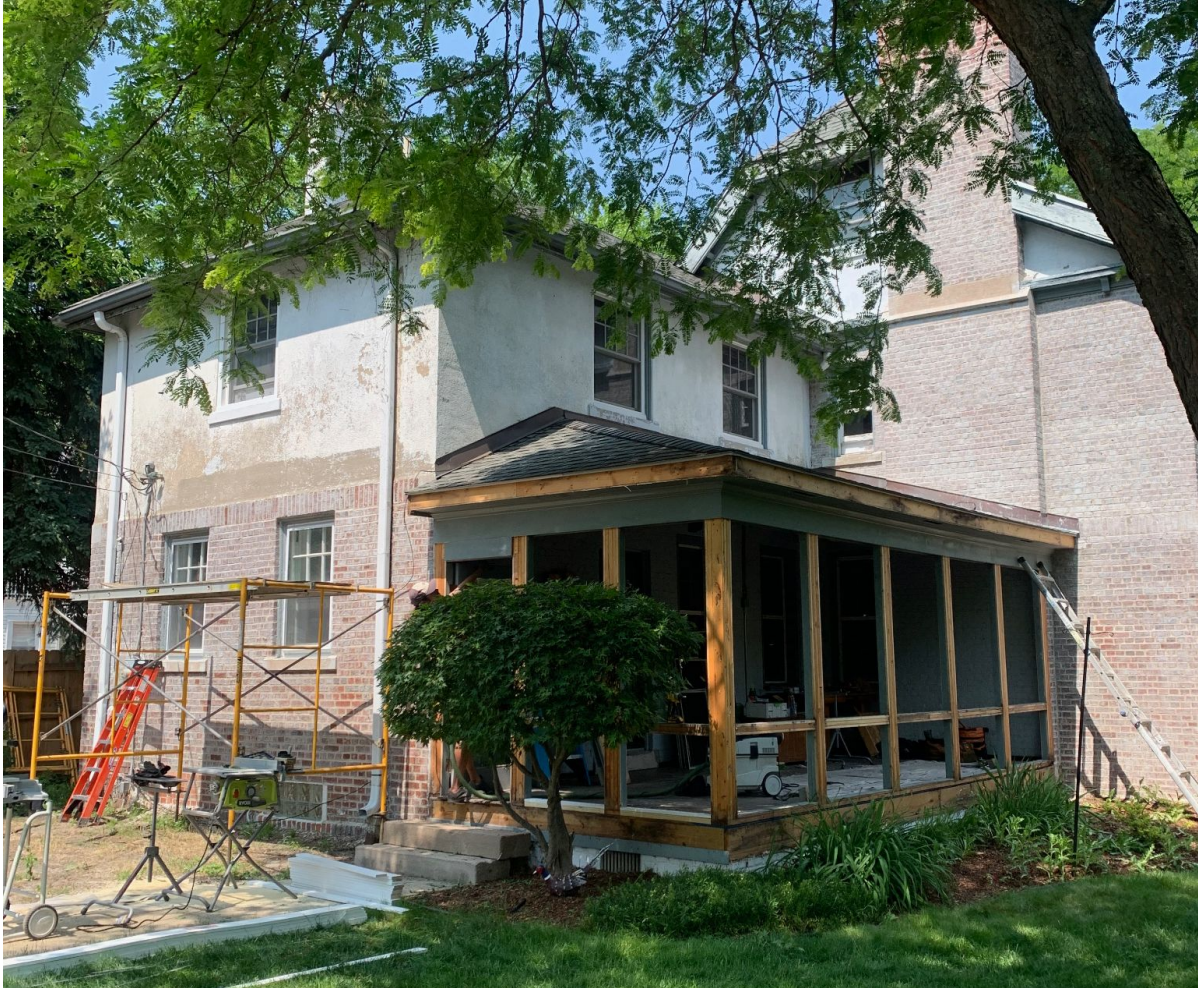
*Southeast Elevation & Southwest Elevation*

*-First Floor: (under porch) 3 vinyl double hung to be replaced with wood windows(6 over 1 lites).  
Leftside 2 original double hung to be restored by Mary Dindas.*

*-Second Floor: (furthest right) small double hung to be restored by Mary Dindas. 2 vinyl double  
hung in center to be replaced(keep 8 over 1 lites). (Leftside) vinyl double hung to be replaced  
with wood window(keep 8 over 1 lites)*

*-Third Floor: vinyl double hung to be replaced with wood(keep 8 over 1)*

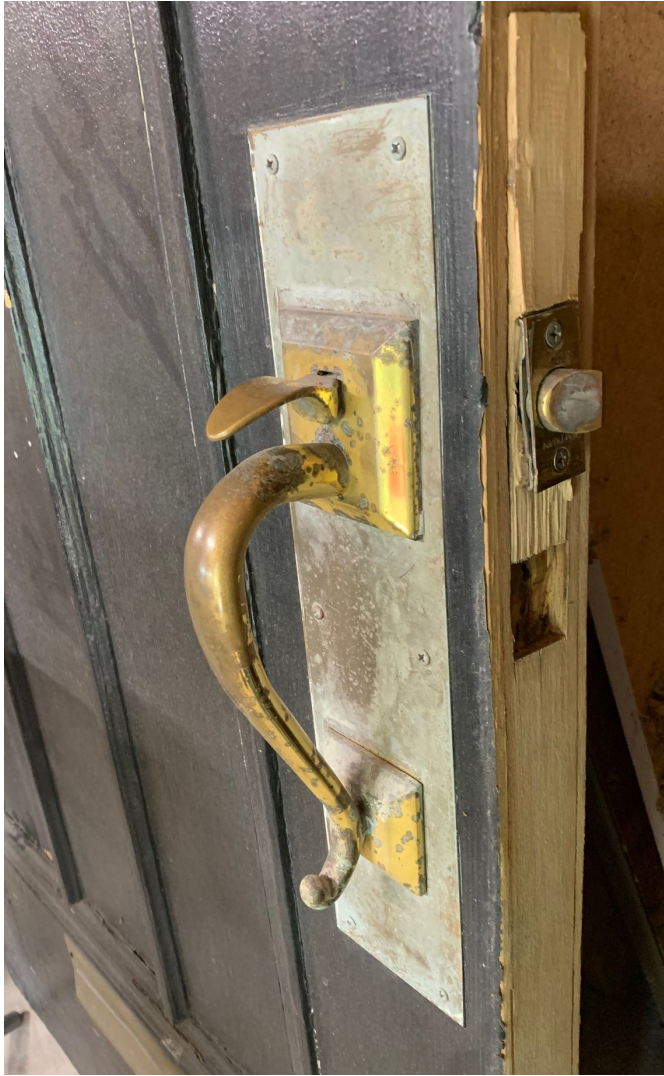
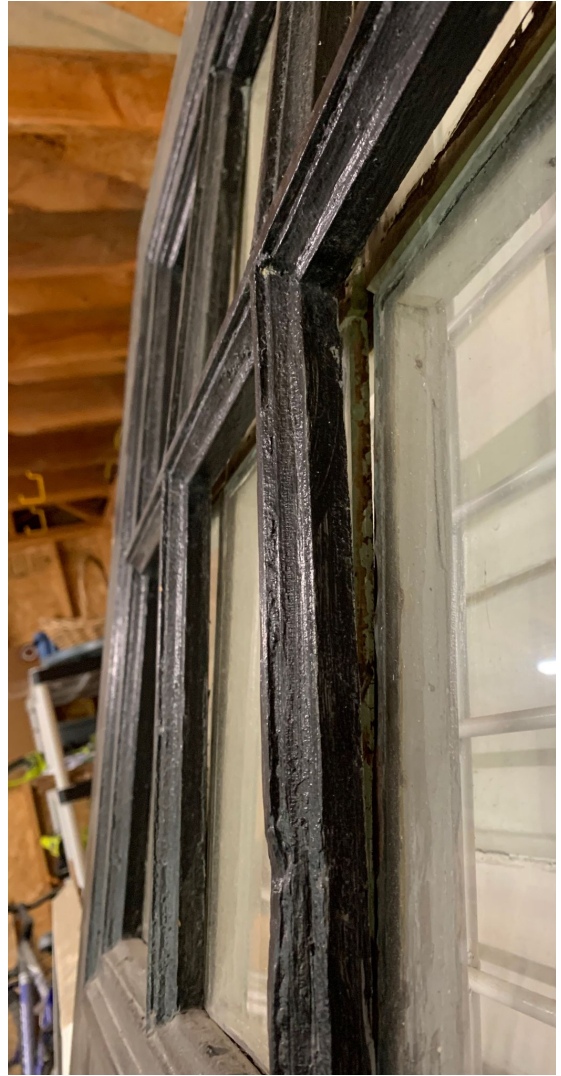
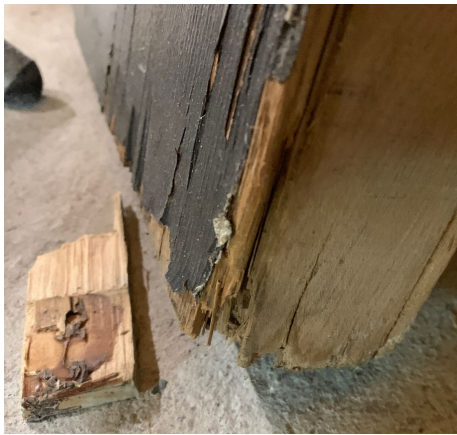
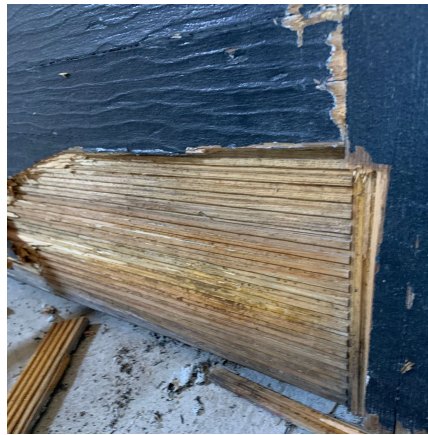
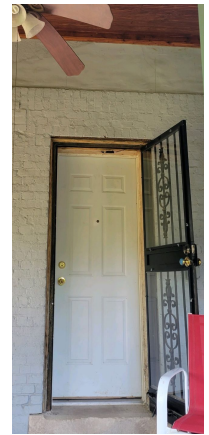
Other exterior carpentry that had not been capped with aluminum have been subject to rot/failure. The stucco has been neglected for some time, and has not been re-sealed properly, and has cracking. A back entrance door has been replaced with a modern steel entrance door(done by previous owner), while the front entrance door, which may not be original to the house, has seen neglect and significant splitting of the rails and stiles, and the wood veneer has been cracking and delaminating from the center of the door. The door has been warped over time, and now it does not sit in its opening properly. Previous owners have tried to retrofit this door with updated hardware, and have damaged the latch side of the door and the door jamb. The muntins of the lite on the door have failed completely, pulling off the door and glass. Though the glass of this door is ¼” plate, it does not seem to be old glass. From our material analysis, this door may not be original to the house, and is more of a “Dutch” style door, and because of its veneer, it could have been at one time made to be stain grade. The construction and material used for this door, may show that it was a cheaper made door.

*Images showing front door deterioration, and back porch entrance door*

- Removal of existing front entrance door, and entrance door found at back porch
- Replace existing “Dutch” style door and steel porch entrance door, with newly designed and period appropriate matching solid white oak door. Exterior of the door is finished to match the tongue and groove ceiling of the entranceways, while the interior is finished to match the darker woodwork of the interior doors, and trim.

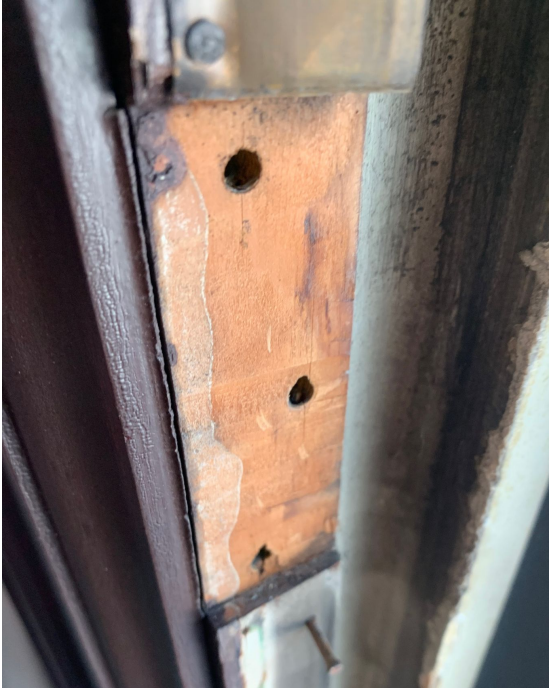
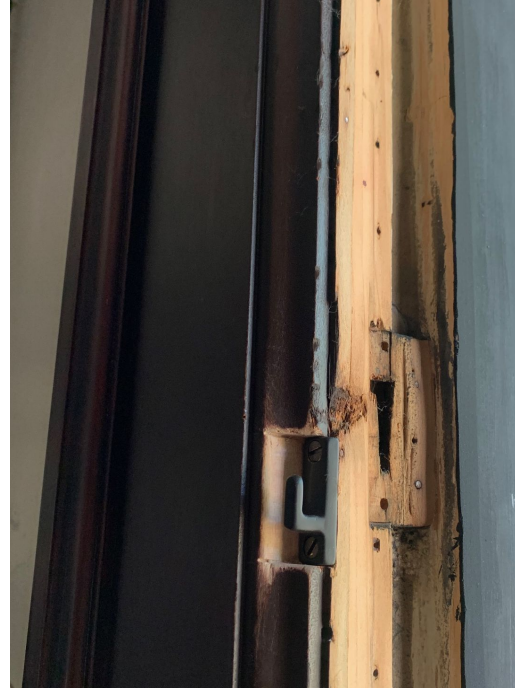
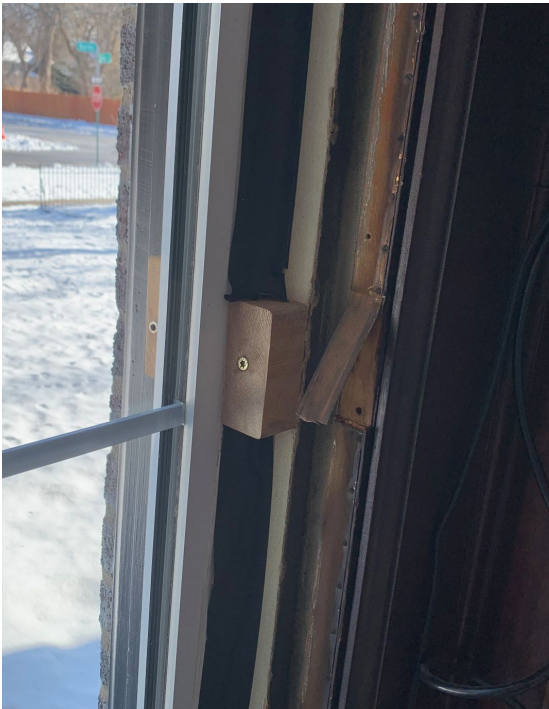
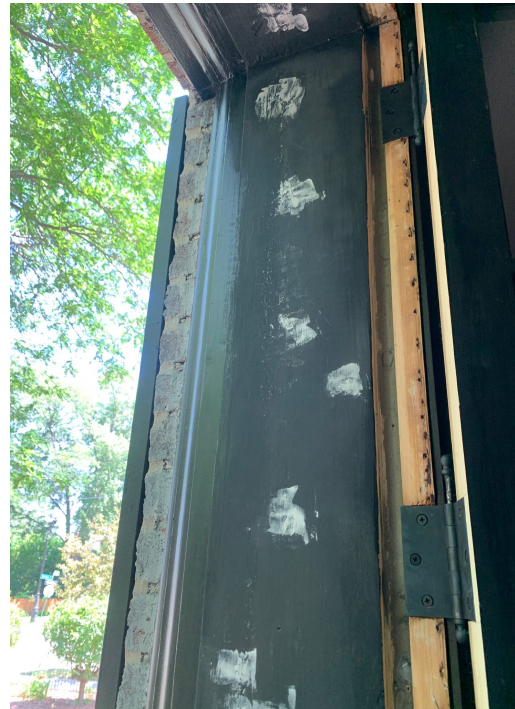
Original hinge and latch locations found at first floor casement openings  
(including picture windows-lower left image)

- New wood windows shall vary in operation. Using the historic hinge locations, the casement style windows shall be inswing, and the new double hung windows shall be built to fit existing historic sash locations. The two vinyl picture windows shall be replaced with period appropriate wood picture windows.

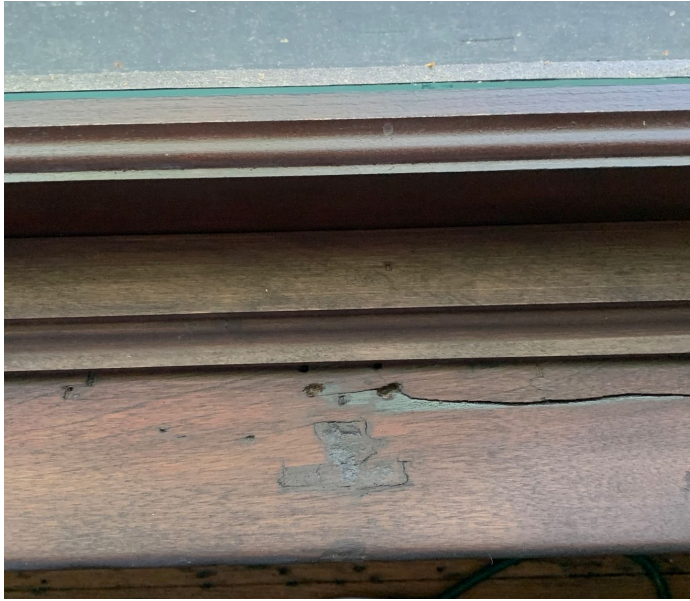
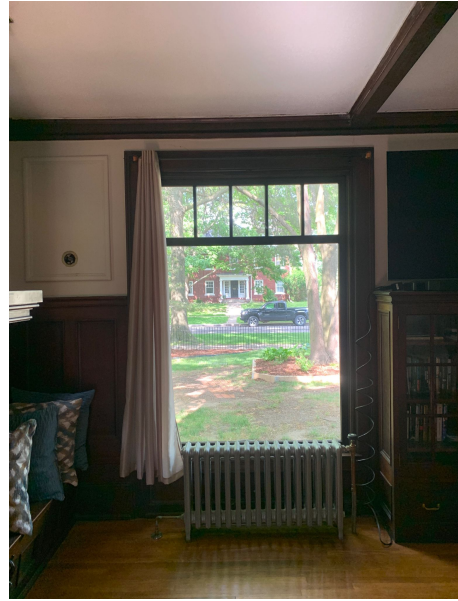
*Original latch location centered on sill of picture window. Radiator in front of picture window*

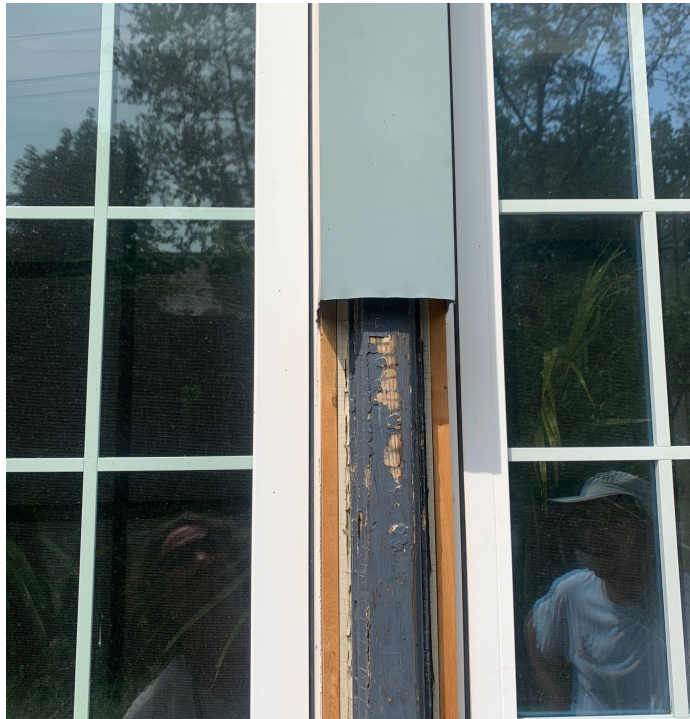
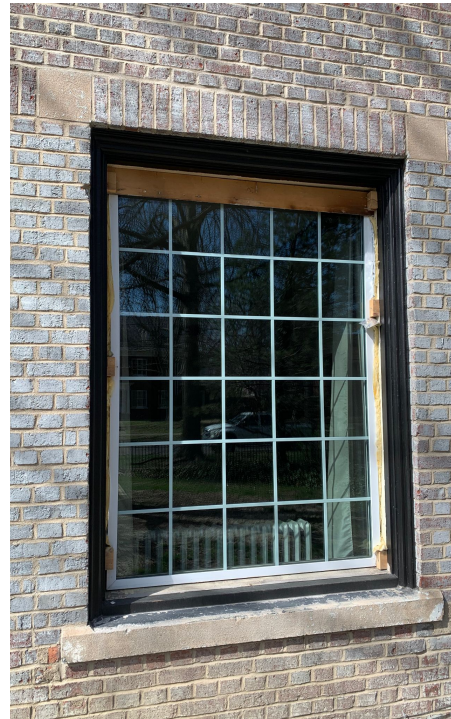
*Aluminum capping covering all brick moulding and mullions. Existing picture window in place*

- Remove all existing vinyl windows on Northeast, and Southeast elevation
- Remove all aluminum window casing to reveal original brick moulding, and sills
