New Hue Restoration + Design, LLC

July 17th, 2023

HDC APPEAL TO LAST STAFF REPORT

2405 BURNS AVE DETROIT MI, 48214

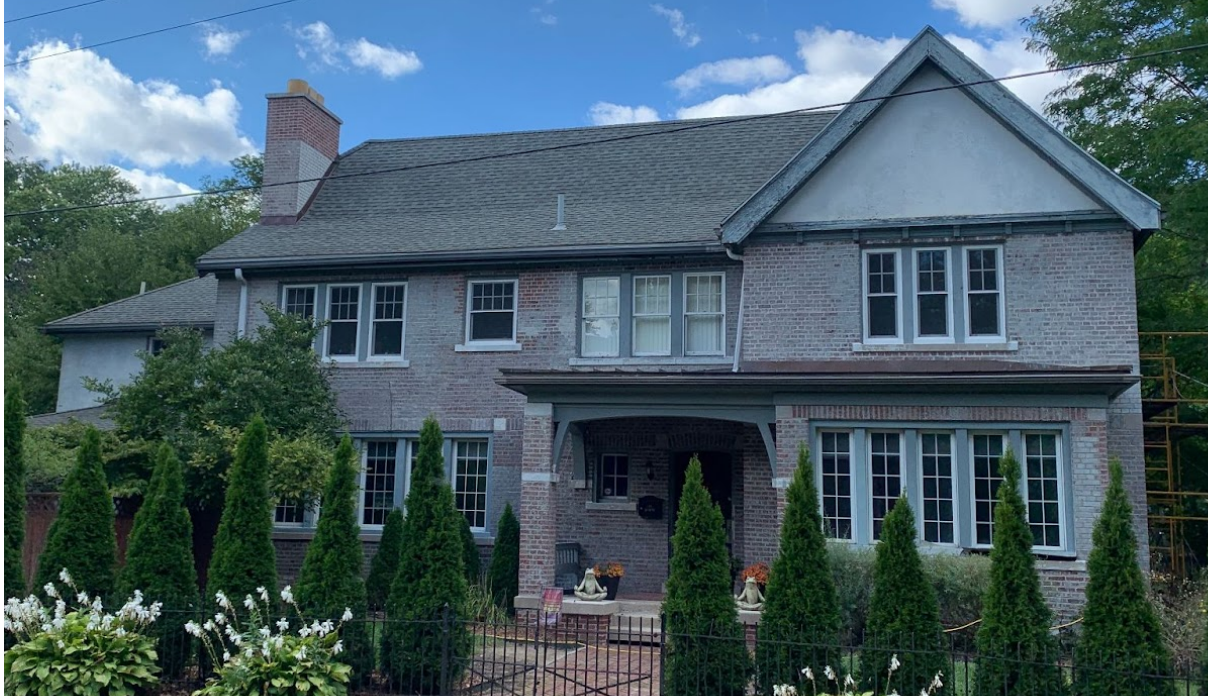
Southeast Elevation

-First floor: (Rightside) series of 5 vinyl casement style to be replaced with wood inswing(utilizing original hinge locations). Small fixed vinyl window under porch to be replaced with wood fixed window(closest window) (leftside) series of 5 to be replaced with inswing casement.

-Second floor: (Rightside) series of 3 vinyl double hung to be replaced with wood sashes(keeping the 4 over 1 lites) middle series of 3 double hung to be restored by Mary Dindas. Vinyl Single 8 over 1 to be replaced. (Leftside) series of 3 vinyl windows to be replaced(keeping the 6 over 1 lites)

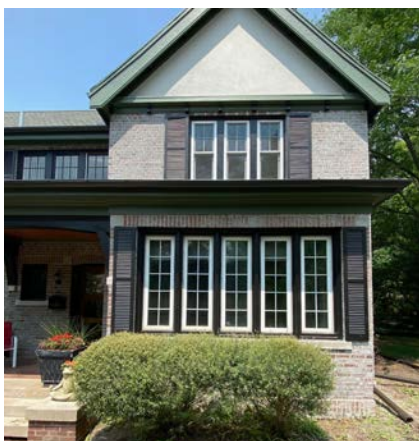
Current state of facade (showing restored brick moulding & gable)

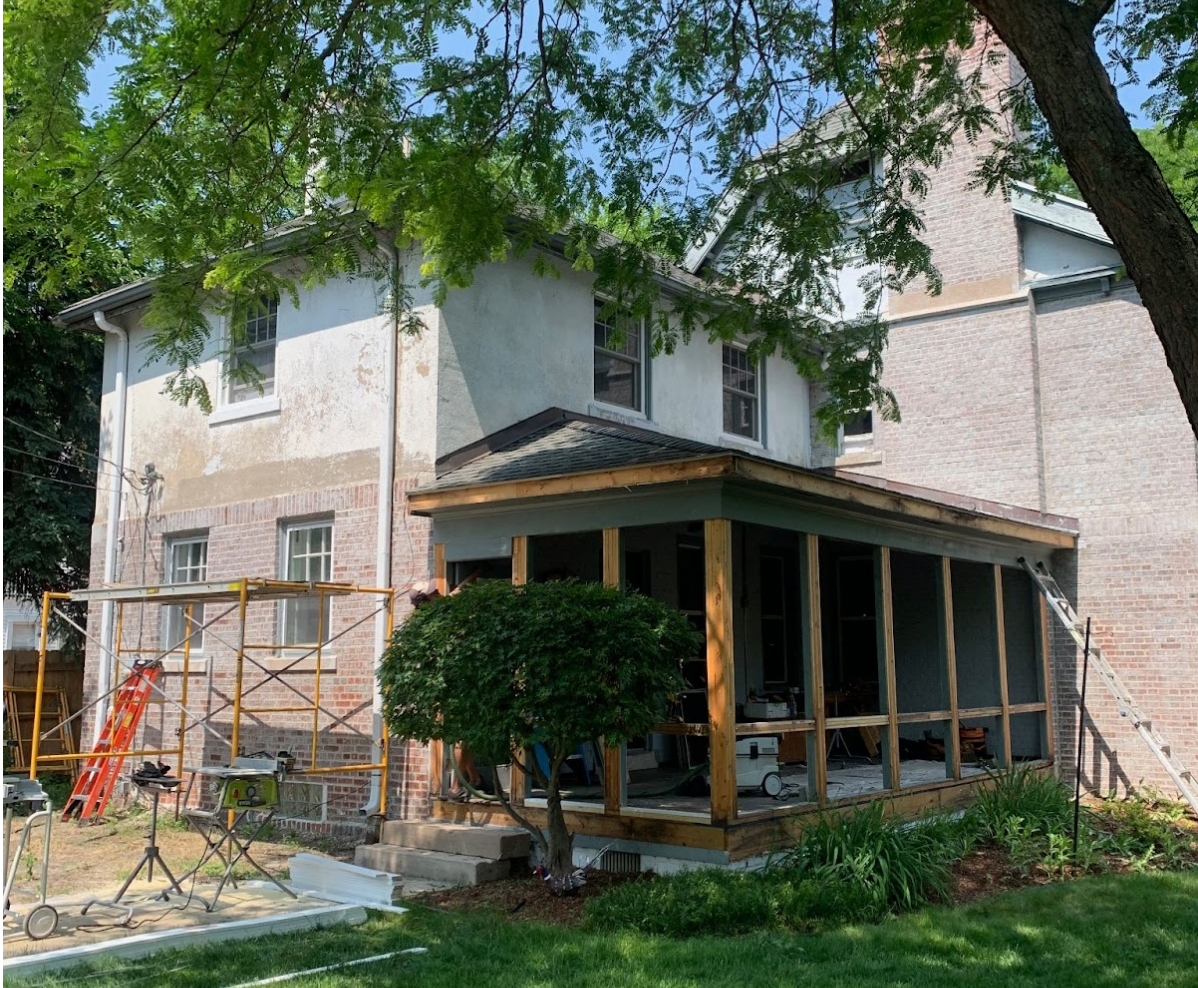
Southeast Elevation & Southwest Elevation

-First Floor: (under porch) 3 vinyl double hung to be replaced with wood windows(6 over 1 lites). Leftside 2 original double hung to be restored by Mary Dindas.

-Second Floor: (furthest right) small double hung to be restored by Mary Dindas. 2 vinyl double hung in center to be replaced(keep 8 over 1 lites). (Leftside) vinyl double hung to be replaced with wood window(keep 8 over 1 lites)

-Third Floor: vinyl double hung to be replaced with wood(keep 8 over 1)

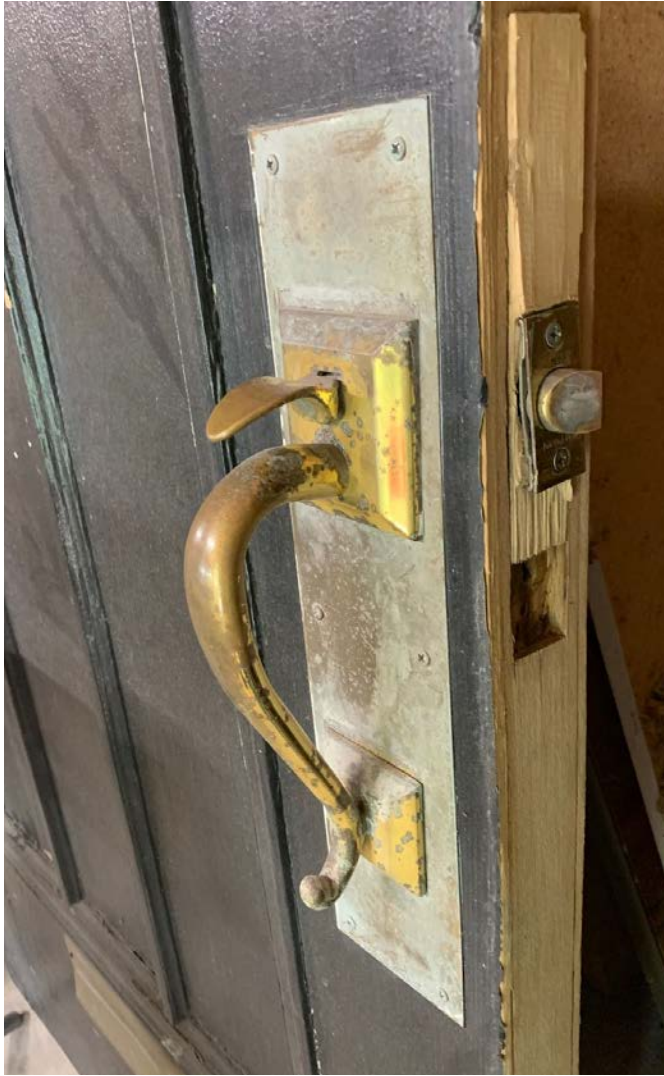
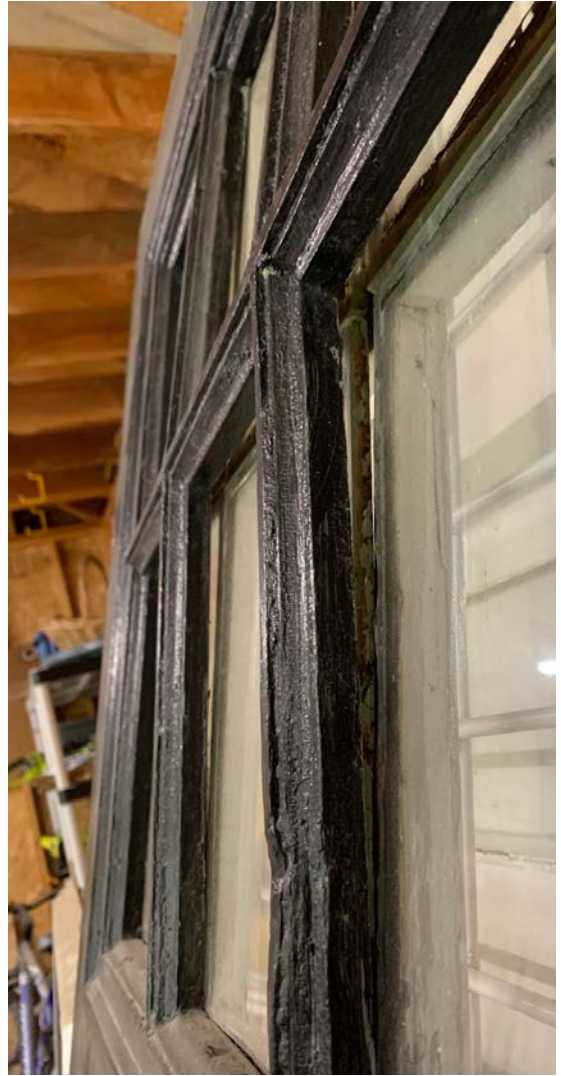
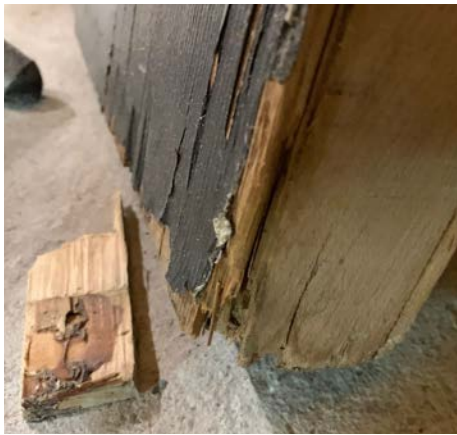
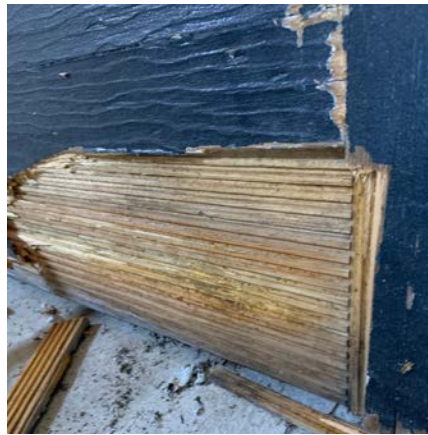
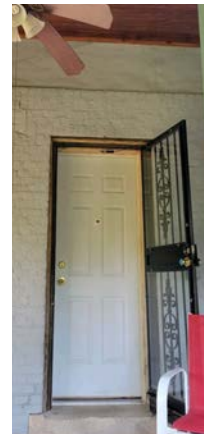
Without having any documentation stating that the front porch door was in fact original, and the condition of the door, we could not logically warrant the money, material and effort it would take to restore it. The bottom panel delaminating from the structure of the door, muntins and glazing rotted through, and swelling causing the door to fit improperly in its jamb were the driving factors in this decision. We instead opted to retain the profile and jamb, and recreate it with a different pane configuration to better fit the French Cottage Farmhouse, using other similar configurations present in Indian Village. The craftsmanship, finish and installation are all period matches to what we hypothesize an original door to have been.

Images showing front door deterioration, and back porch entrance door

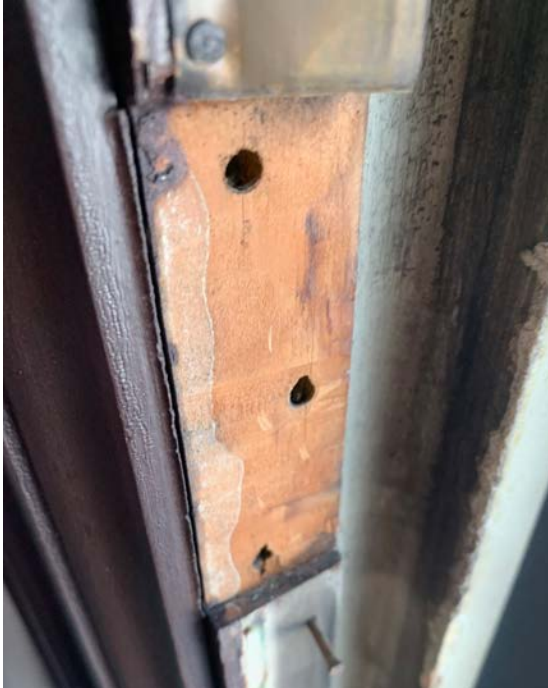
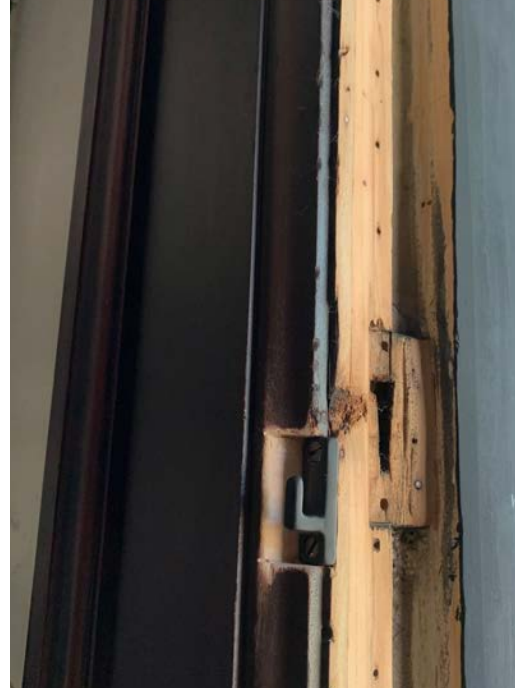
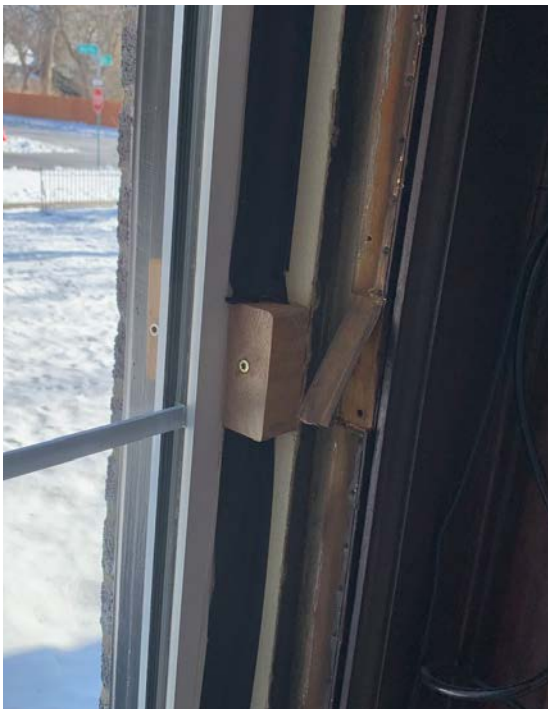
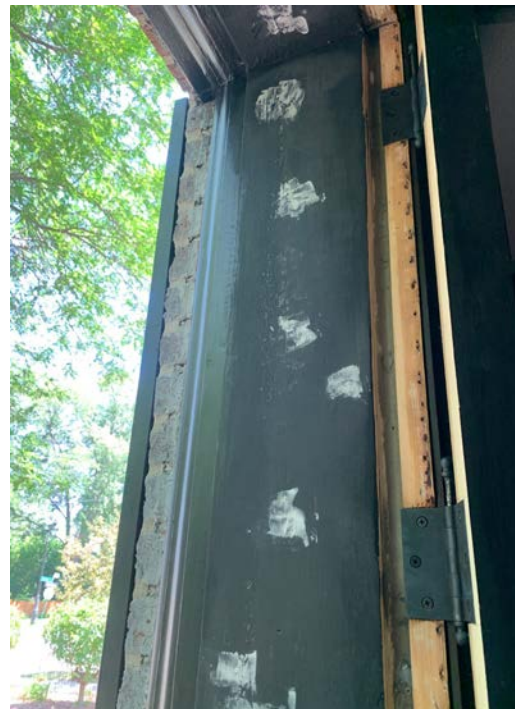
Upon removal of interior trim (Casing, jamb extensions as well as haphazard patch-work), it became clear that the need for many of these elements was primarily due to improper measurements taken for the replacement vinyl windows. Removal of the aforementioned elements also revealed that these window openings originally housed French Style In-swing Casement windows. This conclusion was reached on the discovery of two hinge mortises on each side of the jambs on both windows, all flush with the interior reveal of the jamb. It is our belief that when the radiators were installed in the house, they interfered with the original operation of the windows, which were subsequently replaced with picture windows. (The inherit benefit in this change from operable to fixed windows is that the size of them constituted a security concern for the current homeowner.) The same hinge mortises were also found (again flush with the interior jamb reveal, dictating an in-swing operation) on the 1F-NE Casement Windows as well as 1F-SE Casement Ribbon Windows. Our current beliefs regarding the above factors, in conjunction with the Historical Restoration performed on the 2F-NE Double Hung windows by Mary Dindas, led us to make the decision to redesign the muntin pattern on the windows in question.

Original hinge and latch locations found at first floor casement openings
(including picture windows-lower left image)

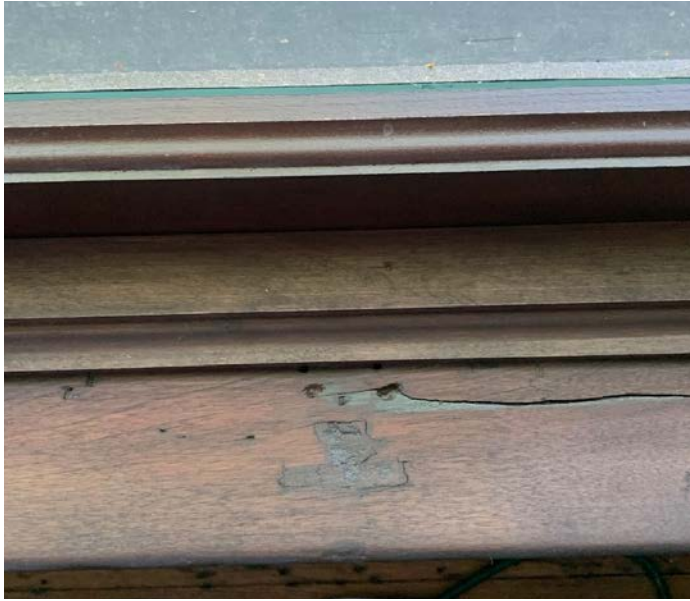
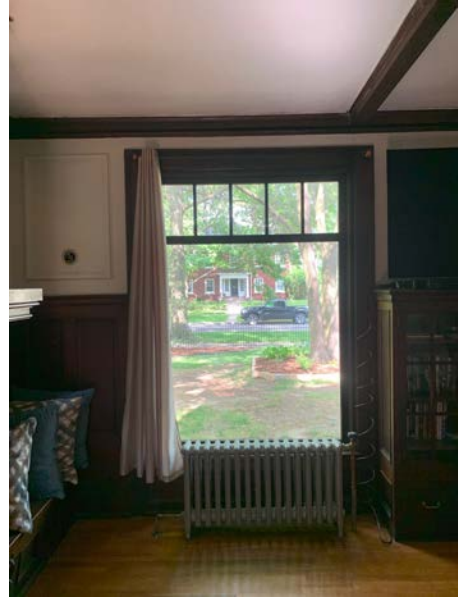
Original latch location centered on sill of picture window. Radiator in front of picture window

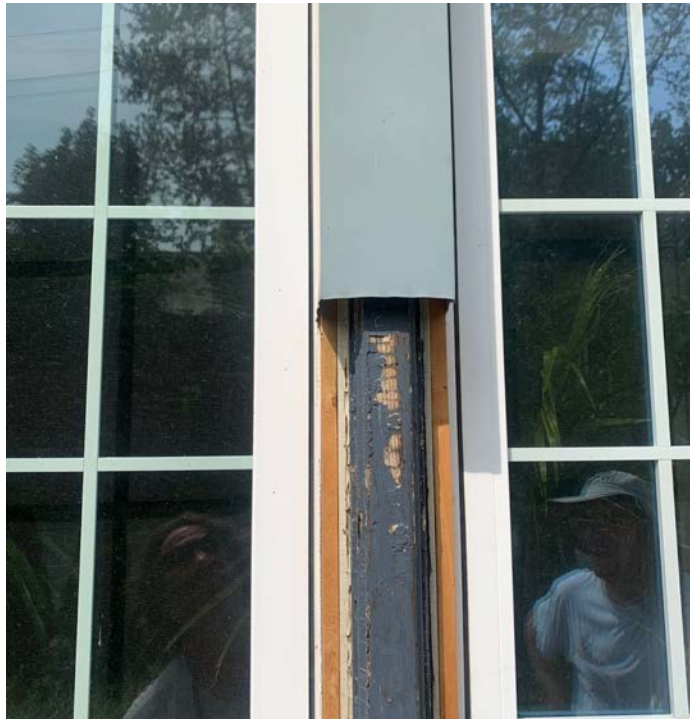
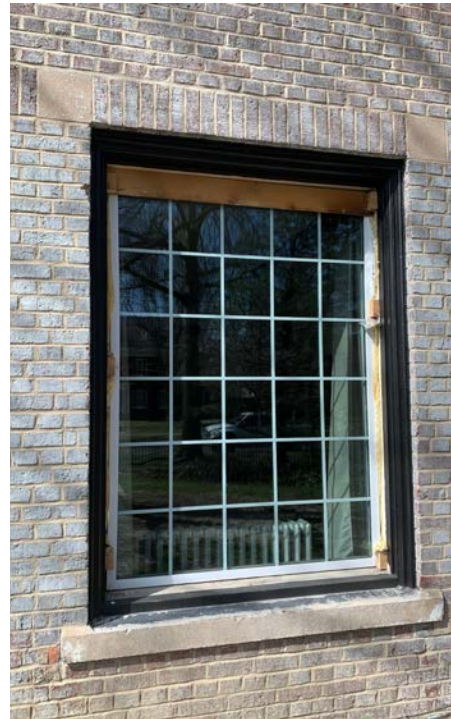
Aluminum capping covering all brick moulding and mullions. Existing picture window in place
