630 Virginia Park Front Door Scope

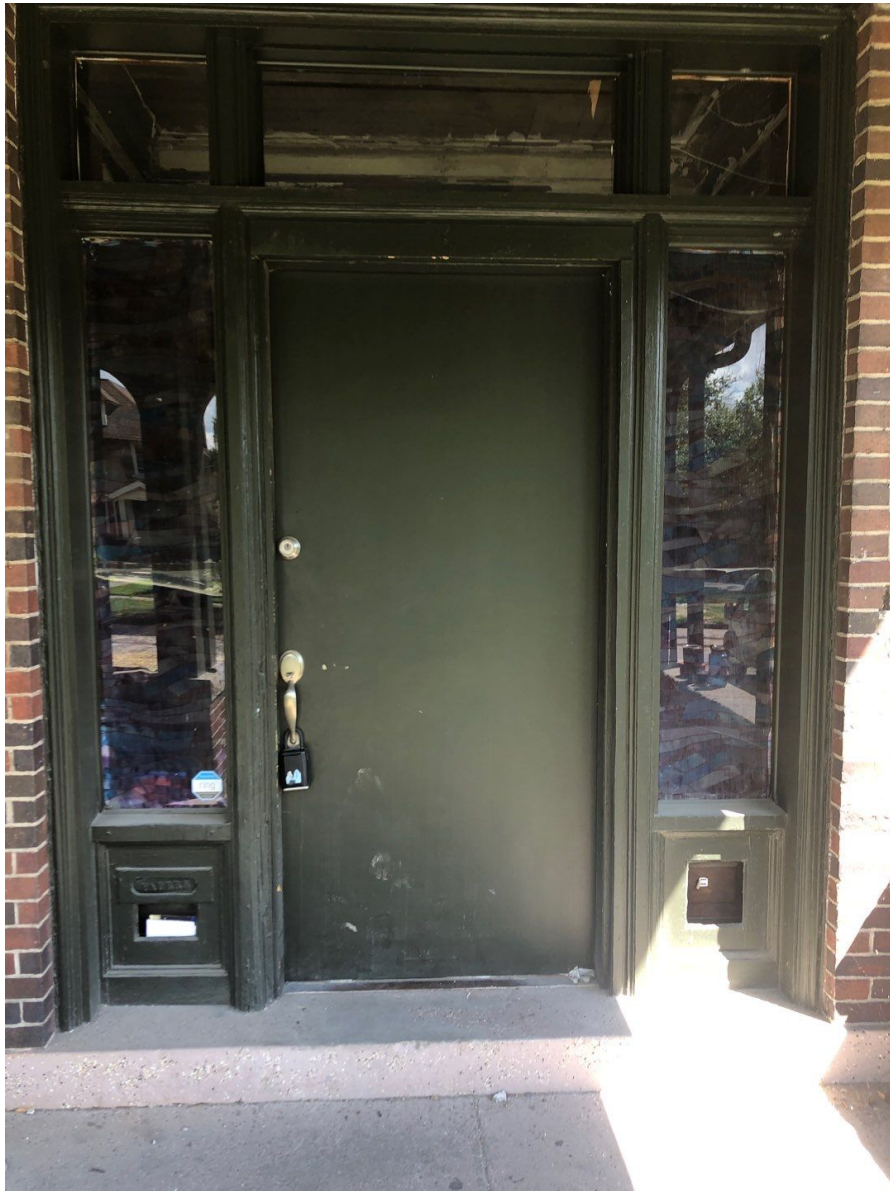
Current Front Door:

- No original glass
- Door itself is not original
- Several pieces of trim replaced throughout years with non-matching trim/casing
- Casing and trim in poor condition/ loss of detail
- Missing panels on bottom portions
- Letter slot non-functioning

- New custom door will be made of wood and painted black
- Proportions will match existing proportions
- Trim and casing will match existing casing
- Plan to salvage brick molding

We are opting for full replacement rather than repair as most items need replacement due to non-original and/or damaged. It is recommended by our door company that creating/replacing the full unit is the only way to ensure uniformity and longevity/functionality. Our experience with local historic restoration companies have been a nightmare and we do have the ability to go years without a functioning front door as we've gone with our historic window restoration.
