New Hue Restoration + Design, LLC

HDC PROJECT REVIEW (Window Schedule)

2405 BURNS AVE DETROIT MI, 48214

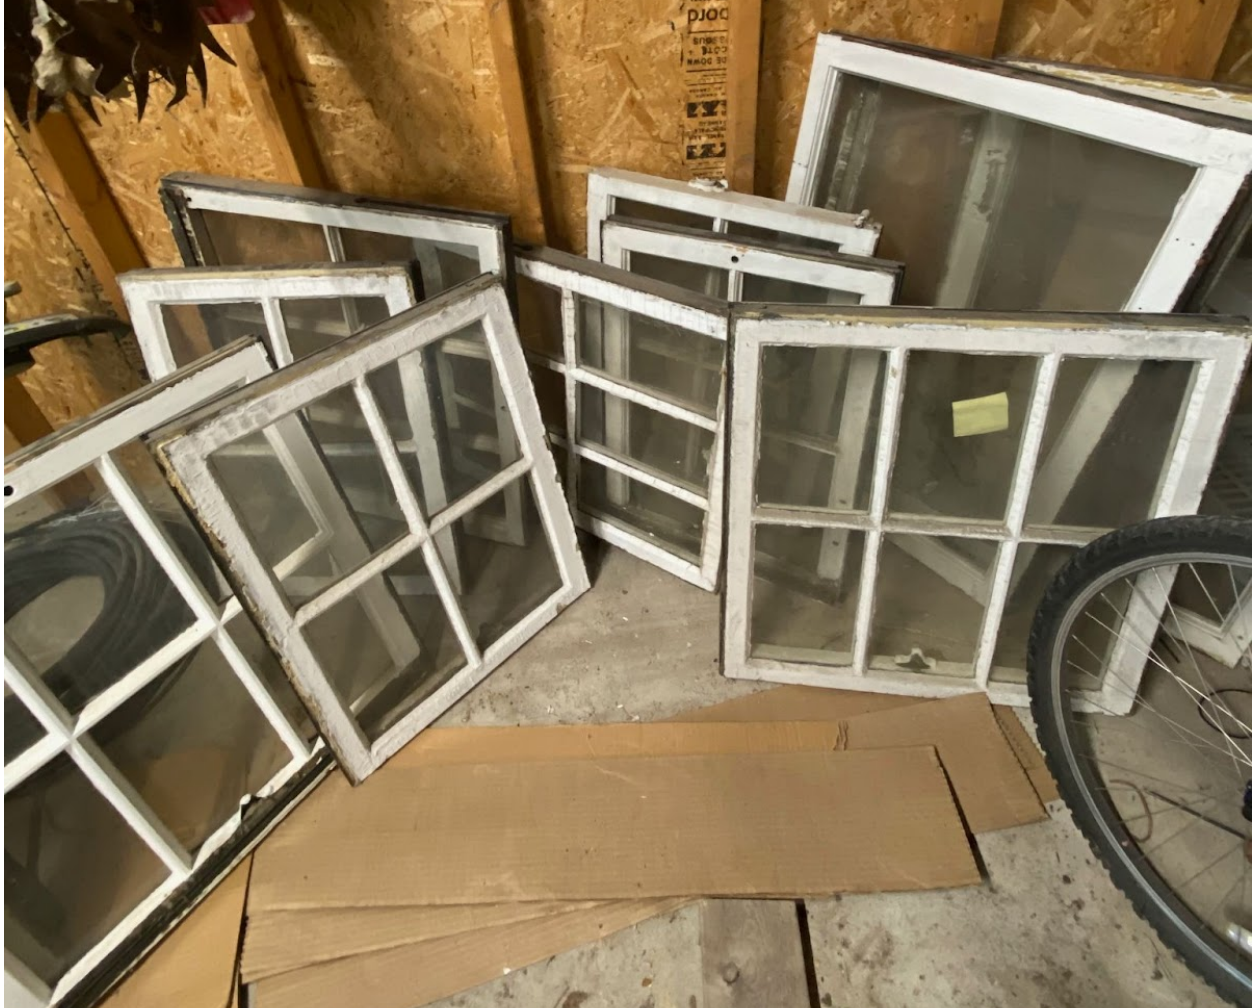
*PICTURE ABOVE: **Existing Sashes** - These are all five window sets(that are not in place) that exist. They fit first and second floor windows found on the NW elevation (a scope of windows that would be done in a later phase).*

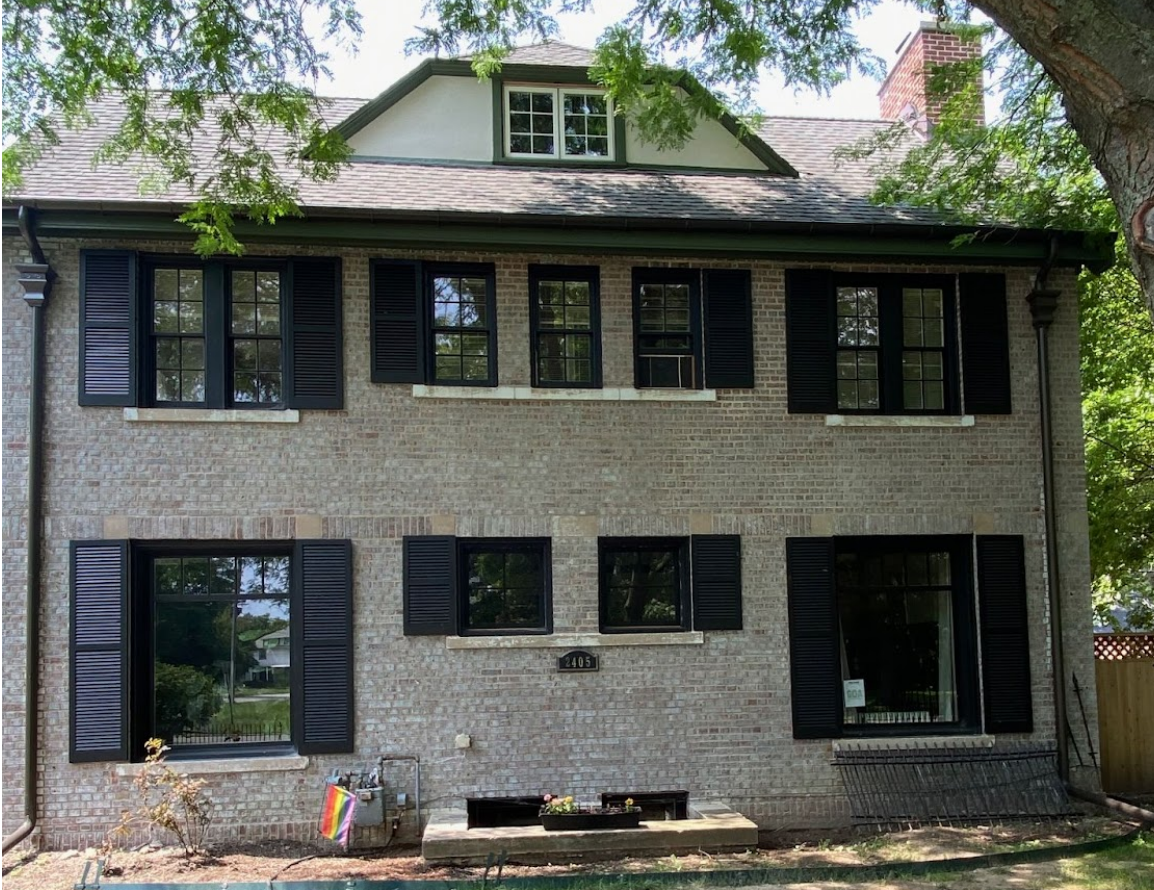
NE ELEVATION-First Floor(right to left) - 1.3 , 1.4 , 1.5 , 1.6 Second Floor - 2.3 , 2.4 , 2.5 , 2.6 , 2.7 , 2.8 , 2.9 Third Floor - 3.1

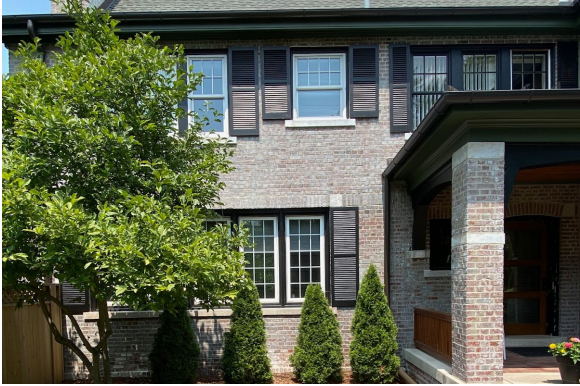
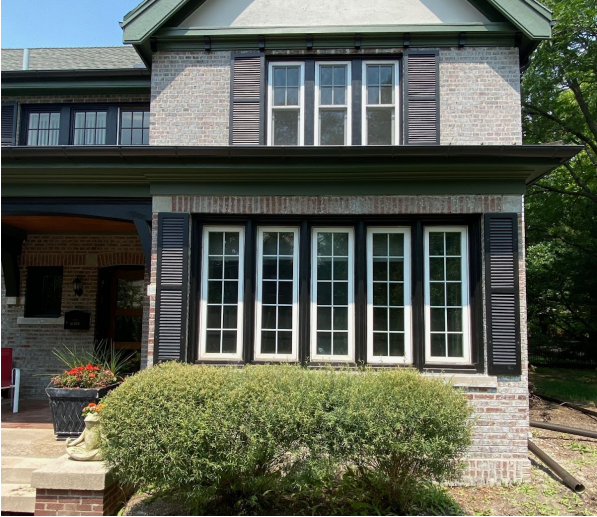
SE ELEVATION

(RIGHT PICTURE) First Floor - 1.8 , 1.9 , 1.10 , 1.11 , 1.12 , 1.13(not seen, side of sun room) , 1.14(fixed closet window under porch) Second Floor - 2.10 , 2.11 , 2.12 , 2.13 , 2.14 , 2.15

(LEFT PICTURE) First Floor - 1.15 , 1.16 , 1.17 , 1.18 , 1.19 Second Floor - 2.16 , 2.17 , 2.18 , 2.19 (18,19 hidden behind tree)

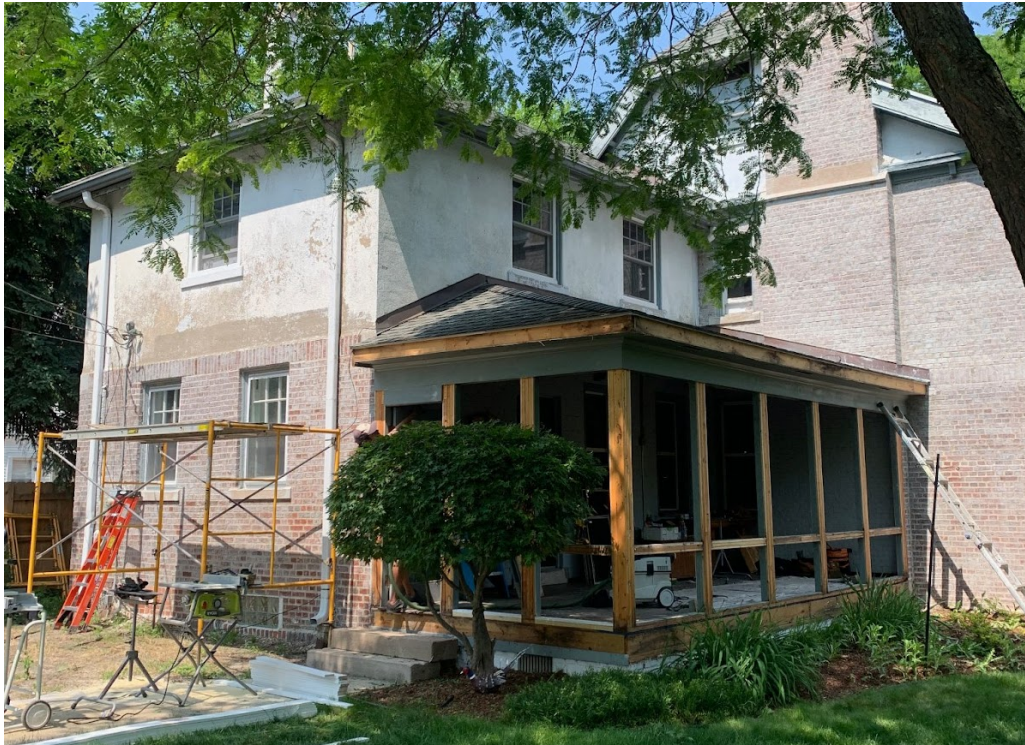
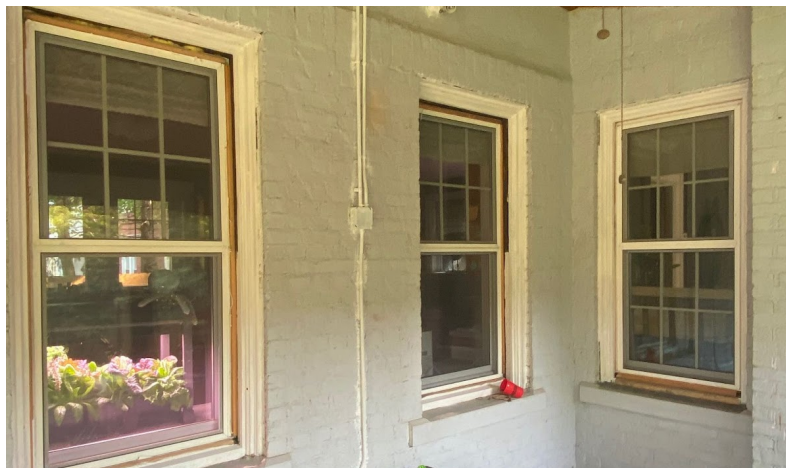
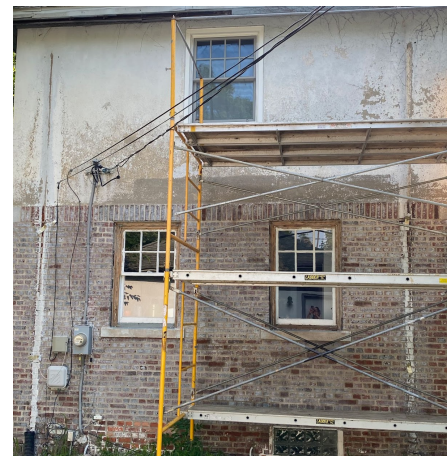
SE & SW ELEVATIONS

(TOP PICTURE) First Floor - 1.20 , 1.21 , 1.22 , 1.23 , 1.24 (20,21,22 under porch) Second Floor - 2.20 , 2.21 , 2.22 , 2.23 Third Floor - 3.2(hidden behind tree)

(LOWER LEFT) Windows - 1.23 , 1.24 , 2.23

(LOWER RIGHT) Windows - 1.20 , 1.21 , 1.22

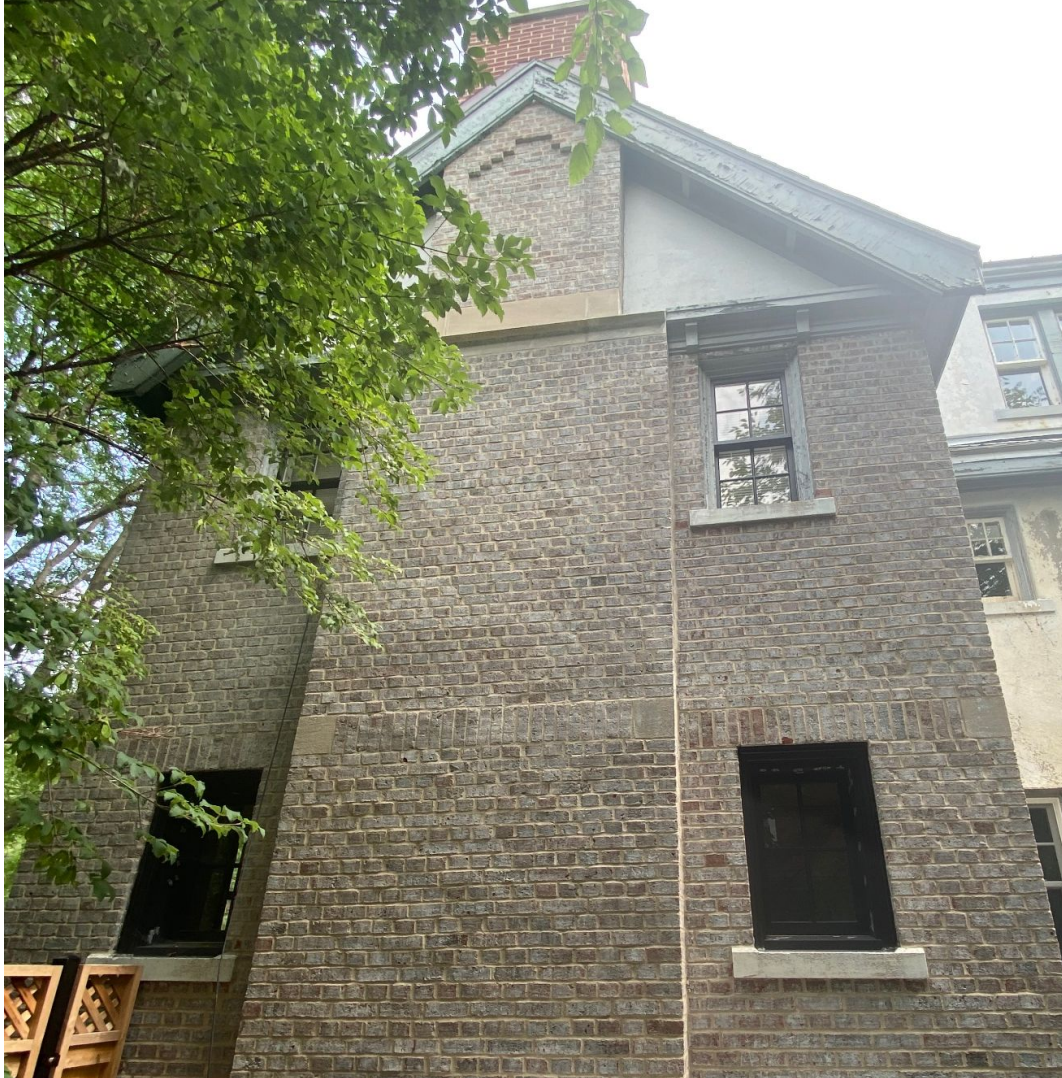
NW ELEVATION - First Floor - 1.1, 1.2 Second Floor - 2.1,2.2

Rotted fasçia at far west elevation: This section of fasçia was poorly repaired and failed. The replacement board was removed. NHR+D will cut back the low hanging flashing that will no longer be covered by K style gutters as 1/2 rounds are being installed to match the gutters on the Vernor/ Burns elevations. We will make a vertical cut horizontally (With track saw) straight above the bottom edge of 1/2 round gutter, mill a solid spline of southern yellow pine dimensionally to match what’s there and glue/ domino the two together. Again, all raw wood is oil back primed by hand/ brush, two top coats applied by hand after a light sanding to knock down grain. Gutter installers will install any additional flashing needed to cover horizontal seam and it will be in bronze tone to match gutter color.

Fasçia: Rotted fasçia to be replaced with dimensionally milled white oak as it is rot resistant, as well as the smaller dimensional trim “ transition trim” between fasçia and soffit. That smaller trim sits both horizontally below and vertically on the edge and tucks under chimney flashing. As stated milled of solid white oak, back primed with linseed based oil- primer, caulked and puttied where required and top coated 2x by brush with S.W. Emerald low-luster.

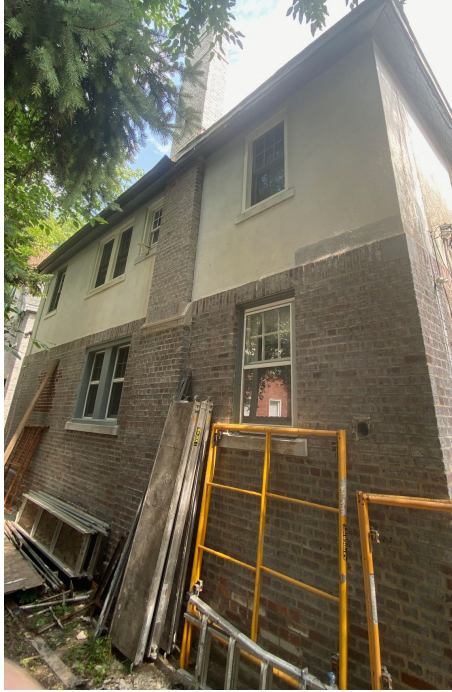
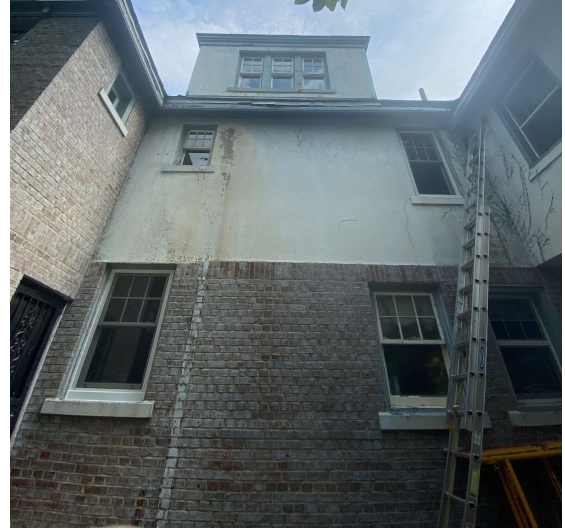
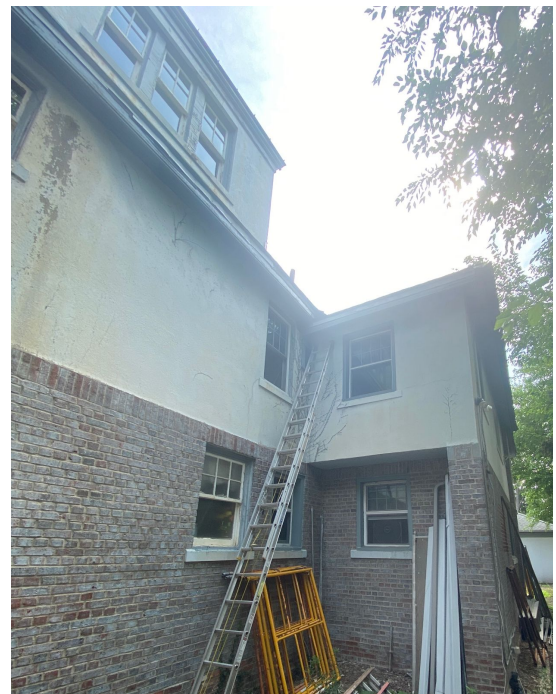
NORTH WEST ELEVATION

North West Elevation: The five double hung original sashes found in the attic, now in the garage are for the second elevation NW corner rooms the five along the second floor first picture of North elevation. Those five are to be repaired (Mary). First floor, the corner window is a repair (Mary), the other two are a replacement. Recess or grotto wall: The third floor dormer windows, repair (Mary). Small window second floor, stucco portion Repair (Mary). Other two windows 2nd fl. stucco will be replacement. 3 of the 4 windows on the first floor will be replacement, the smaller square window will be repaired (Mary). The four windows on the brick wall on the NE corner near Burns, the 2nd floor windows were repaired by (Mary) in 22', the 1st floor are replaced/ replica of original and follow the original hinge placement, and in swing operation and period hardware to match existing patina.
