**Subject:** [EXTERNAL] Re: 19511 Shrewsbury - HDC application

I reviewed the application materials for the proposal to replace the tile flooring at the front entrance, and I have the following questions:

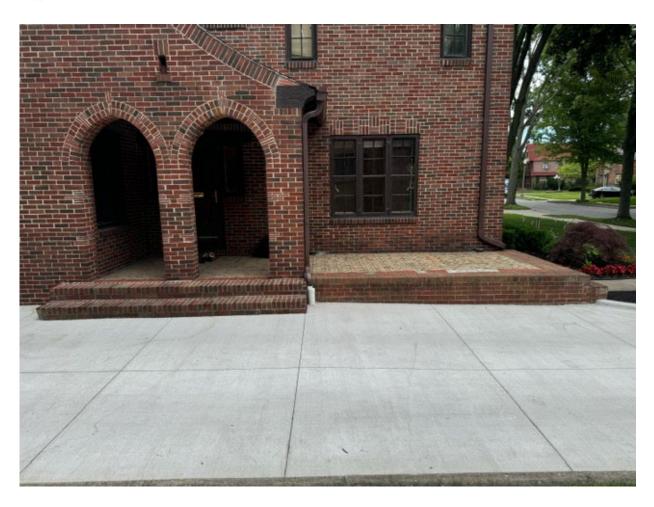
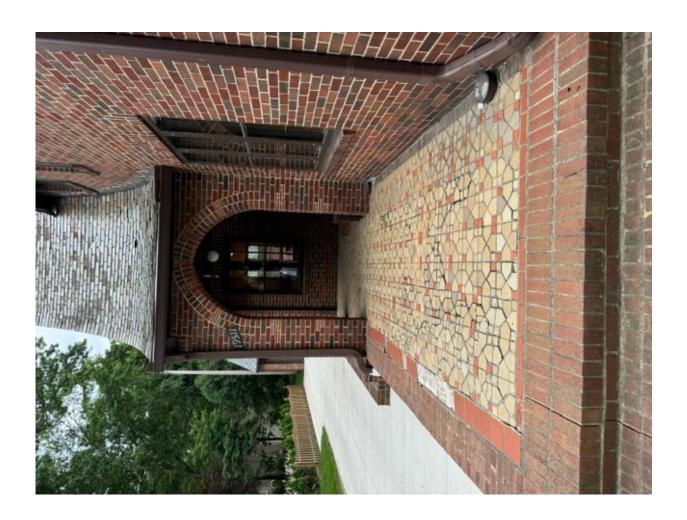
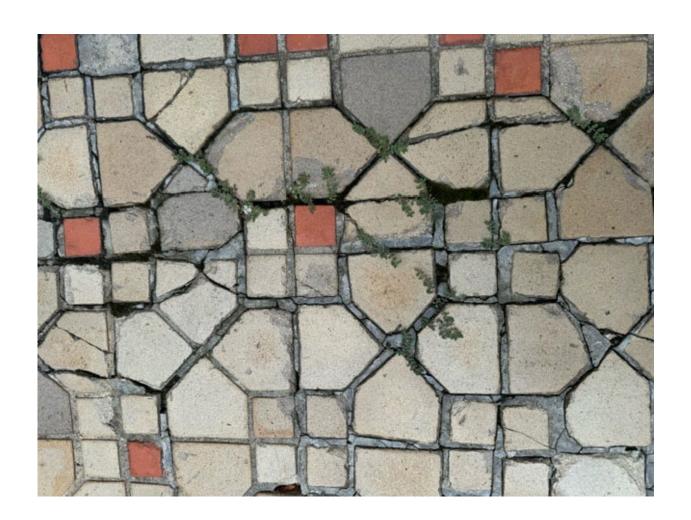
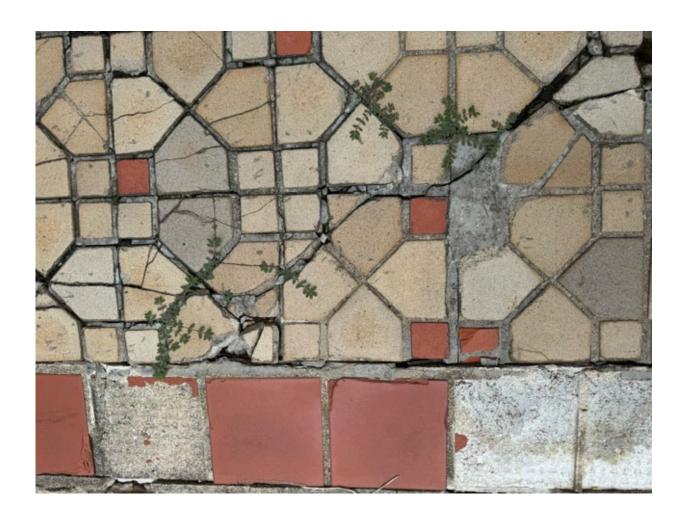
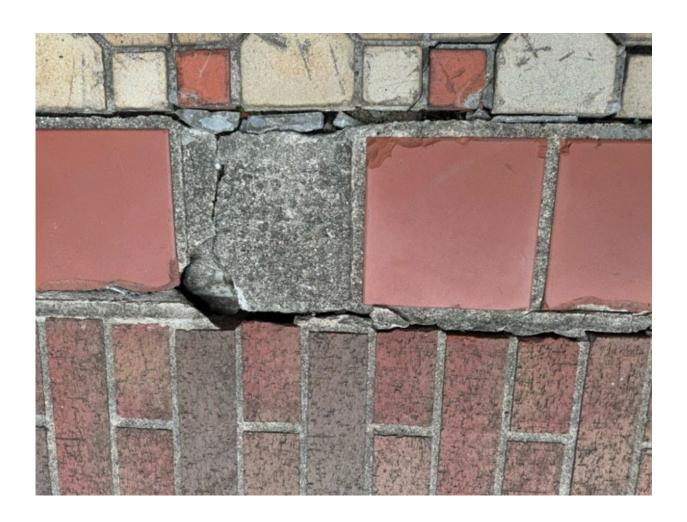
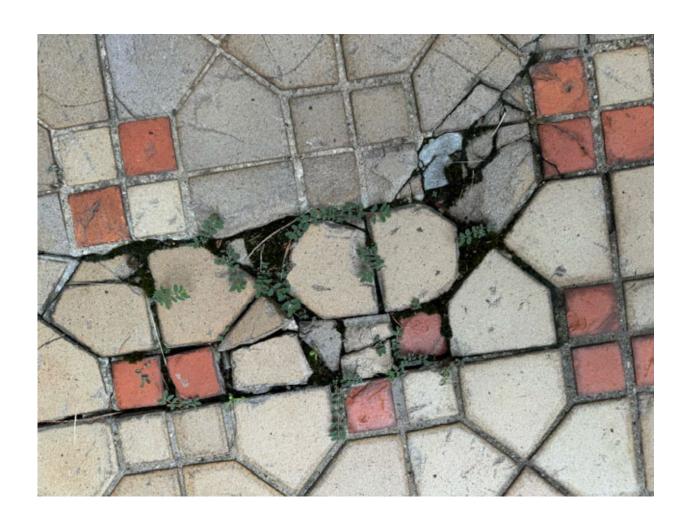
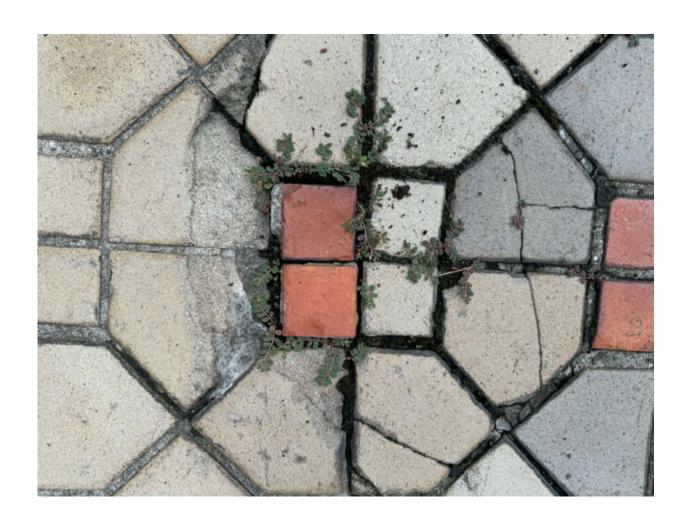
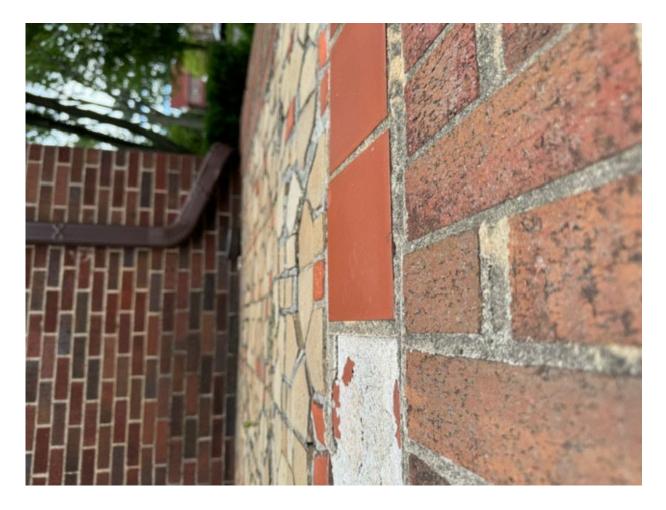
I first need to explain that this is not just the front entrance. I need to replace the entire porch because the tiles are broken and deteriorating as a result of almost 100 years exposure to the snow and ice. As a matter of fact, the front entrance is fine, because it is covered by a roof. But, we obviously can't do a partial replacement, so we'll have to replace the entire area. Here are some pictures to show you what I mean:

We want to replace the deteriorated tiles with something affordable that replicates the current design and colors. We cannot afford to restore it. We don't have that kind of money.
