## Description of Existing Conditions 1730 Edison

Application ID: HDC2024-00331

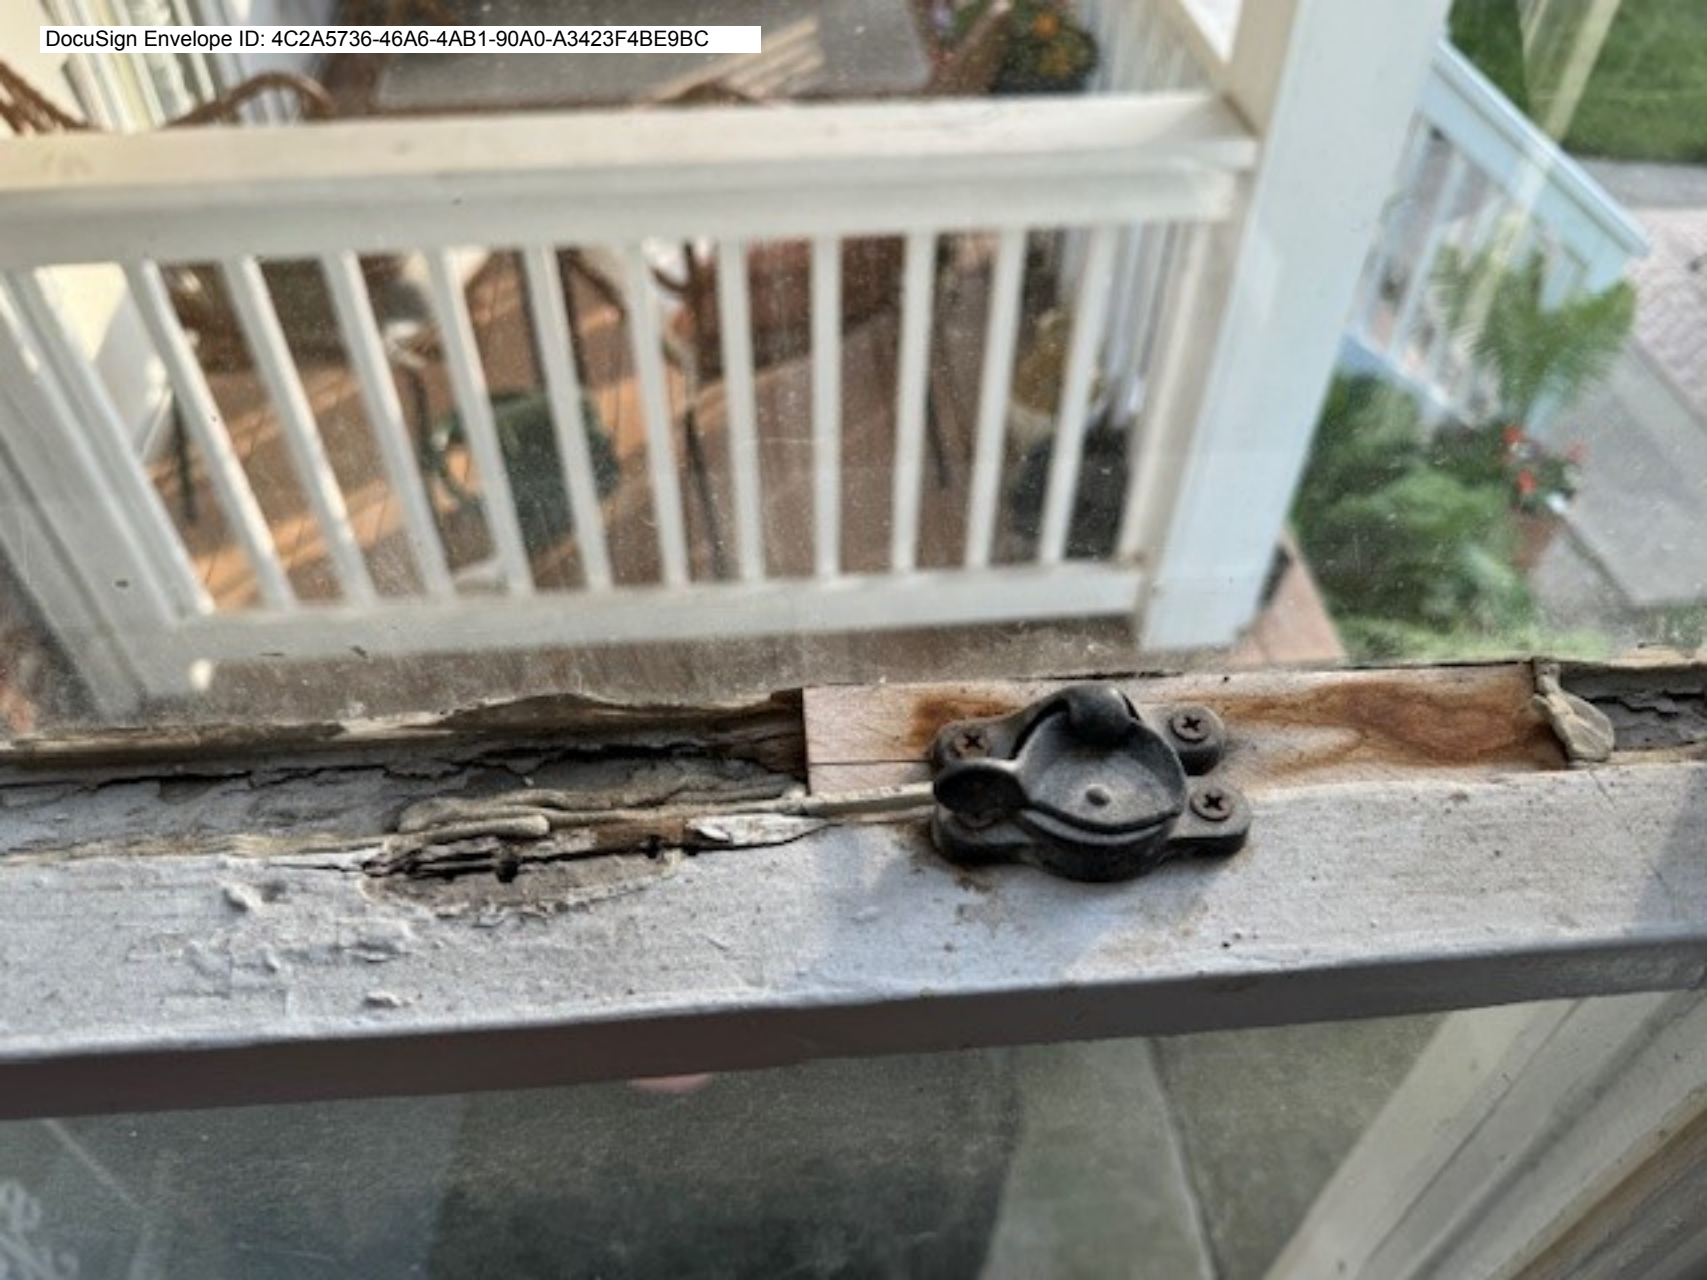
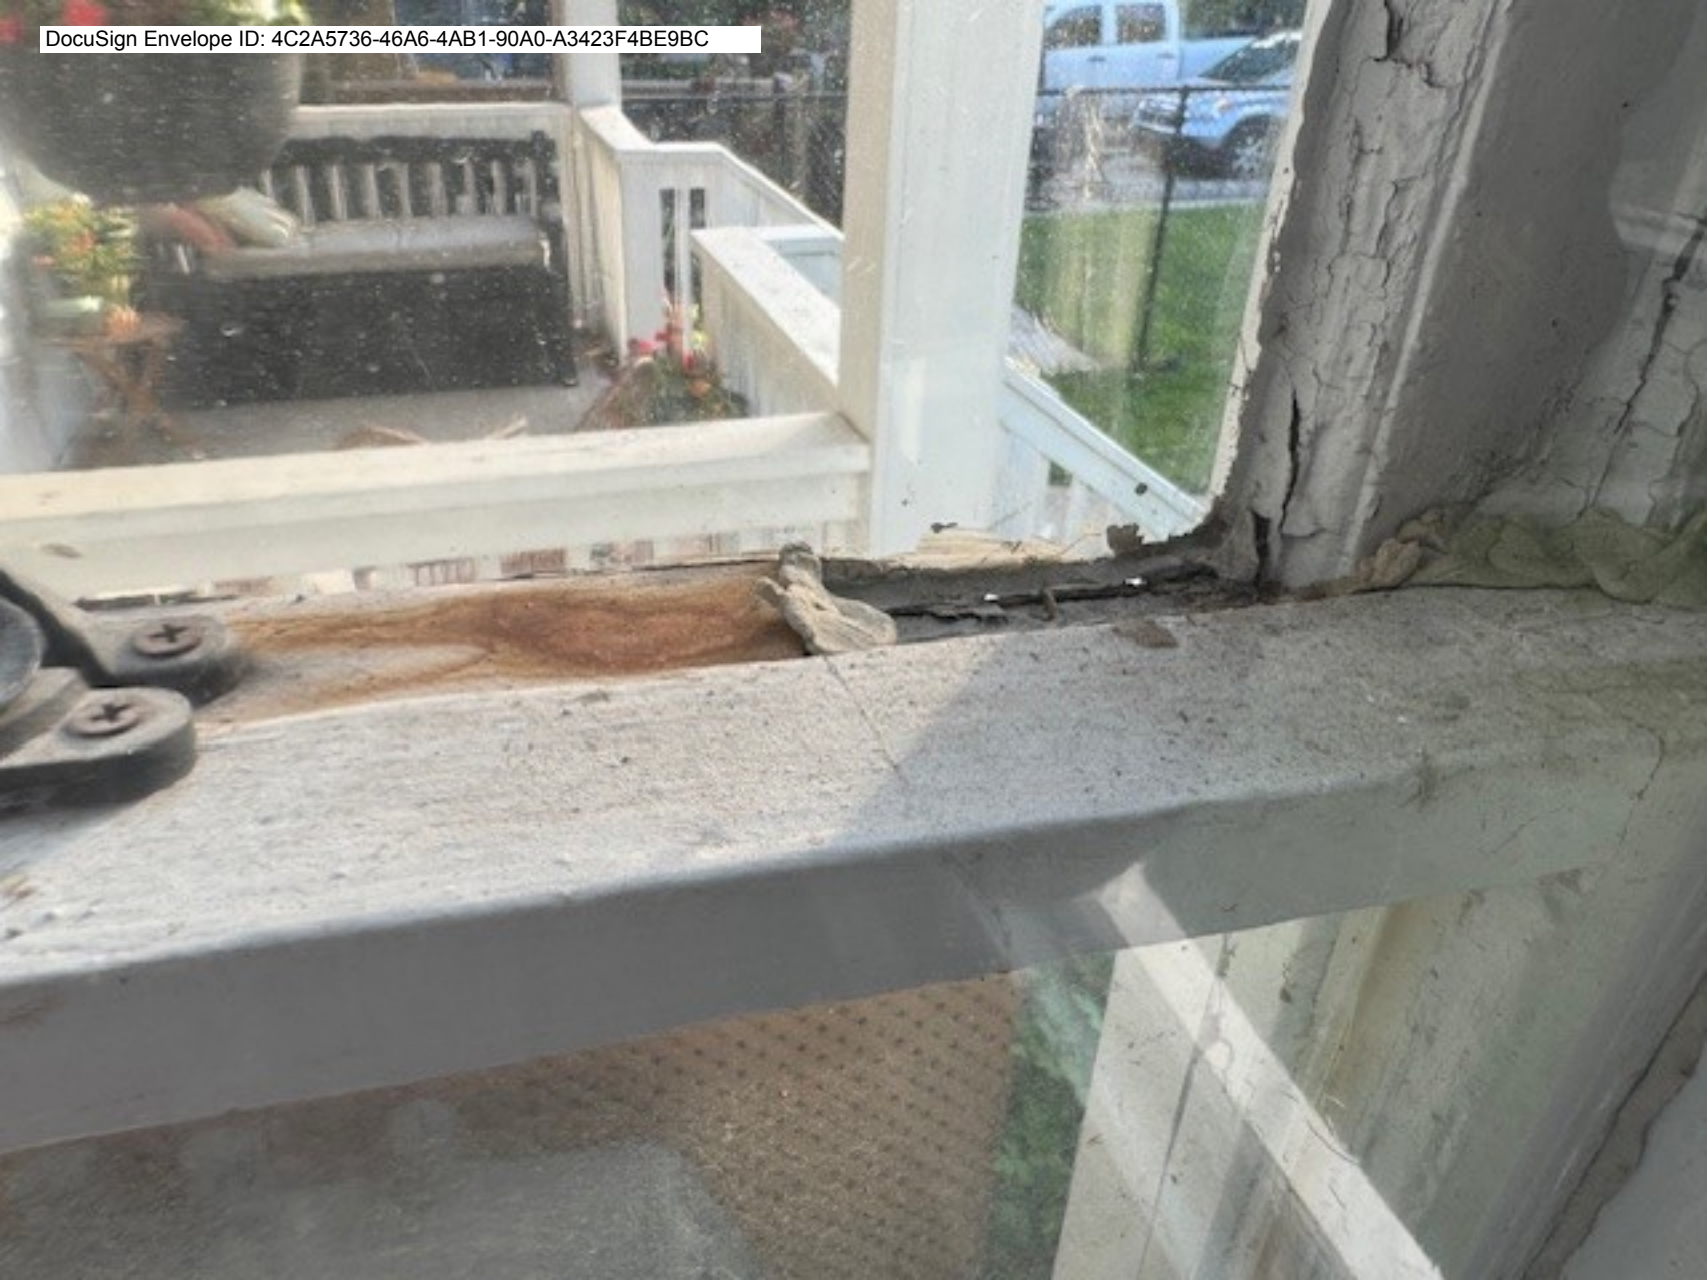
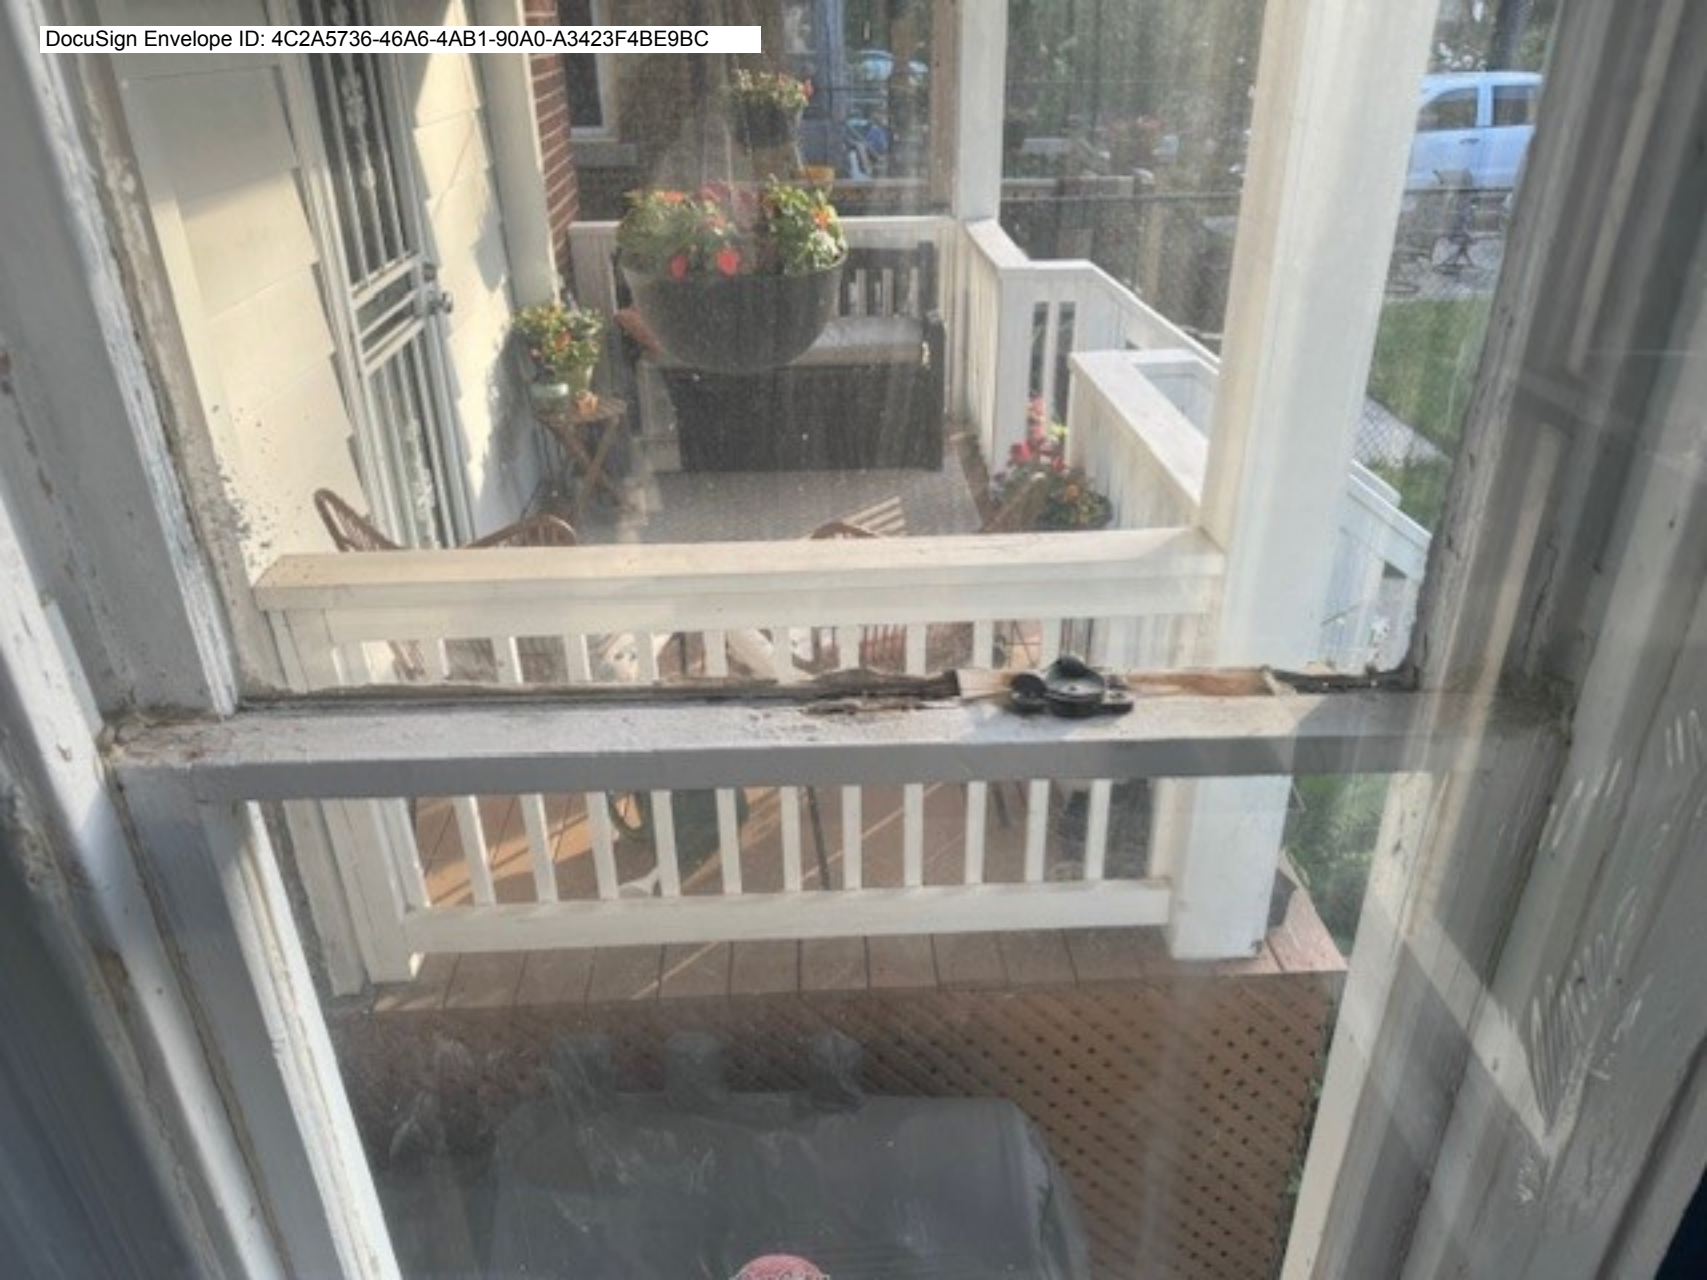
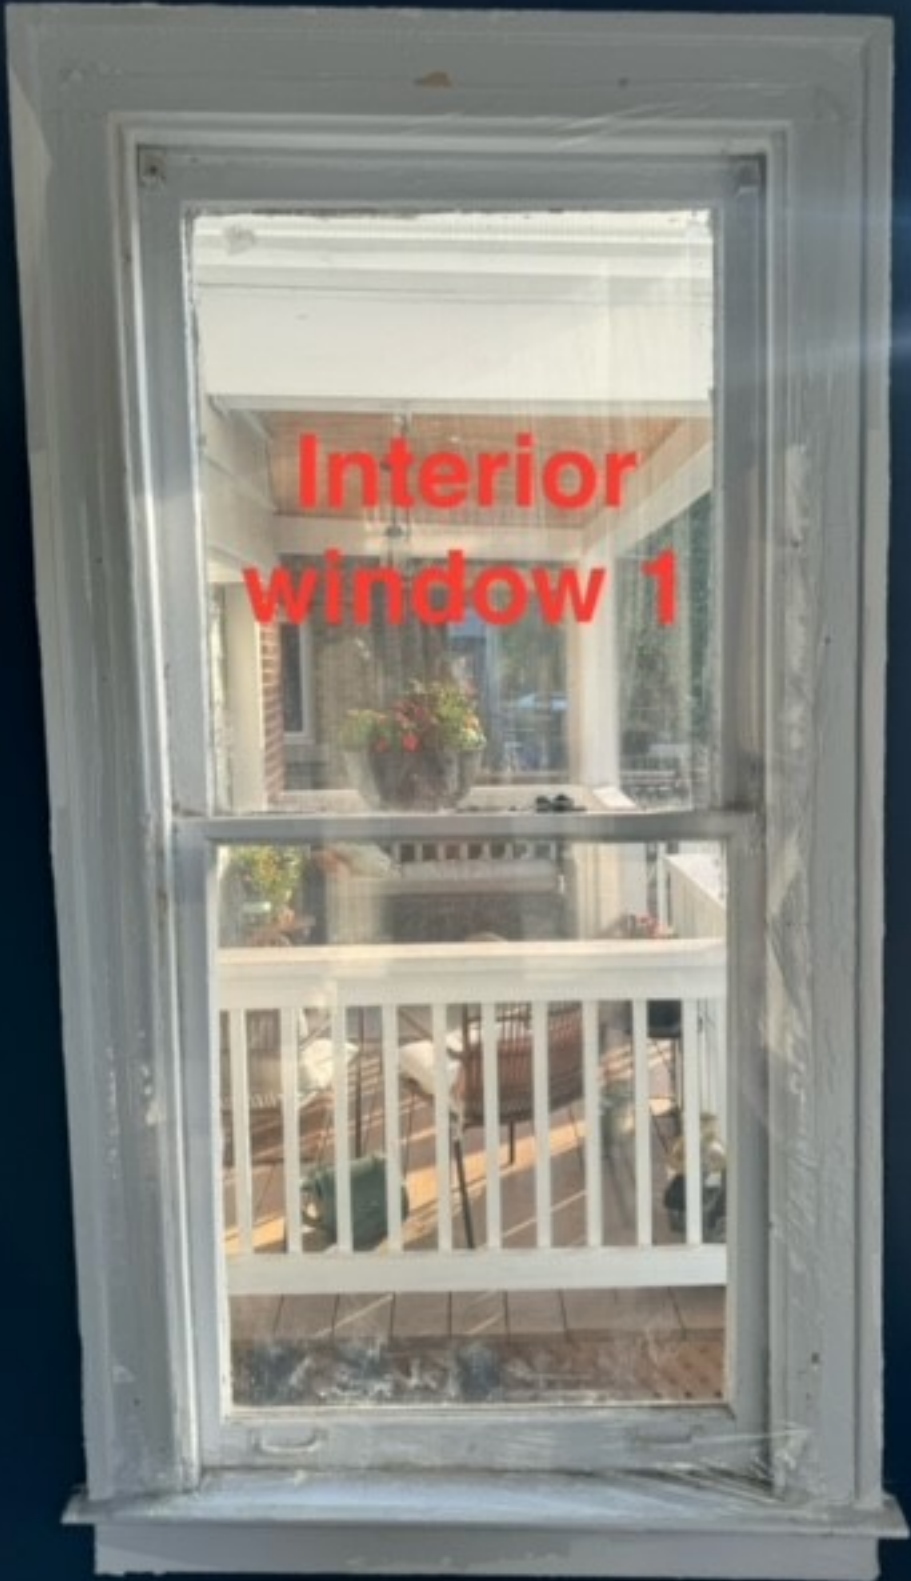
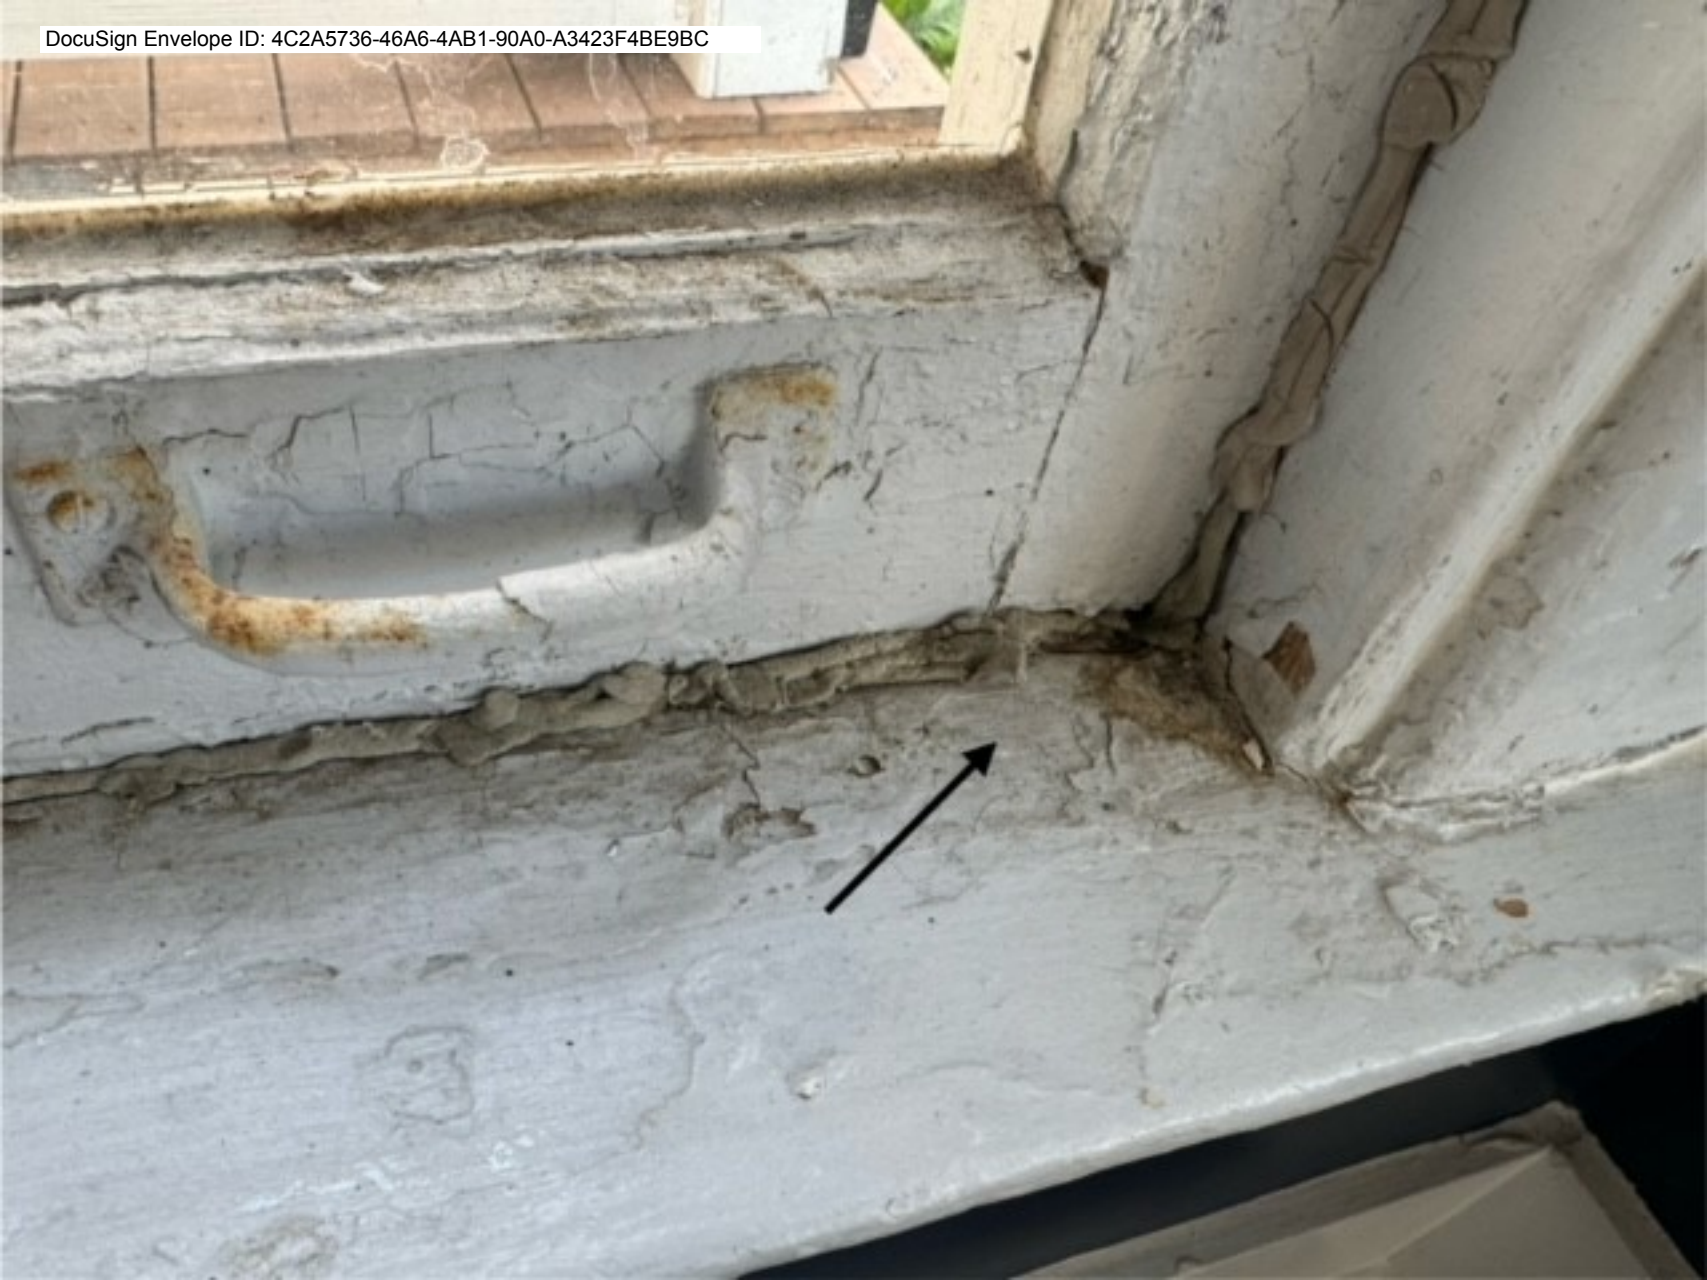
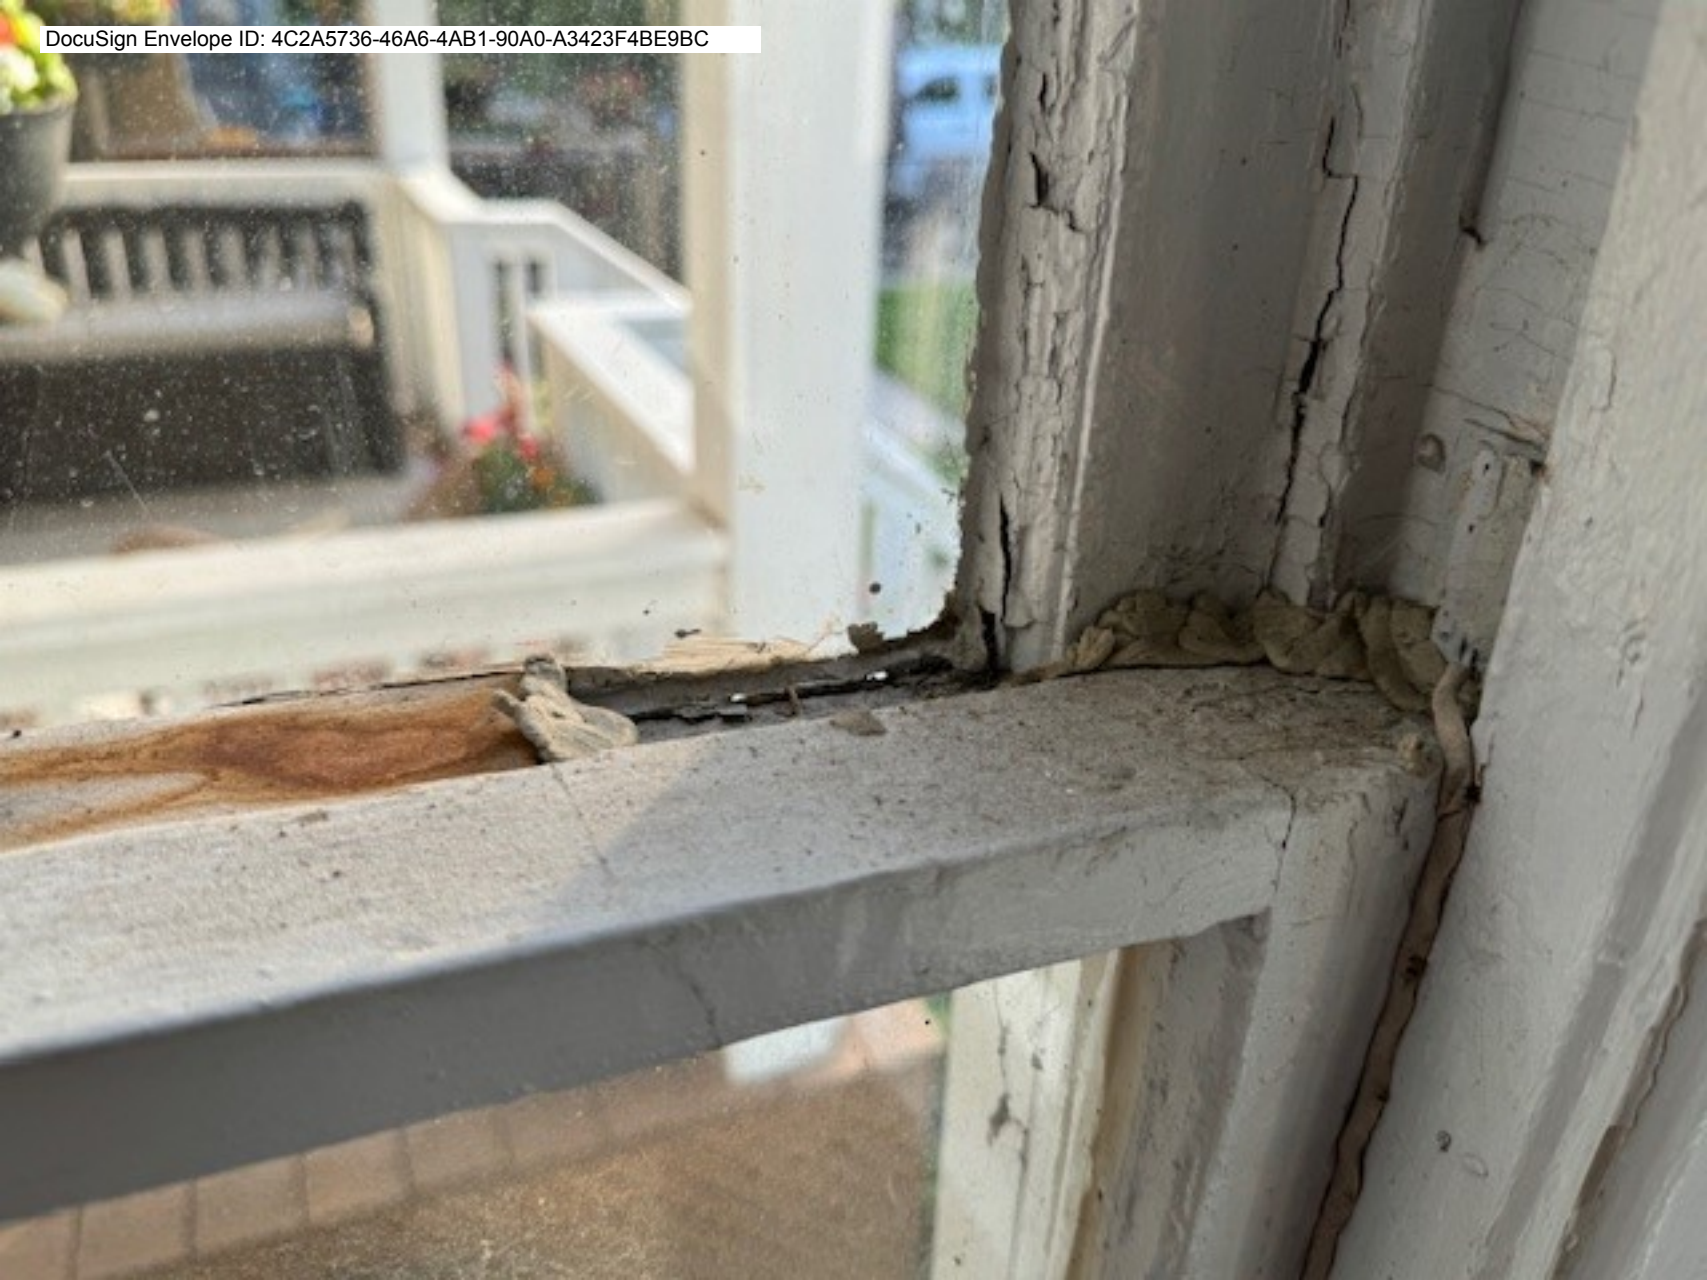
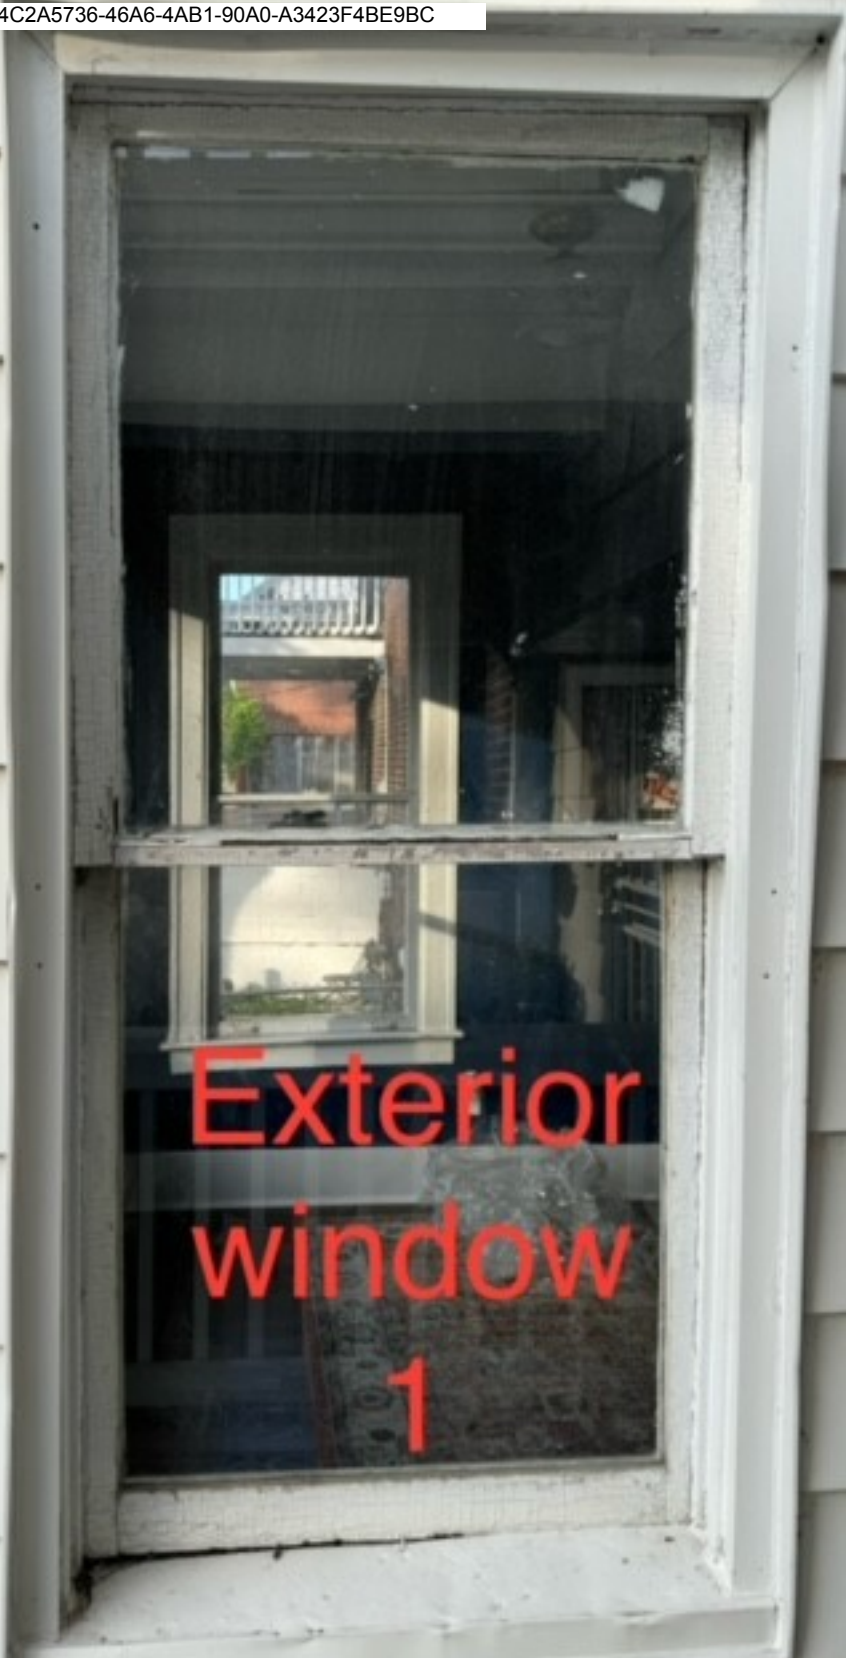
Exterior  
window  
1

Exterior: Upper glass pane has separated from the window sash. Lower left corners of upper and lower portions display rot, including missing portions of the wood sash and wood that is soft to the touch. Bottom of window is not flush with sill.
