## Description of Existing Conditions 1730 Edison

Application ID: HDC2024-00331

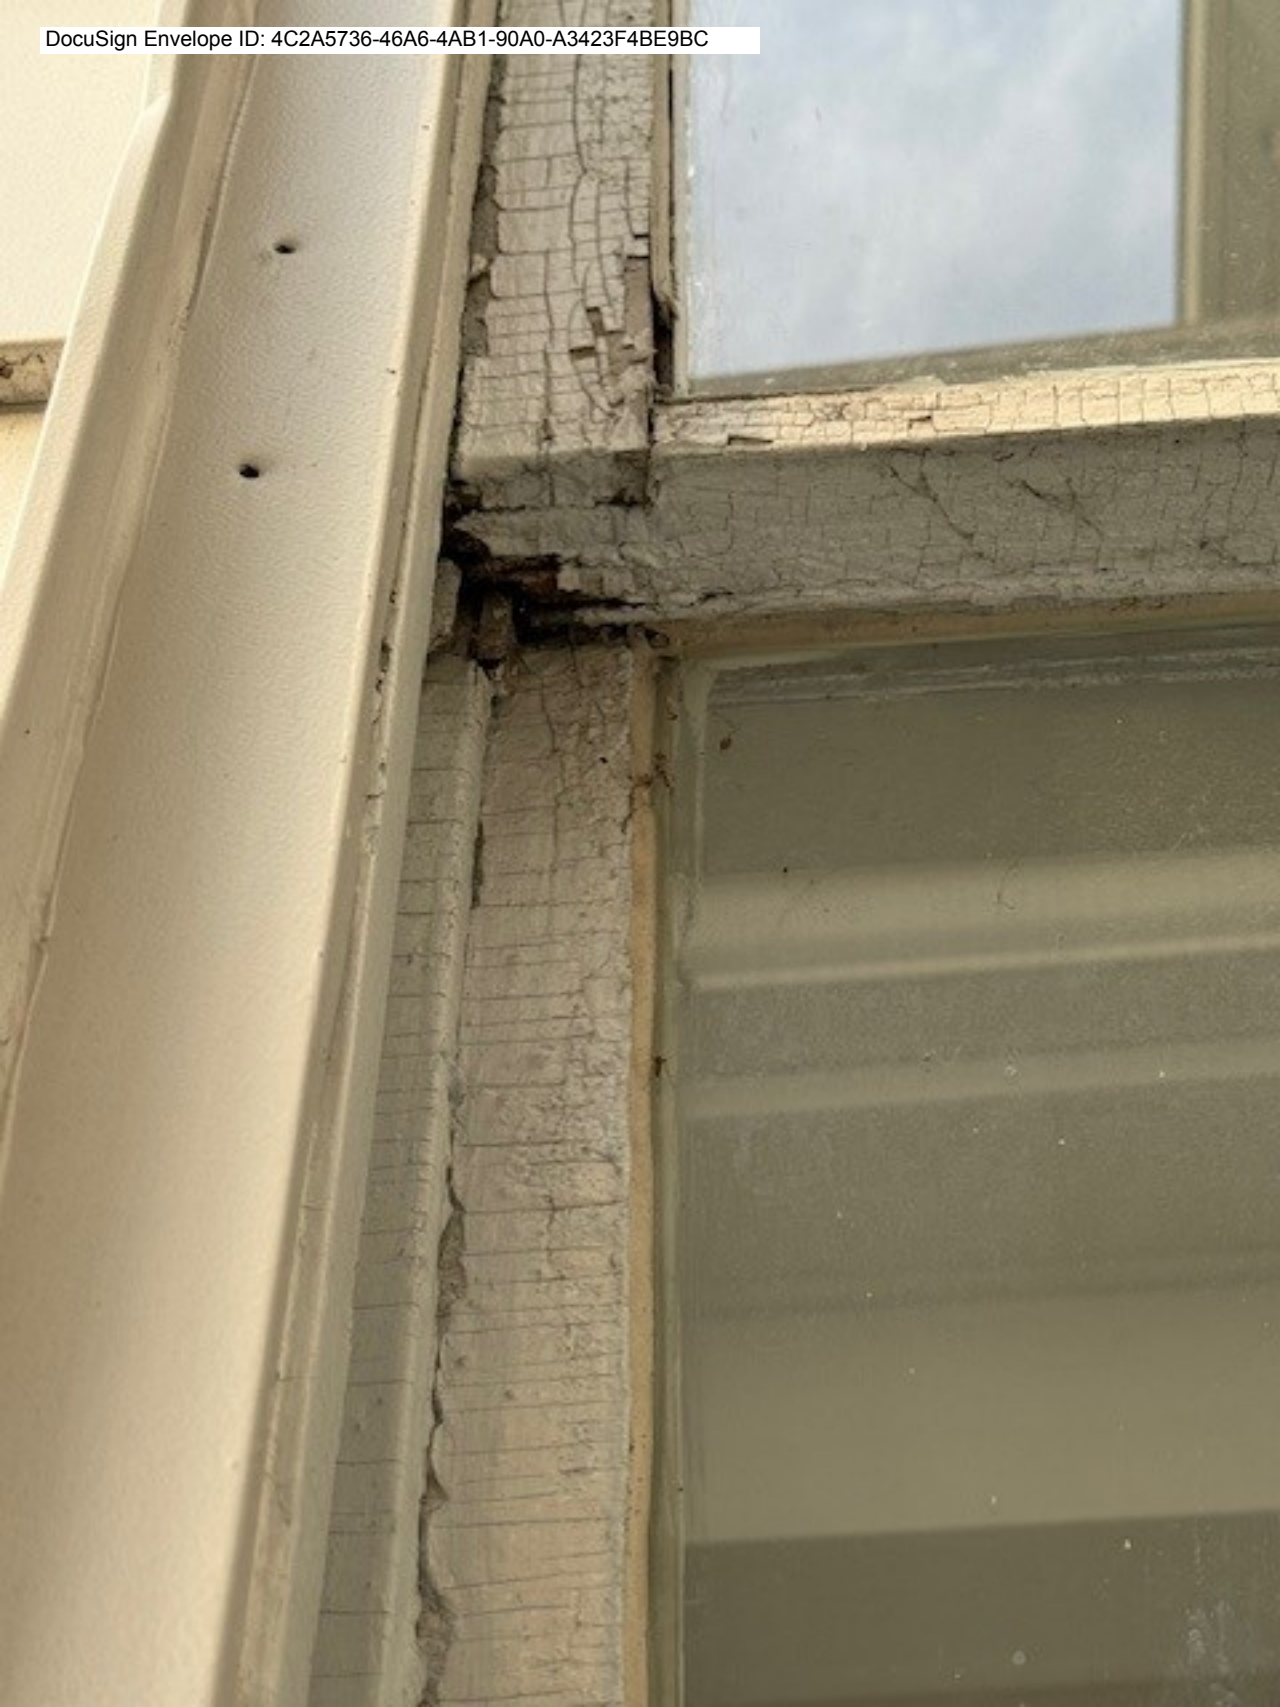
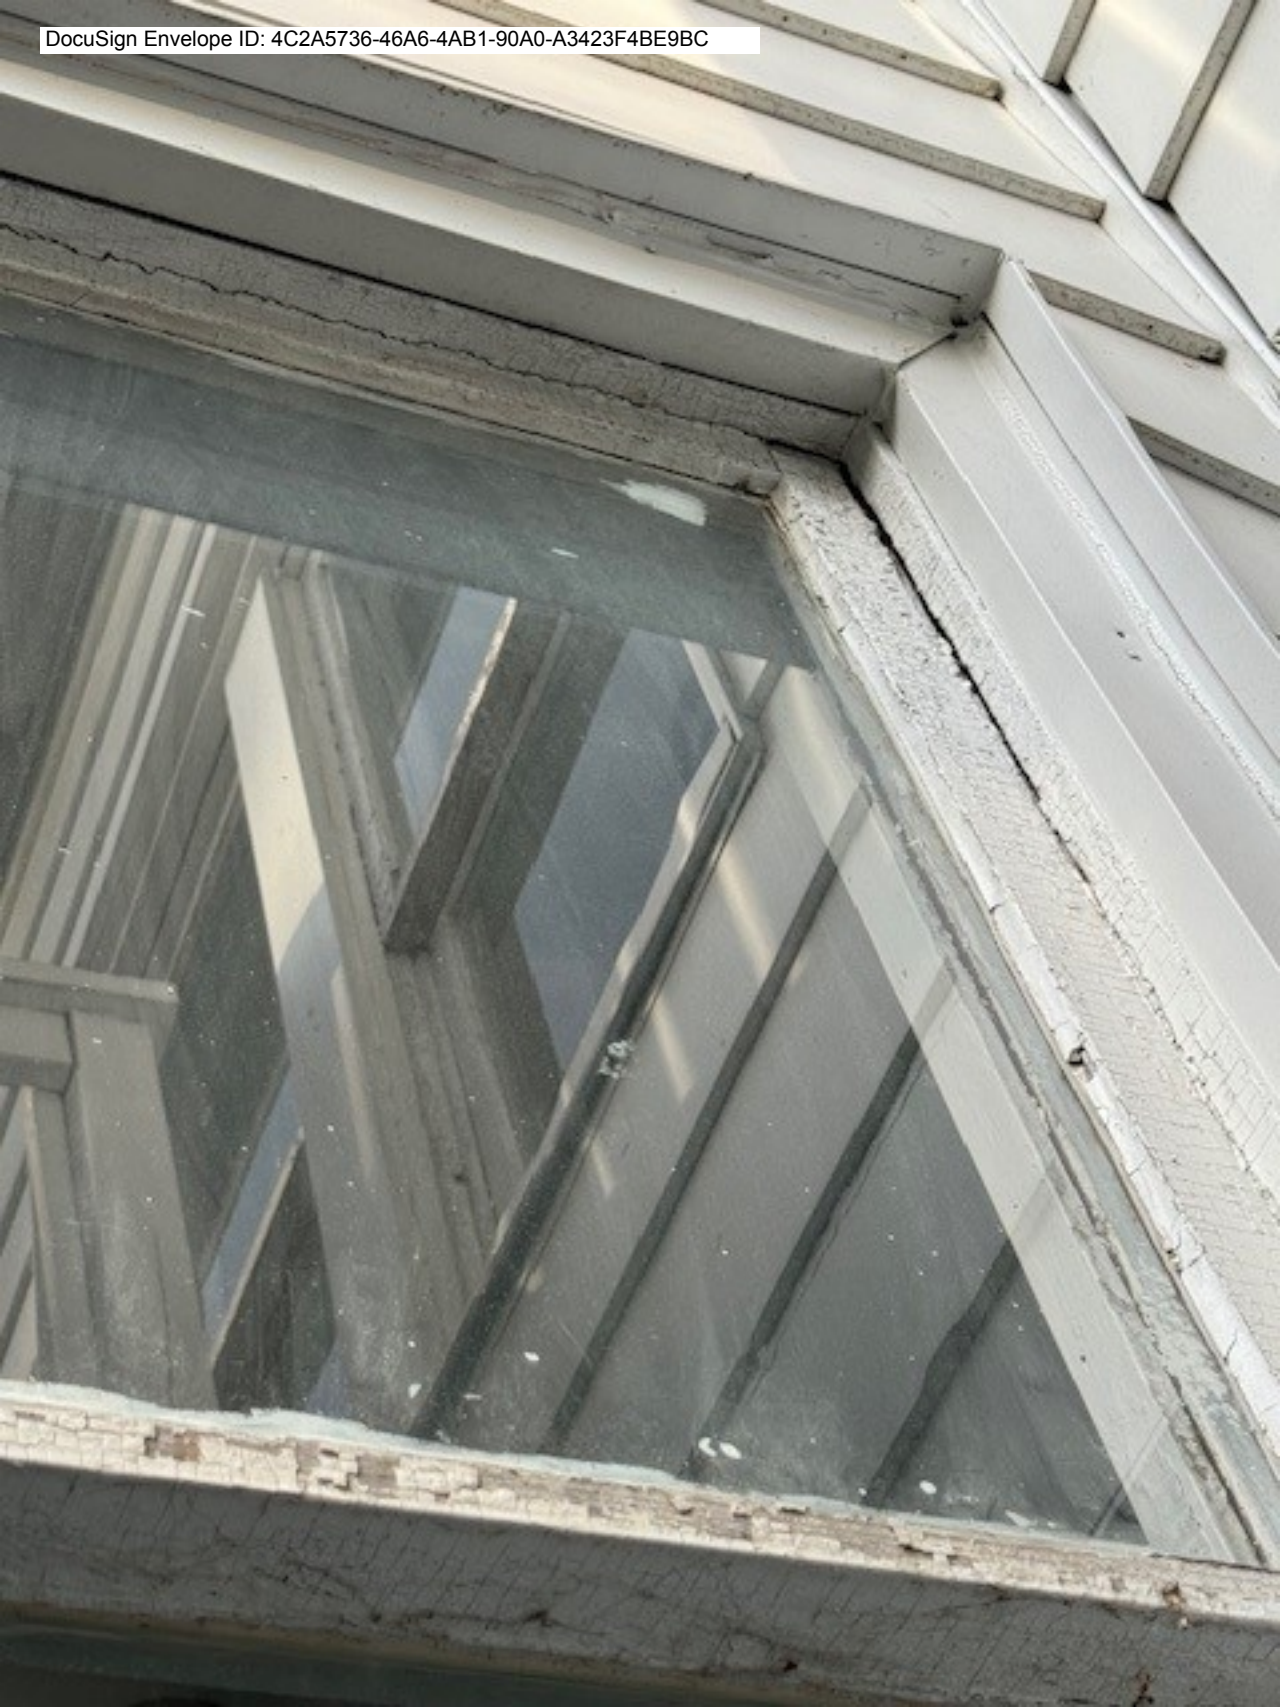
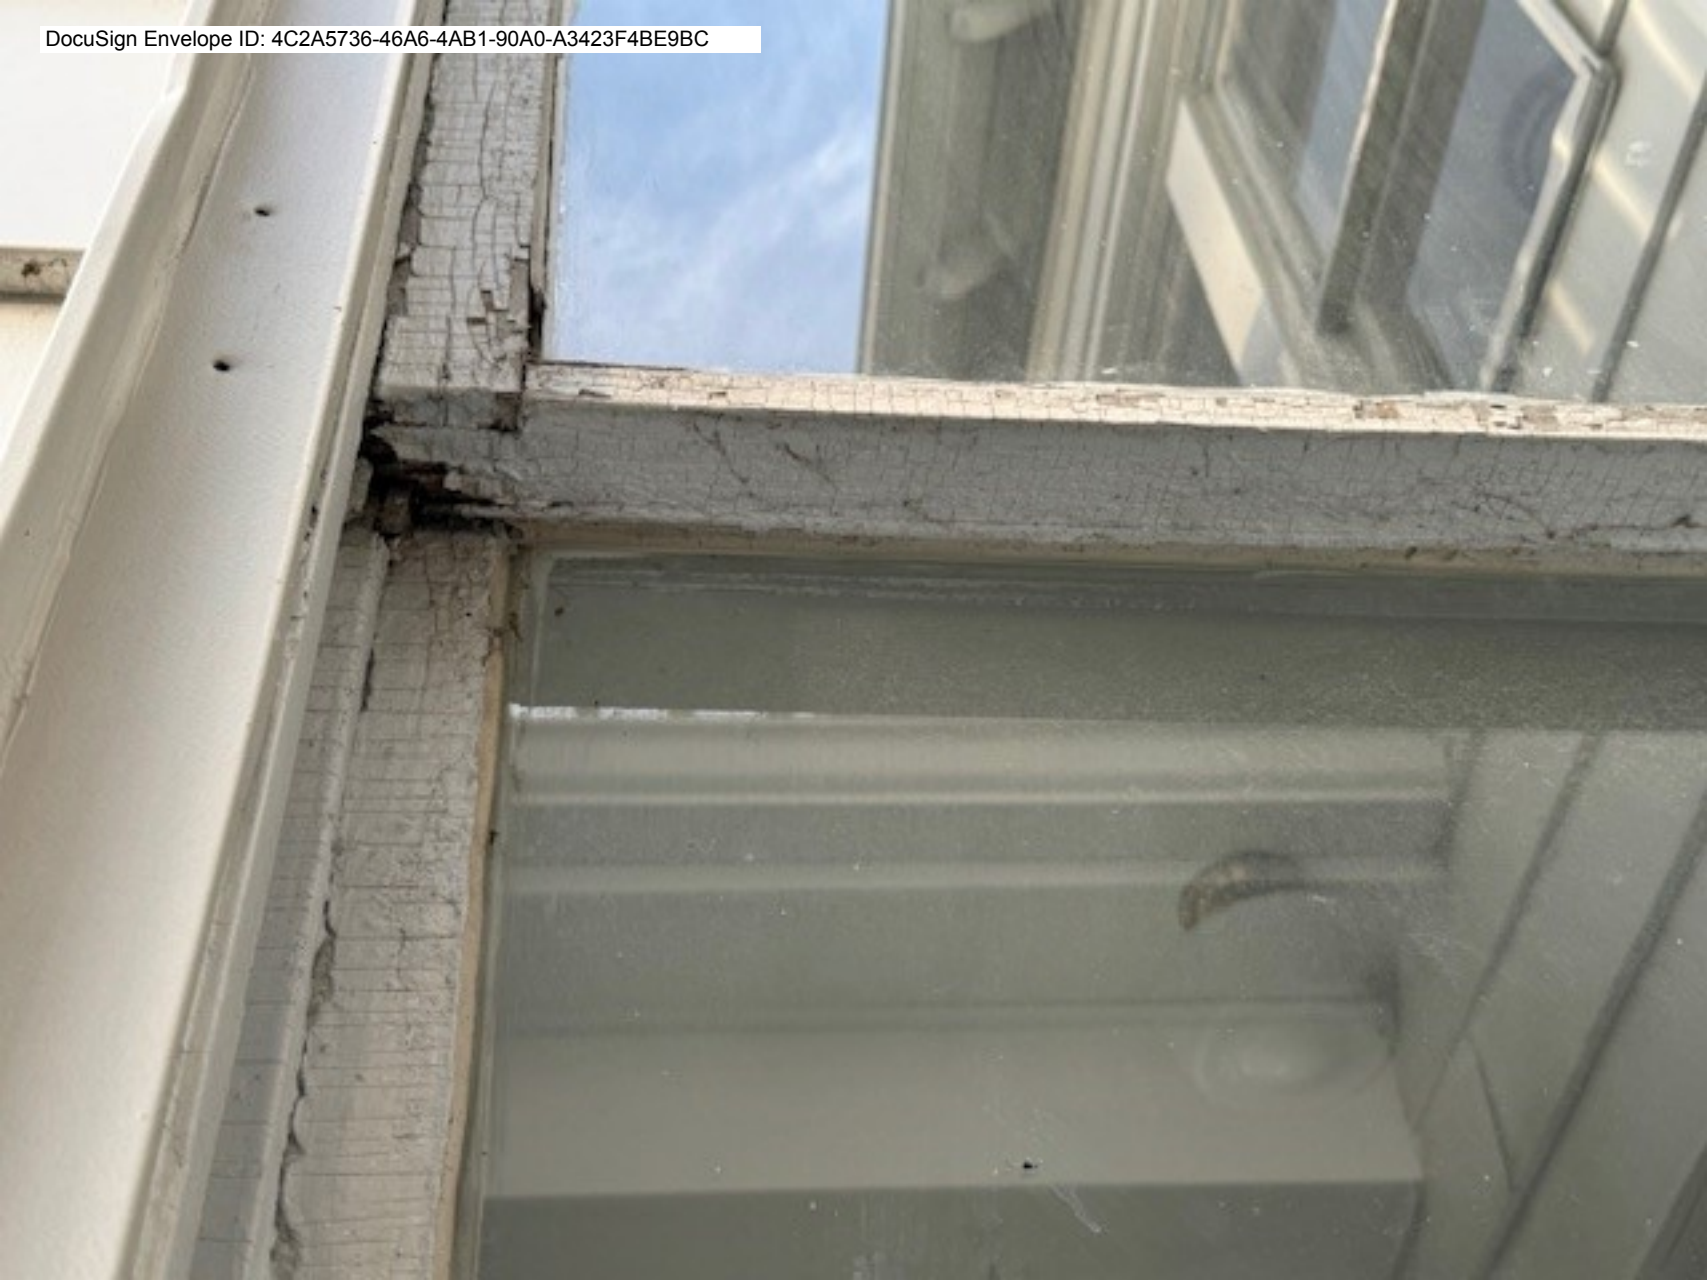
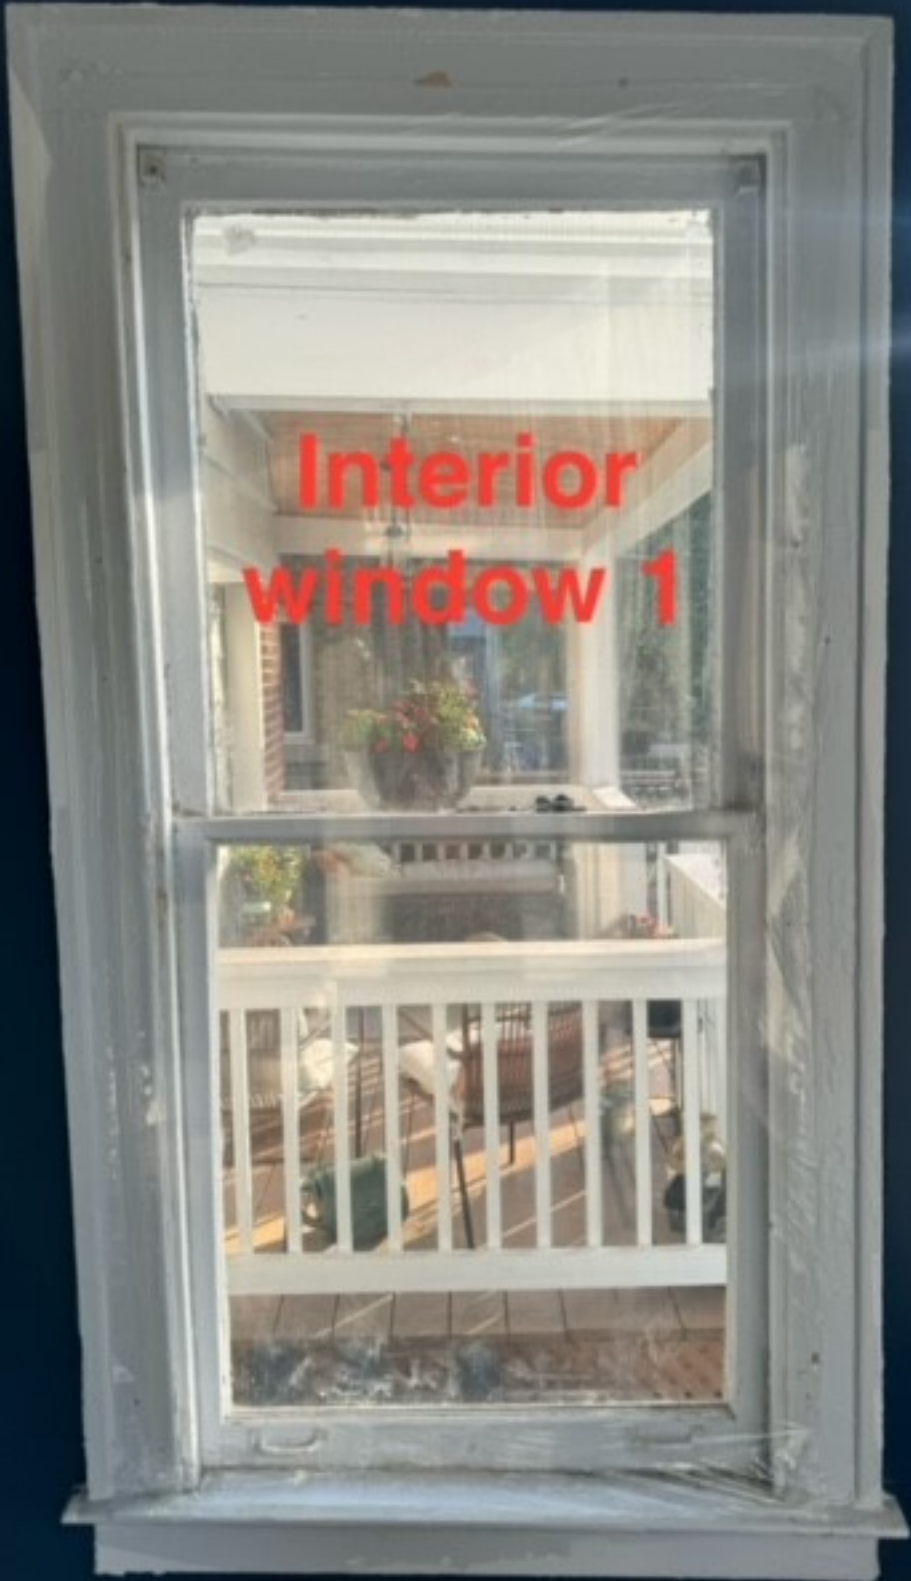
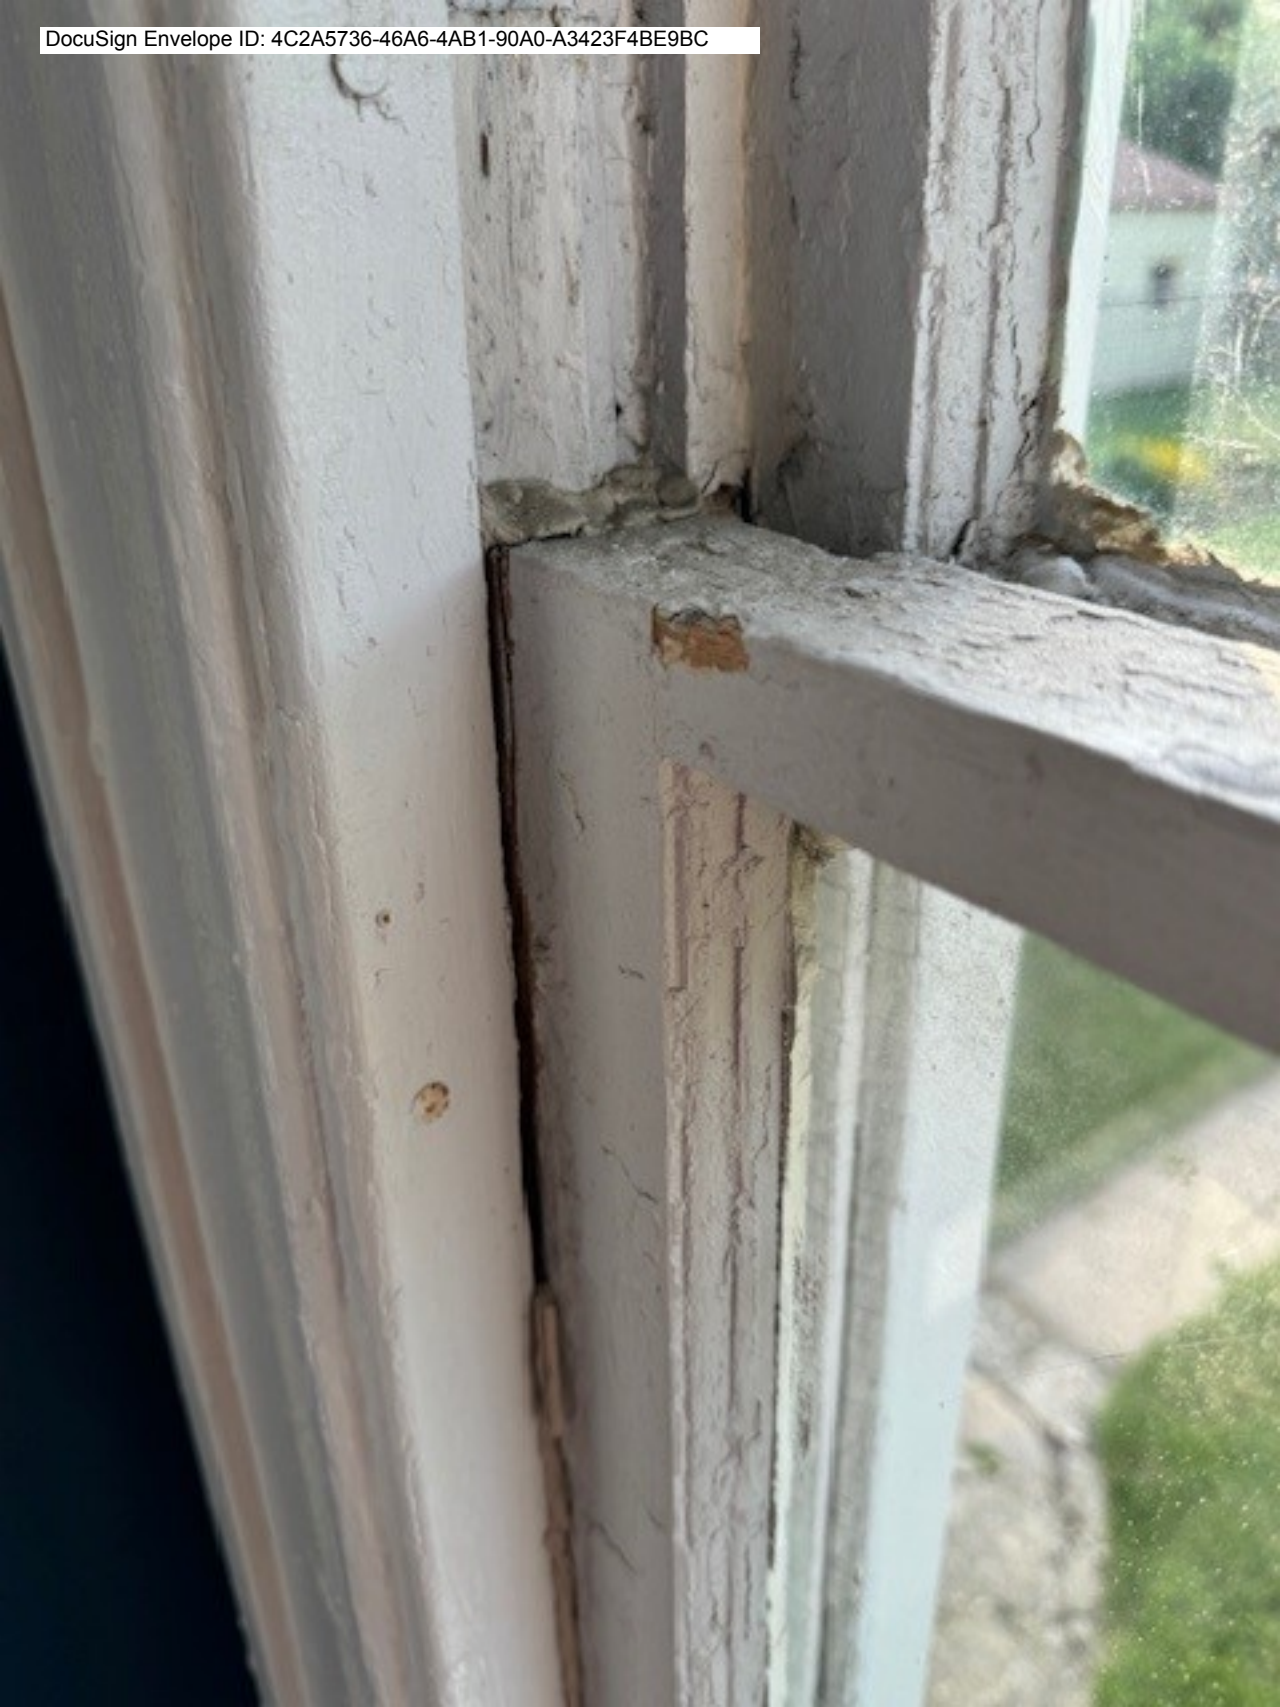
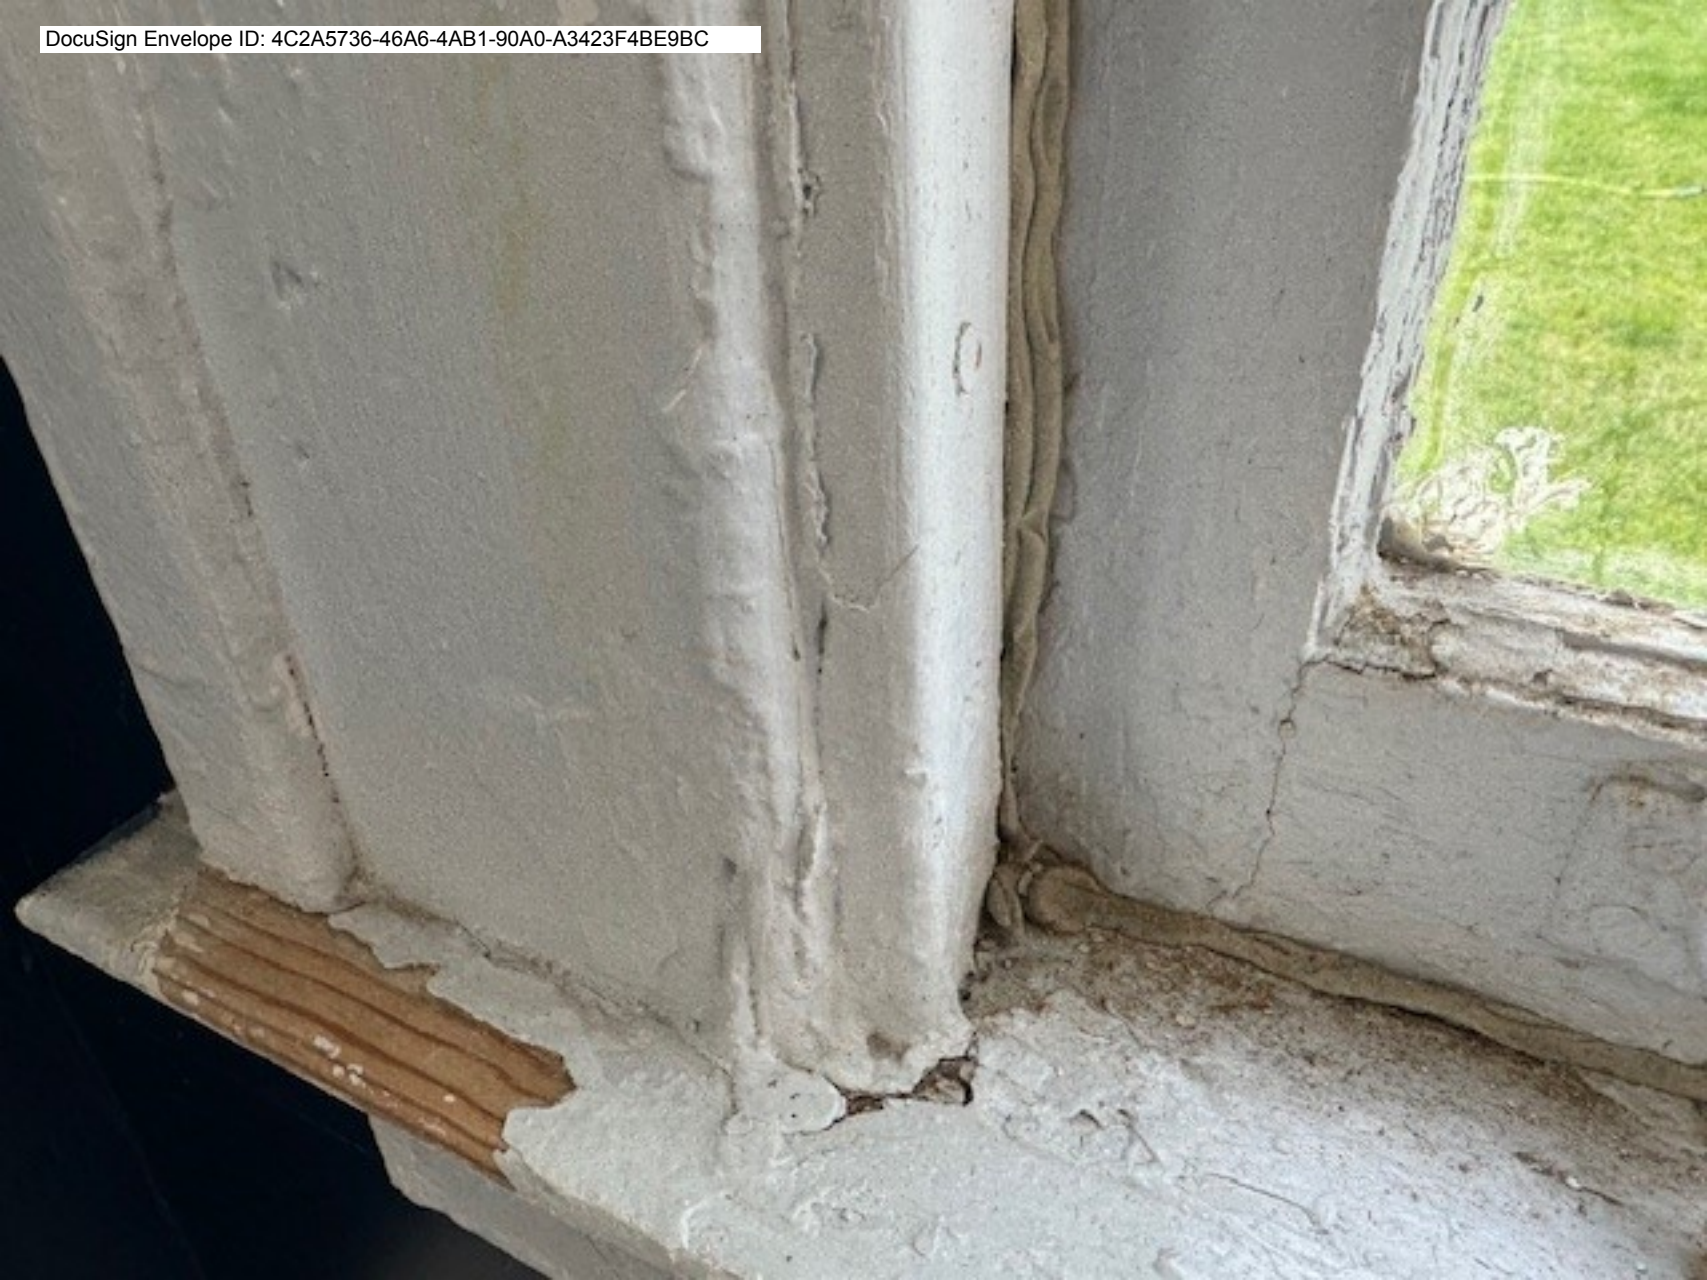
Exterior  
window  
2

Exterior: Missing pieces of lower and upper window sash, stop, and jamb. Wood is soft to the touch. Bottom of window is not flush with sill.
