## Description of Existing Conditions 1730 Edison

Application ID: HDC2024-00331

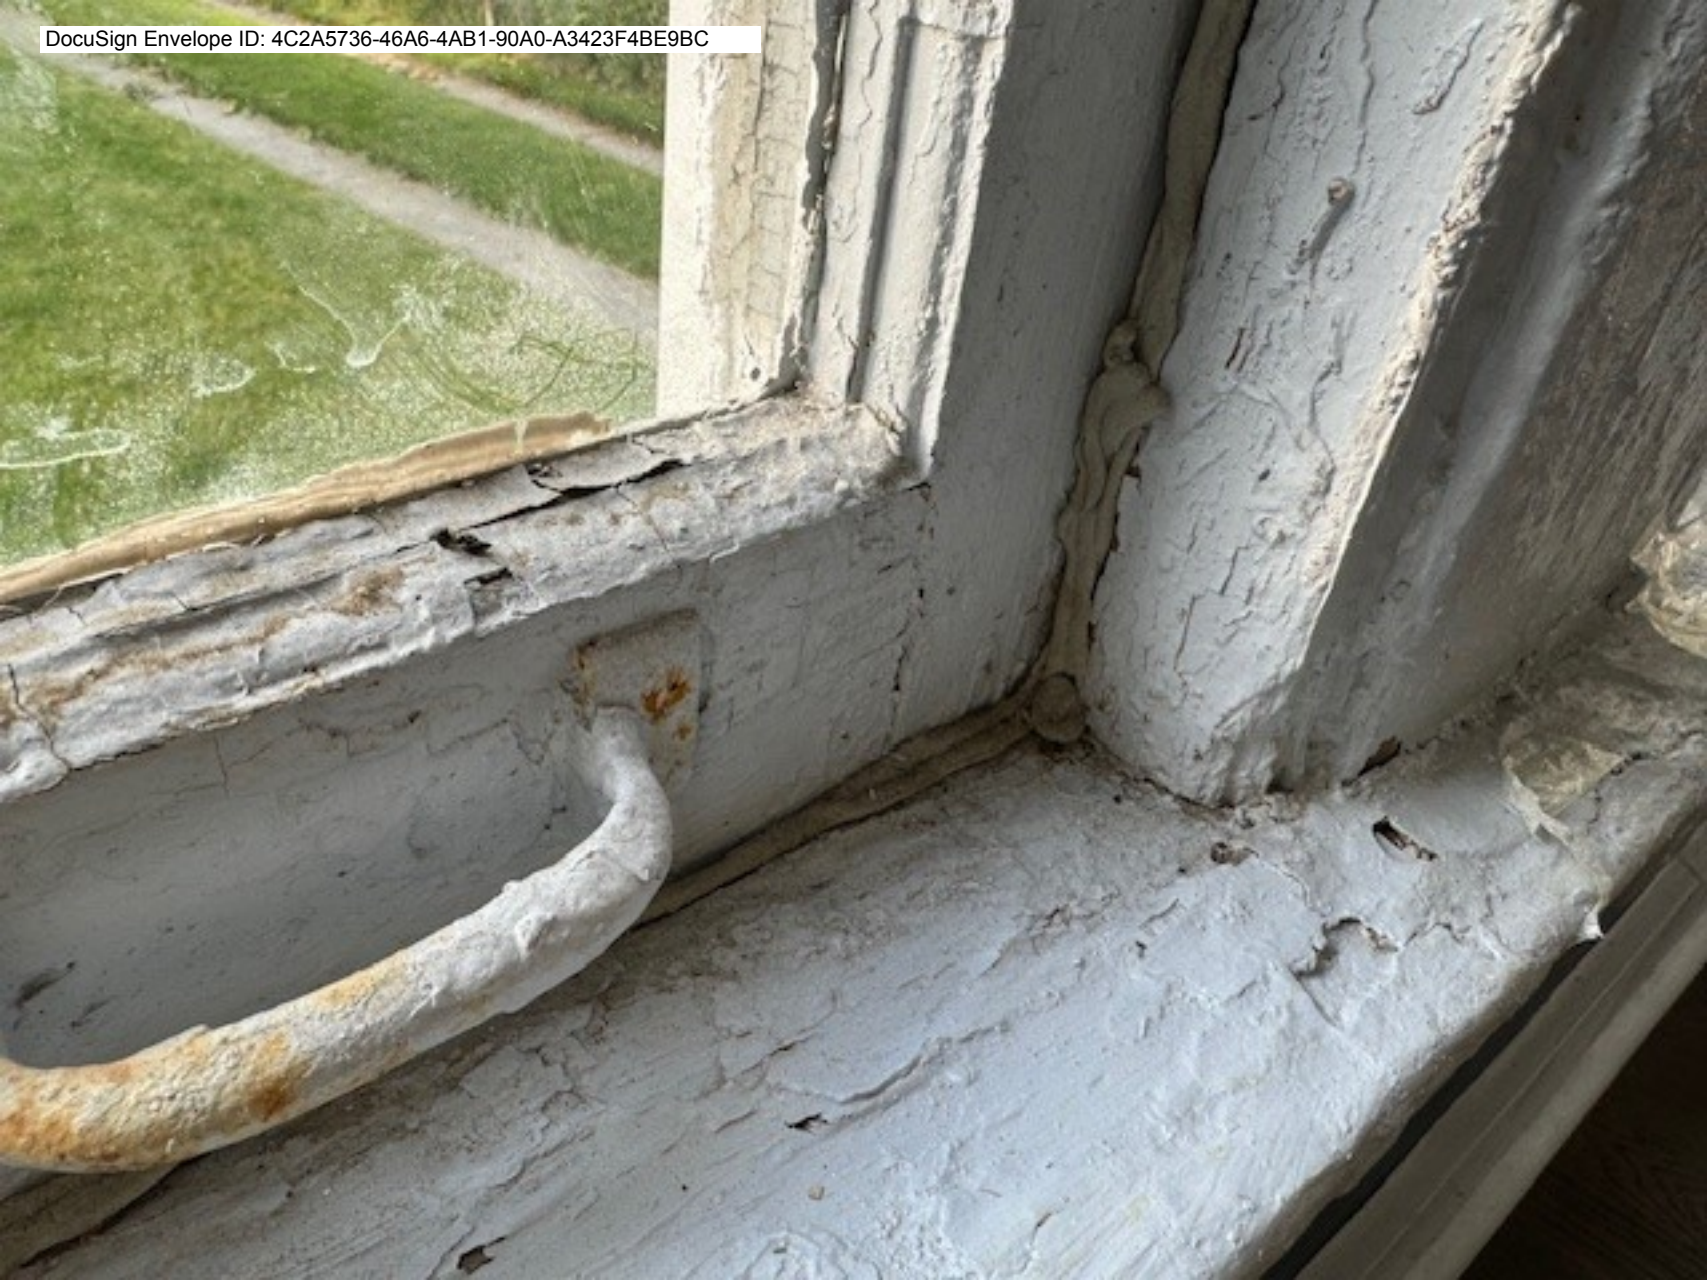
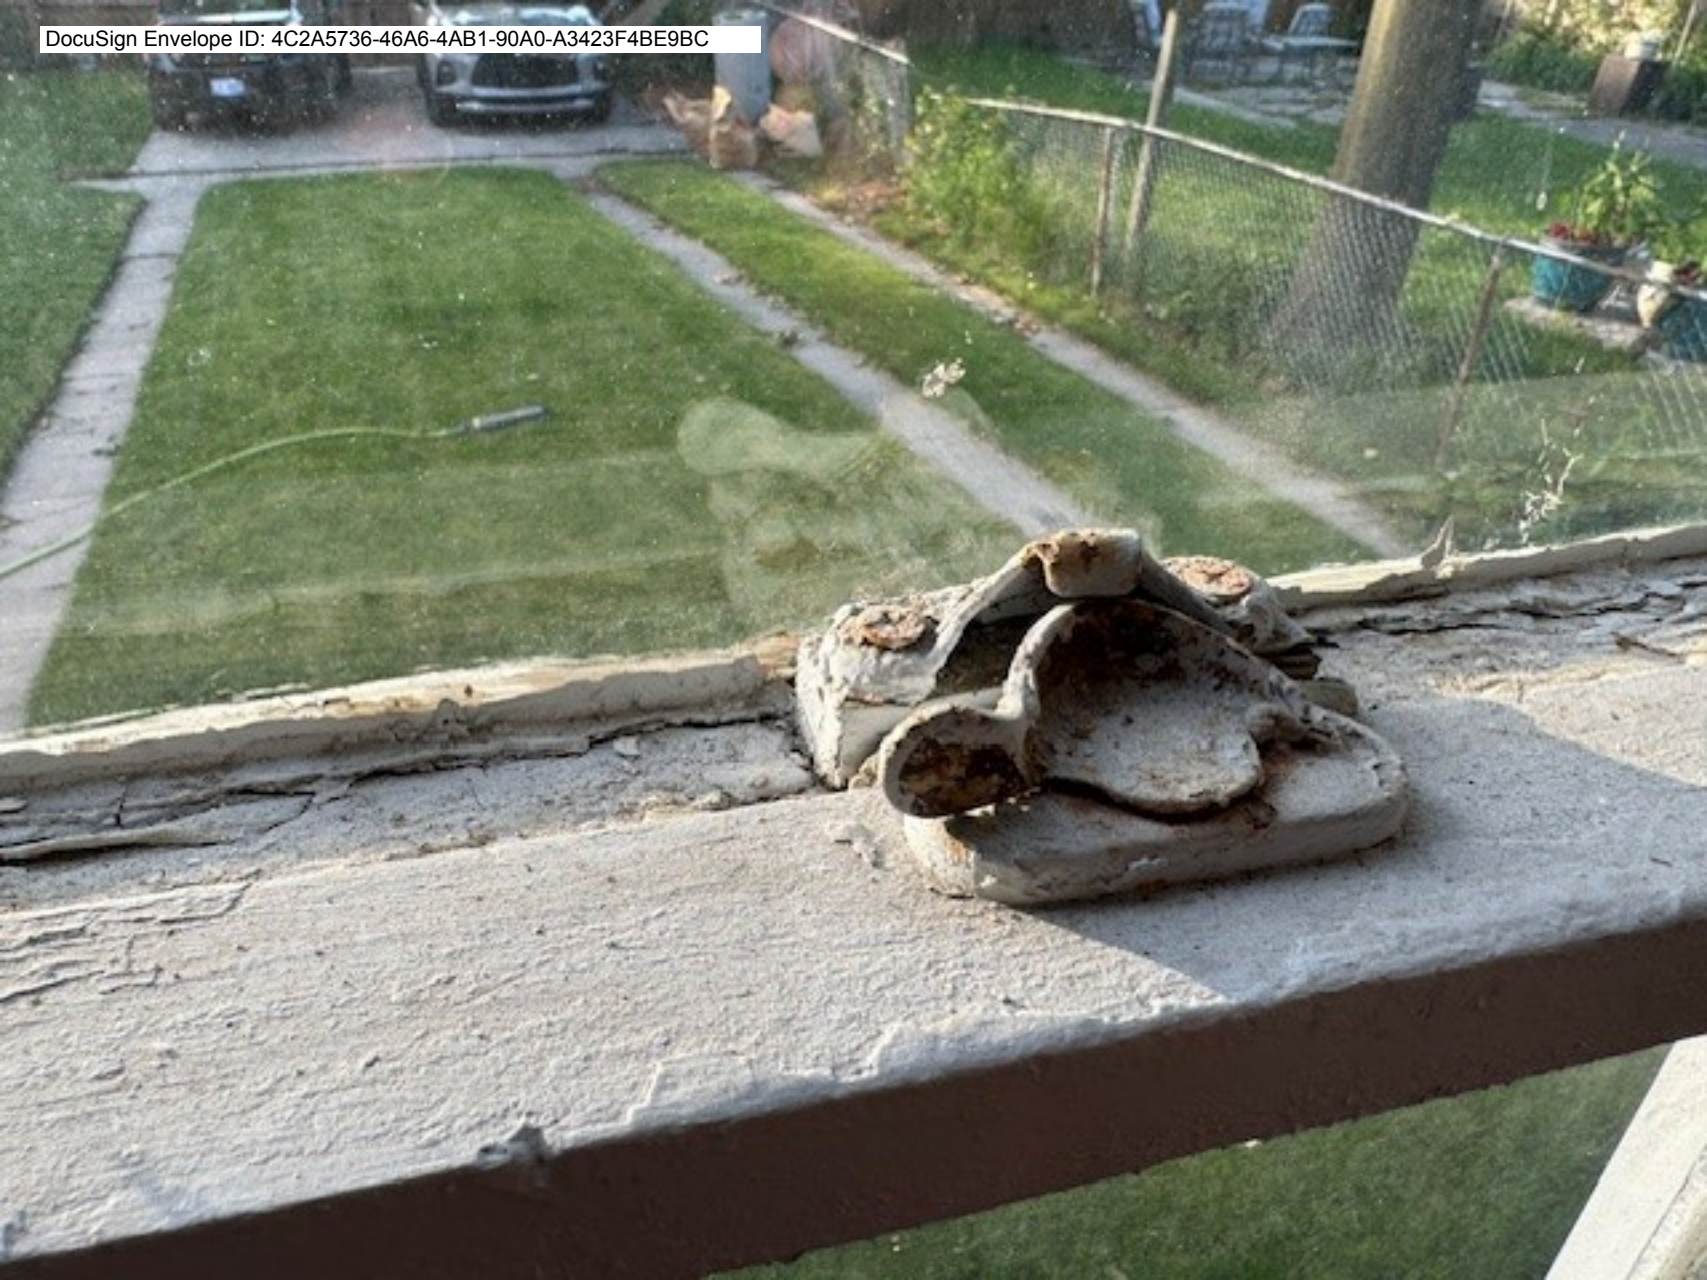
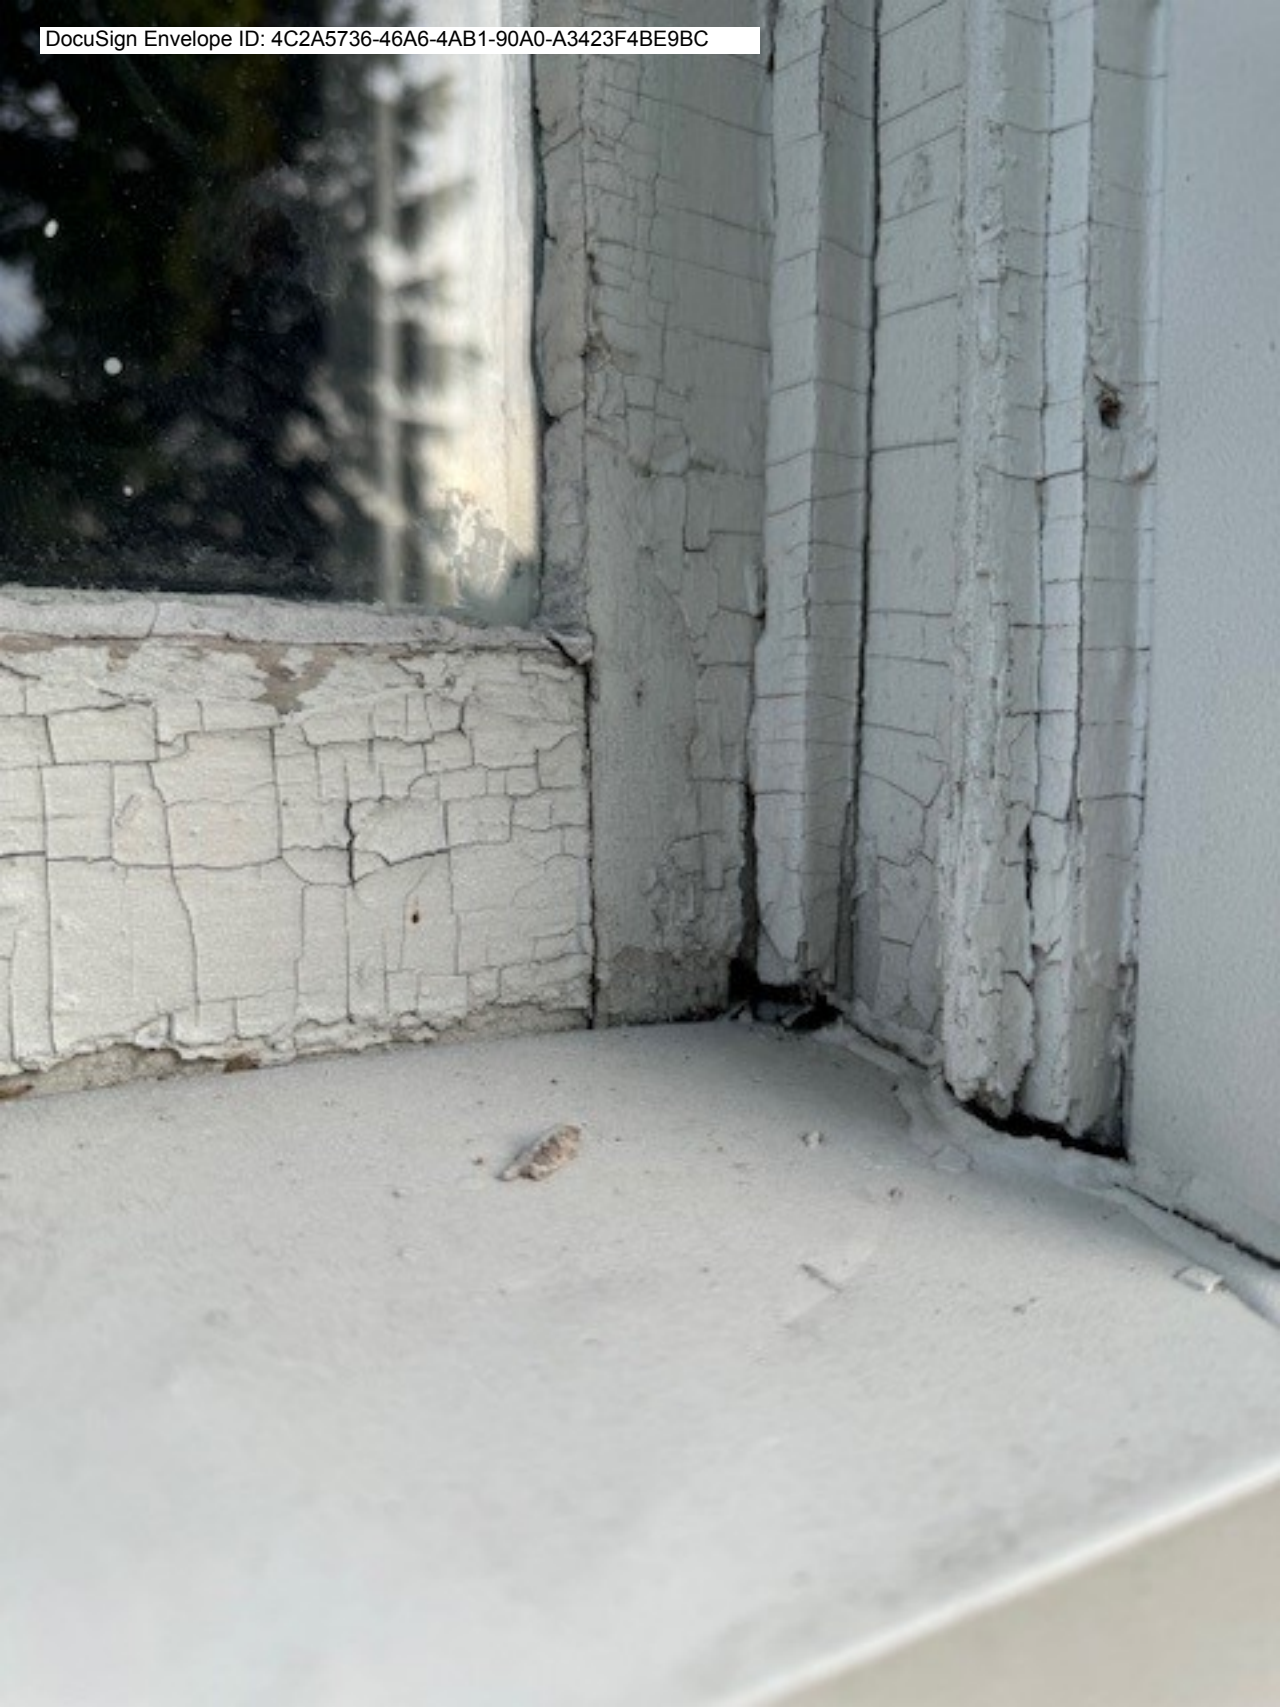
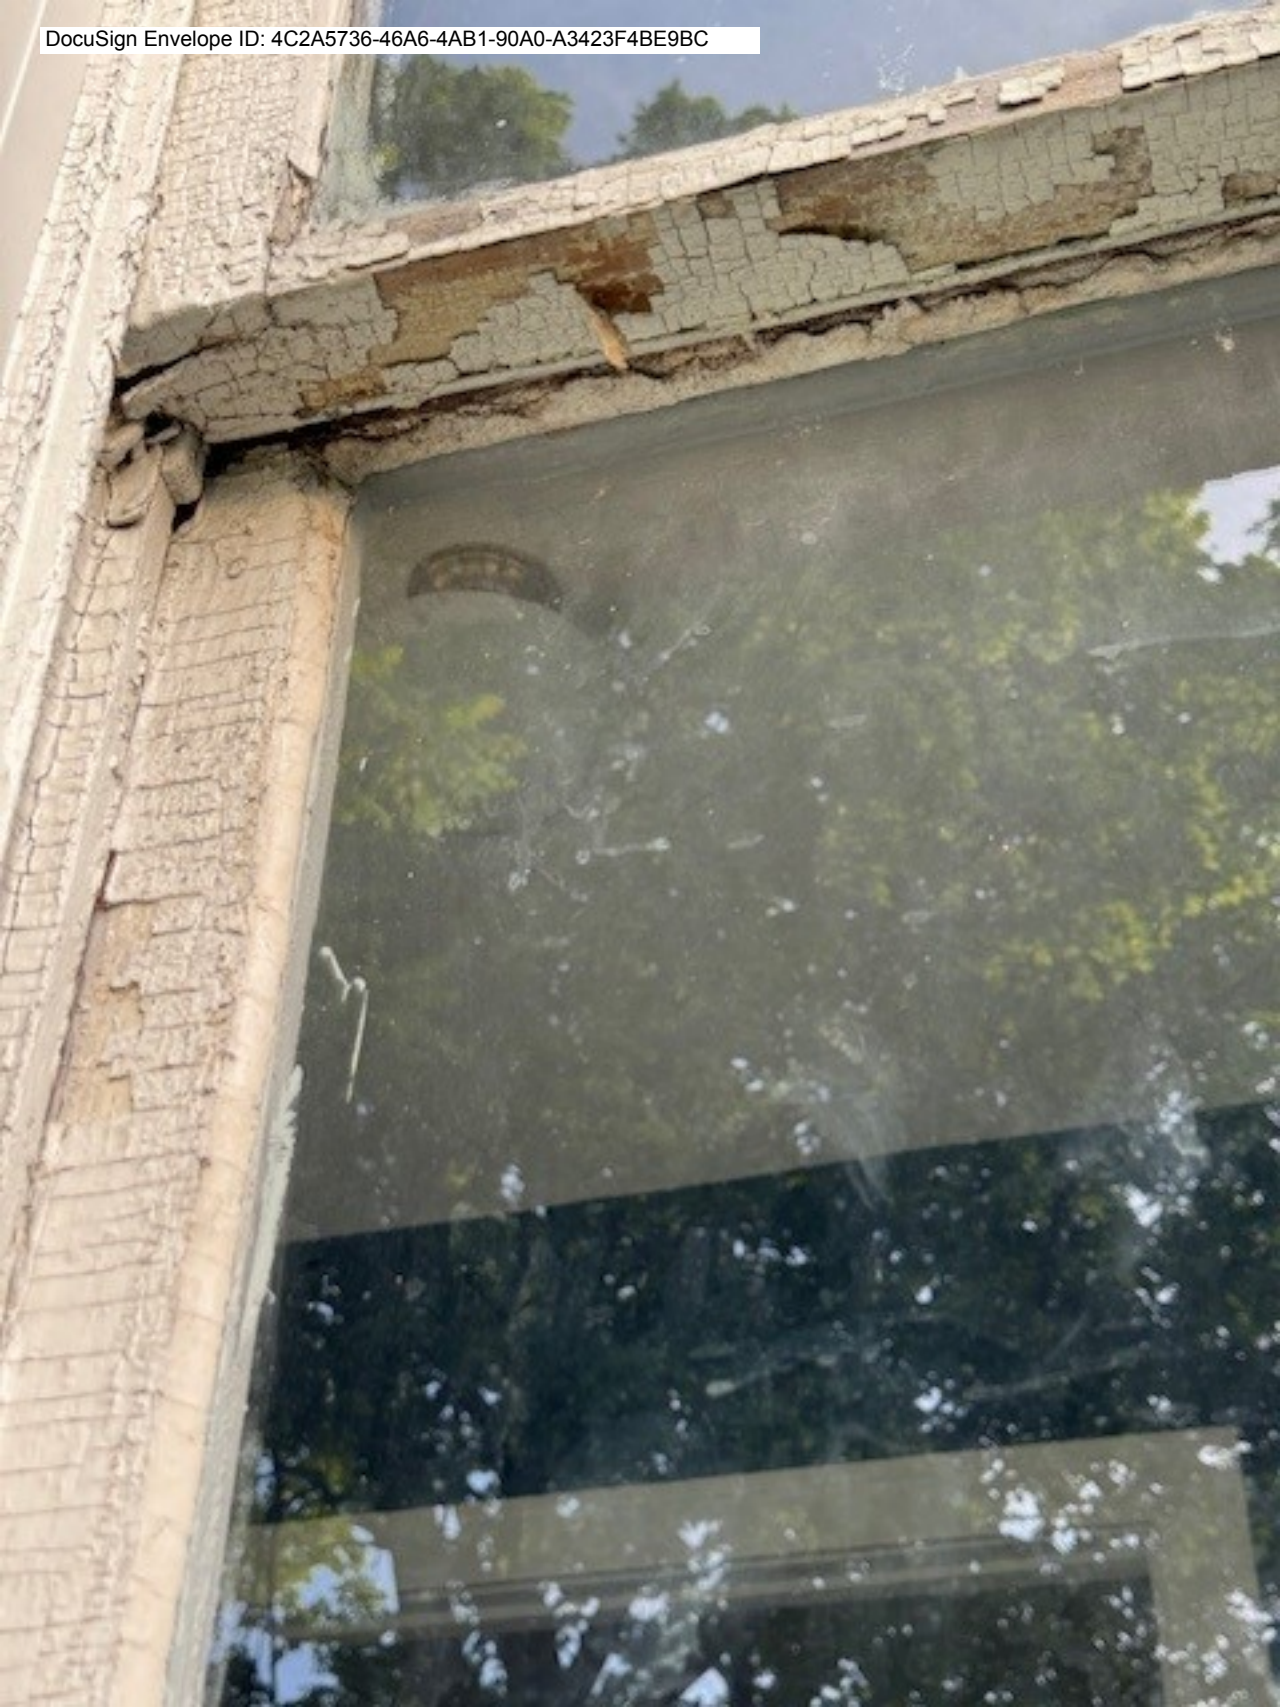
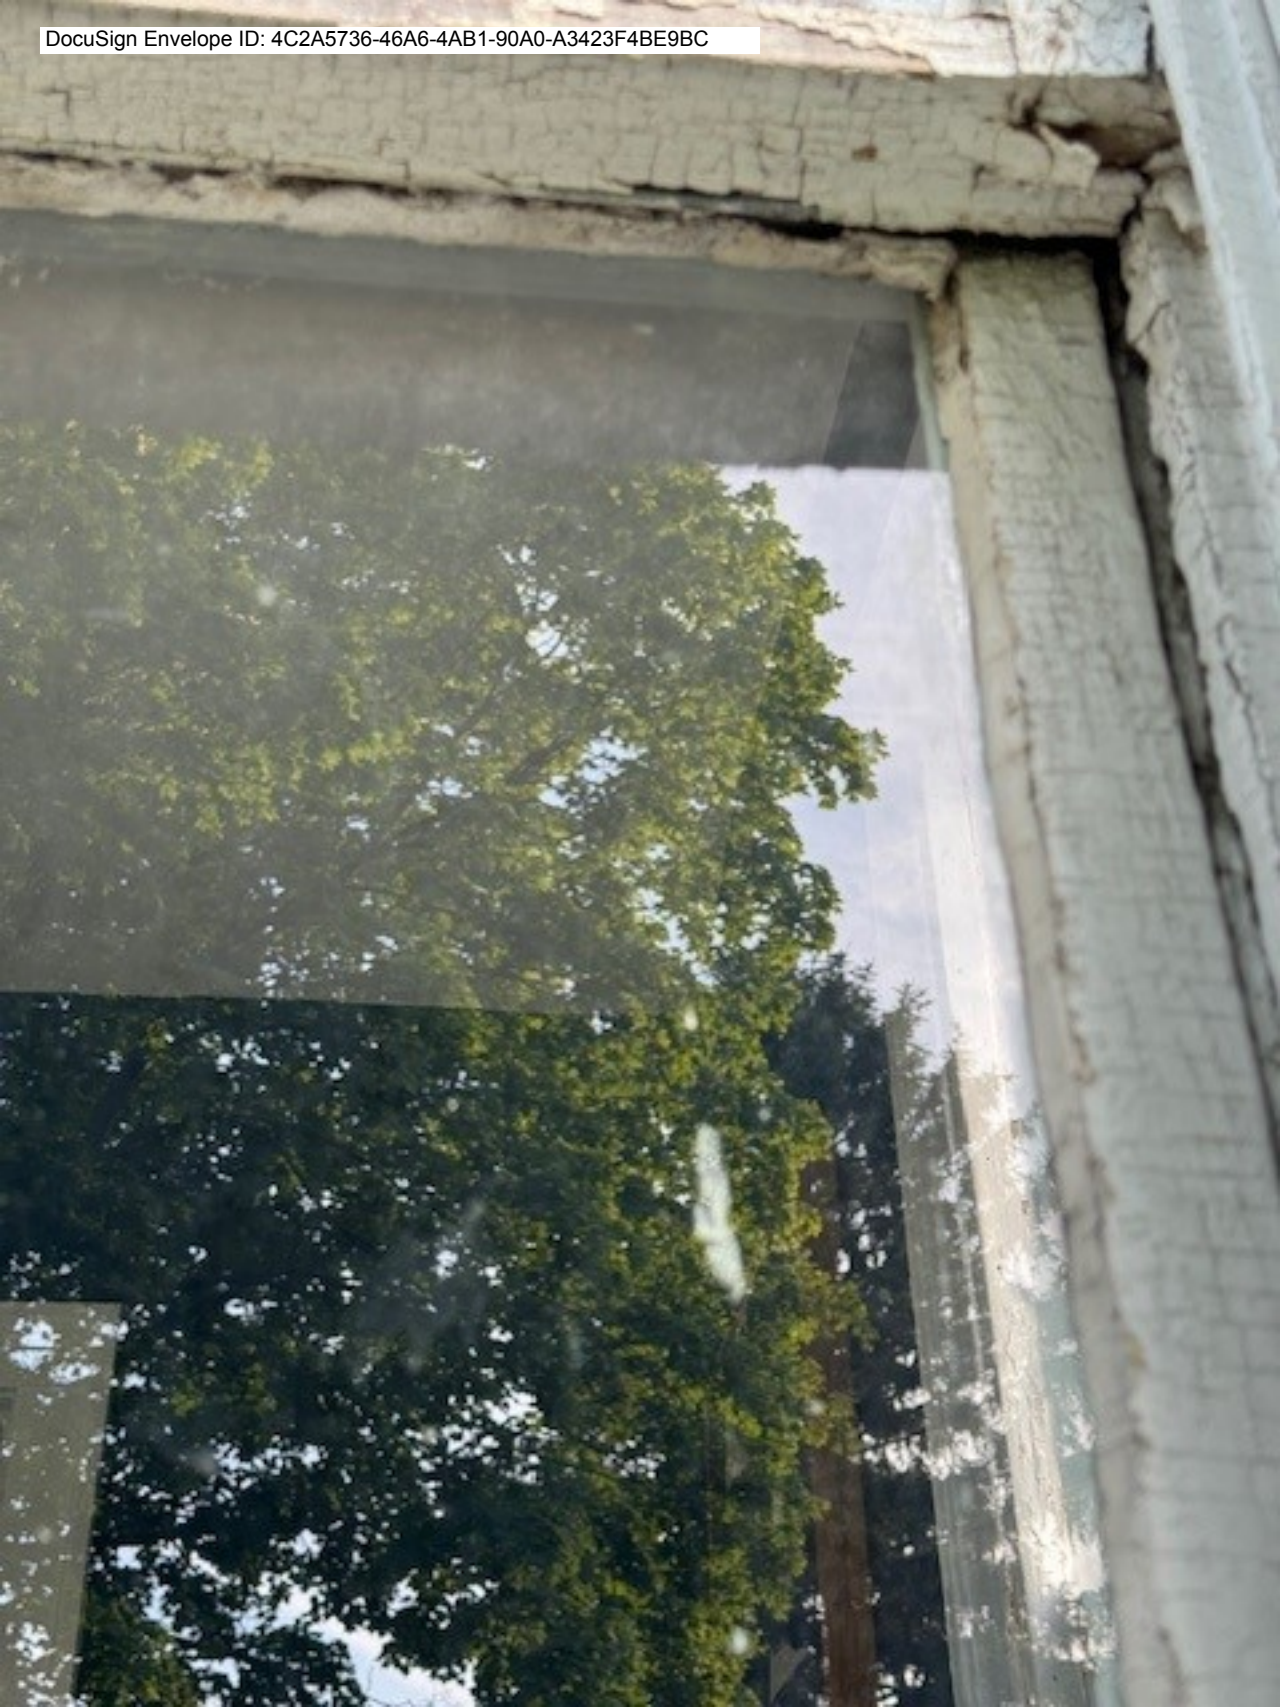
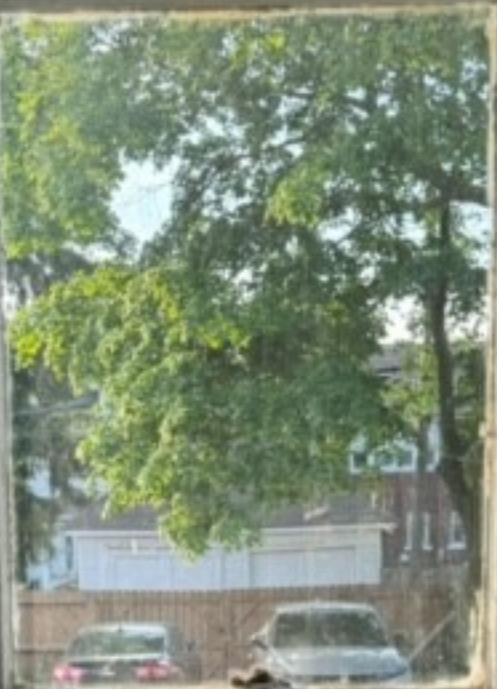
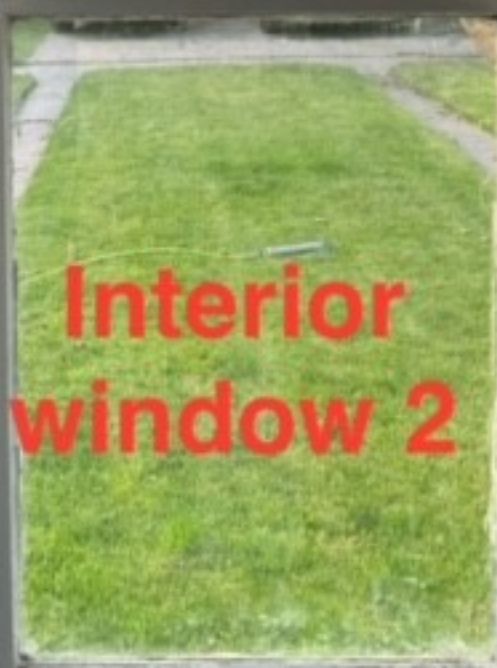
**Interior  
window 2**

Interior: Lower portion of window displays signs of rot in upper left and bottom right corners.

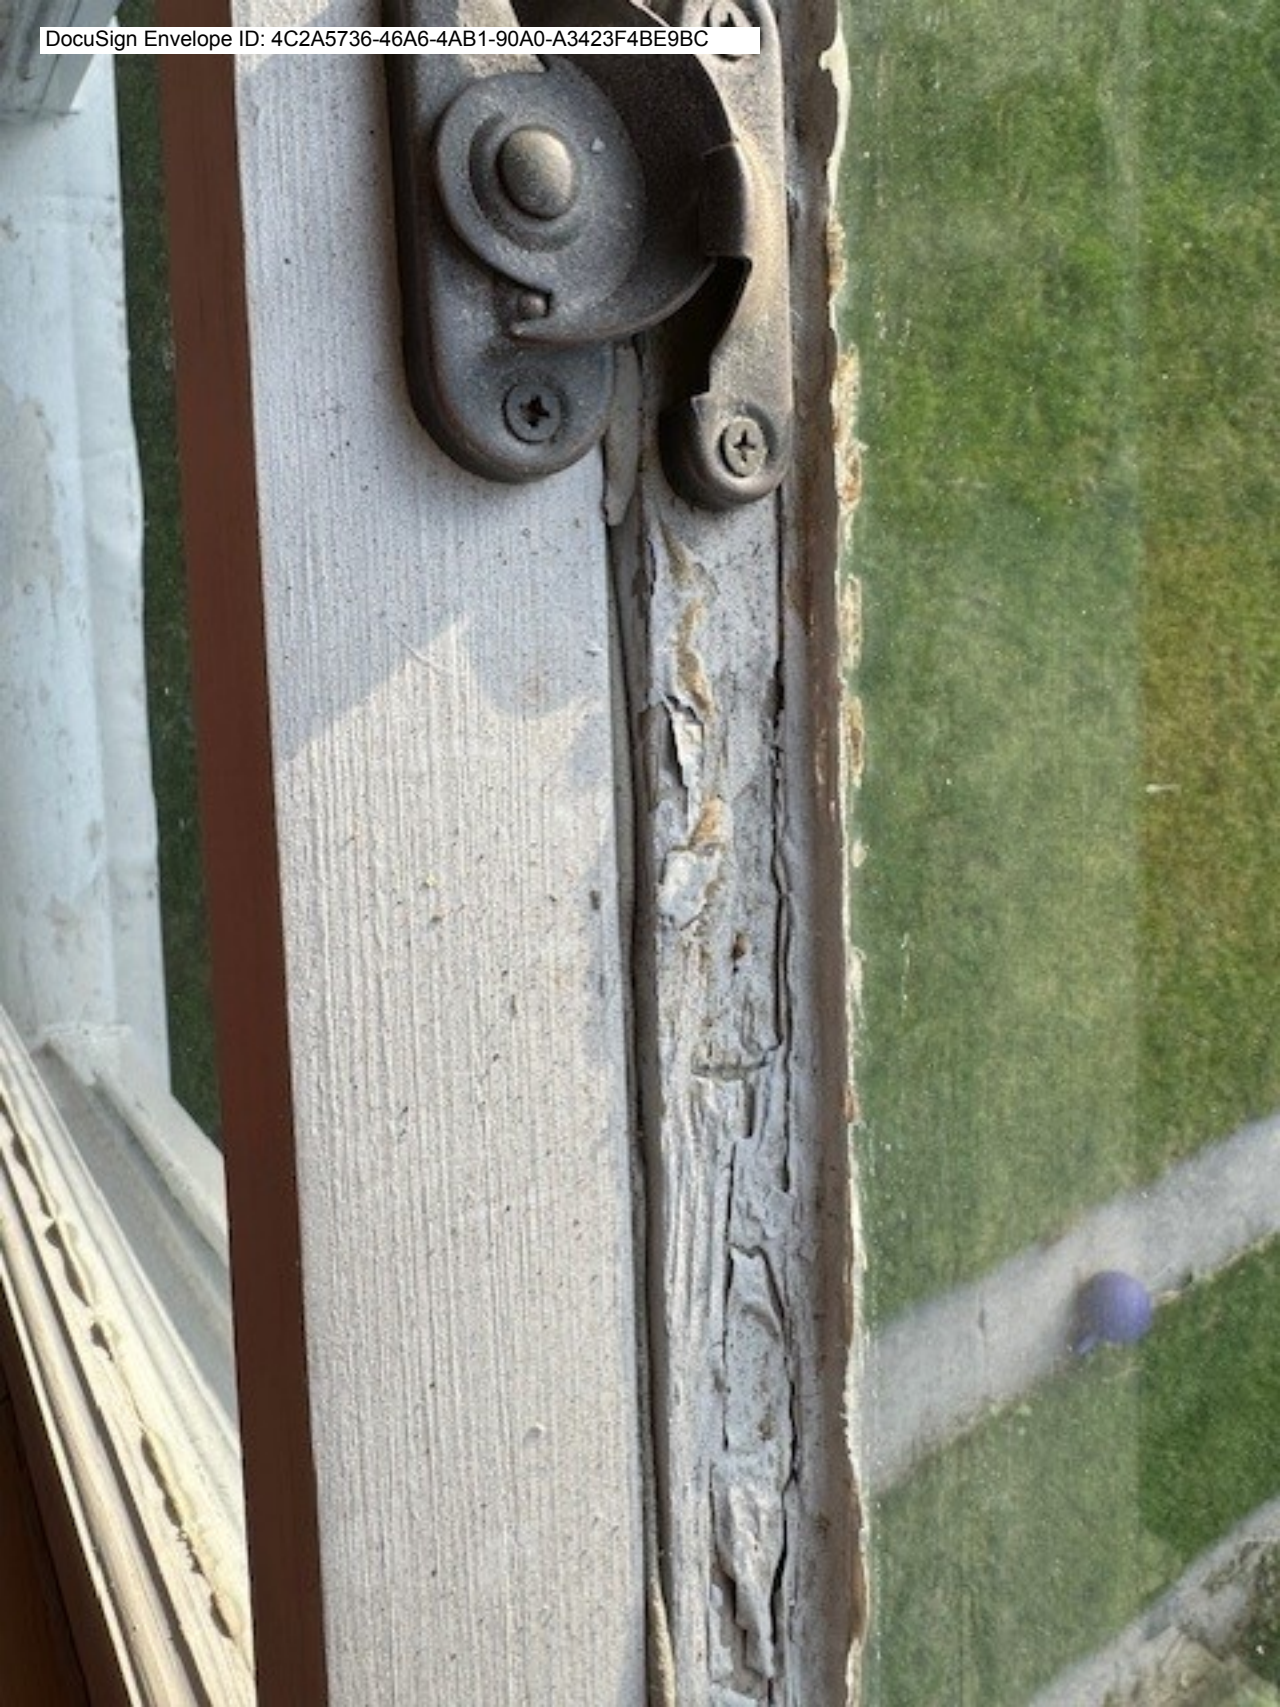
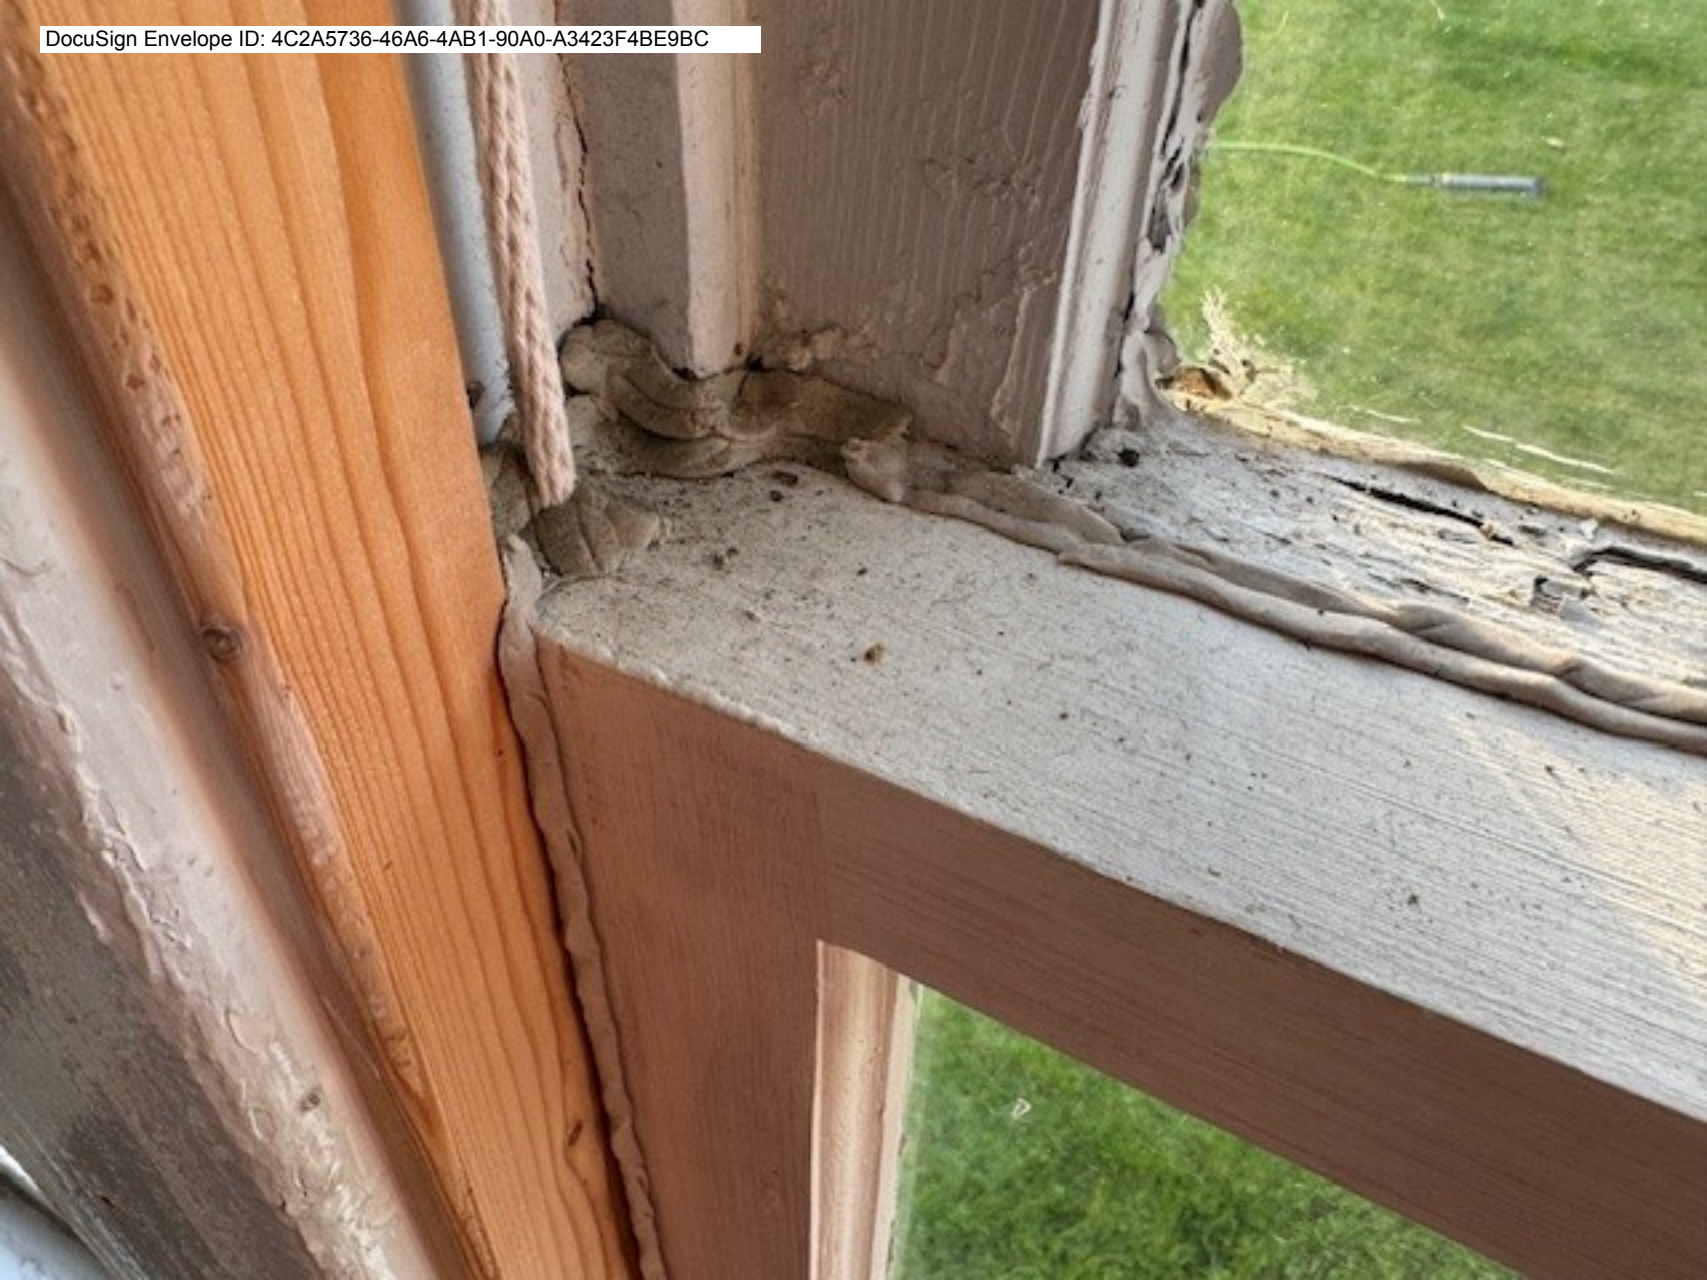
Exterior  
window  
3

Exterior: Missing pieces of upper window sash, stop, and jamb. Wood is soft to the touch. Bottom of window is not flush with sill.
