## Description of Existing Conditions 1730 Edison

Application ID: HDC2024-00331

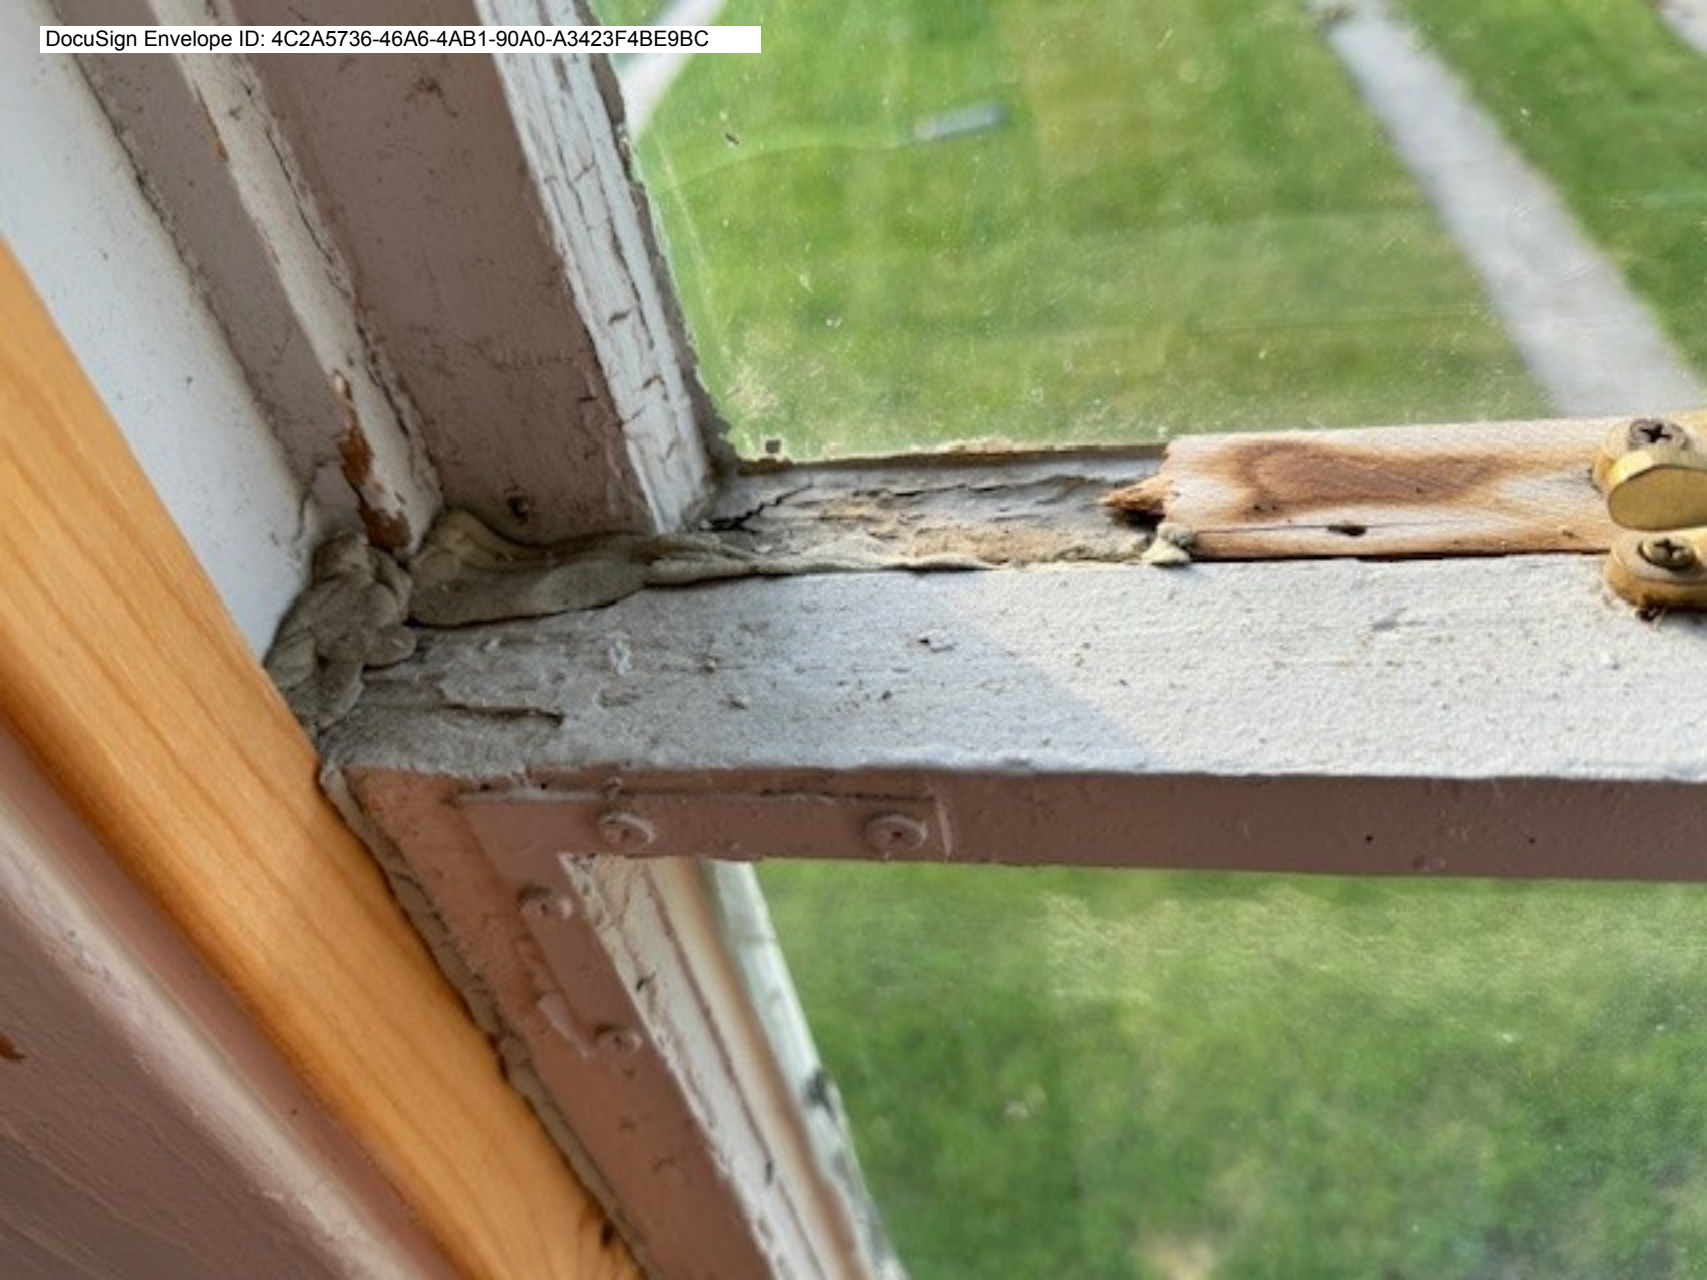
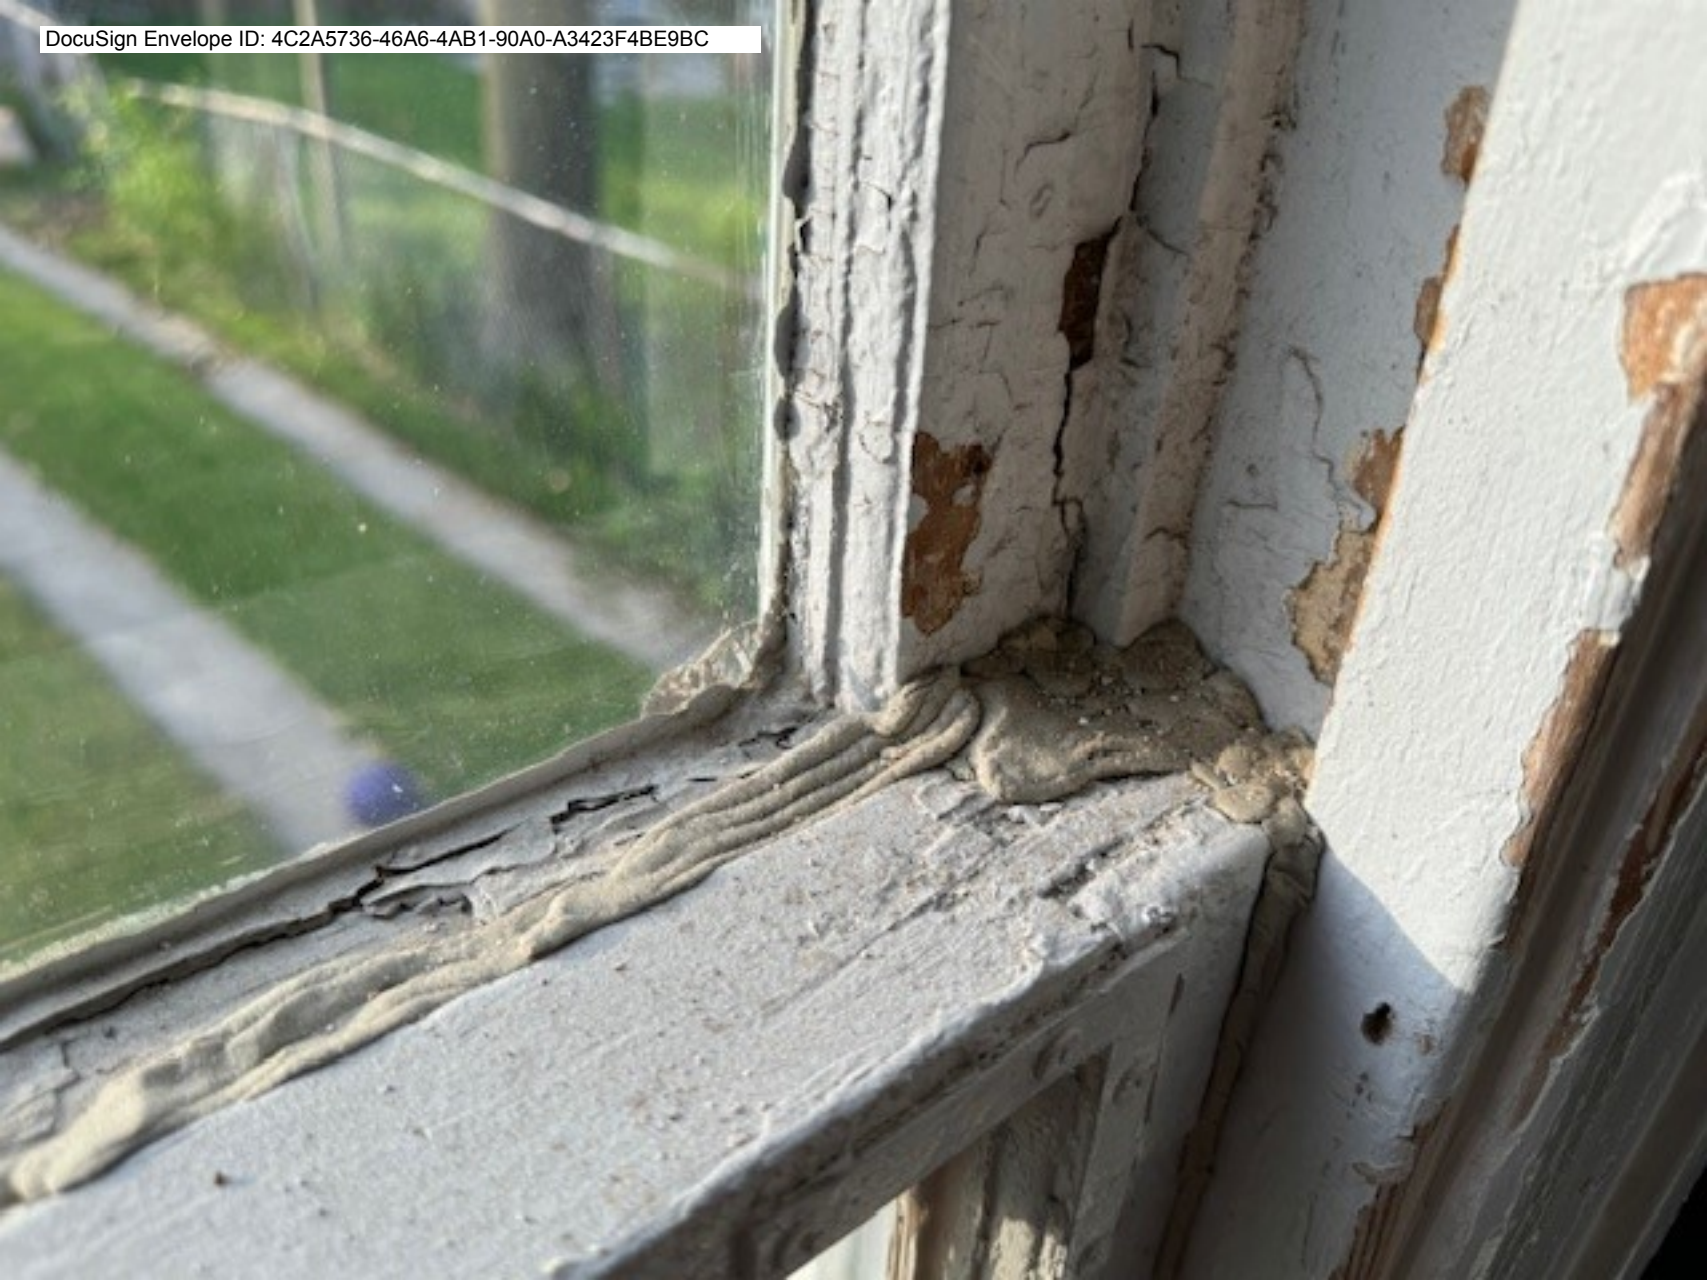
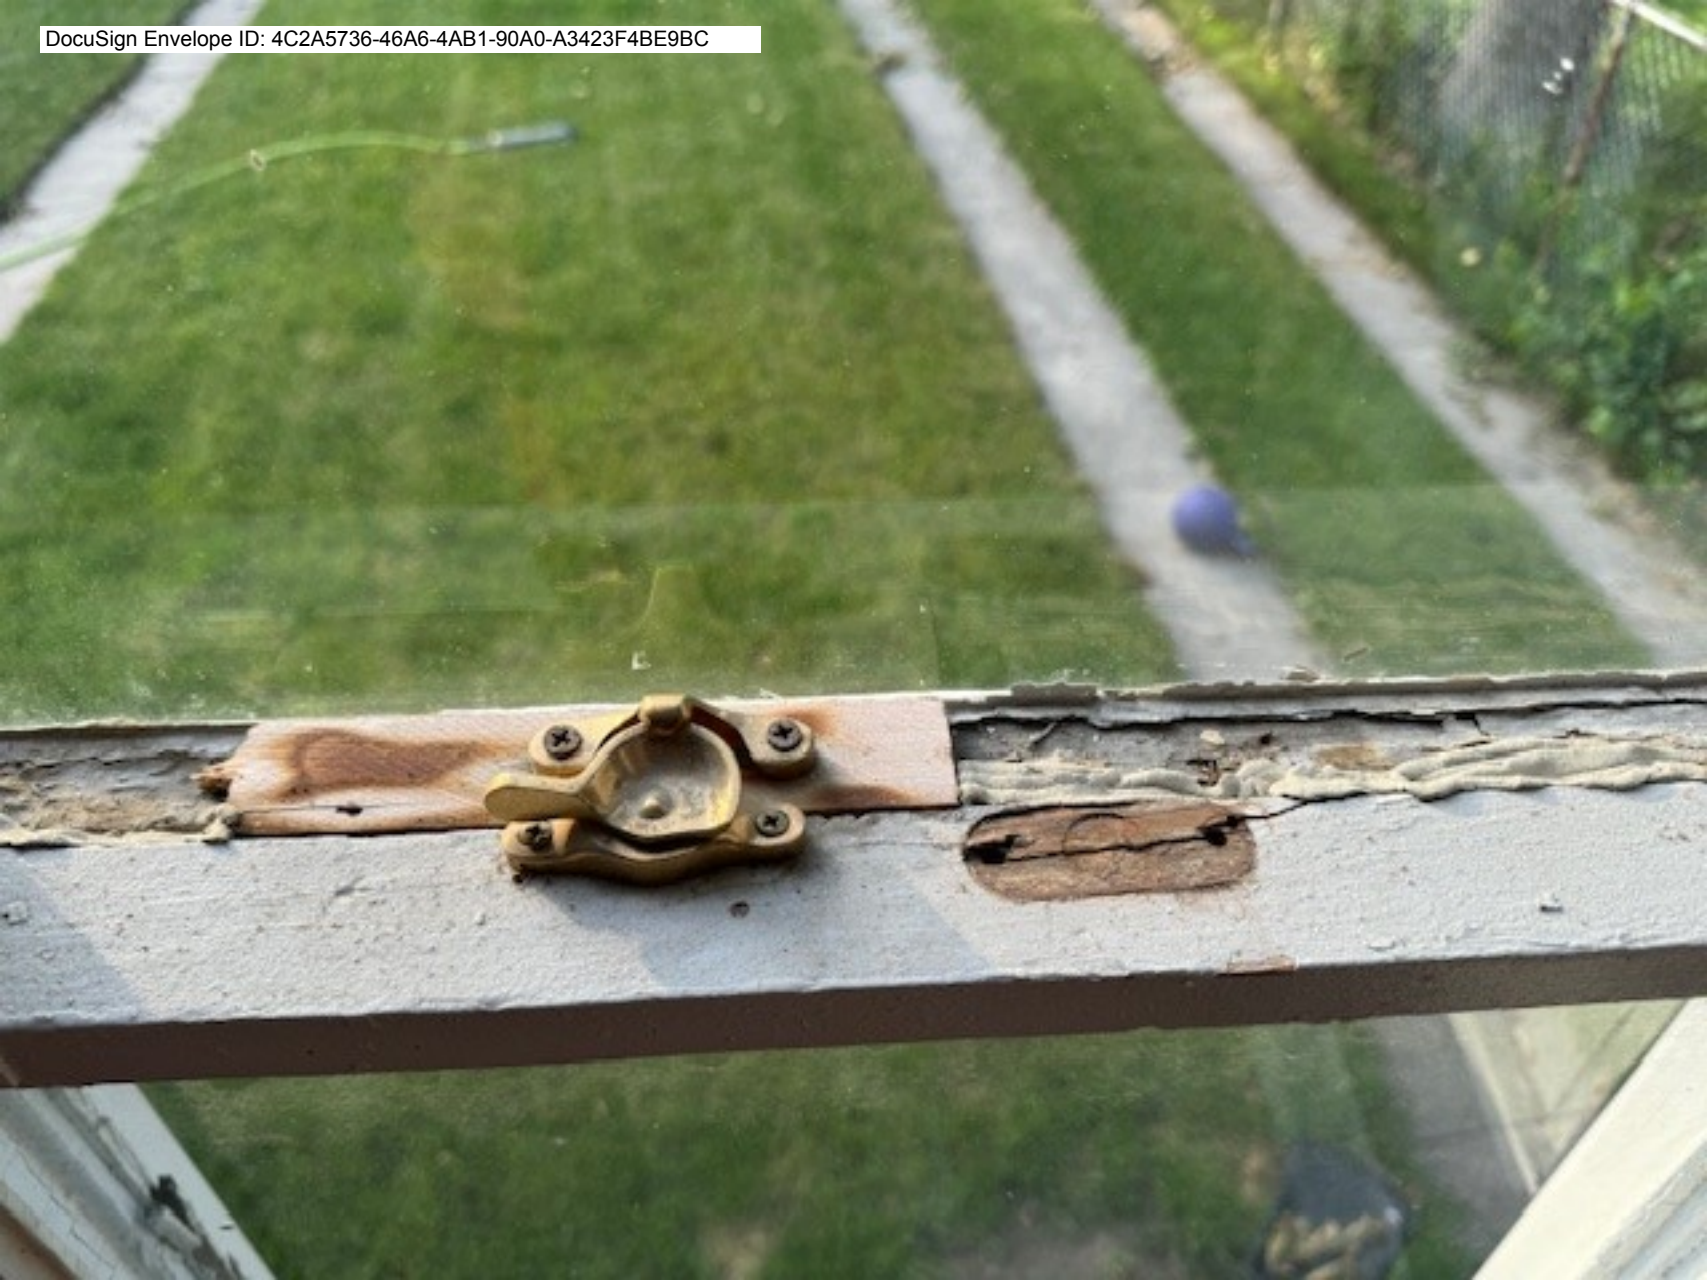
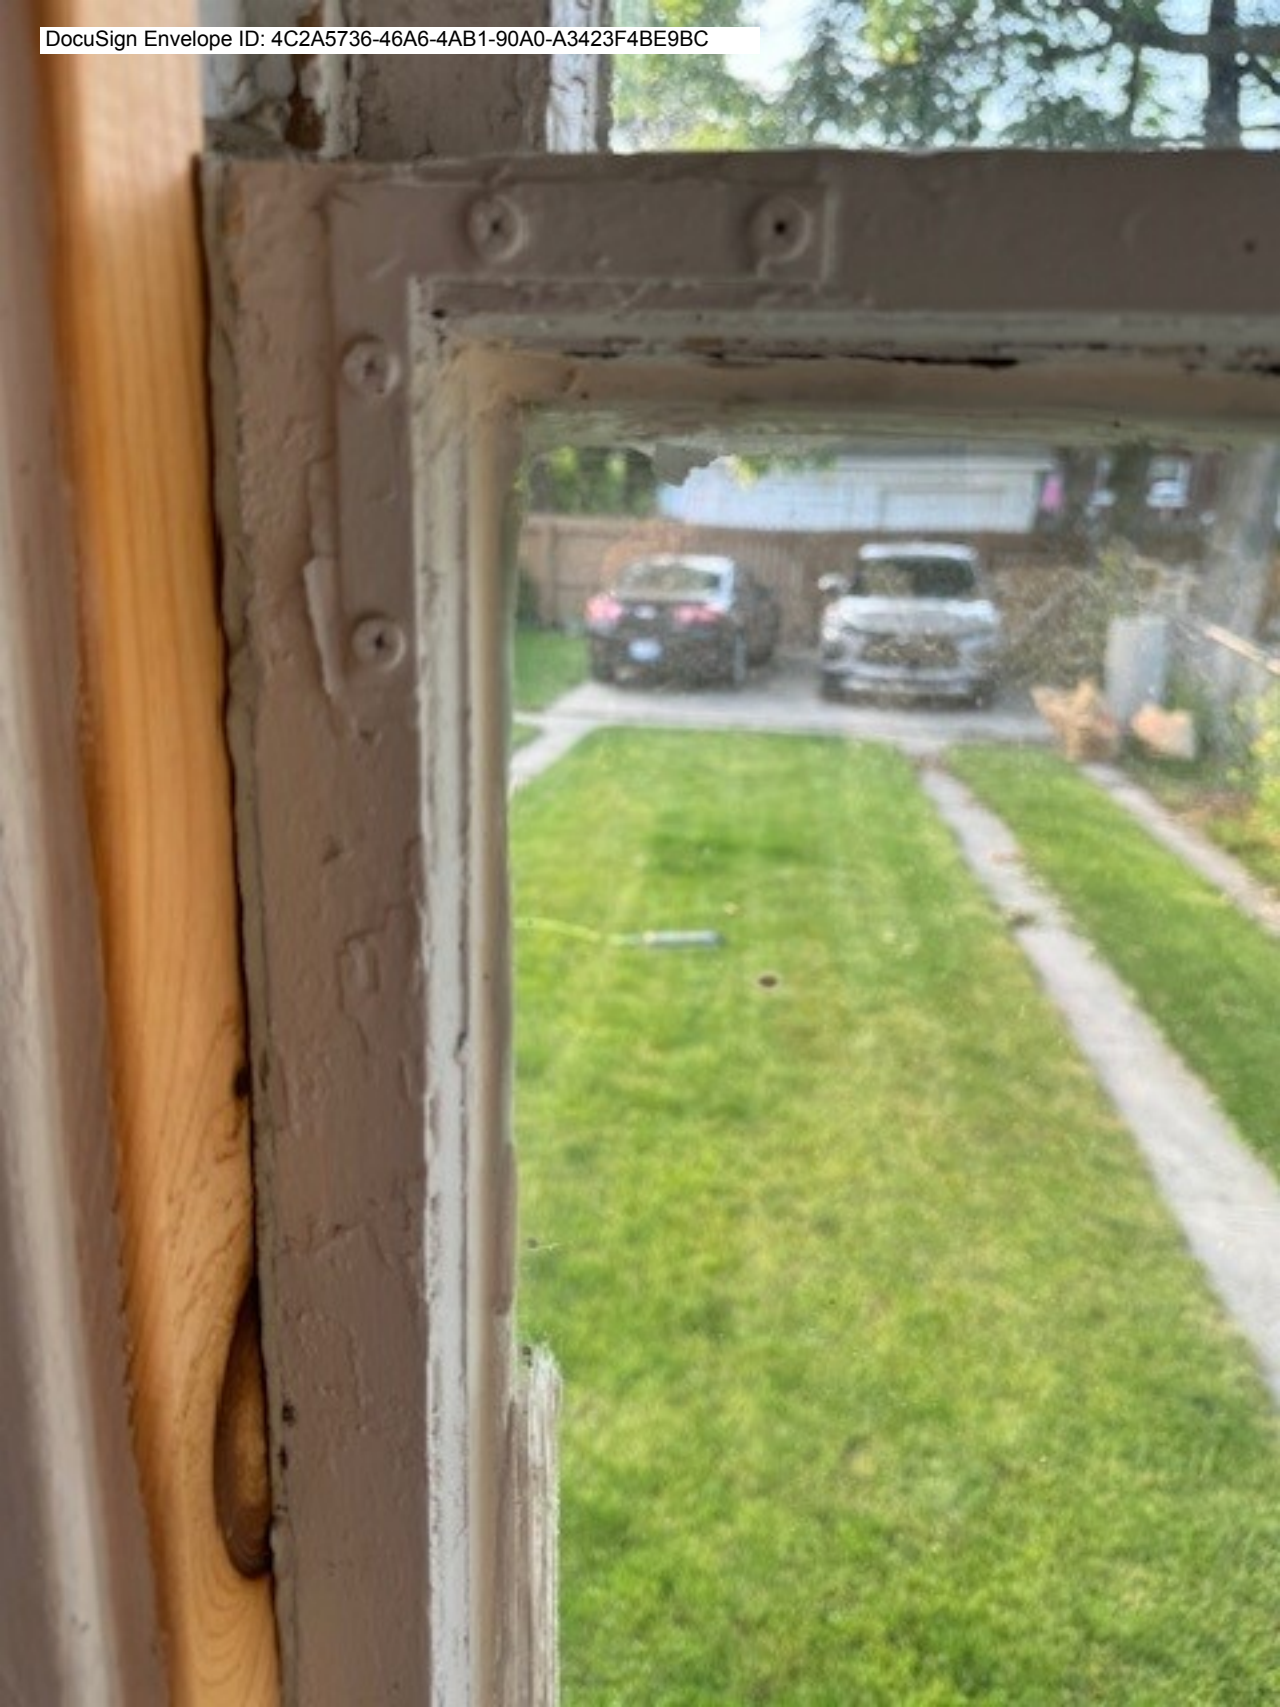
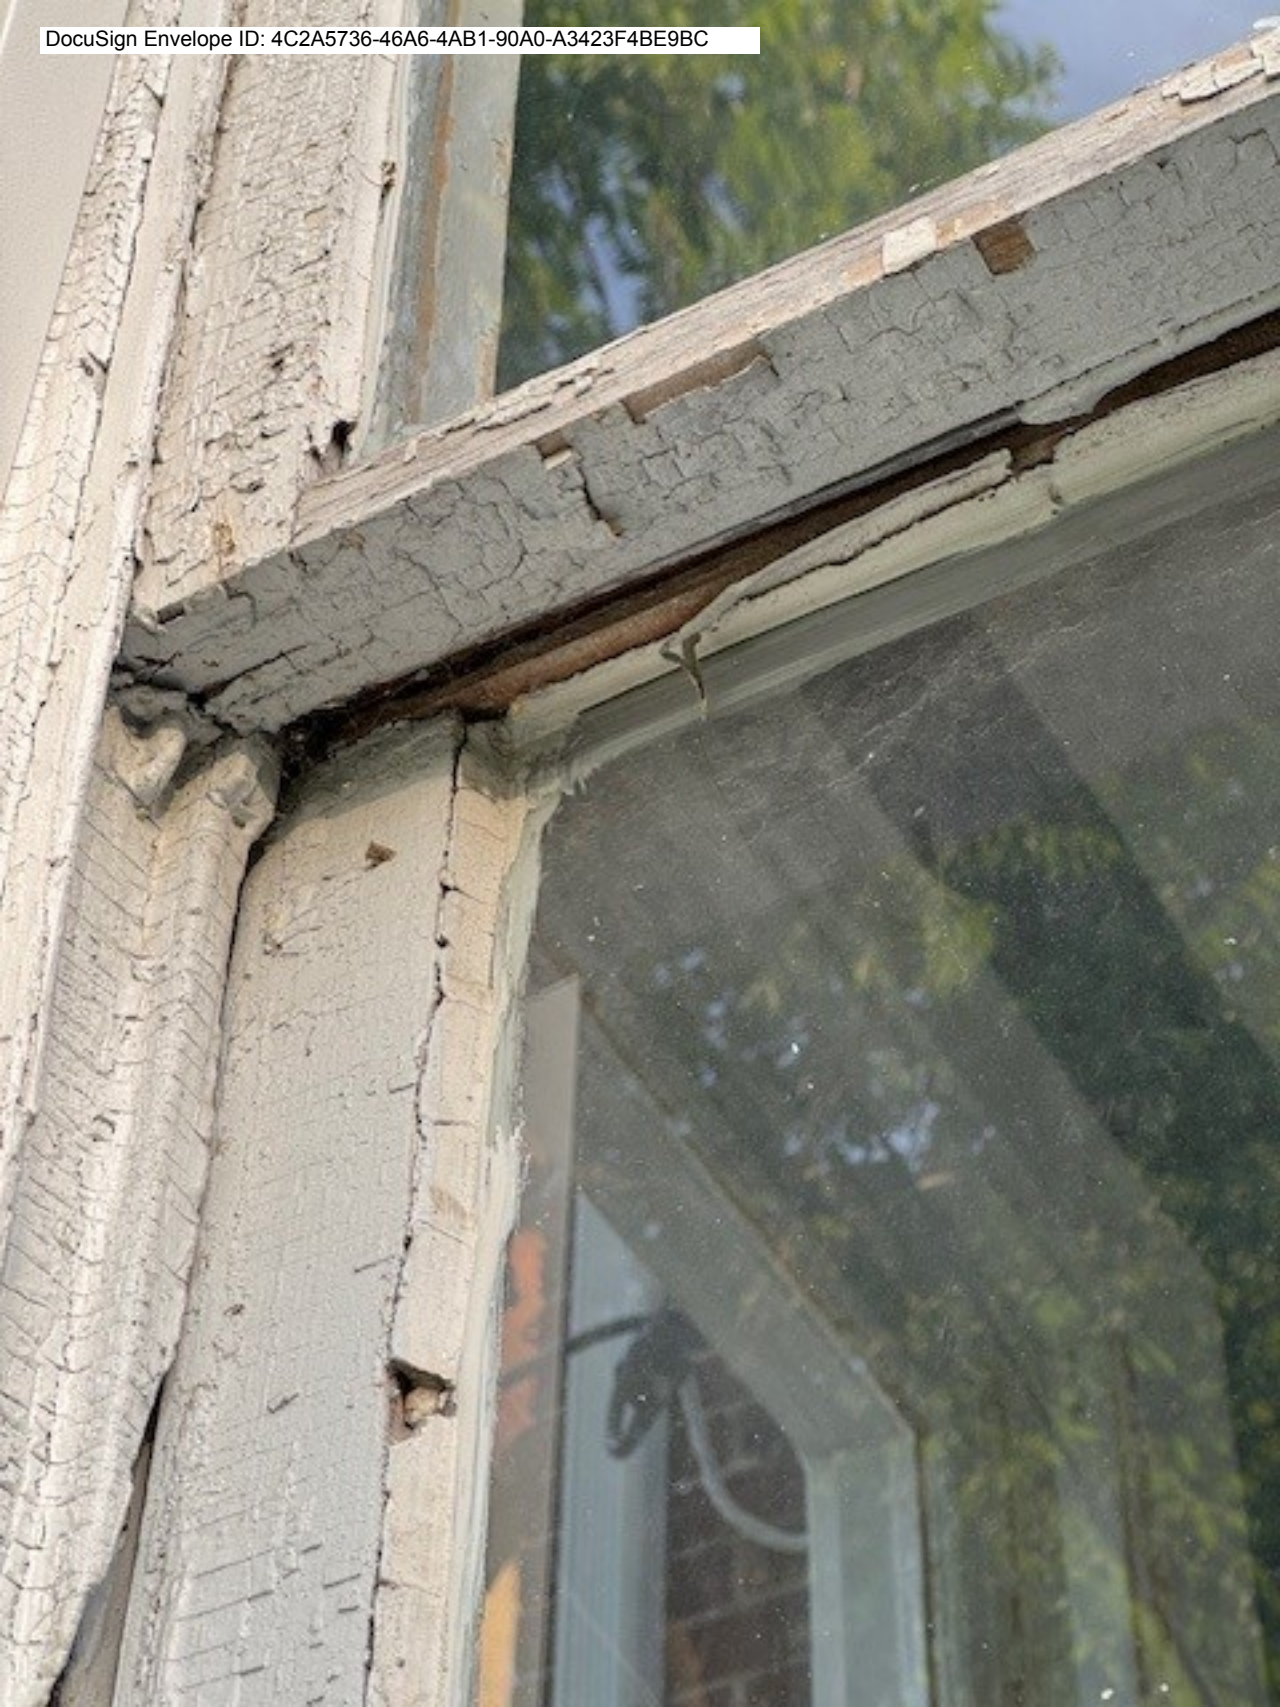
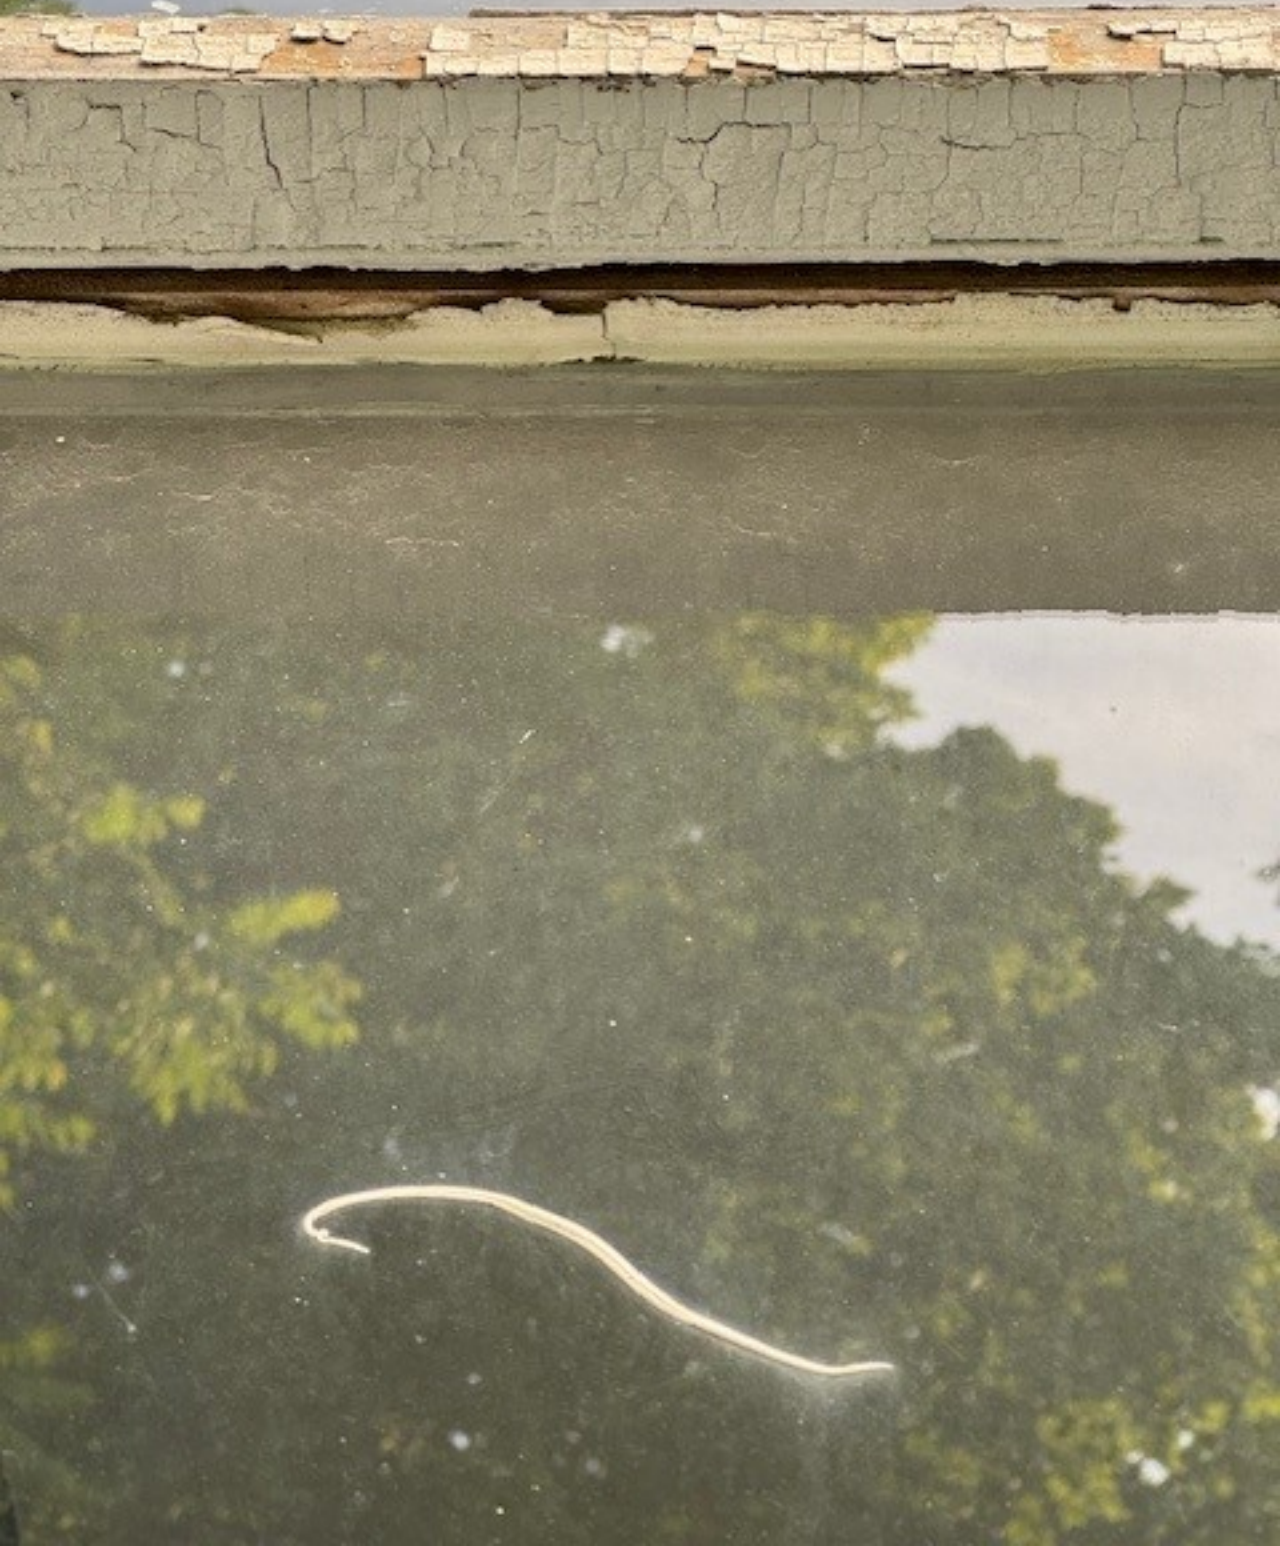
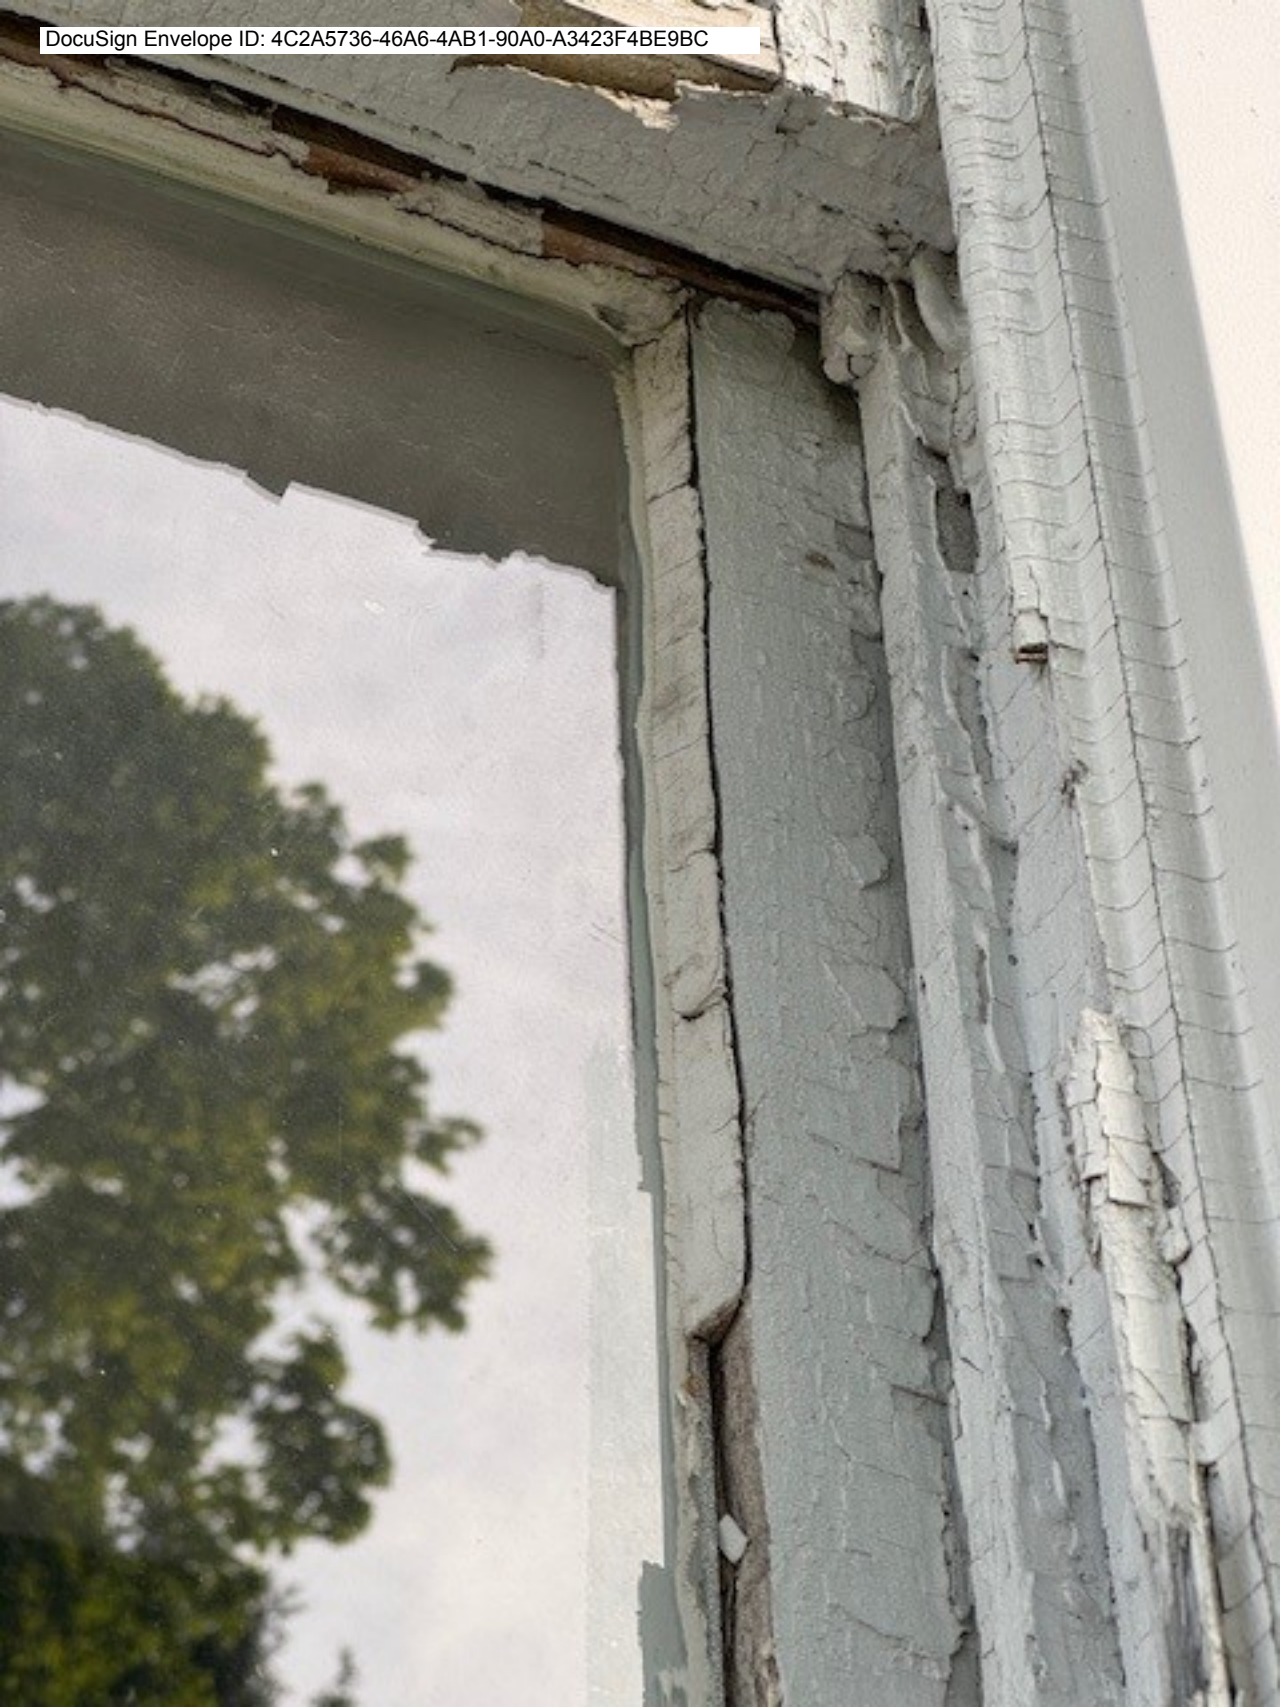
Exterior  
window  
4

Exterior: Missing pieces of upper window sash, stop, and jamb. Wood is soft to the touch. Bottom of window is not flush with sill. Displays wood rot.

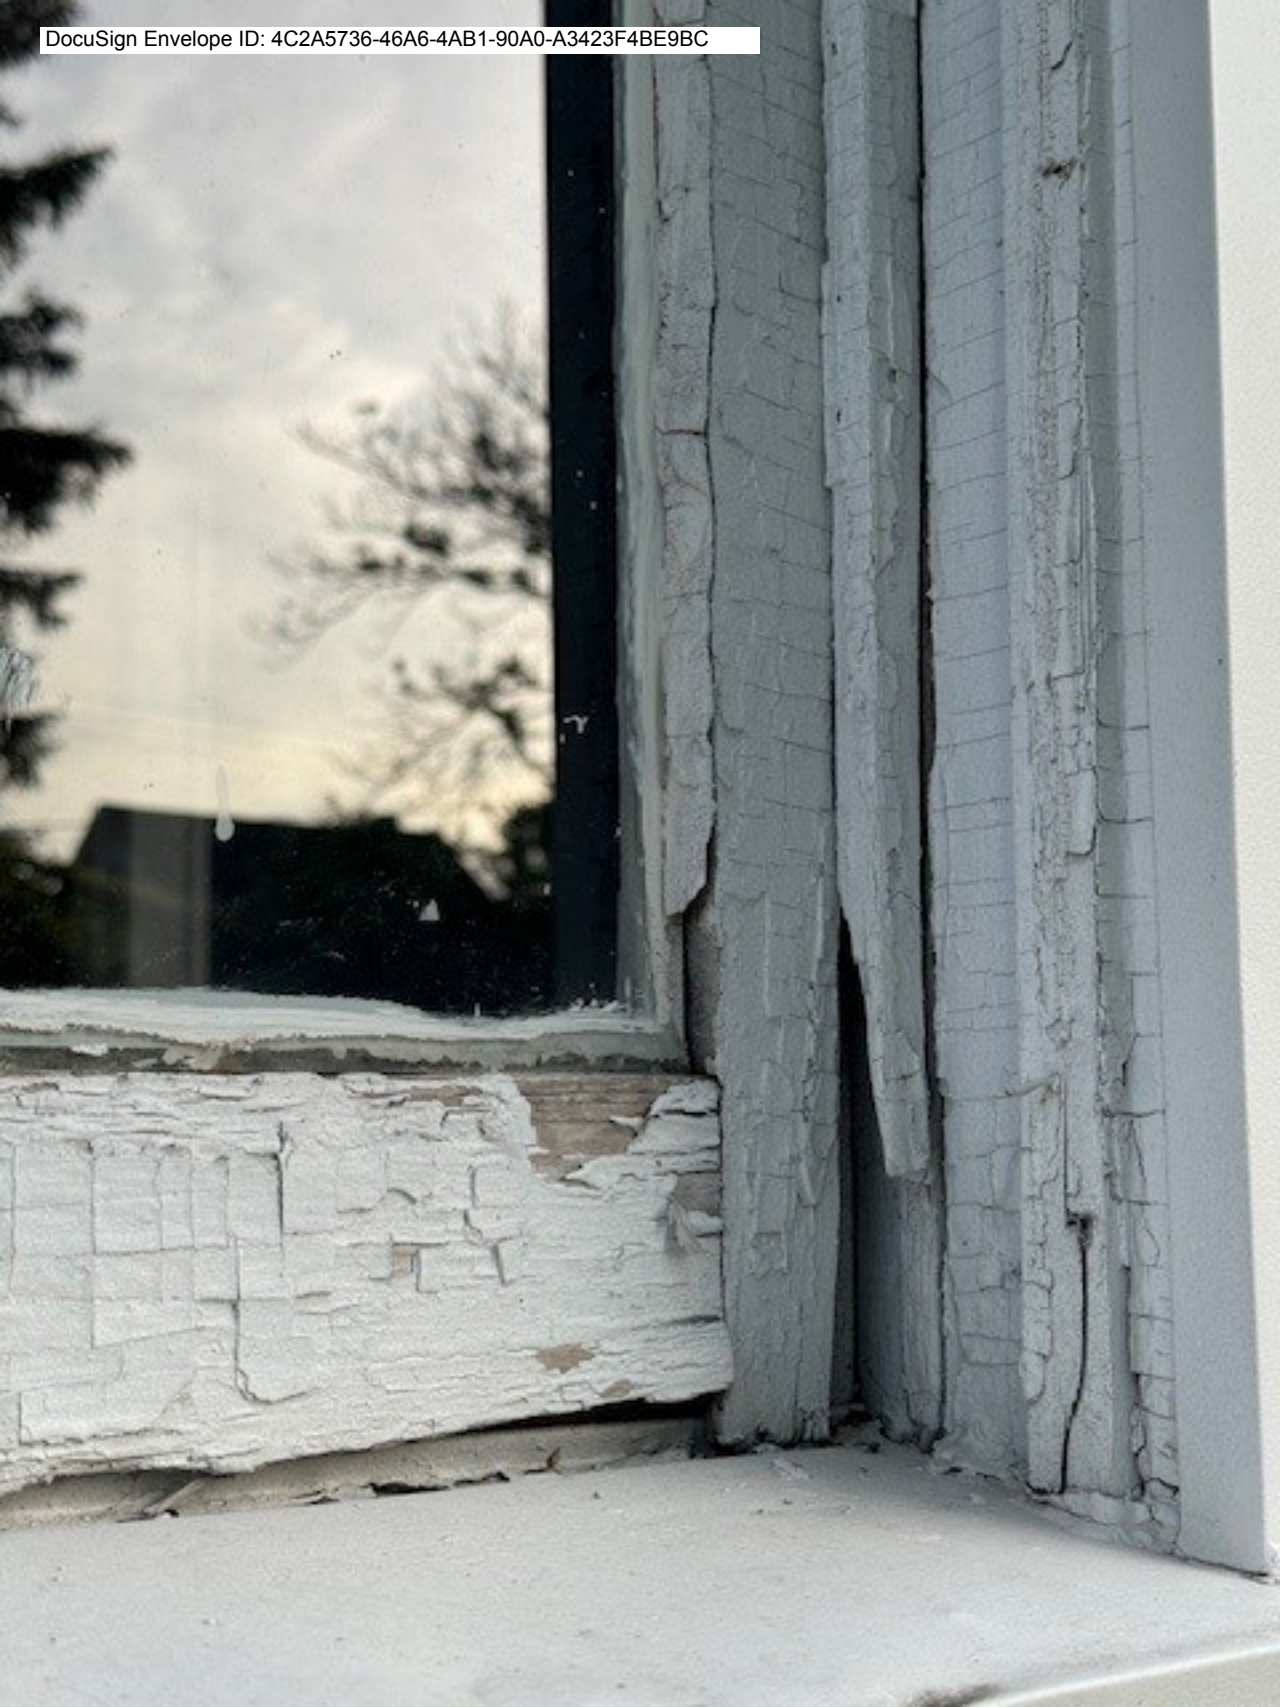
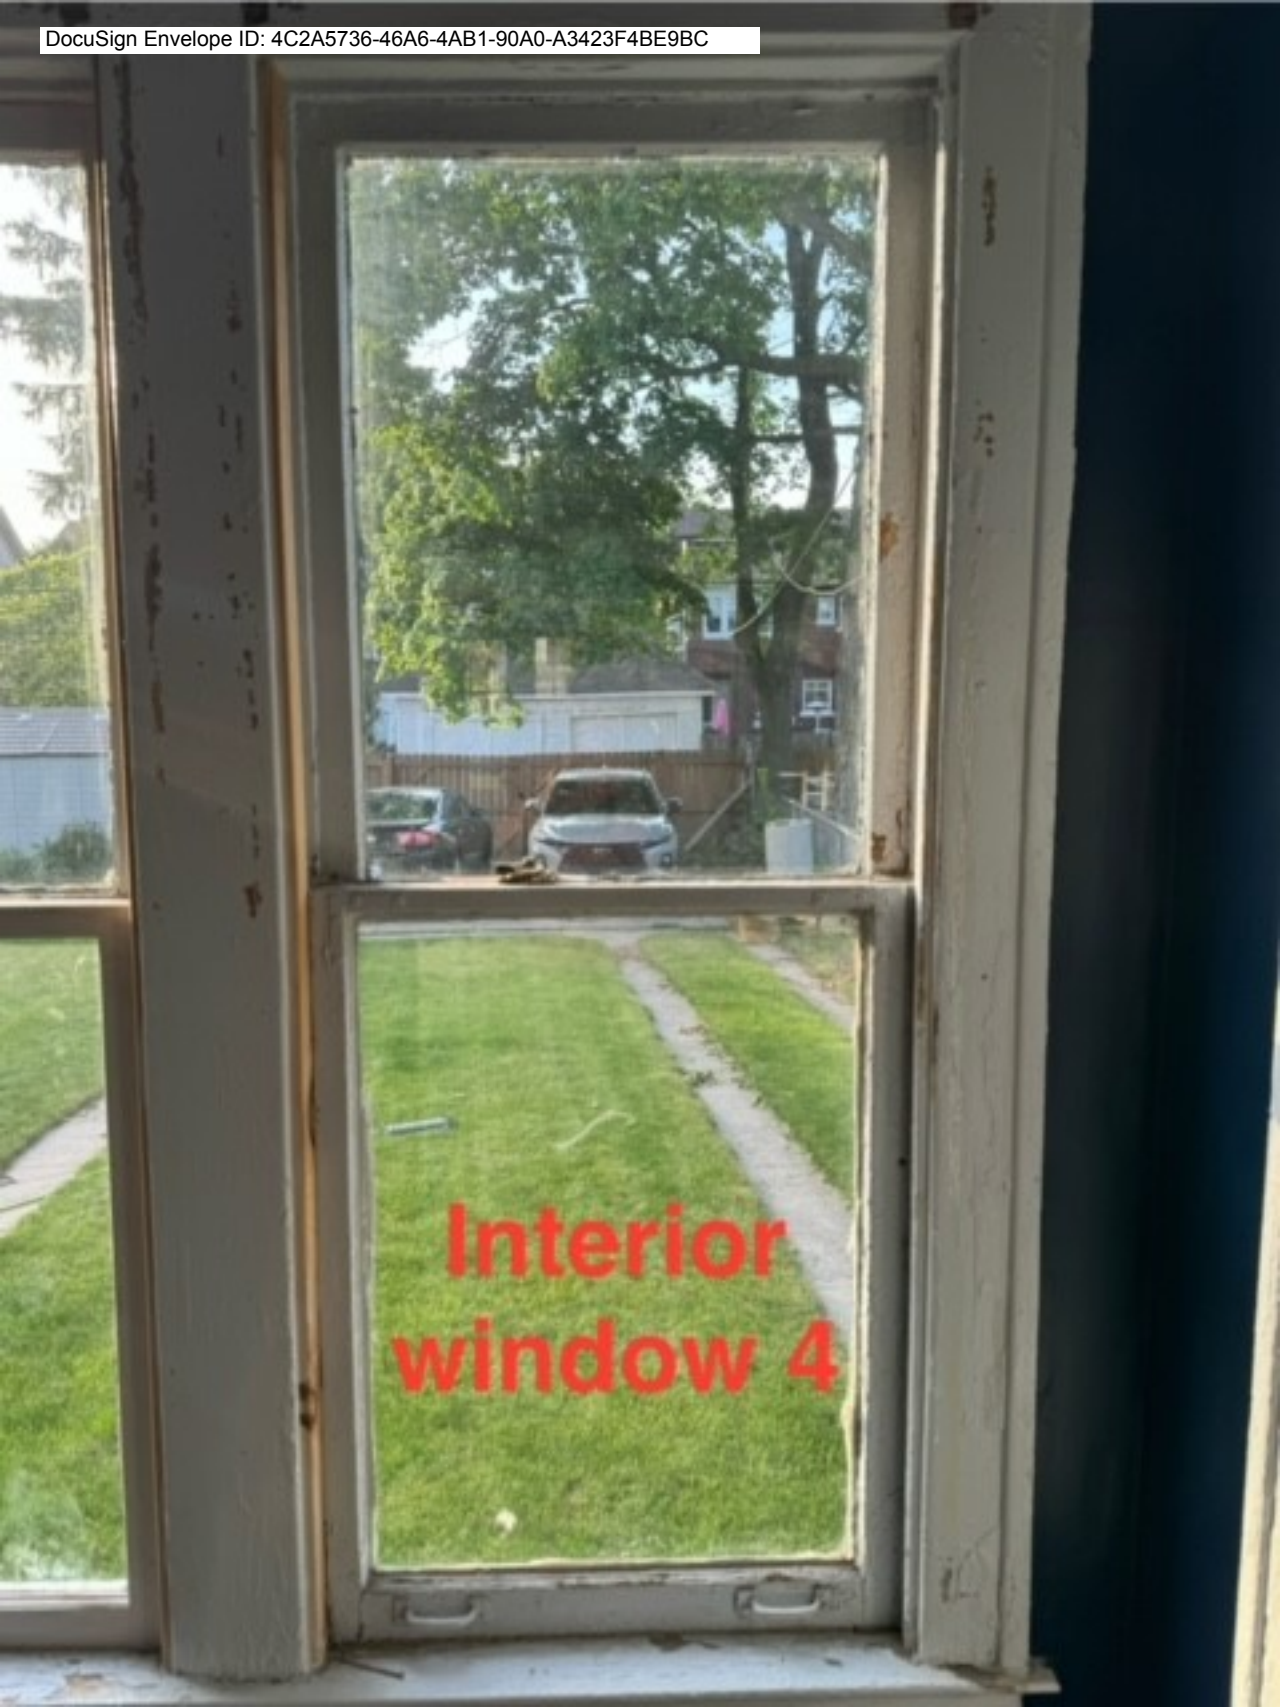
**Interior  
window 4**

Interior: Lower portion of window displays signs of rot in middle of the bottom window near the lock. soft to the touch.
