## Description of Existing Conditions 1730 Edison

Application ID: HDC2024-00331

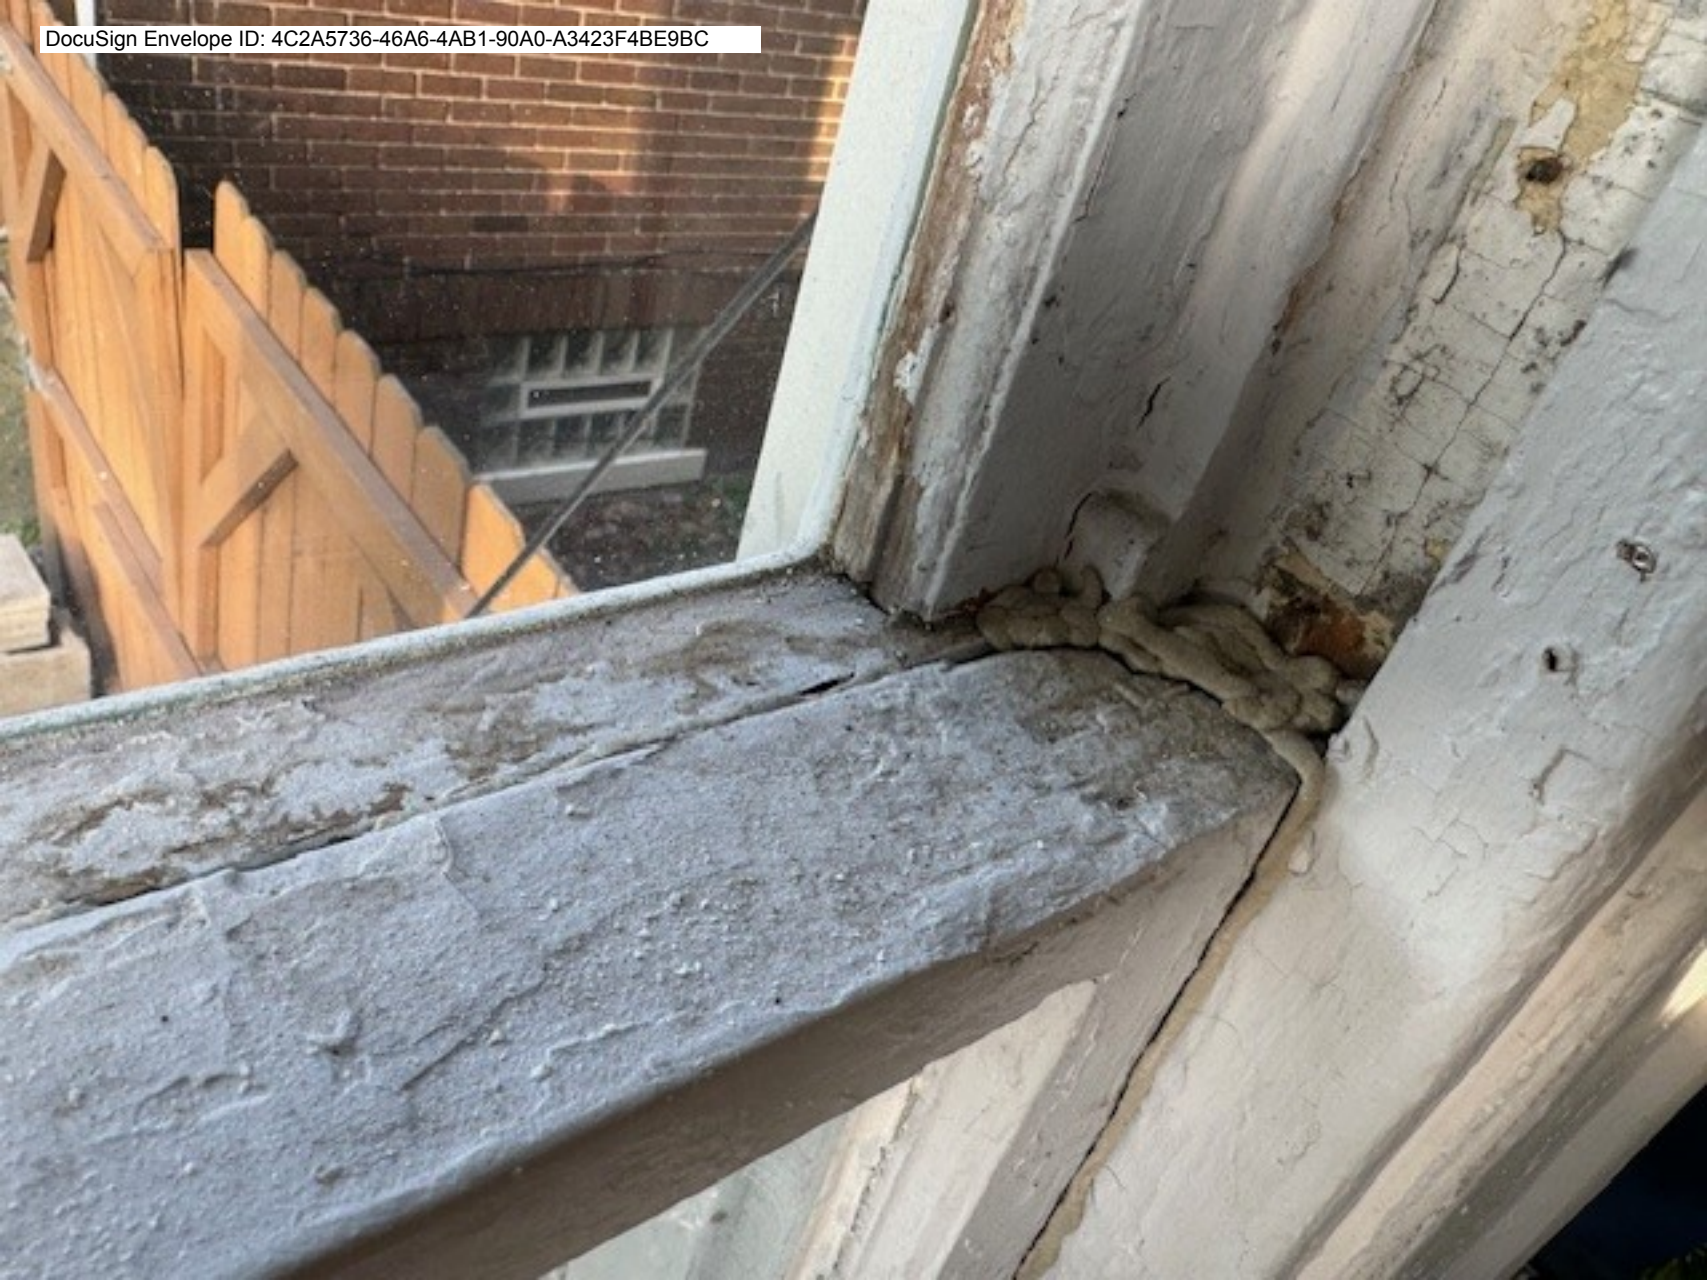
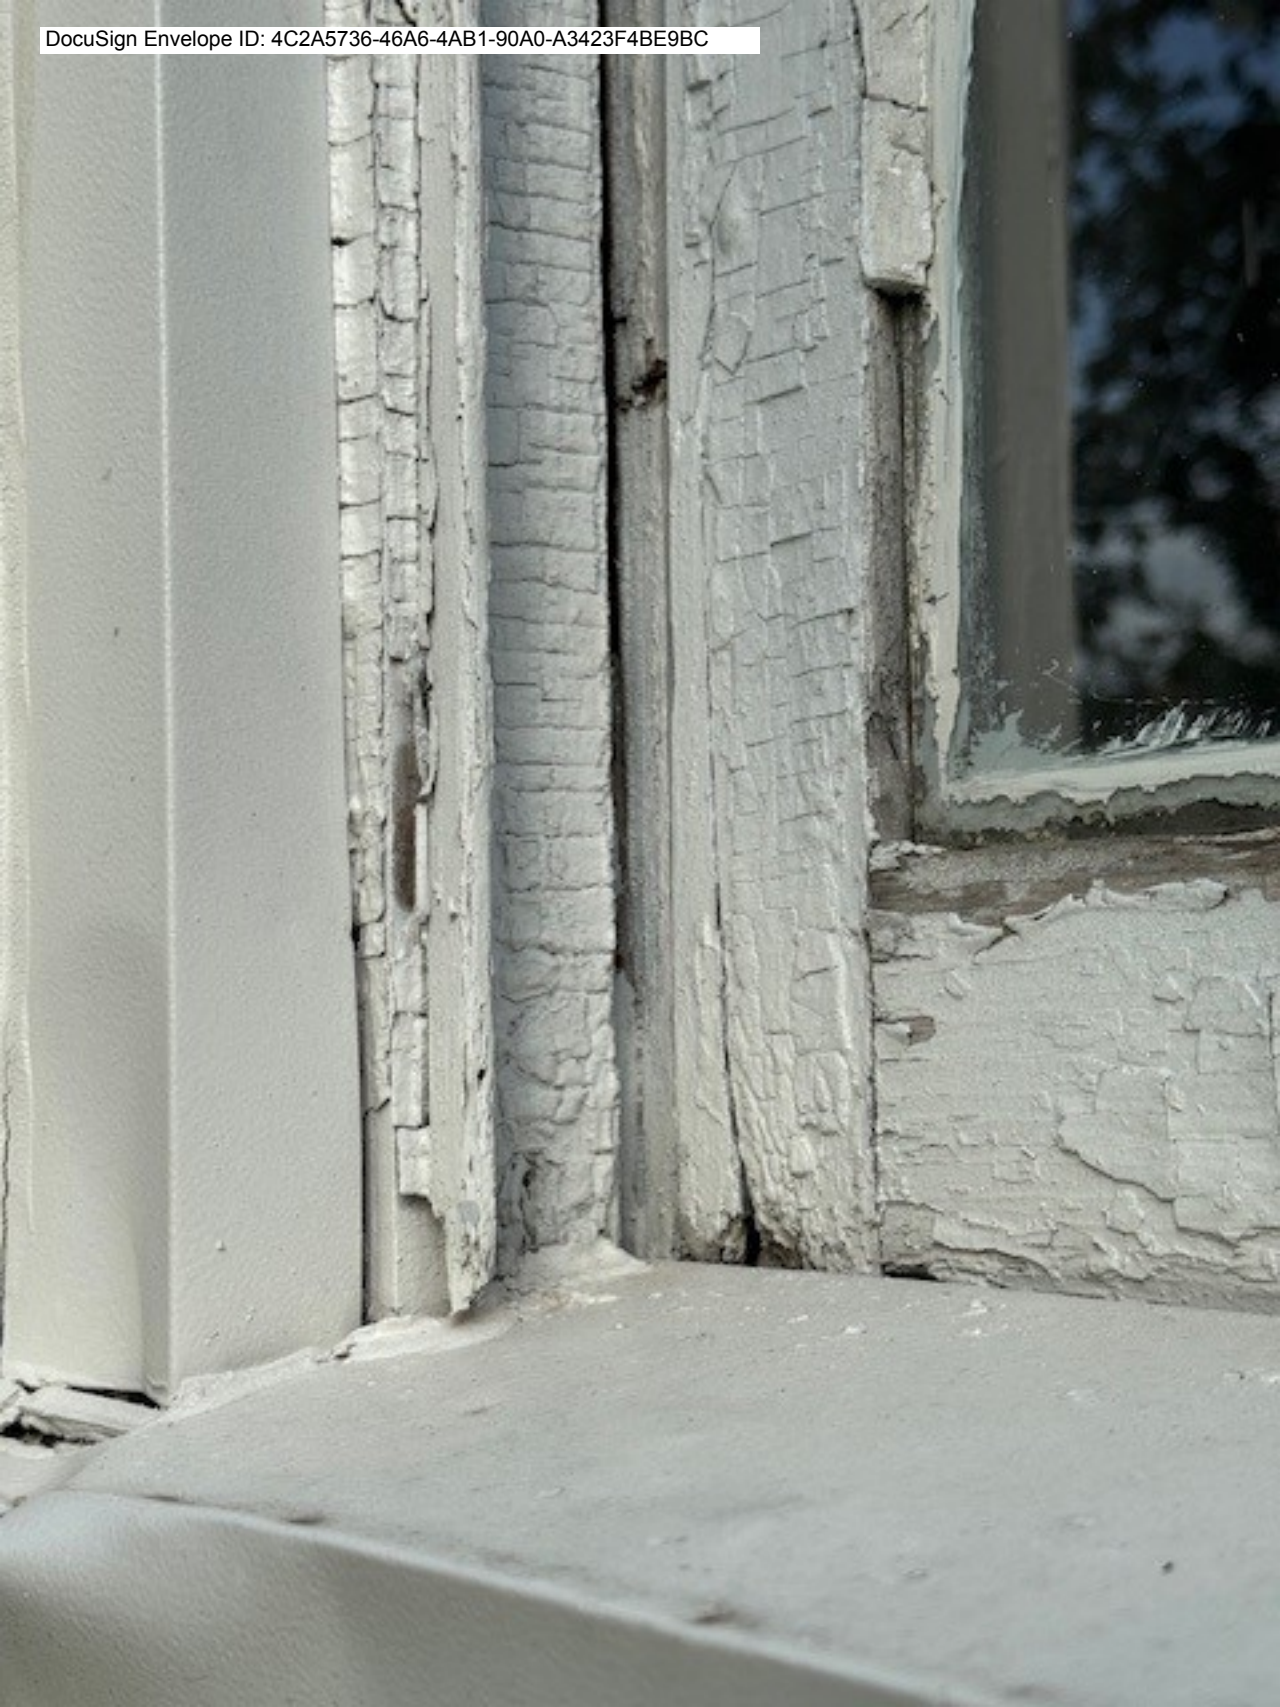
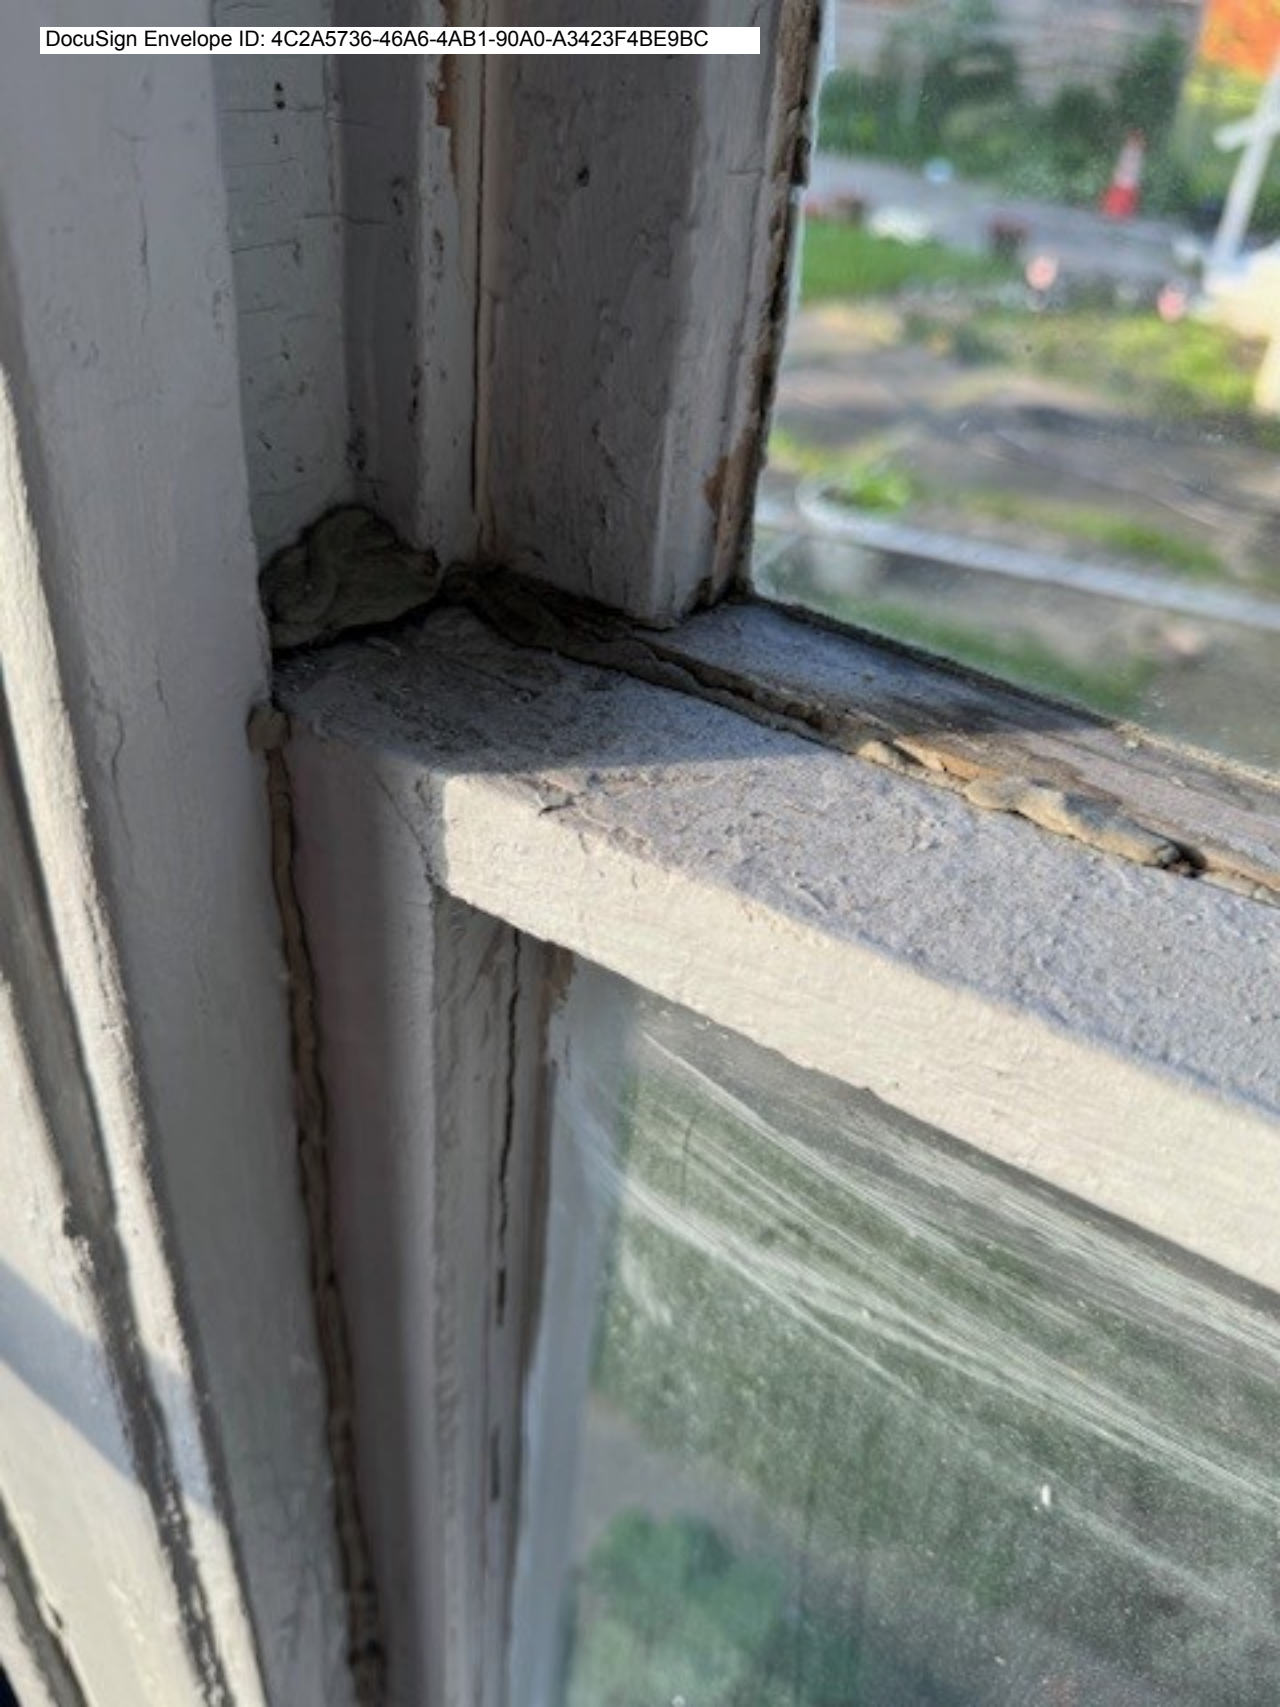
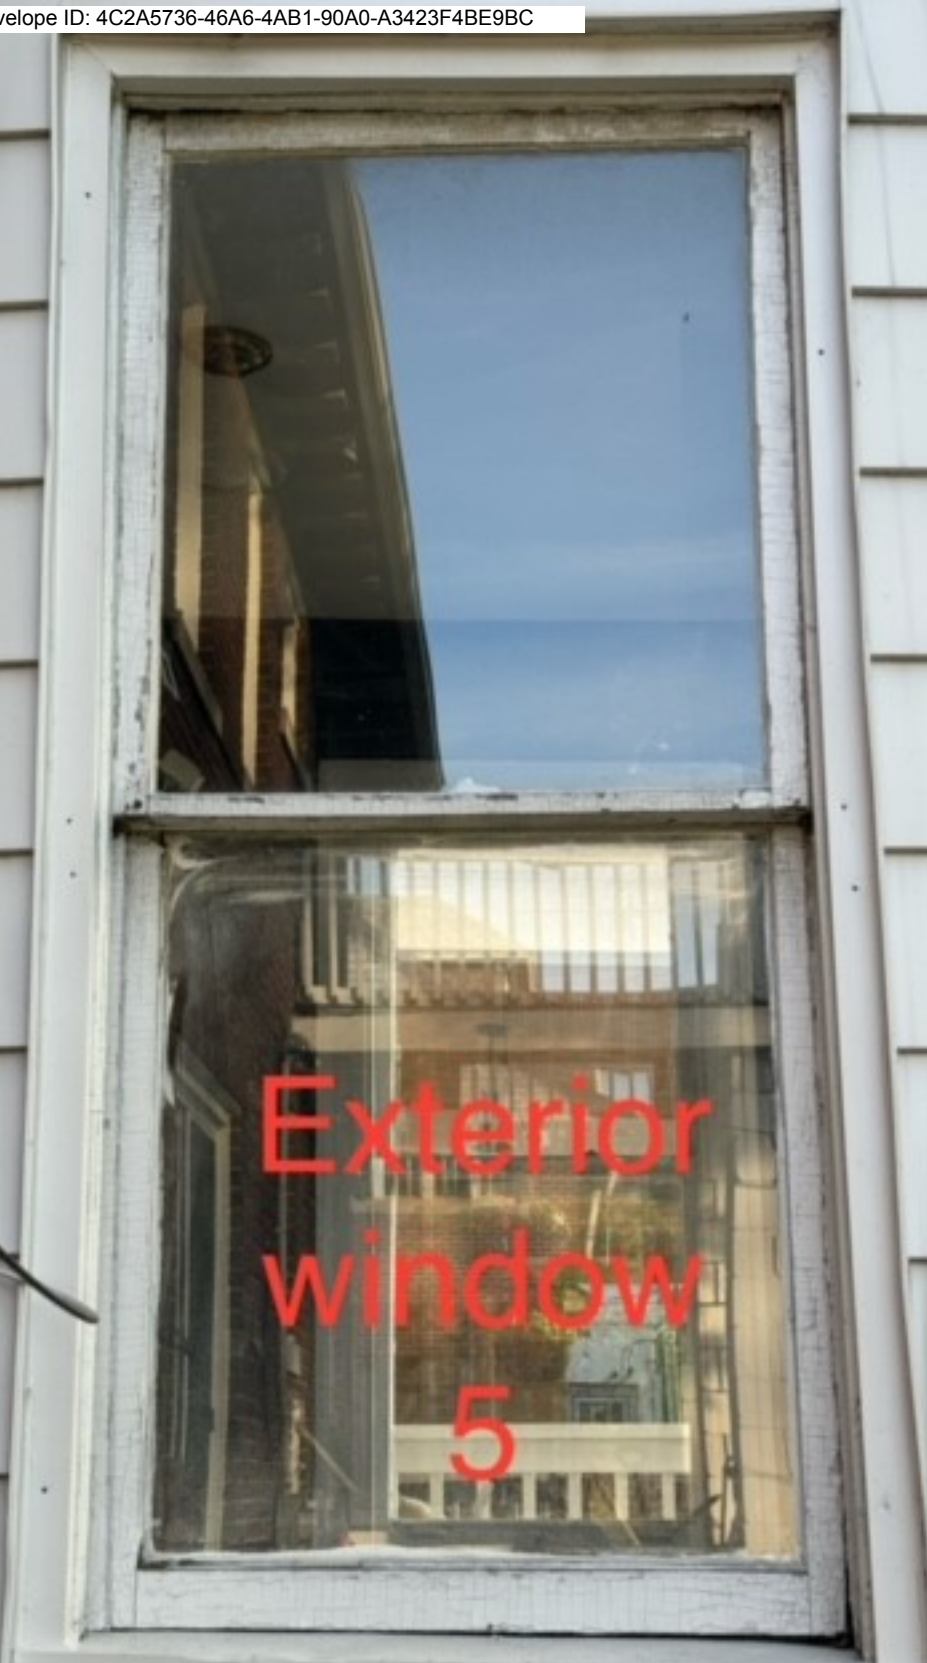
Exterior  
window  
5

Exterior: Window is broken in the bottom left corner. The top left corner is held together by an L-shaped piece of metal. Missing pieces of upper window sash, stop, and jamb. Wood is soft to the touch. Bottom of window is not flush with sill. Displays severe wood rot. Window is not original to the house.
