ELEVATION ENERVATION

SOLID GROUNDS LLC

932 EDISON ST.
DETROIT, MI 48202

A-2

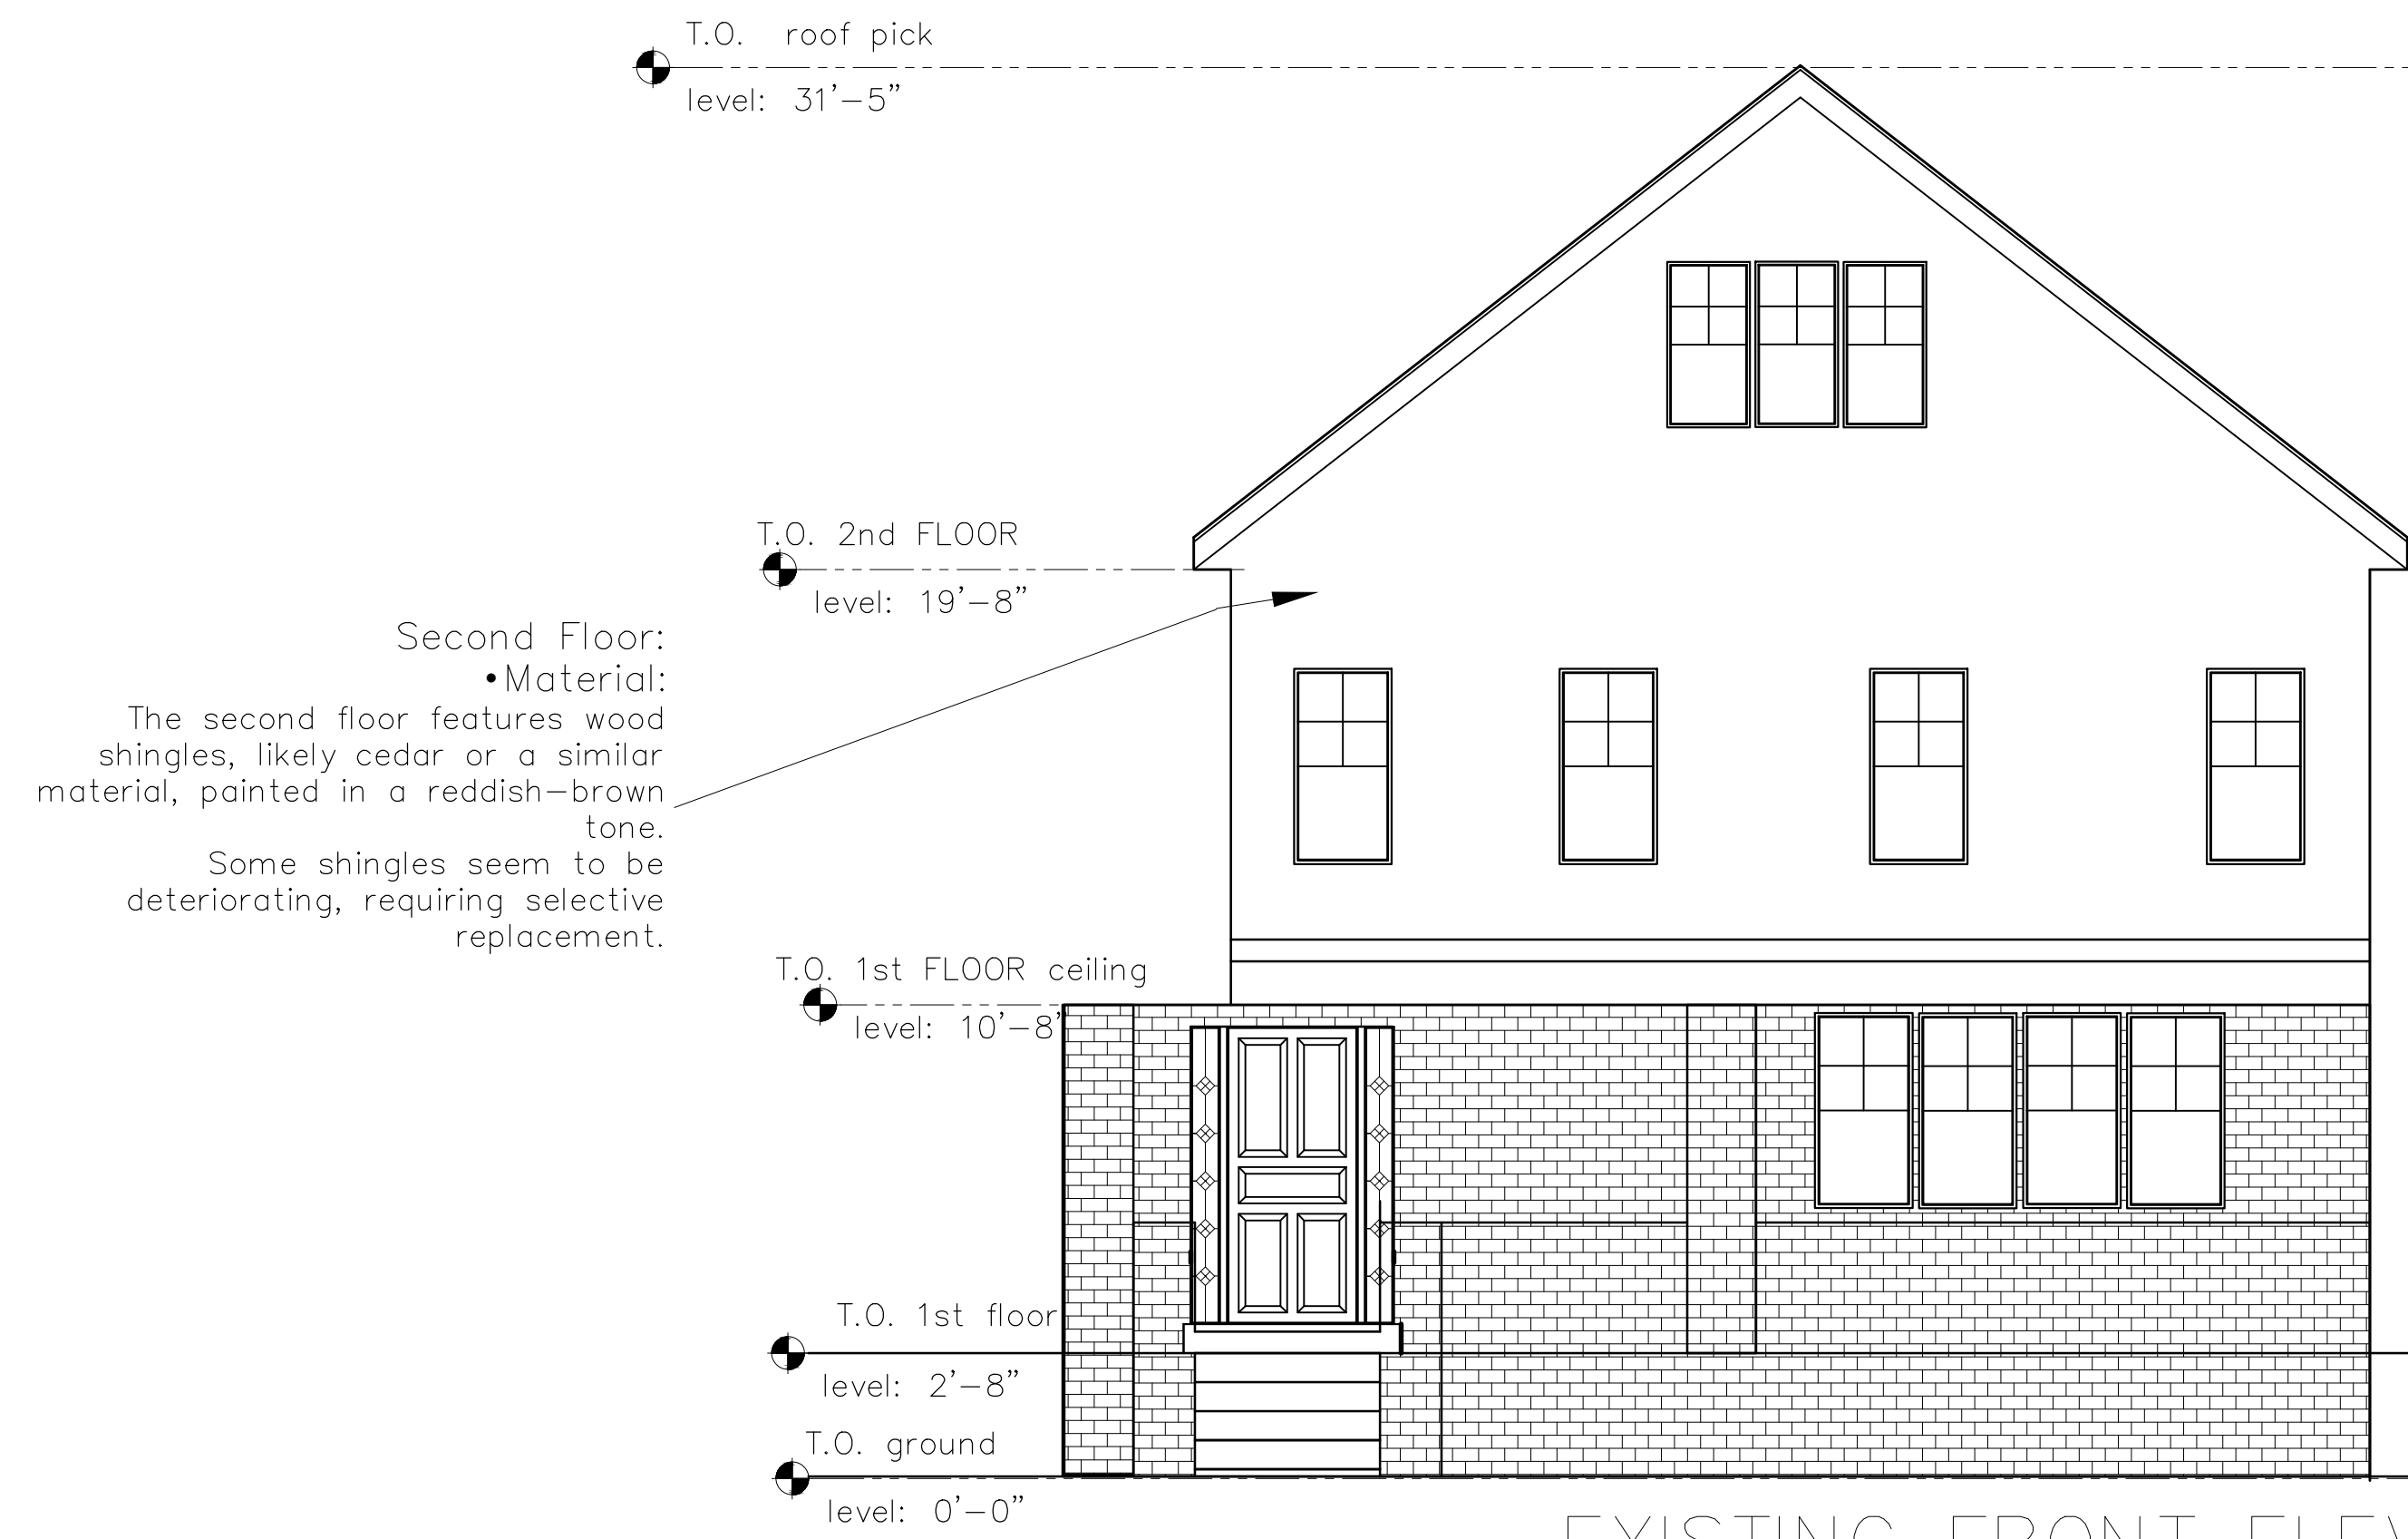
EXISTING FRONT ELEVATION

Second Floor:
•Material:
The second floor features wood shingles, likely cedar or a similar material, painted in a reddish-brown tone. Some shingles seem to be deteriorating, requiring selective replacement.

First Floor:
•Material: The first floor is primarily brick, which appears to be a red-brown hue. This brick is likely an older, hand-laid type, which may need careful matching if repairs or replacements are required.

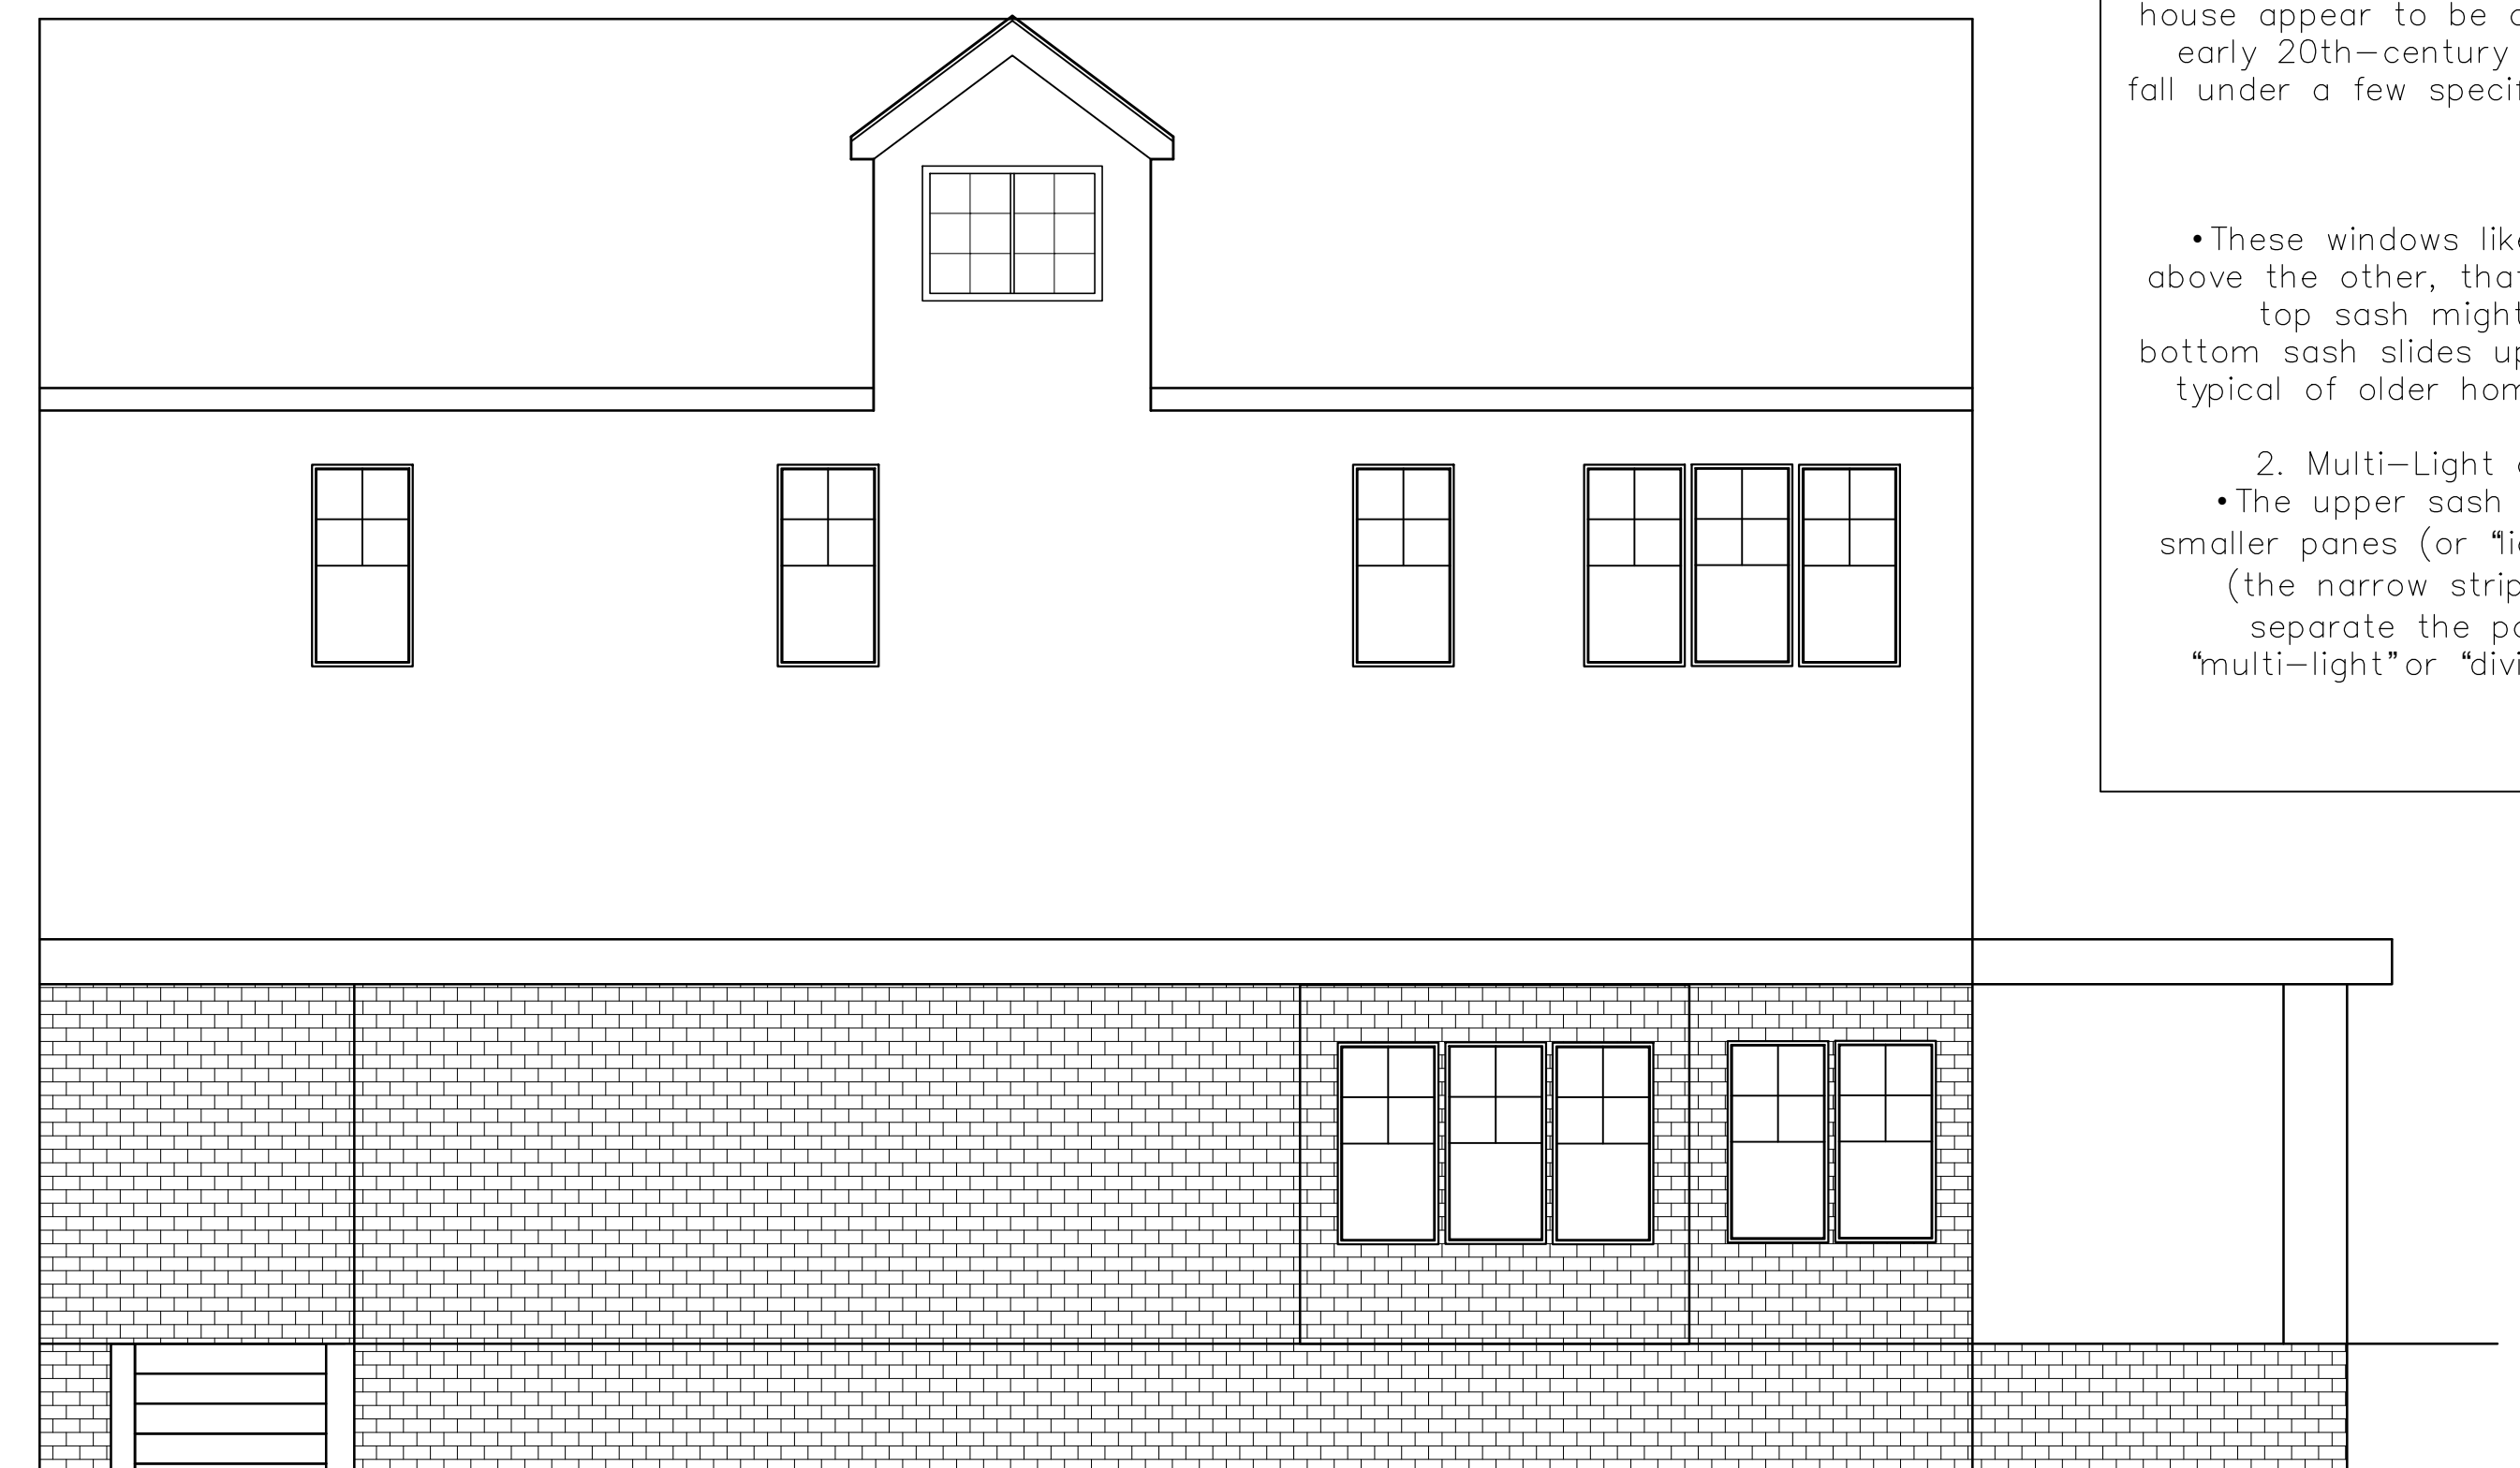
EXISTING LEFT ELEVATION

The windows on this historic house appear to be a style commonly used in early 20th-century architecture, which could fall under a few specific names based on their design.
