HISTORIC DISTRICT COMMISSION APPLICATION FOR WORK APPROVAL

APPLICATION ID
HDC2024-00658

ADDRESS(ES): 15107 Minock
HISTORIC DISTRICT: Rosedale Park

<p>BRIEF PROJECT DESCRIPTION: Remove and haul away existing shed. Build new detached garage approx 22x20 on new cement floor and ratwall.</p>
--

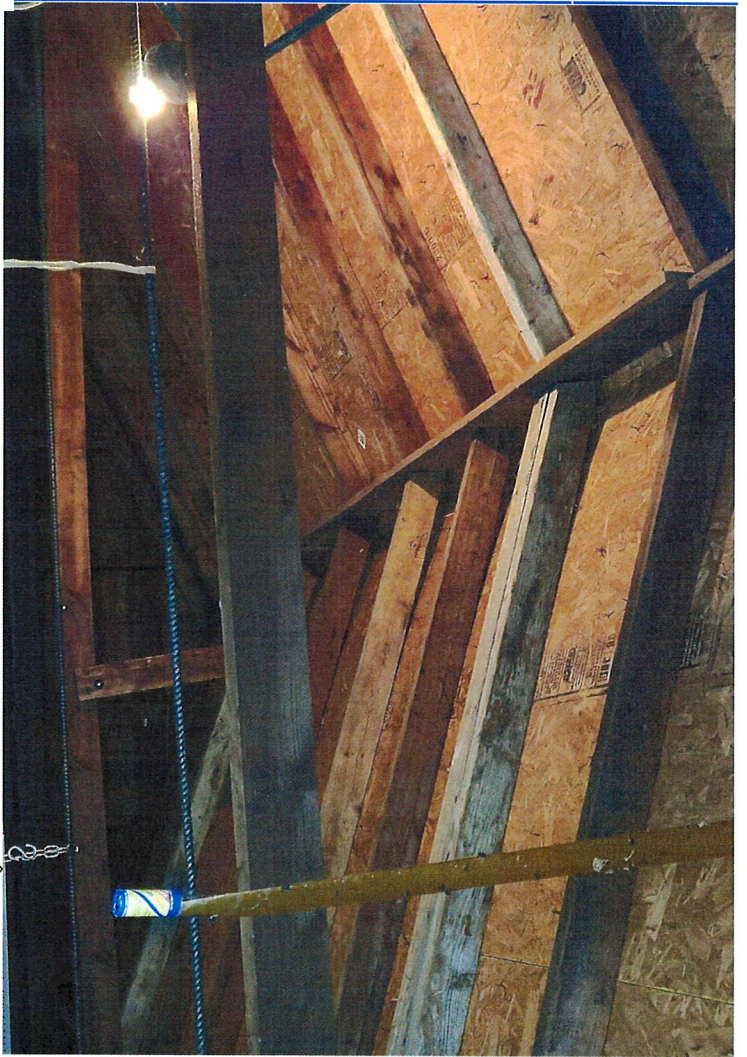
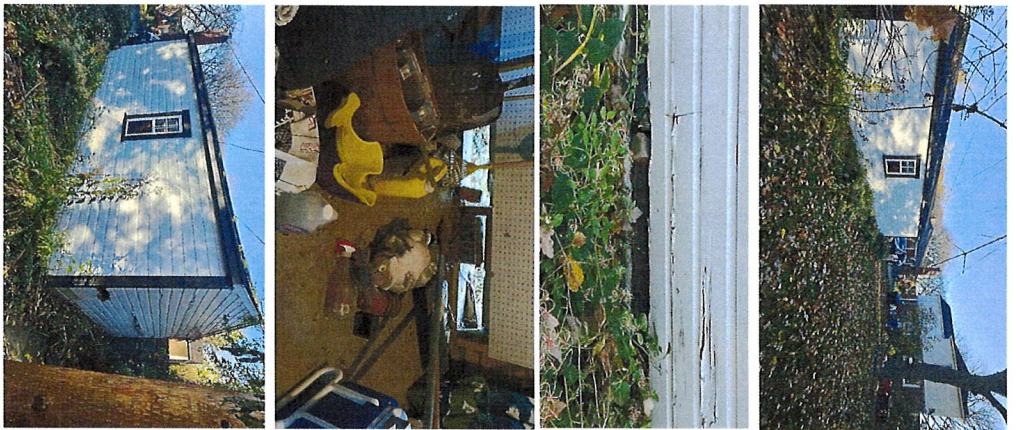
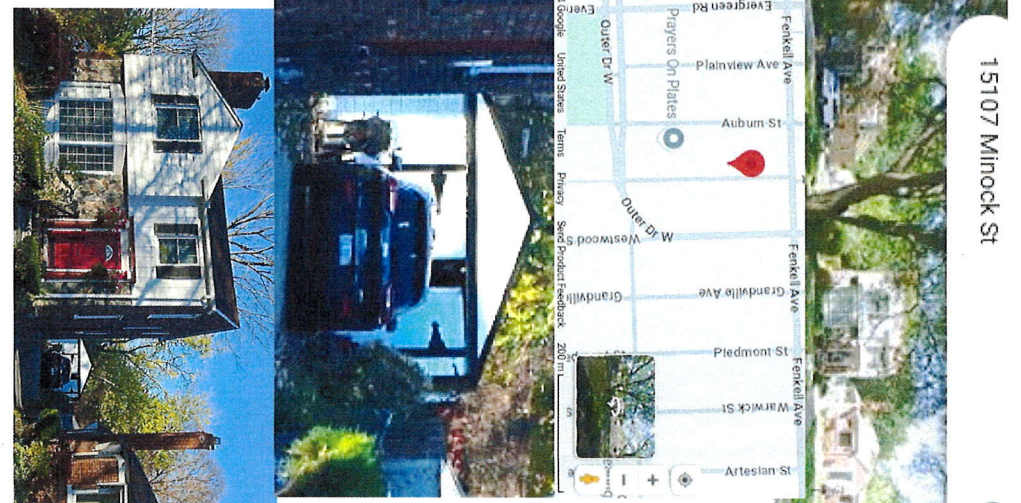
PICTURES SHOWING UNSOUND STRUCTURAL INTEGRITY REVIEW OF GARAGE AT BACK OF HOUSE

The superstructure of the Garage is not in good shape -- Joints of roof structural members are not secure, ridge board is undersized and is deflecting; rafter connections are not sound; walls are leaning, there are breaks and gaping holes in the siding. The Garage floor is below finished grade; surface runoff is shedding towards Garage floor

I visited the job site on Nov-08-2024 accompanied by Lunar Construction (586-709-2761) to look at the condition of the detached Garage at the back of the house from structural integrity viewpoint. The Garage is structurally unsound and needs to be demolished.

Based on my field inspection, the information provided to me, my engineering judgment and my practical experience, I believe the Garage is structurally unsound and needs to be demolished.

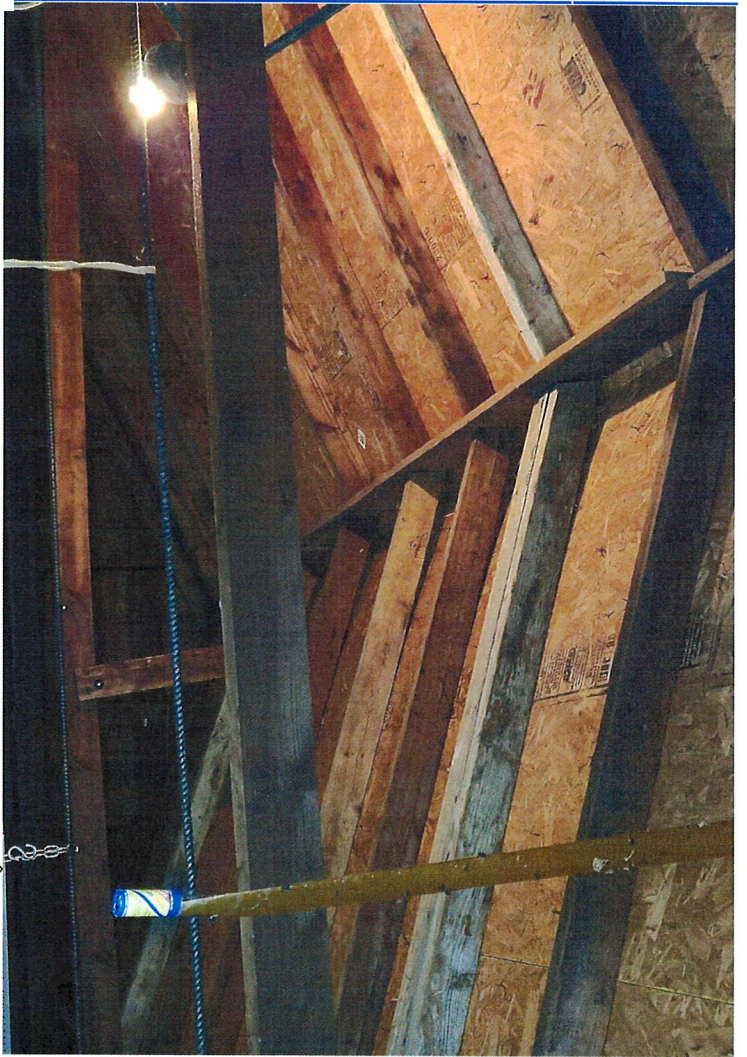
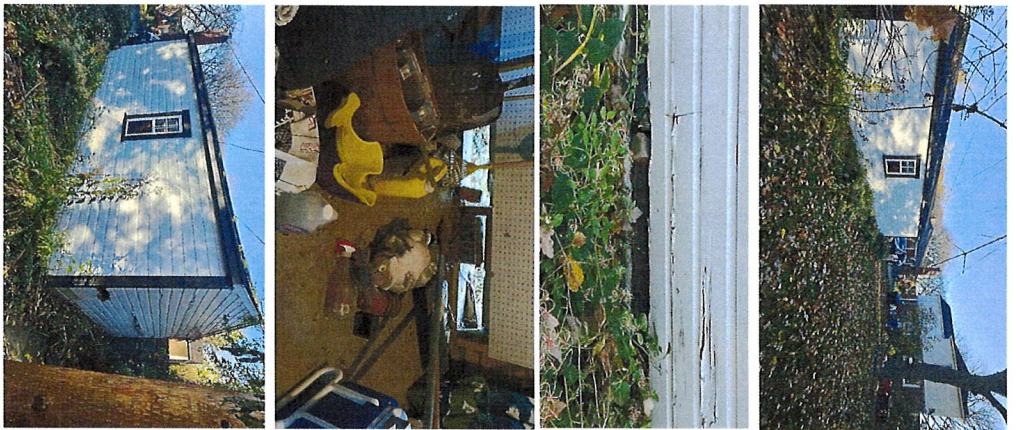
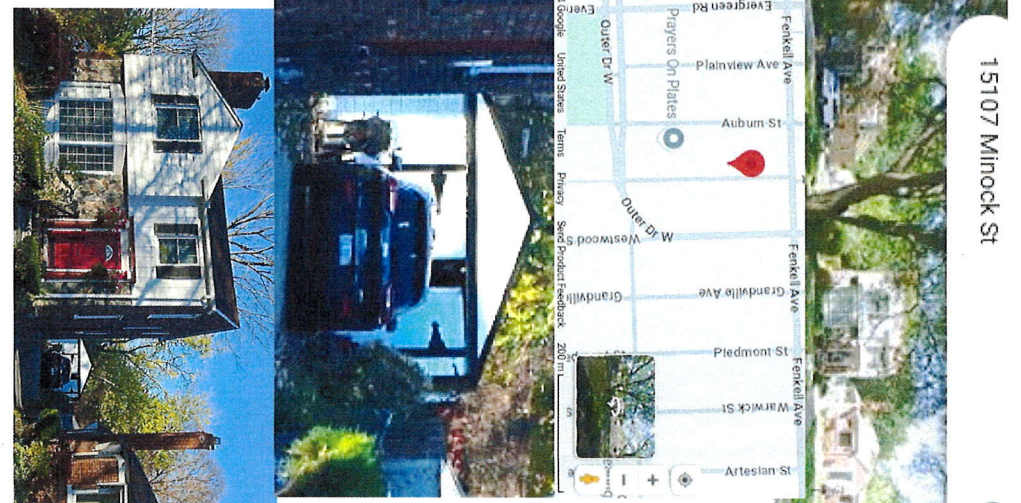
PICTURES SHOWING UNSOUND STRUCTURAL INTEGRITY REVIEW OF GARAGE AT BACK OF HOUSE

The superstructure of the Garage is not in good shape -- Joints of roof structural members are not secure, ridge board is undersized and is deflecting; rafter connections are not sound; walls are leaning, there are breaks and gaping holes in the siding. The Garage floor is below finished grade; surface runoff is shedding towards Garage floor

I visited the job site on Nov-08-2024 accompanied by Lunar Construction (586-709-2761) to look at the condition of the detached Garage at the back of the house from structural integrity viewpoint. The Garage is structurally unsound and needs to be demolished.

Based on my field inspection, the information provided to me, my engineering judgment and my practical experience, I believe the Garage is structurally unsound and needs to be demolished.
