AGENDA

STAFF REPORT 6-26-2019 MEETING
APPLICATION NUMBER 19-6254
ADDRESS: 1723 LONGFELLOW
HISTORIC DISTRICT: BOSTON - EDISON
APPLICANT: JENNIFER JARENA
DATE OF STAFF VISIT: 06-21-2019

PREPARED BY: B. CAGNEY

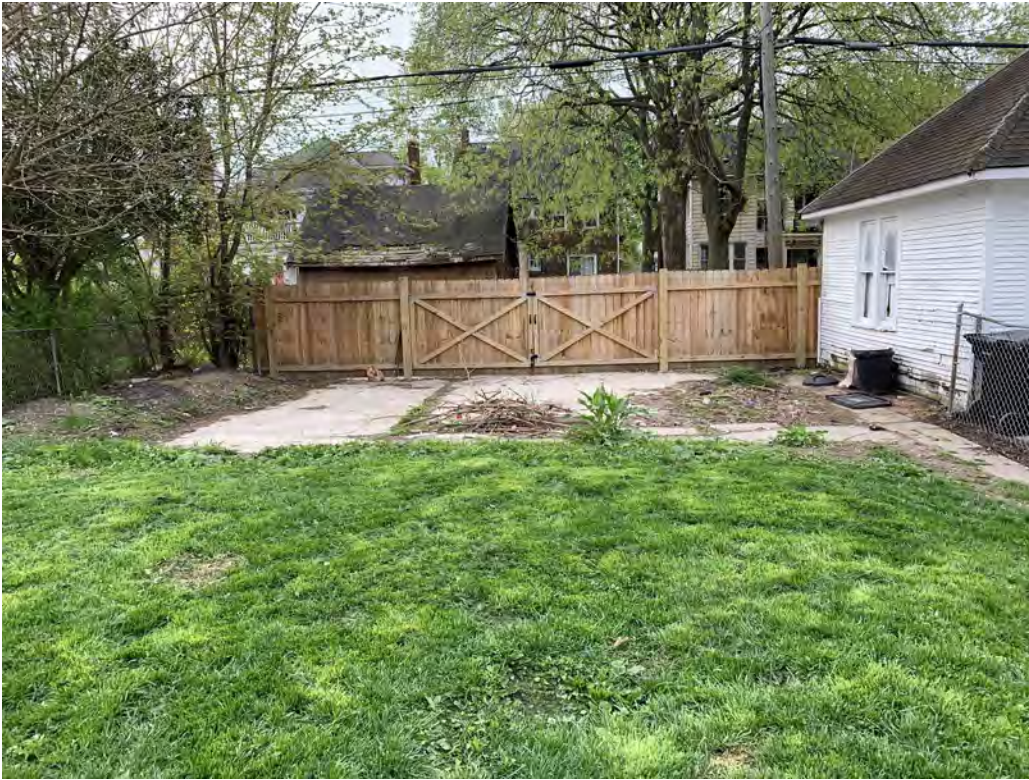
1723 Longfellow Rear Yard, applicant photo

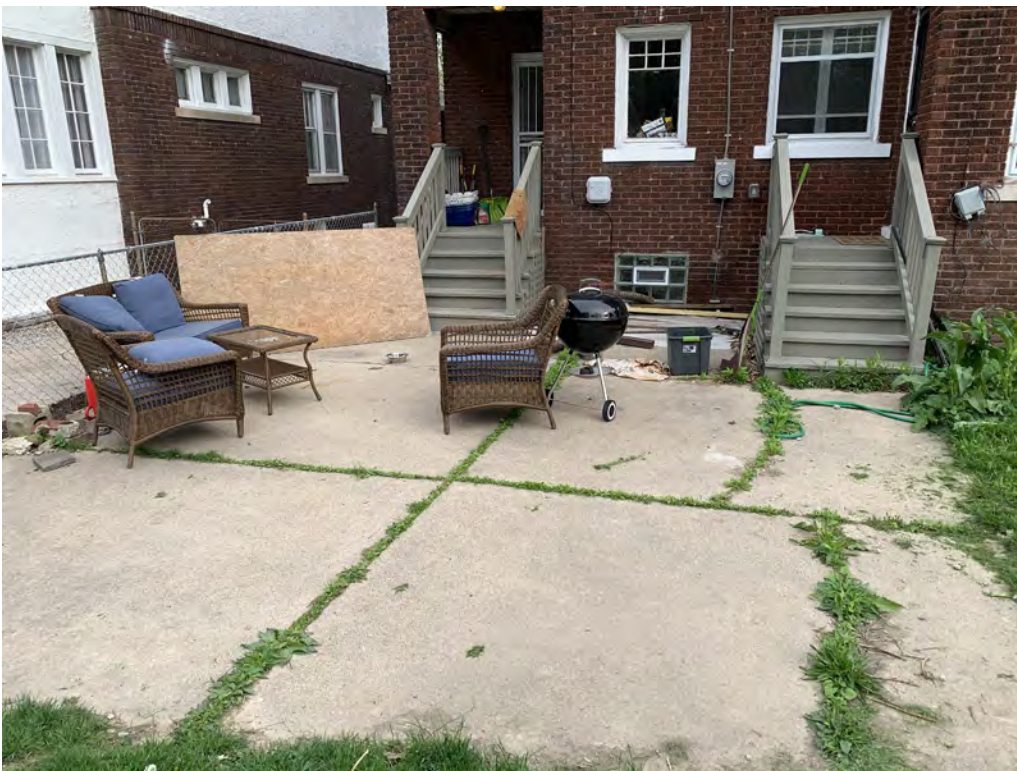
1723 Longfellow existing patio, applicant photo

The existing sod and excess soil must be removed due to weeds and unevenness. The yard must be leveled. The concrete must be removed since it is broken, and will be replaced with a new patio design. A new white vinyl fence will be replacing the broken/rusted chain fence.

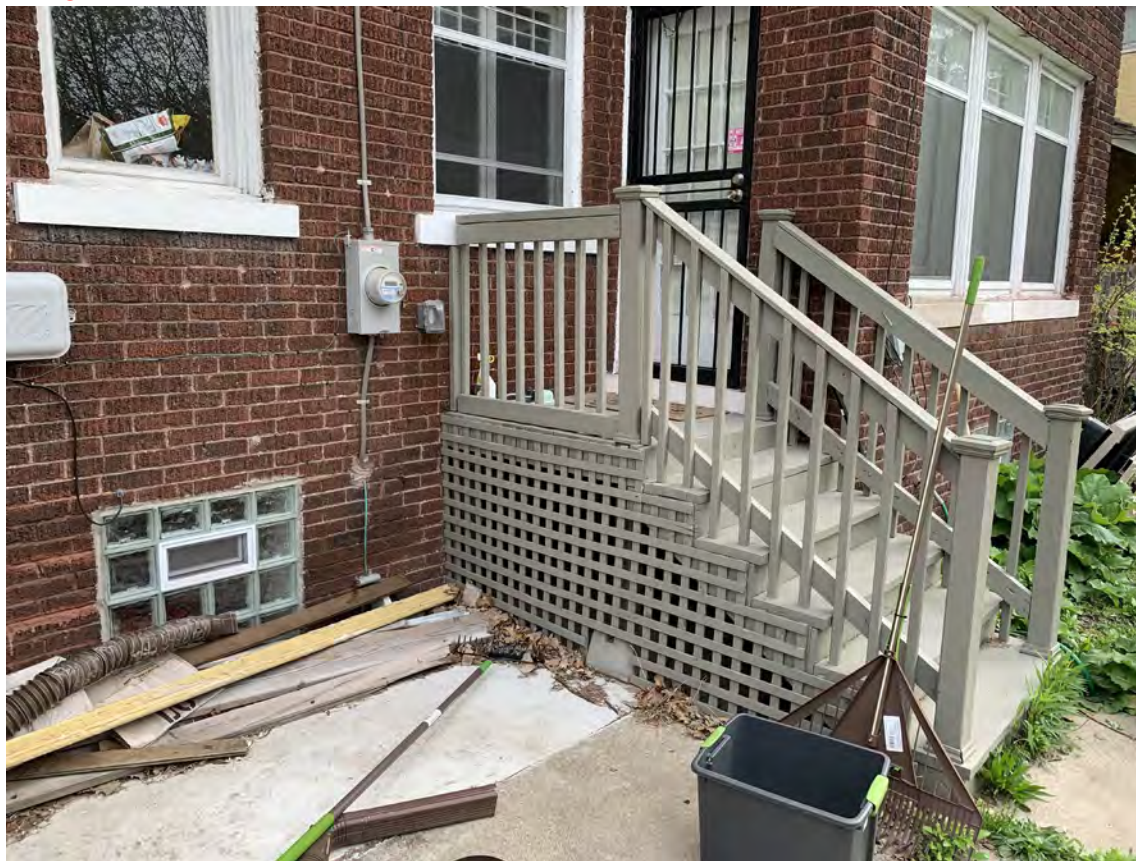
There are two doors from the house with access to the back yard, one from the kitchen, and one from the sun room. The wooden steps extending from both of these entrances are in disrepair, the applicant reports that they are “steep and uneven, with nails sticking out.” The concrete patio area that currently exists is also in disrepair, with cracks and is uneven. The applicant also reports that the lawn / sod is uneven and that the yard needs to be leveled. In the rear corner of the yard, an existing concrete slab remains in poor condition at the location of the original garage. There is no information from the applicant when the garage was demolished. HDC records have no COA on file, though it appears that the removal occurred many years ago.

1723 Longfellow - Existing Steps (1), applicant photo

- To be installed to spec, on 21AA Crushed Limestone & NS Sharp Bedding Sand and polymeric Jointing Sand
- Replace steps with Fendt Wall Block and Coping per design
- Install grill enclosure with Fendt Wall Block and Coping per design
- Create Patio with Fire Pit using Fendt Wall Block, Fire Pit Block and Coping per design
 - Including 14' dia. seating wall

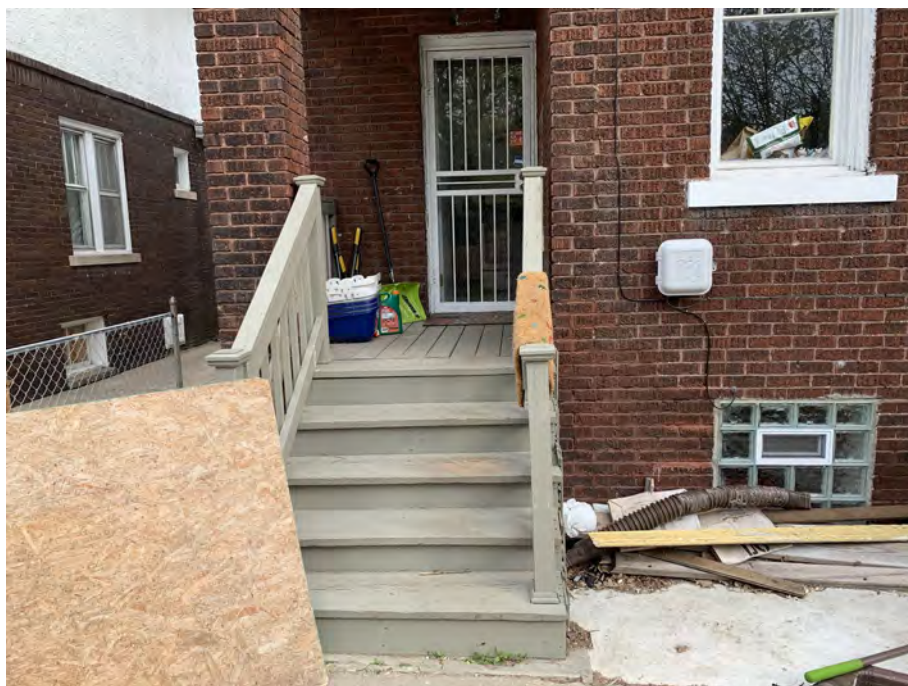
1723 Longfellow - Existing Steps (2), applicant photo

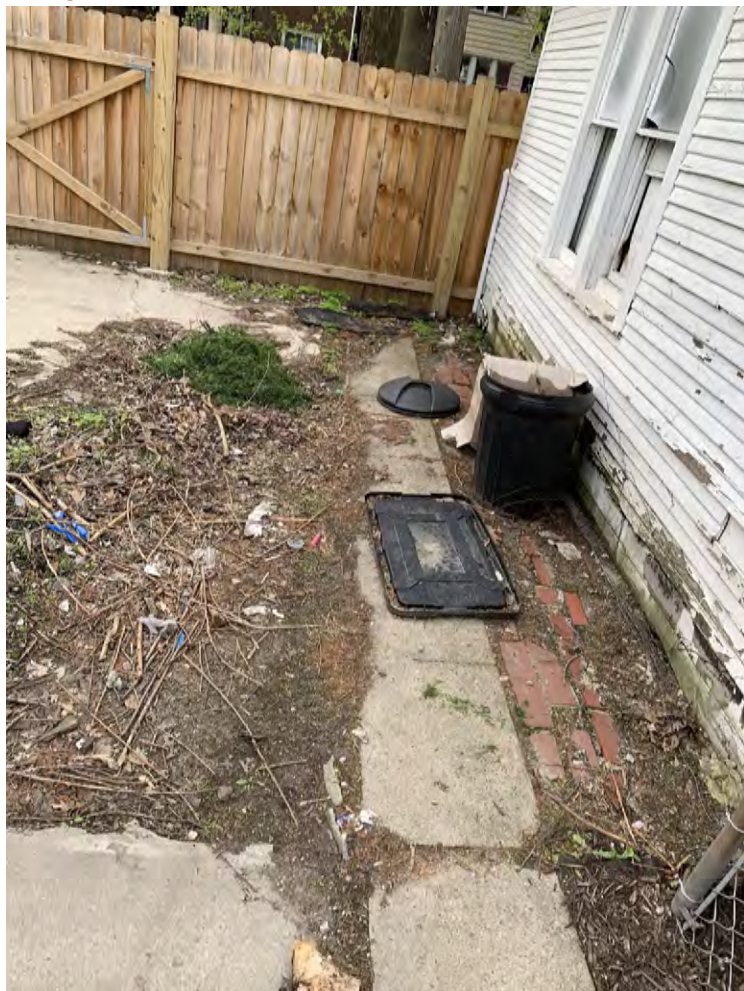
1723 Longfellow - Existing fence and concrete

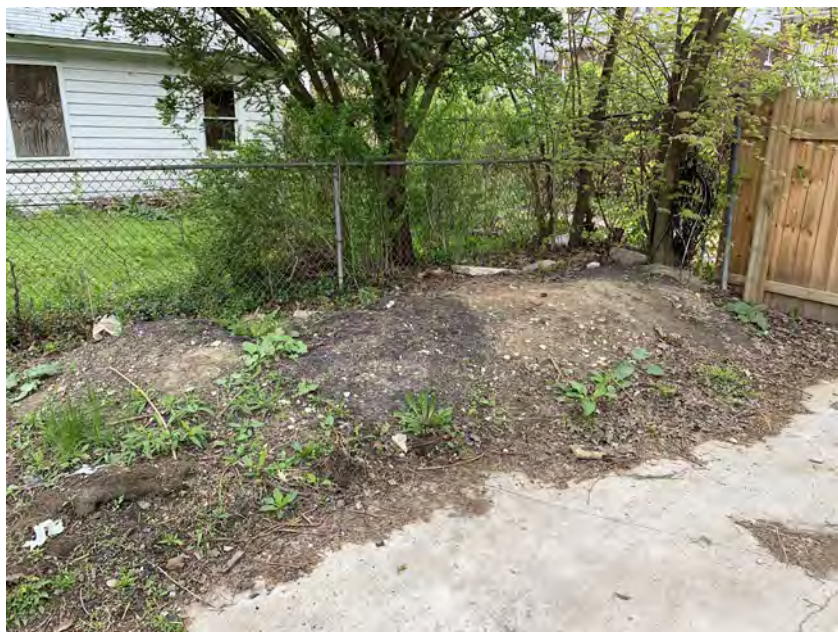
1723 Longfellow Existing fence and concrete

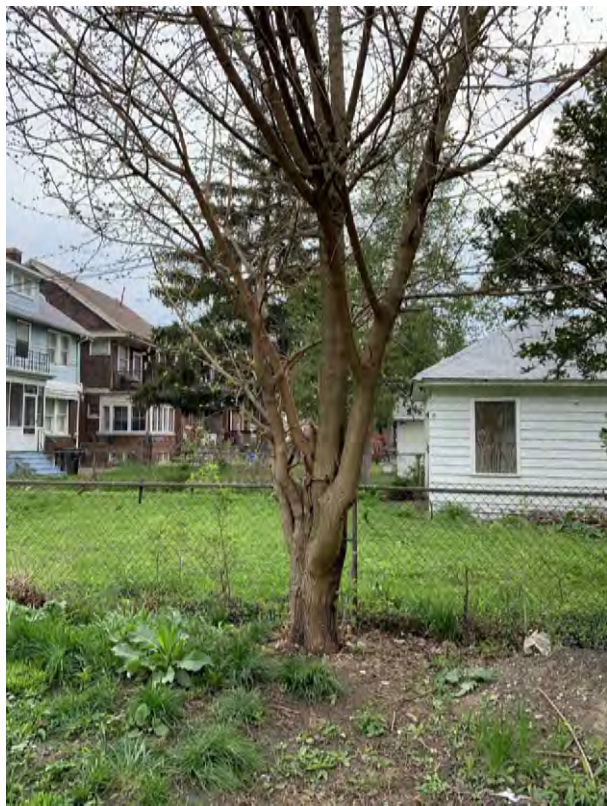
1723 Longfellow - Tree proposed for removal

There is two exits from the house that allows access to the backyard space, one off of the kitchen, and one off of the sunroom. Each of these exits are wooden steps. The current steps are steep and uneven, with nails sticking out. Below these steps is a broken cement patio area, which leads out into the yard area. The current lawn is filled with weeds, and is very uneven throughout the entire space. To the back of the yard, there is another broken cement area. Currently there is a wooden fence in the back of the yard with a gate to the alley way, as well as a chain fence on both sides of the yard. There are two trees along the back corner of the yard, that may interfere with power lines.

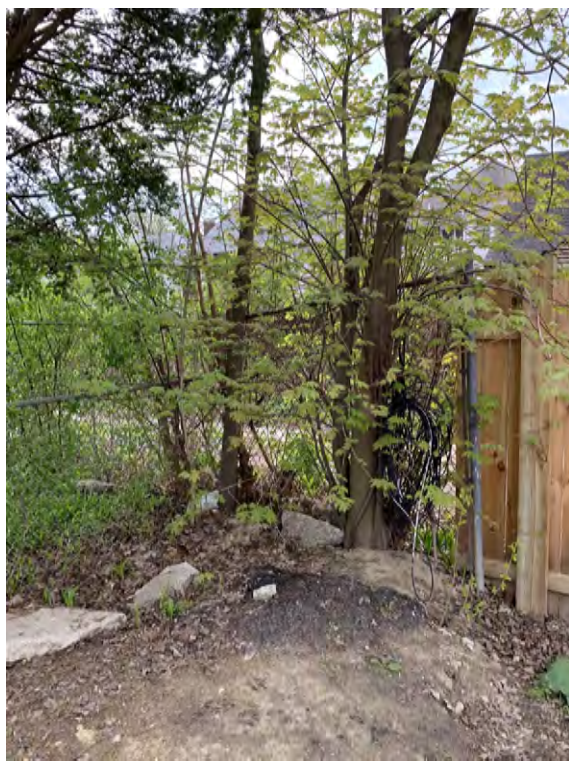
1723 Longfellow - Tree proposed for removal
