STAFF REPORT 6-26-2019 MEETING

APPLICATION NUMBER 19-6255

ADDRESS: 671 EDISON

HISTORIC DISTRICT: BOSTON - EDISON

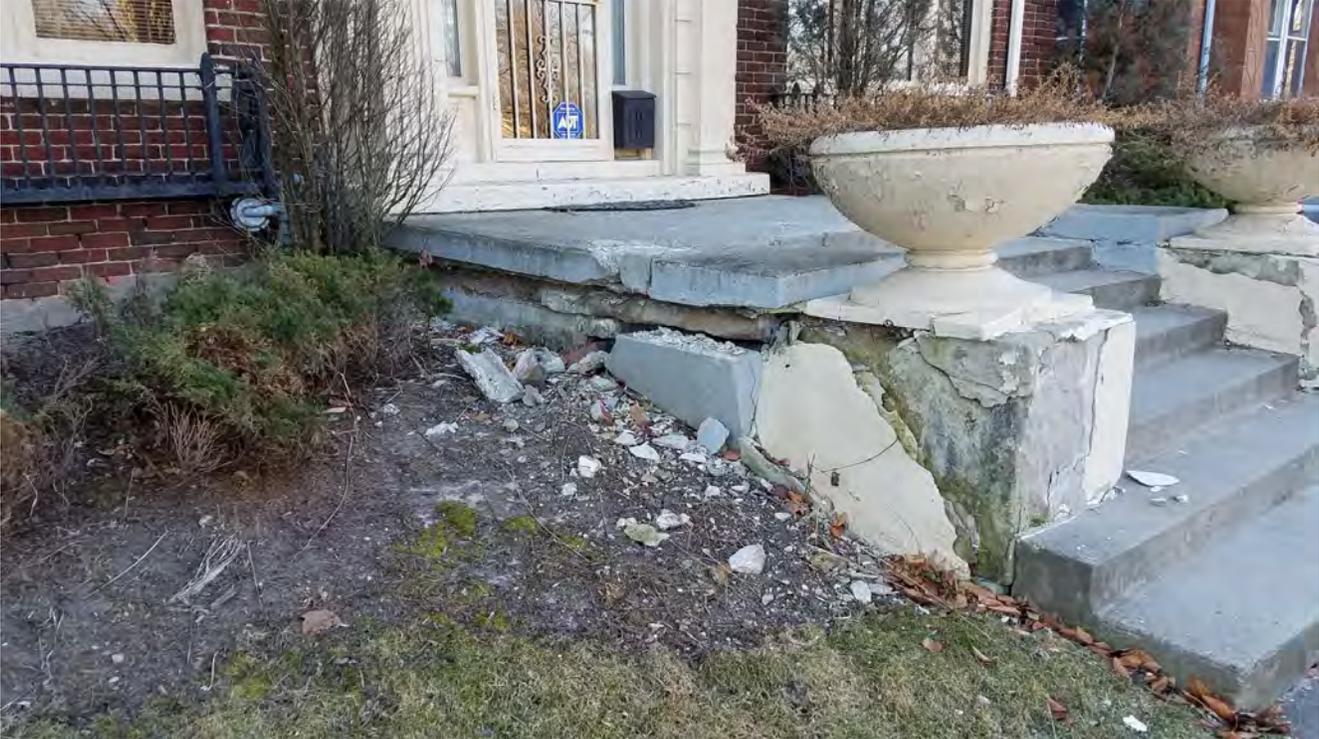
The concrete hardscaping at the front porch of the house has decayed significantly throughout the years. The concrete wingwalls extending from the porch down both sides of the walkway, including the caps and the planters are all in a state of disrepair. The applicant would like to replace the porch and walkway with new concrete. The applicant has also proposed to rebuild the concrete “columns” that extend down the steps with red brick to match the existing brick home as “best possible”. The proposed “columns” would be capped with limestone as a gesture to the limestone window sills that are present around the house. The landscape planters will also be replaced.

671 Edison, Applicant Photo- Porch Detail

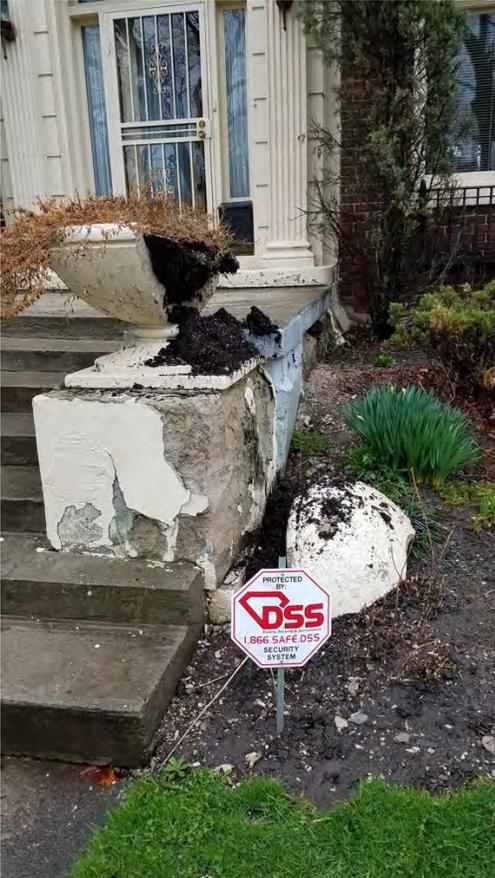
671 Edison, Applicant Photo- Porch Detail

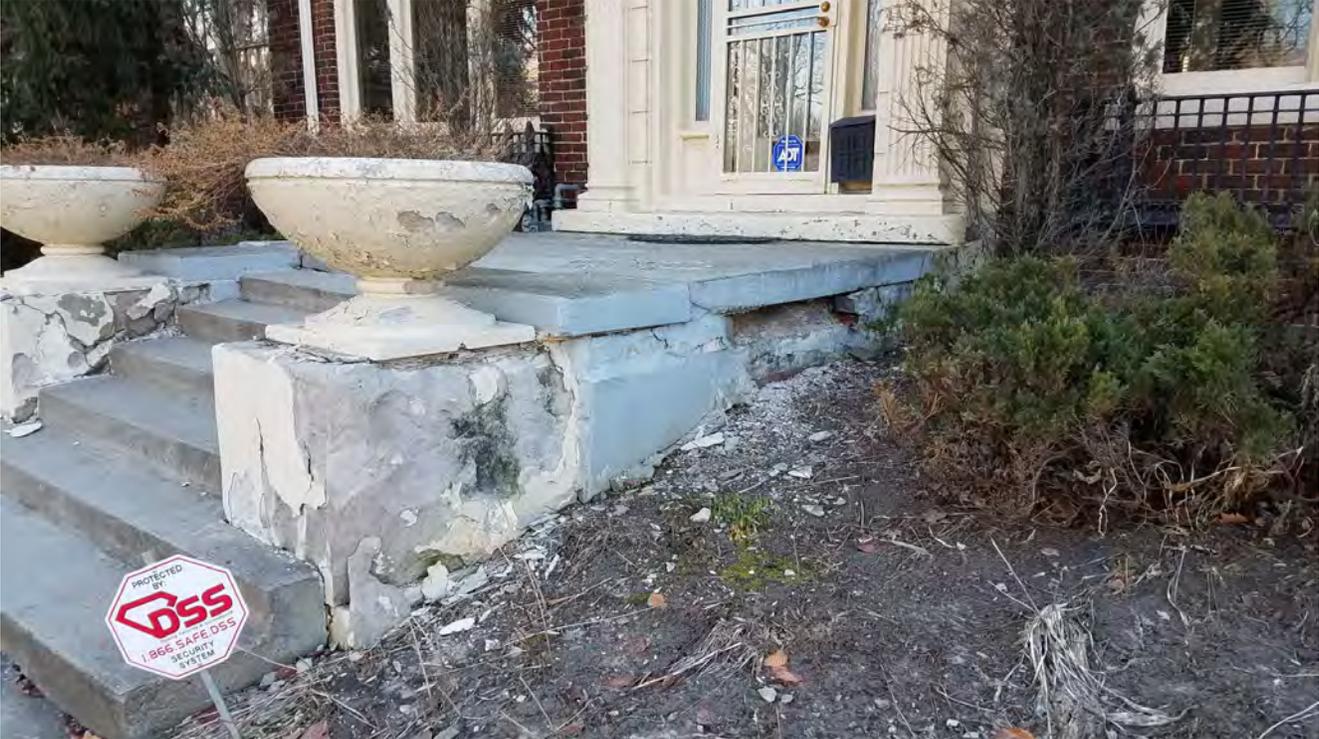
671 Edison, Applicant Photo- Porch Current

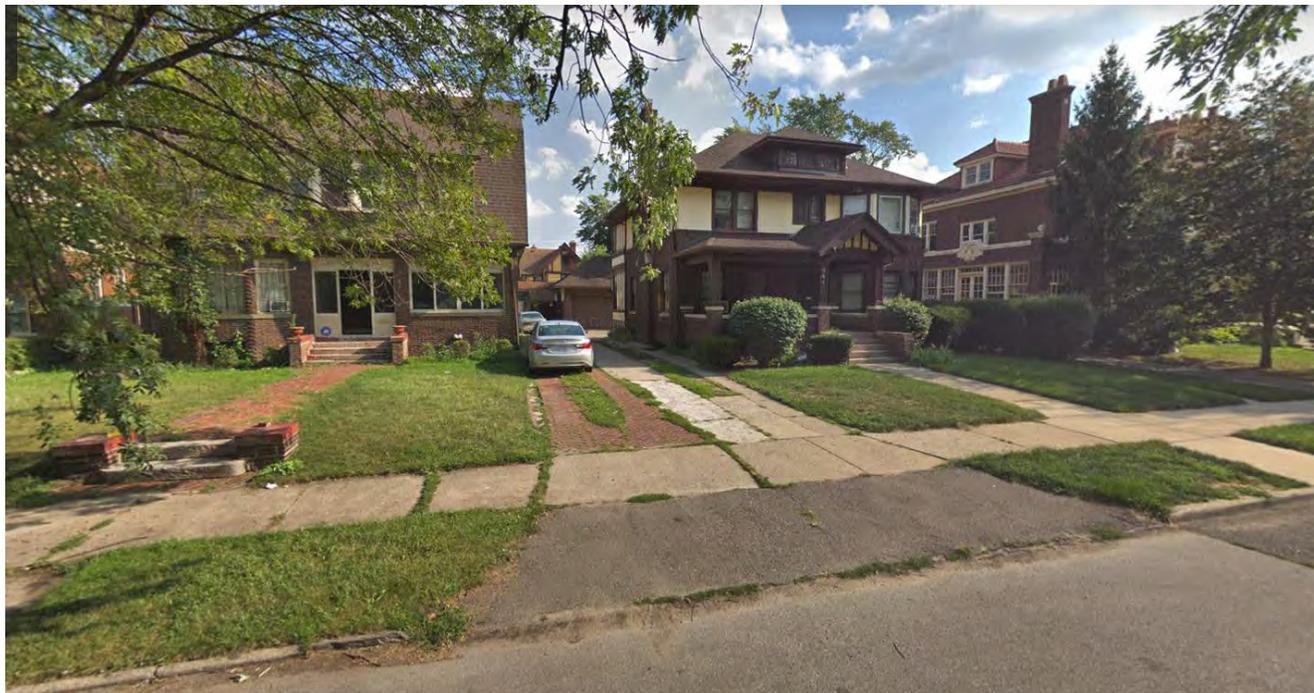
While the applicant has proposed a change in material for the porch and "columns," this alteration from concrete to brick does not destroy historic materials that characterize the property. Wing walls of brick construction can be found on the two homes immediately east of 671 Edison, while the two homes immediately west of 671 have concrete wing walls ([Google streetview images included at the end this report](#)).

Homes immediately east of 671 Edison with brick wingwalls - Google Street View Image, 2018

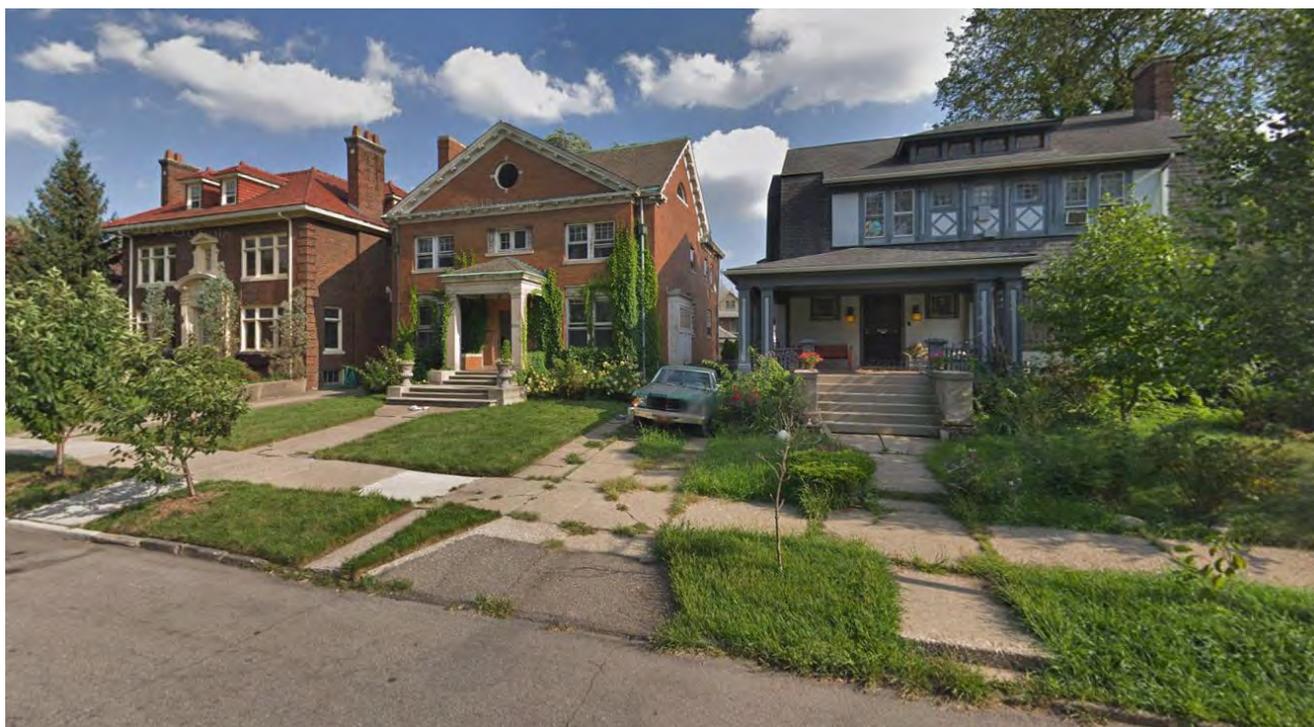
Homes immediately west of 671 Edison with concrete wingwalls - Google Street View Image, 2018
