**STAFF REPORT 07-24-2019 SPECIAL MEETING**  
**APPLICATION NUMBER: 19-6340**  
**ADDRESS: 1205 HUBBARD STREET**  
**HISTORIC DISTRICT: HUBBARD FARMS**  
**APPLICANT: TRACIE MCMILLAN**  
**STAFF SITE VISIT: 07-16-2019**

**PREPARED BY: A. PHILLIPS**

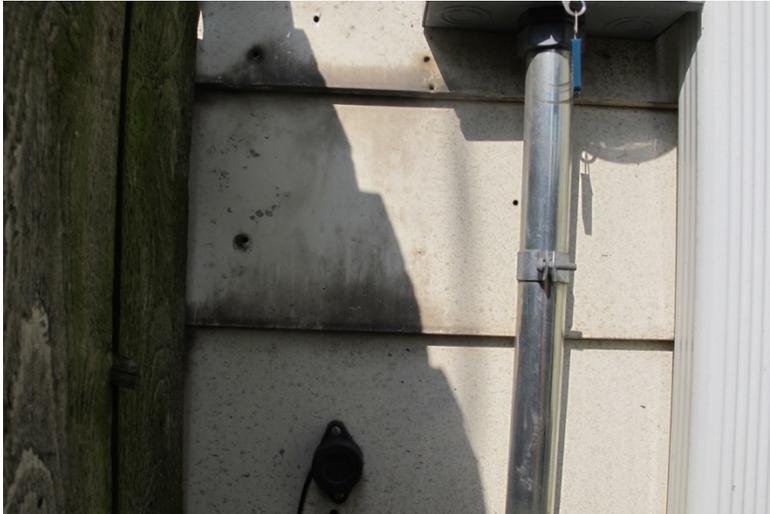
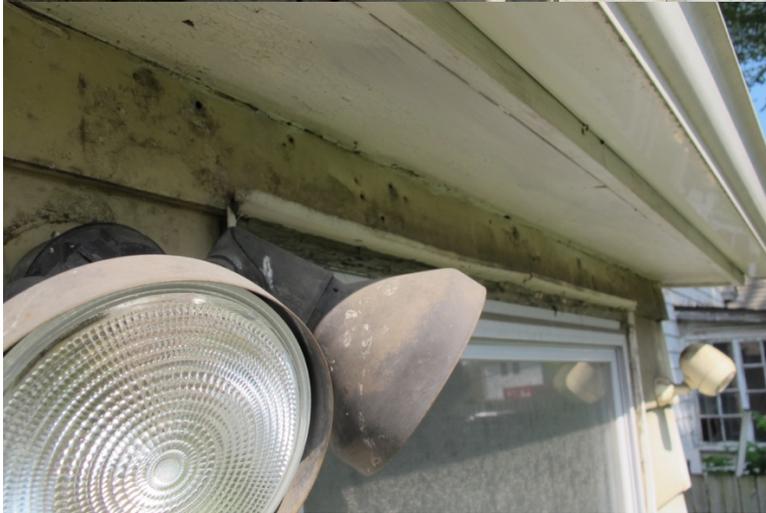
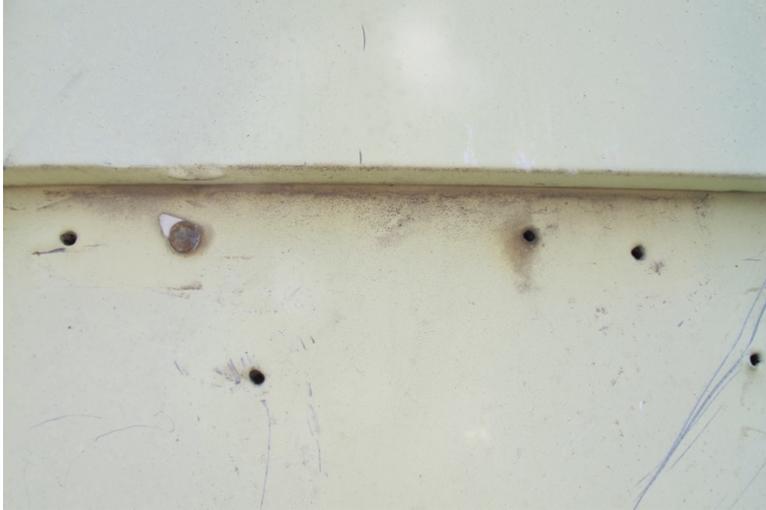
Holes in siding

Much of the building's caulk is brittle and cracked; there are many holes in the siding; and there are signs of mold. There are some issues with flashing having been installed poorly.

- Remove awnings and mounting hardware from front/east of building
- Patch all holes, and caulk all seams, of siding for exterior
- Power wash all siding for exterior
- Paint exterior with Benjamin Moore color, 2063-15 (between 2063-10 and 2063-20)
-

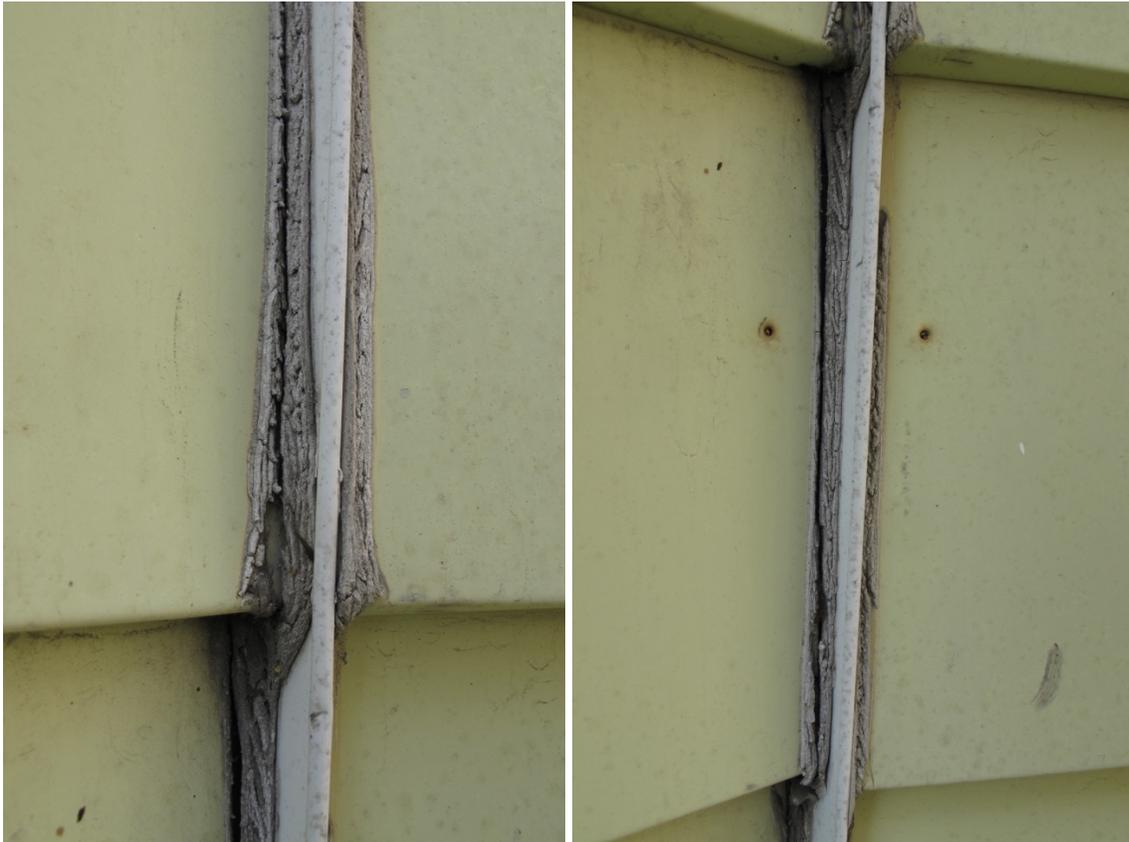
Deteriorated caulking on south side, similar across exterior

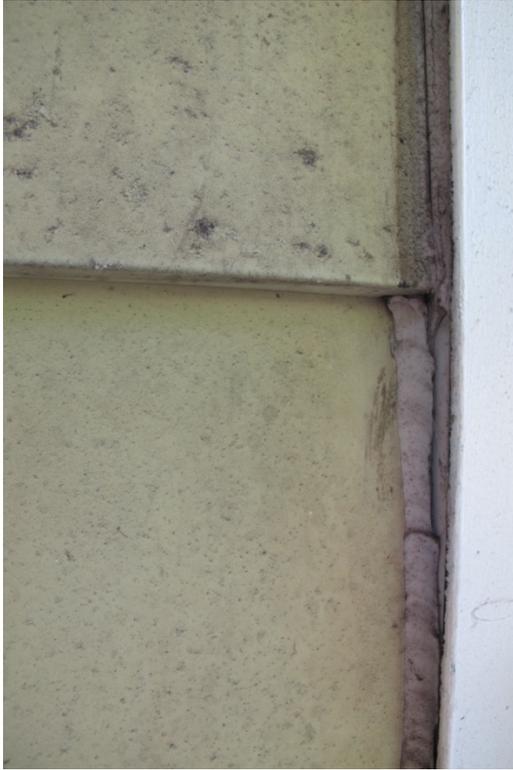
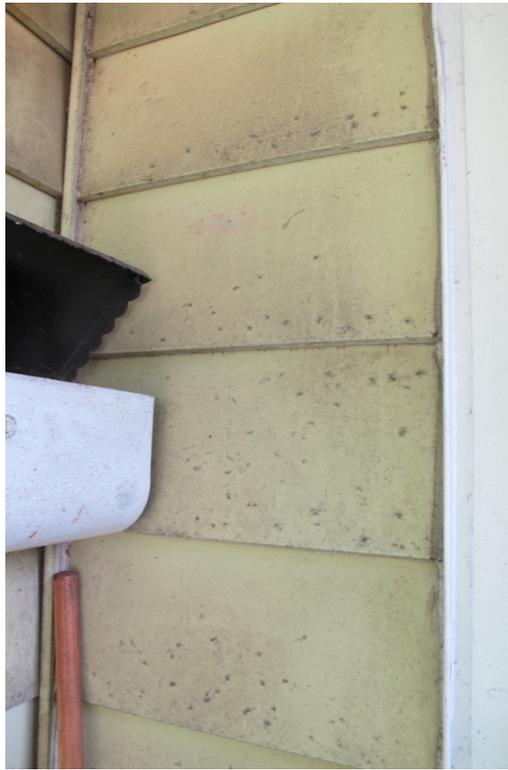
Deteriorated caulking, mold at building entry on east side

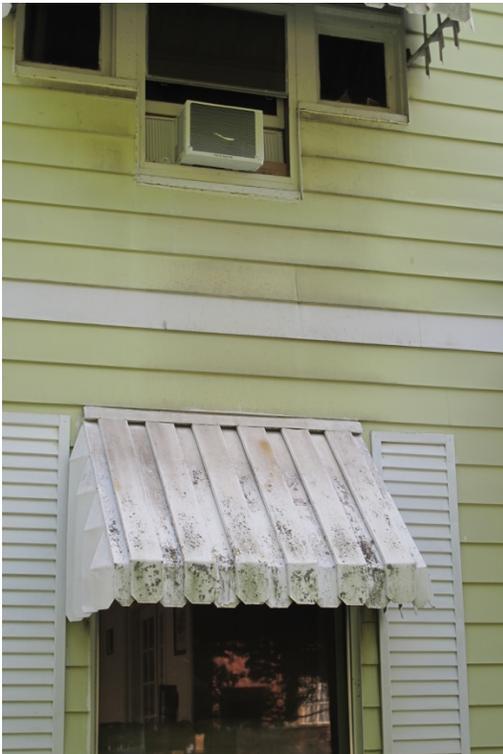
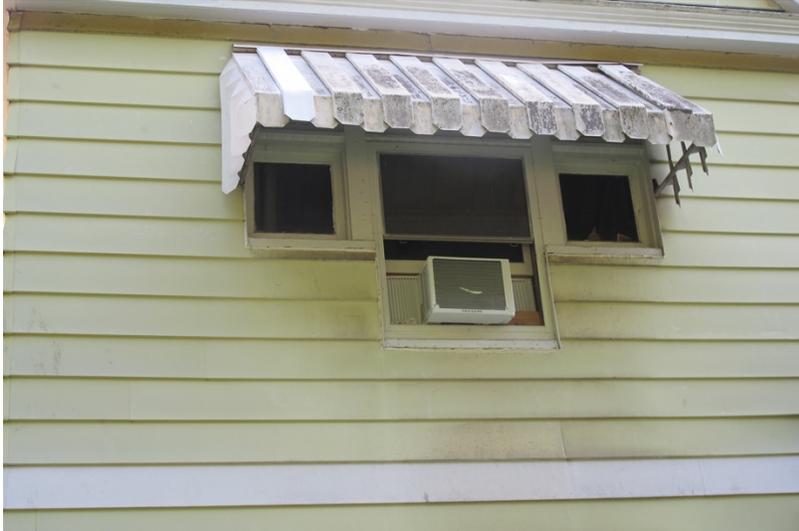
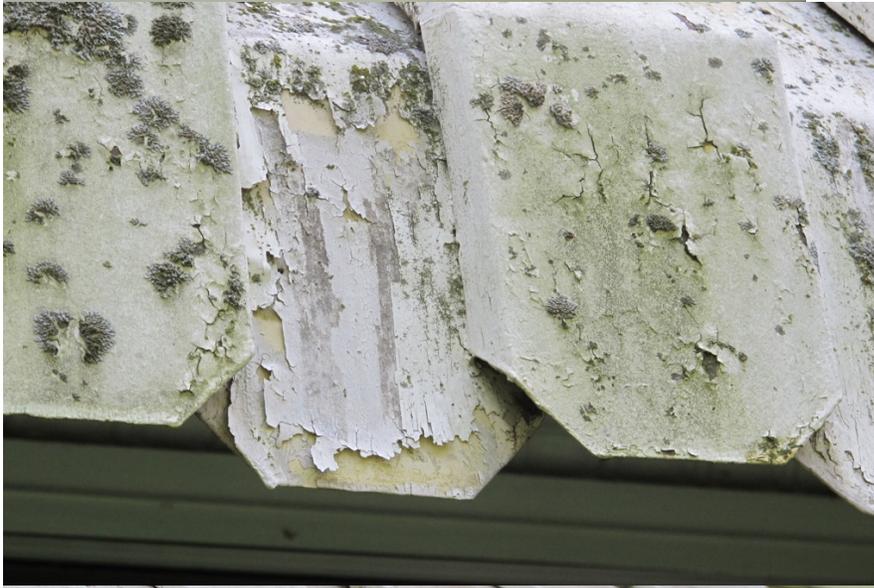
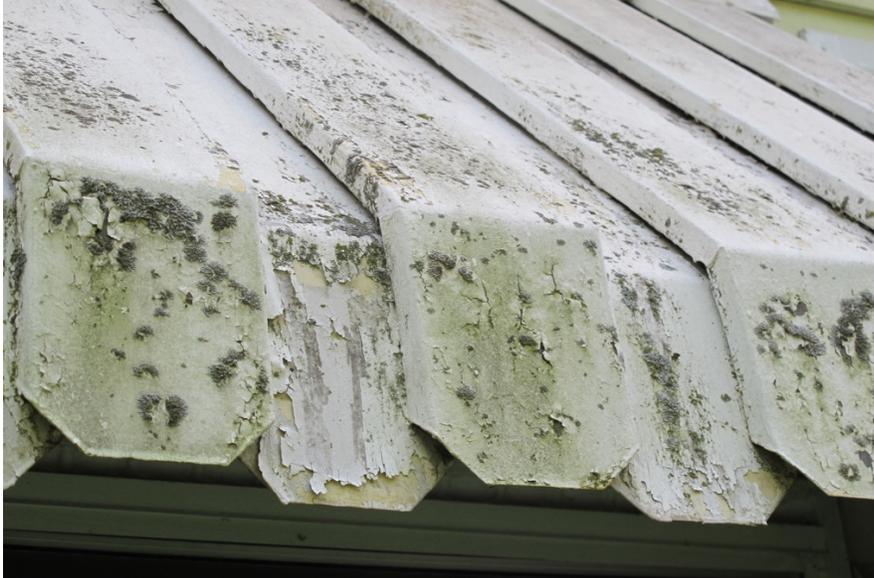
*Awnings*

- Existing aluminum awnings are not considered historic nor are they character-defining features of the style of architecture in which the house is built.

There are also two aluminum awnings—dirty, rusted, of aluminum, and likely added in the 1960s when they were in fashion—on the front of the house. They were painted poorly by previous painters, and this has opened the door for mold.

I would also like to **remove the aluminum awnings**, which were likely added in the 1960s and have no historic value.
