STAFF REPORT 9-11-2019 MEETING
APPLICATION NUMBER 19-6438
ADDRESS: 2225 W. BOSTON
HISTORIC DISTRICT: BOSTON EDISON
APPLICANT: JACQUELINE CUTRIGHT
DATE OF COMPLETE APPLICATION: 8-1-2019
DATE OF STAFF SITE VISIT: 9/9/2019

SCOPE: REPLACE WOOD COLUMNS WITH NEW FIBERGLASS COLUMNS

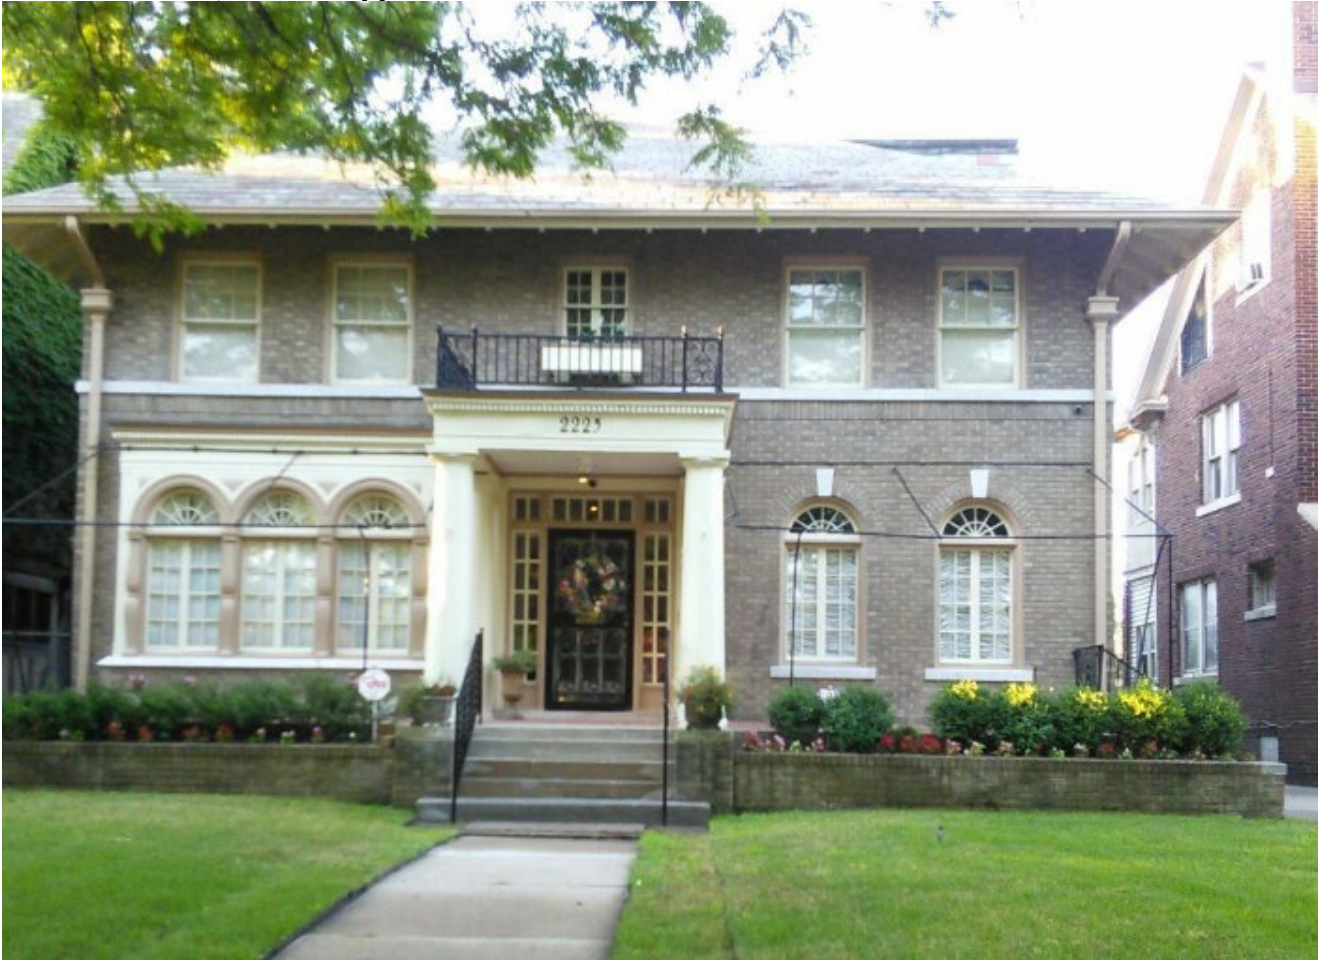
2225 W. Boston, current appearance

existing trim/pilasters. The applicant has stated that the homeowner wishes to replace the columns because they are rotted at the base.

- The applicant has provided photographic evidence of the wood rot at the base of the two columns. Staff has reviewed these photos and is of the opinion that the columns can be repaired.
- It is also staff's opinion that the columns are significant character-defining features of the home

As per the above, it is staff's opinion that the two columns proposed for replacement can be repaired. Staff therefore recommends that the Commission deny the issuance of a Certificate of Appropriateness for the work as proposed because it does not meet the Secretary of the Interior Standards for Rehabilitation, standard # 6) *Deteriorated historic features shall be repaired rather than replaced. Where the severity of deterioration requires replacement of a distinctive feature, the new feature shall match the old in design, color, texture, and other visual qualities and, where possible, materials. Replacement of missing features shall be substantiated by documentary, physical, or pictorial evidence.*
