STAFF REPORT: 12-11-2019 MEETING
APPLICATION NUMBER: 19-6526
ADDRESS: 1155 CLARK
HISTORIC DISTRICT: HUBBARD FARMS
APPLICANT: KOBLAR JACKSON
DATE OF COMPLETE APPLICATION: 11/5/2019
DATE OF STAFF SITE VISIT: 12/6/2019

SCOPE: REPLACE PORCH AT REAR ELEVATION

Historic District Commission Project Review Request—1155 Clark Street, Detroit, MI 48209

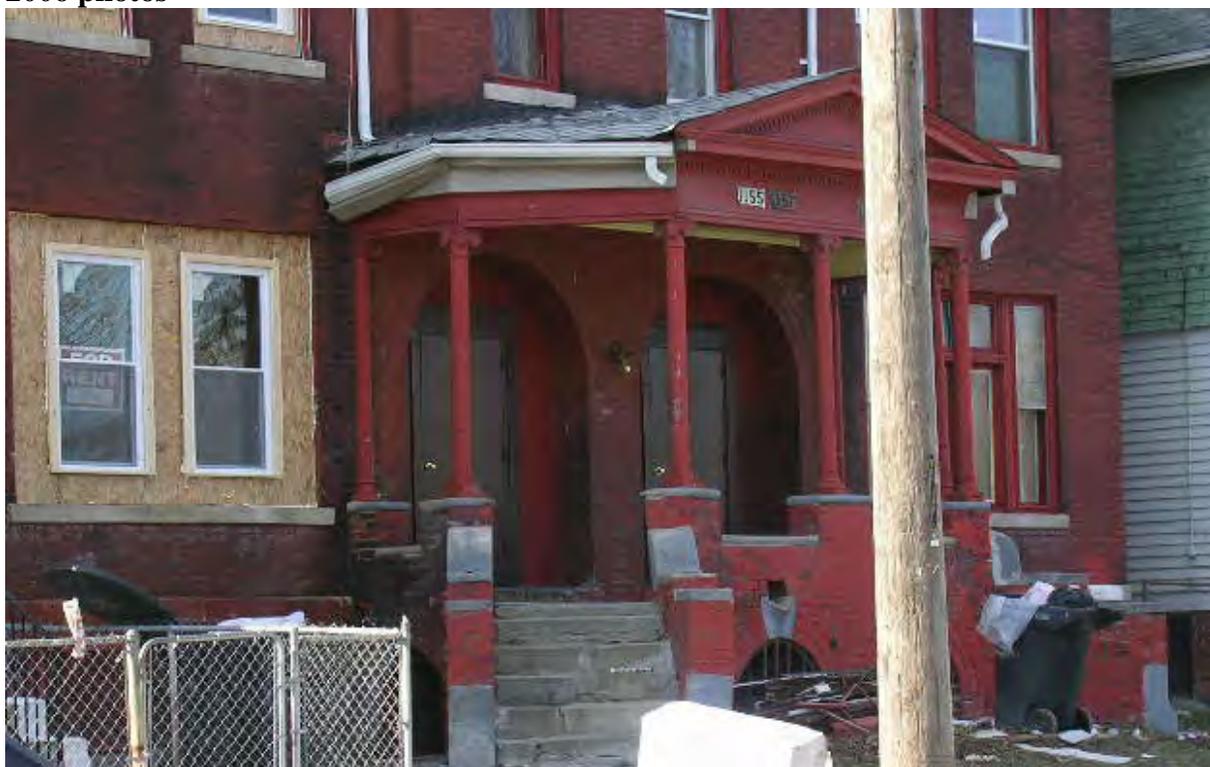
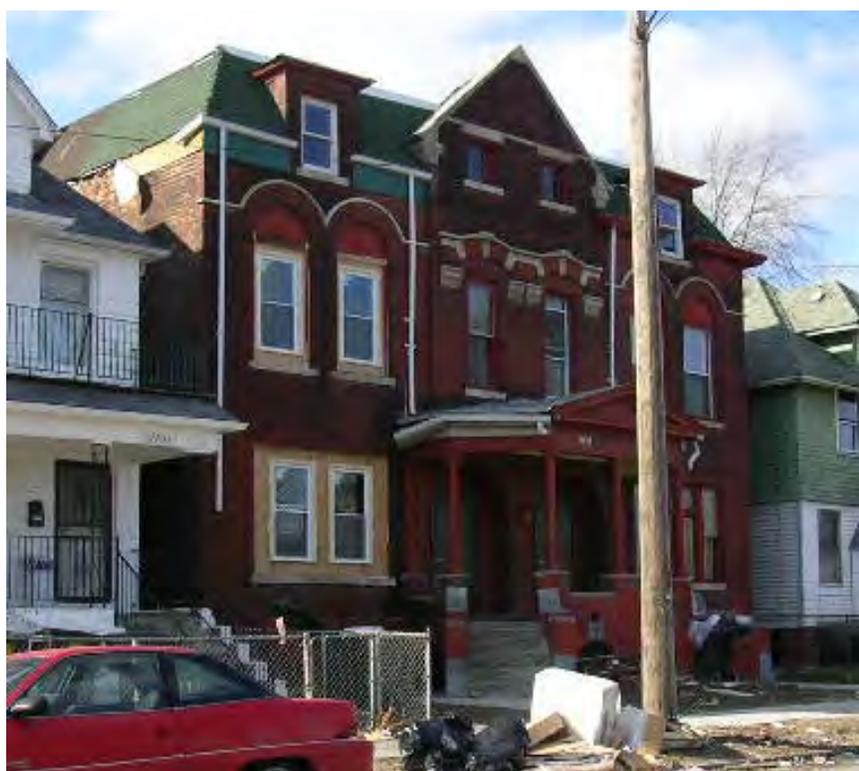
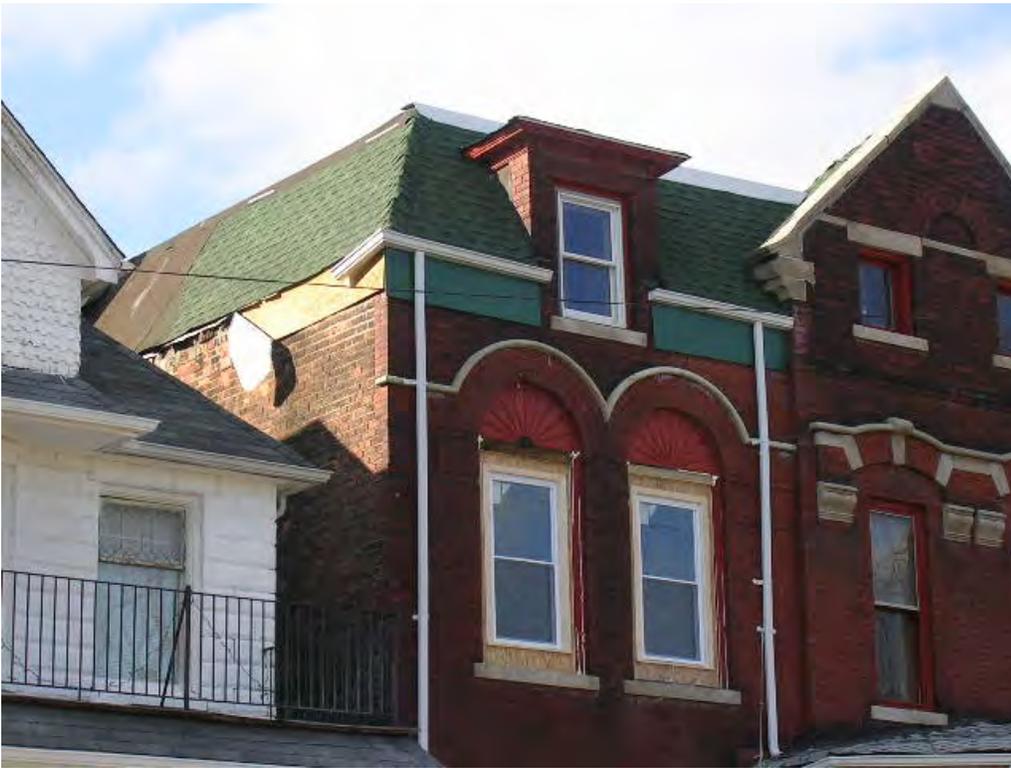
2006 photos

- The porch proposed for removal is historic age. However, it appears to be in poor conditions and appears to have been significantly modified over time. It is staff's opinion that the structure is not a character defining feature of this historic house.
- The submitted drawings indicate that the small deck which leads to the elevated door at the proposed new central stair enclosure does not have a railing. Building code will require that a railing be installed at this location
- A review of the property file revealed that original windows were removed, opening were partially infilled with plywood, and new vinyl windows were added without HDC approval and or permit in 2006. Please see the below scanned pictures of the 2006 violation:

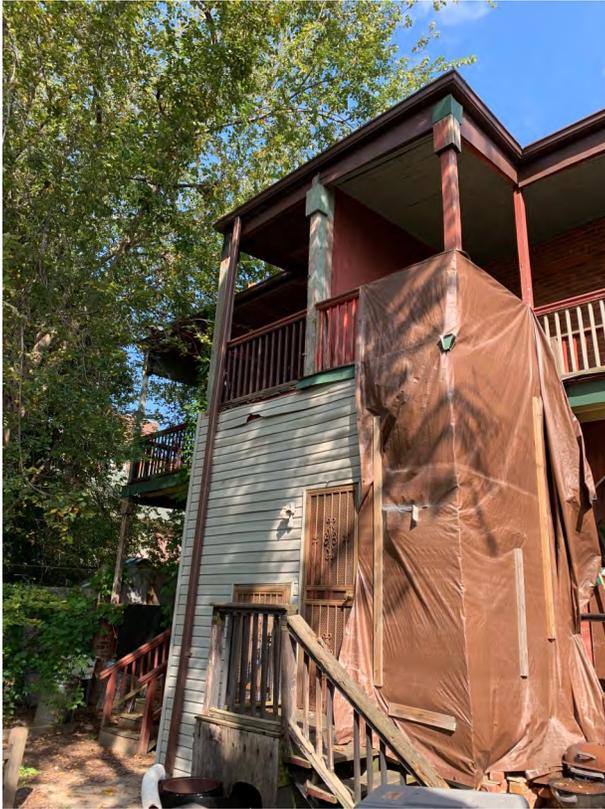
Below: (B1) Central Stair Column providing egress and access to second floor deck and basement. Tree Strike covered by tarp. Proposed to be Rebuilt with same access points / Layout as existing, to Modern Code.

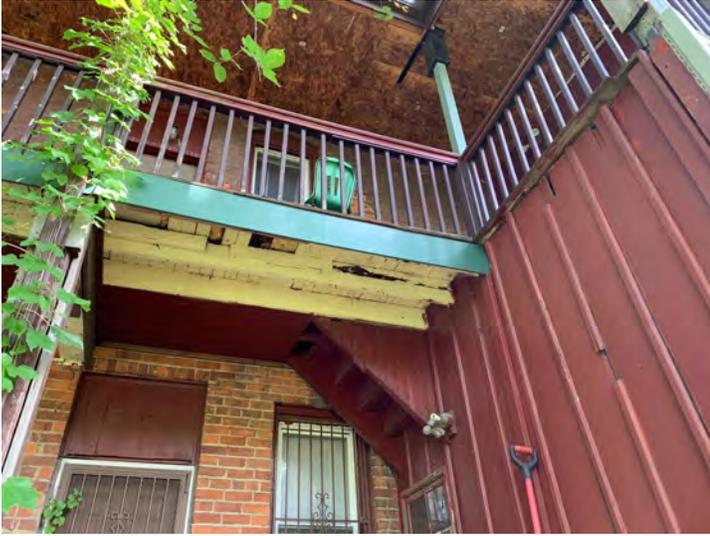
Above: (D1) Existing Decking condition, as well as stair detail shot. Note deterioration in the existing decking, as well as the condition of the existing board and batten (B&B) siding.

There is also significant water damage to the existing structure. Most of the upper deck boards have either rotted away, or will be unstable soon, resulting in covering with O.S.B. (photos D1, D3, D6), and the column to joist connections have begun to fail (Photo D6)

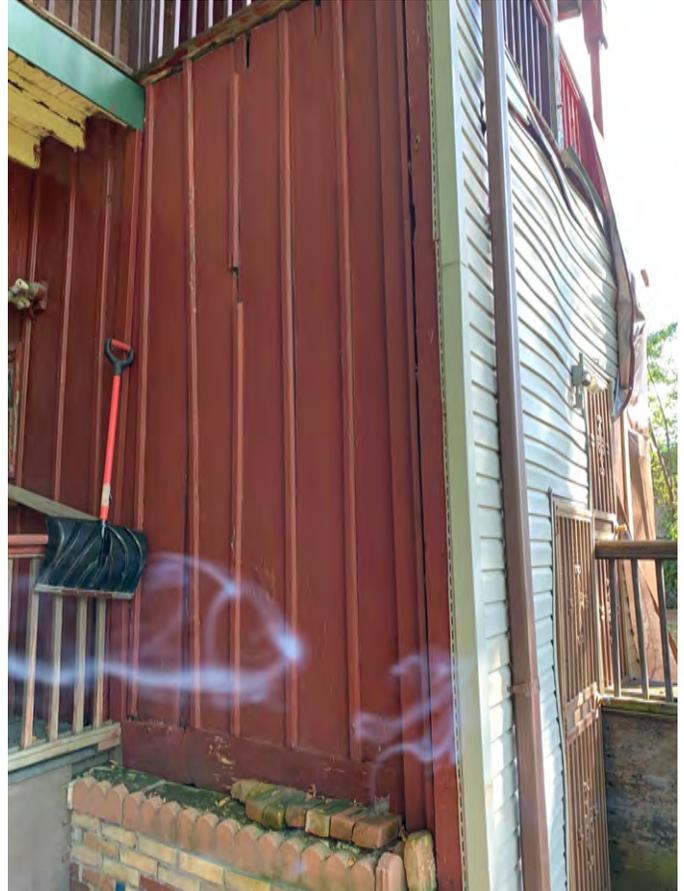
Right: (D2) Transition between perceived original B&B siding and new Vinyl lap siding. Condition of existing vinyl is quite poor, and doesn't match in pattern or material the perceived original B&B.

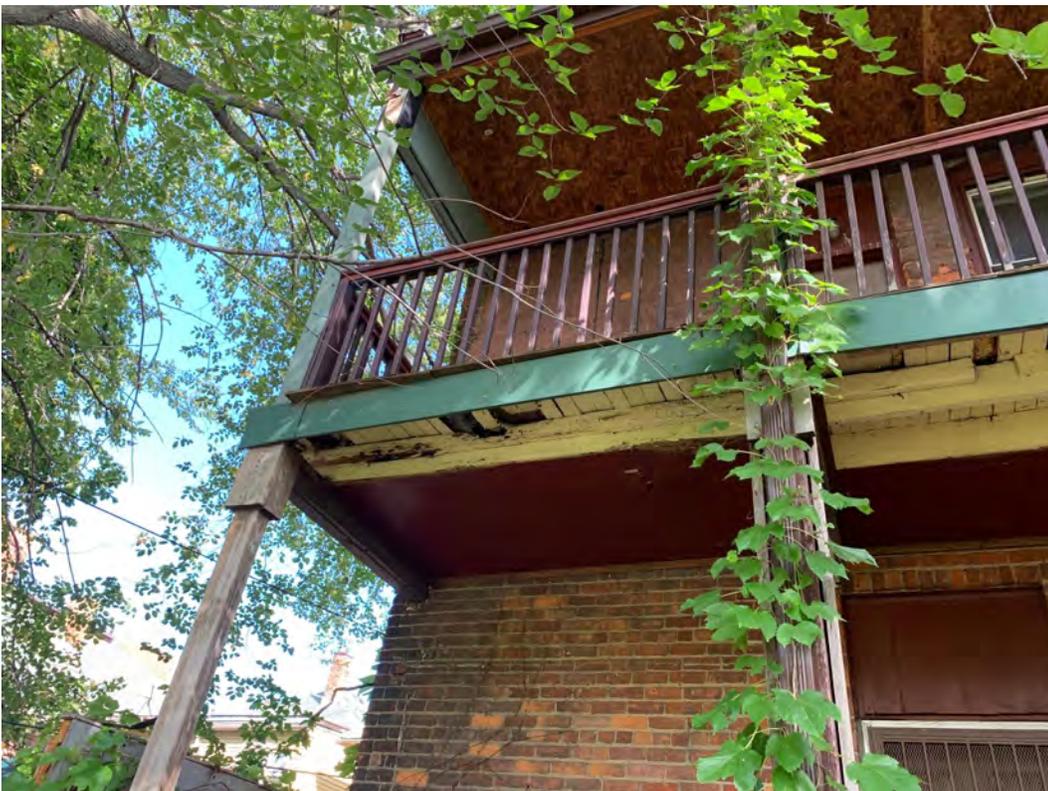
Left: (D3) Further existing decking details. Also note the O.S.B. Sheathing on the underside of the roof deck. Original has deteriorated to the point of need cover.

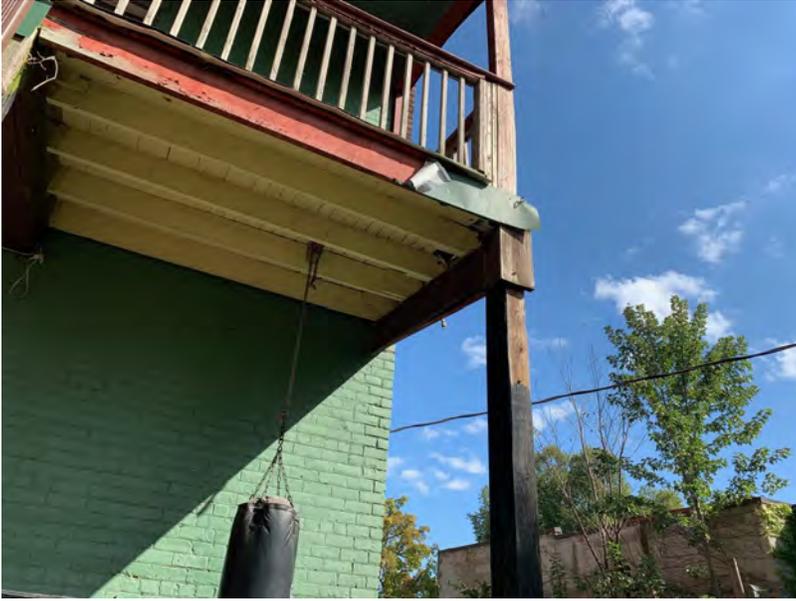
Above: (D4) RH side of deck Structural detail. Note slight bow in upper 4"x4", condition of joist over the beam, and extra blocking around the floor to floor connection.

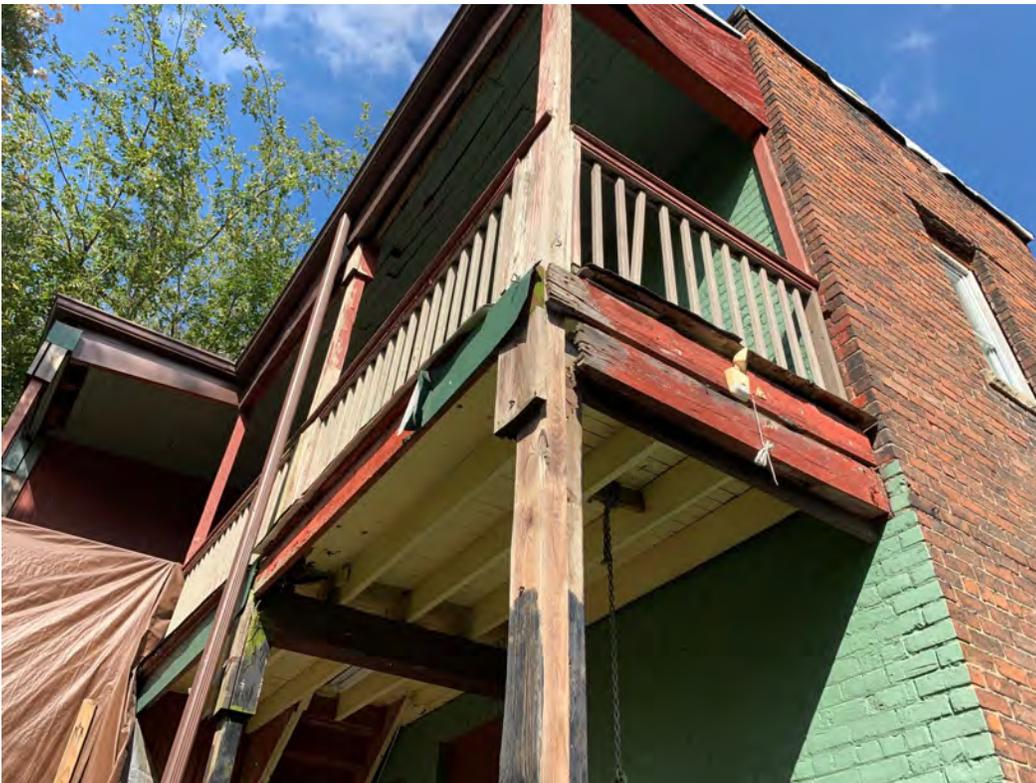
Left: (D6) RH Deck Structural Detail. Note Deterioration of Beam connecting column to Building. Also of note, deterioration of bead board ceiling on second floor. Floor to floor connection is out of plumb.

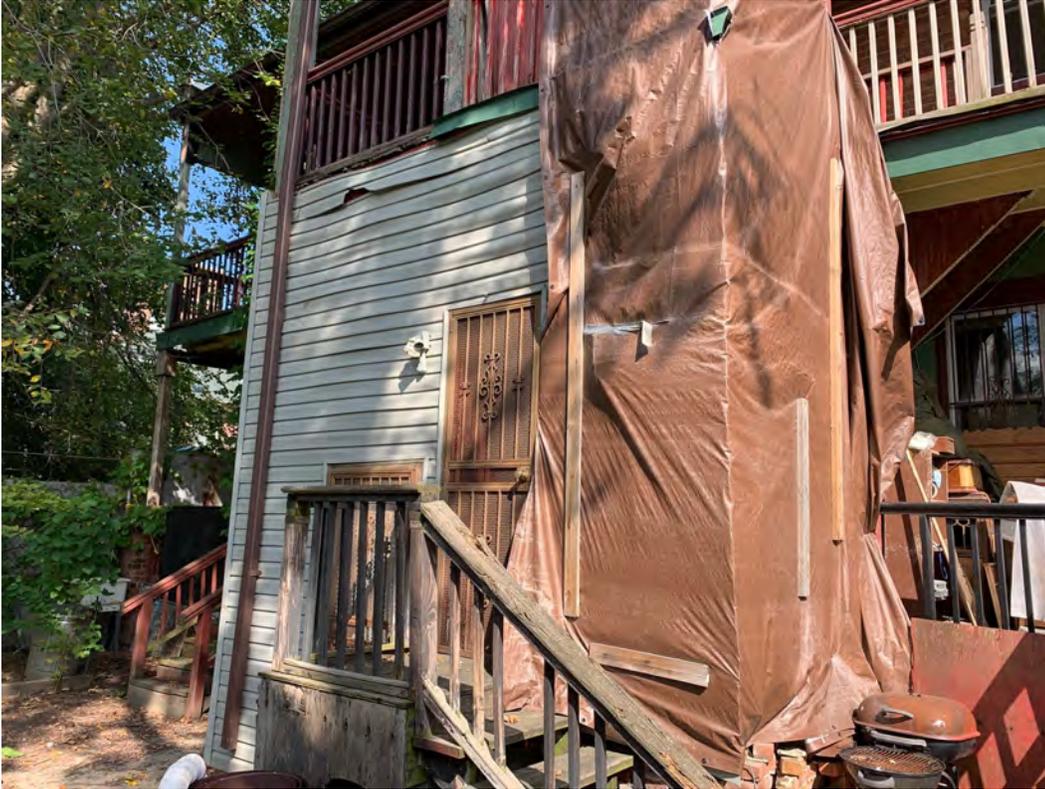
Left: (D7) Center Stair Column Detail. Area Covered by Tarp had a Tree Strike. Fair Amount of damage, Interior has been braced by homeowner temporarily.

There is significant damage from a tree fall on the center stair column (the area is tarped at the moment, for a temporary weather barrier) Photos D7, D8 and D9 show the afflicted areas. The framing has been affected, and the foundation wall is delaminating as a result.

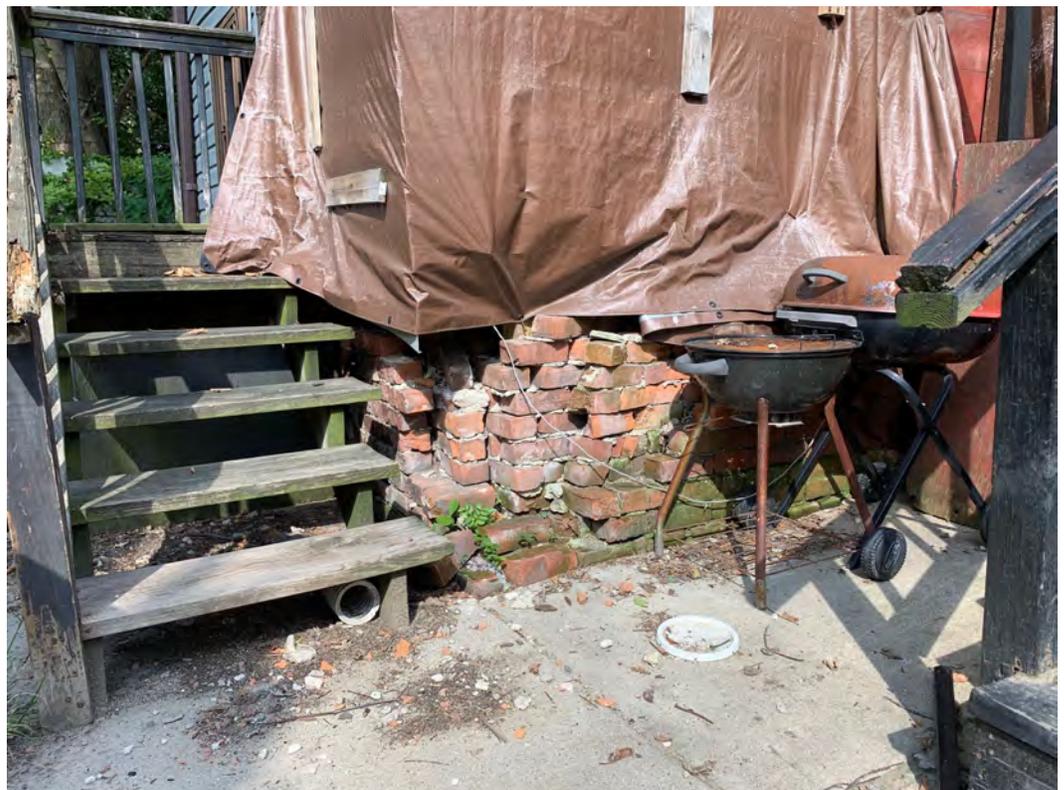
Right: (D8) Stair Column Foundation Detail. Brick Corner (3 wythe) of foundation wall sustained significant damage from tree strike. Far Corner (Behind Stair Run) shows water damage, with the top several feet of the foundation wall delaminating.

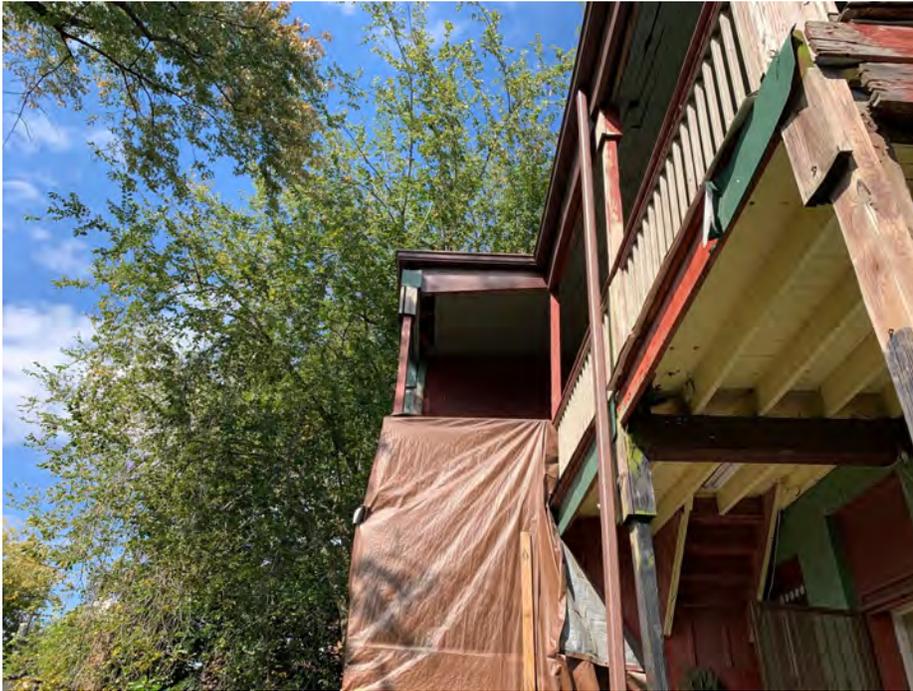
Left: (D9) Profile of center stair column. Notice the bow on the outer-most post on the stair column. The middle column floor to floor connection also shows serious water damage.

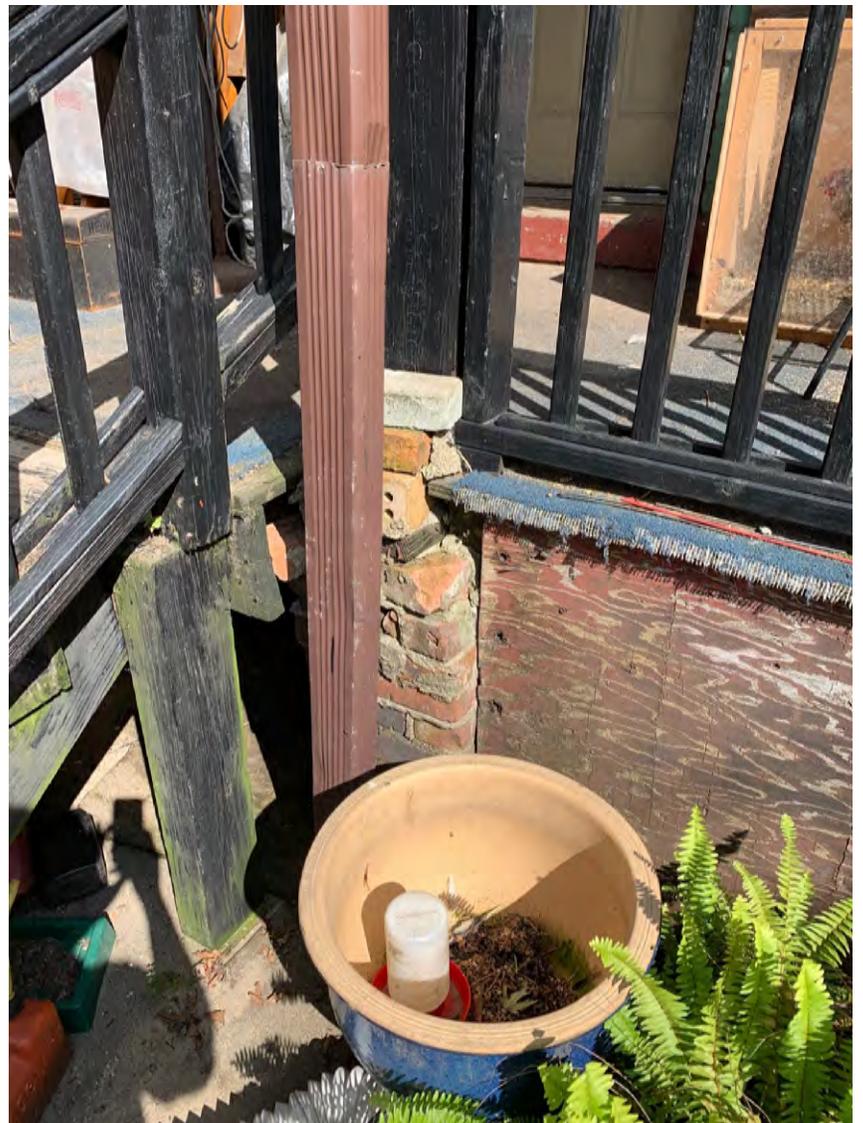
Right: (D10) Column pier Detail. This picture represents the typical condition of the column support piers. They are brick, roughly 3' tall and 1' square. The current condition is out of plumb, with mortar failing and on some piers, bricks missing. The columns also are not set in a bracket, are loose on top of masonry piers.
