STAFF REPORT 01-22-2020 REGULAR MEETING
APPLICATION NUMBER: 20-6602
ADDRESS: 2224 SEMINOLE STREET
HISTORIC DISTRICT: INDIAN VILLAGE
APPLICANT: STEVEN FLUM, ARCHITECT
PROPERTY OWNER: BENSON BRADY
DATE OF COMPLETE APPLICATION: 01-02-2020
STAFF SITE VISIT: 01-07-2020

SCOPE: CONSTRUCTION OF THREE (3) NEW ADDITIONS TO EXISTING GARAGE

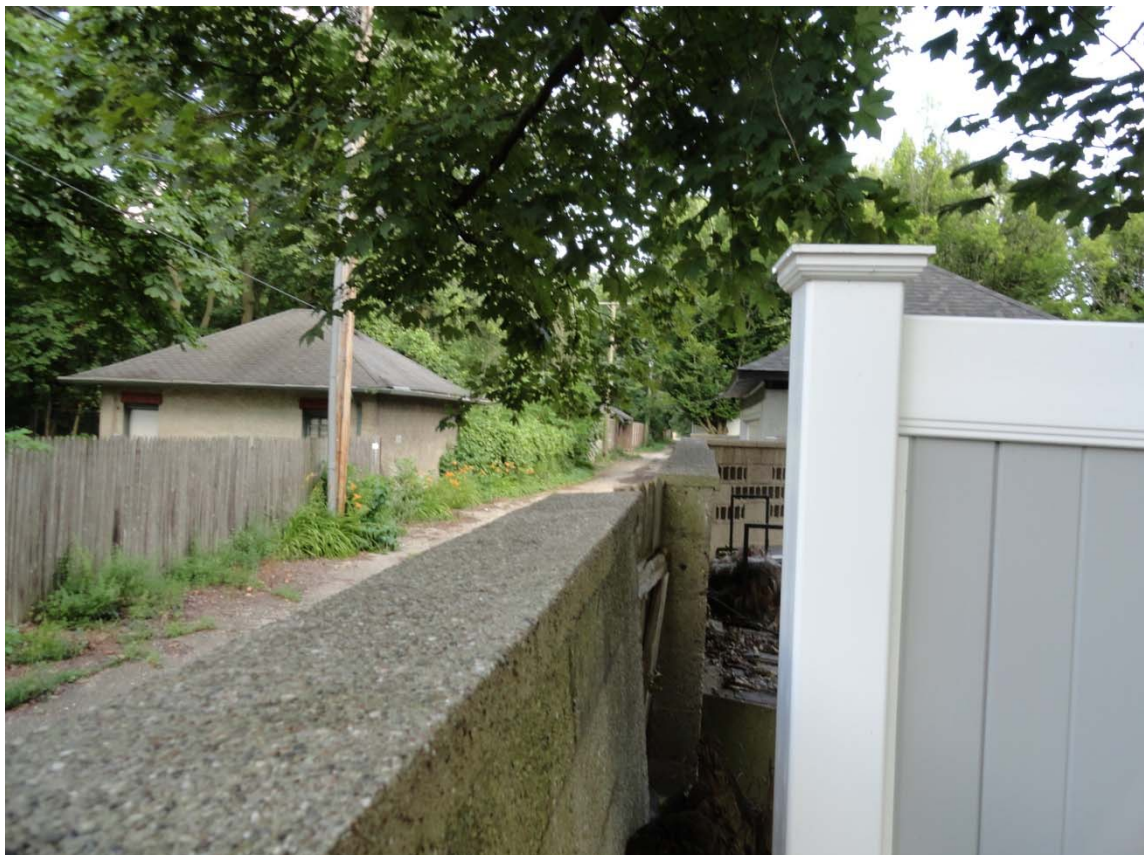
Existing failed masonry wall and existing vinyl fence

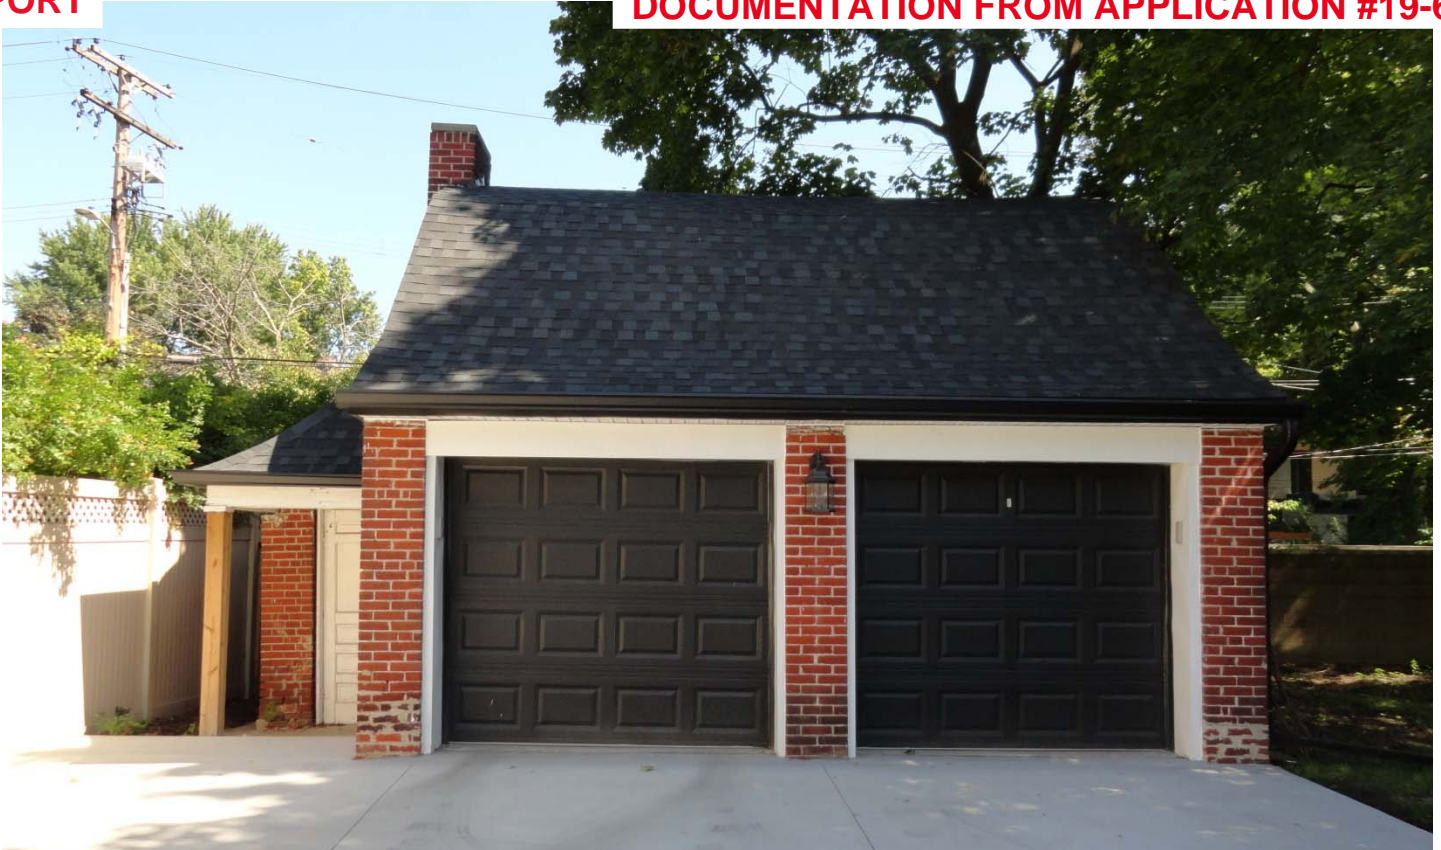
1-West Elevation

- Good Condition. There are newer asphalt roof, metal flashing, gutters and downspouts (Pictures #1, #2)

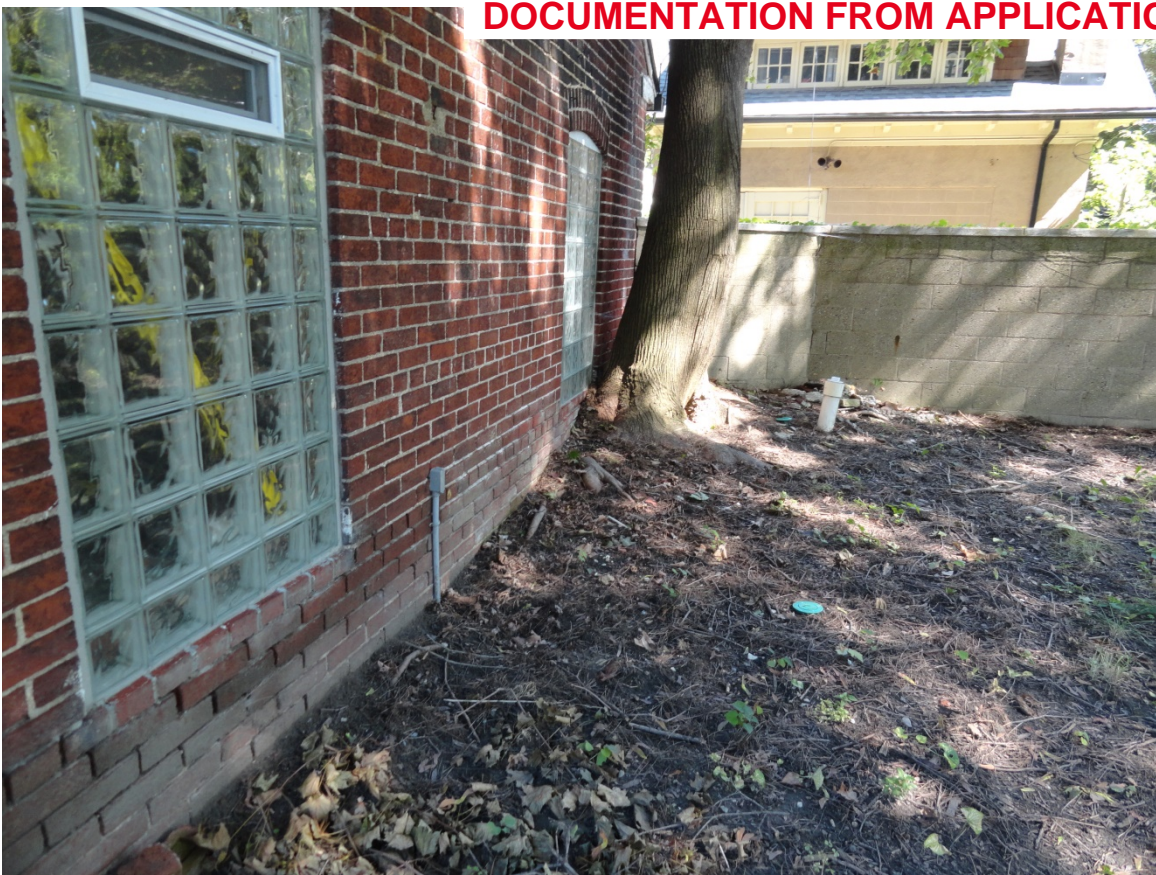
- Poor Condition. There are three maple trees in the rear yard causing damage. The first tree is approximately 20" in diameter and is located next to the south wall of the garage. The tree is causing damage to the garage wall and foundation, cracking the alley CMU screen wall and foundation and possible damage to the sanitary line beneath the tree. (Pictures #5, #6). The second tree is approximately 12" in diameter and is located next to the alley CMU wall. The tree and its root system has pushed out the wall and will collapse in the alley right of way (Pictures #20, #21). The third tree is approximately 30" in diameter and is the largest and most mature tree on the property. The tree and its long branches are a threat to the house to the garage and the neighbor's property.

5-South Elevation Tree Encroachment

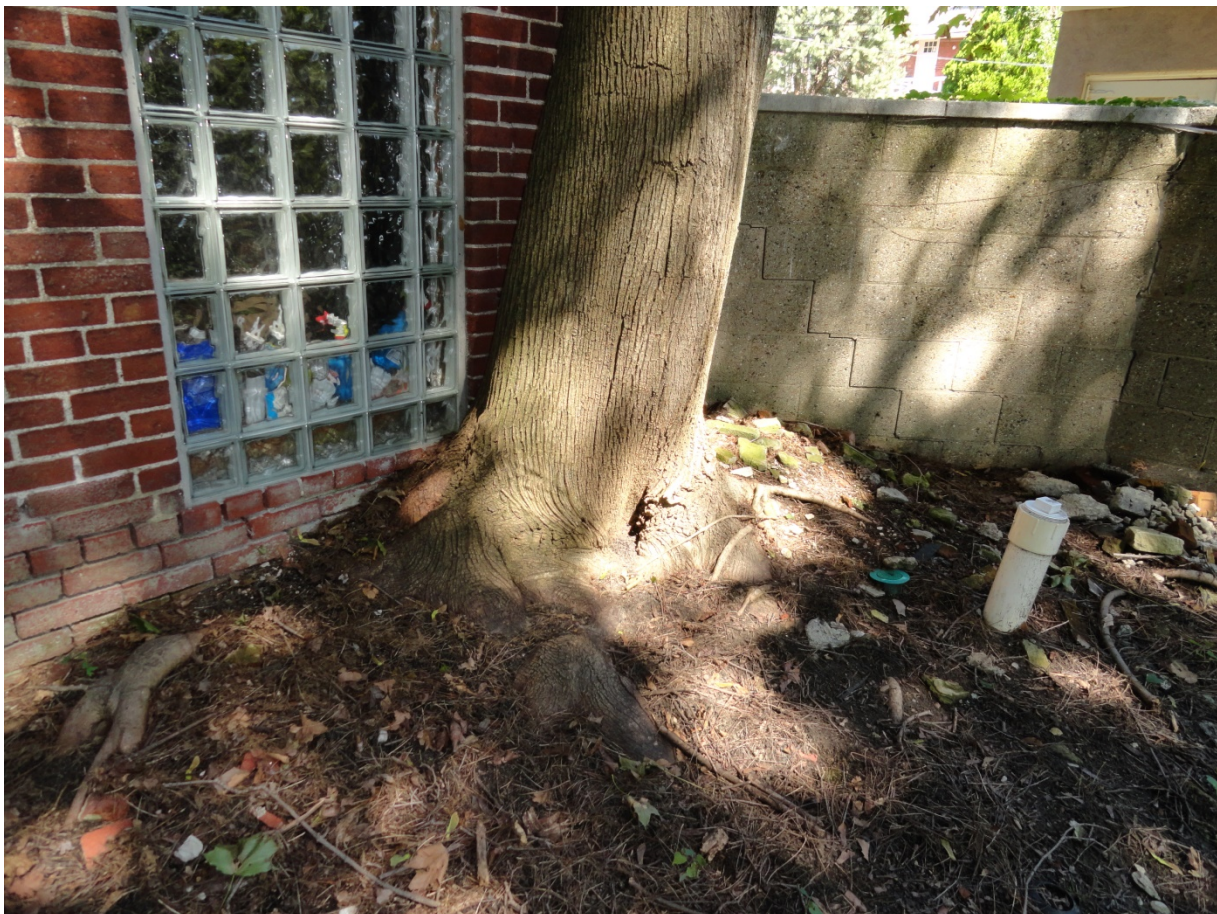
6-South Elevation Tree Encroachment

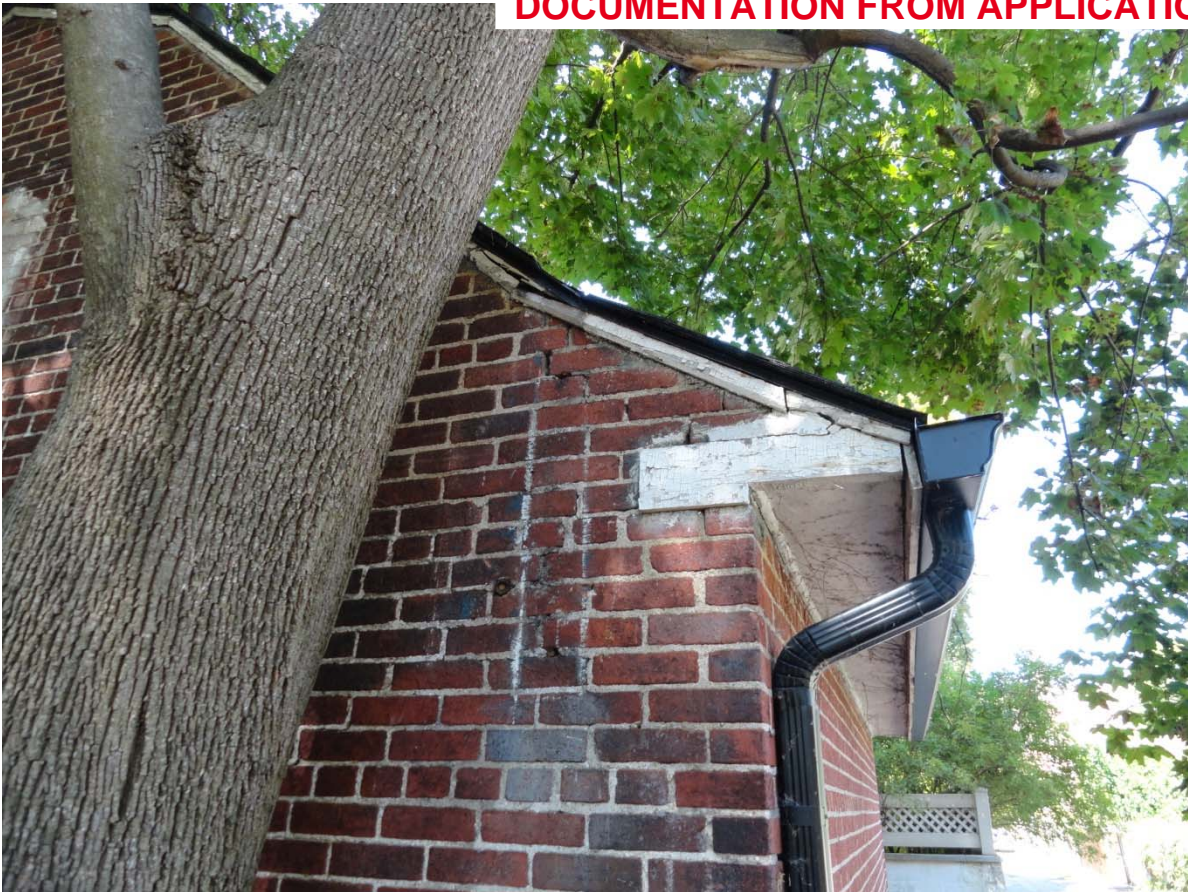
7-Southeast corner masonry issue

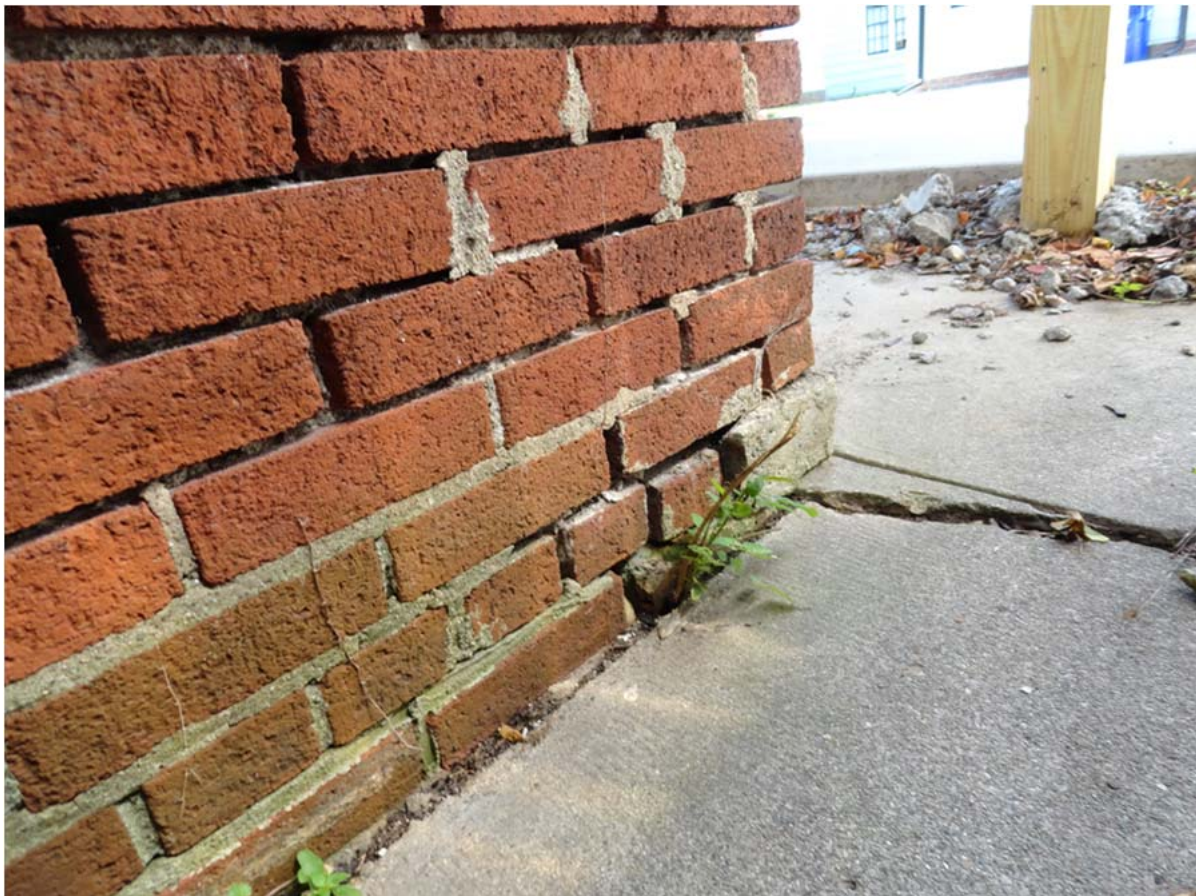
- Fair Condition. The brick masonry has been tuck-pointed in places. Additional tuck-pointing is needed including reconstruction of the shed walls and openings (Pictures #1-#4, #8, #9, #15-#18)

8-Northwest corner masonry issue

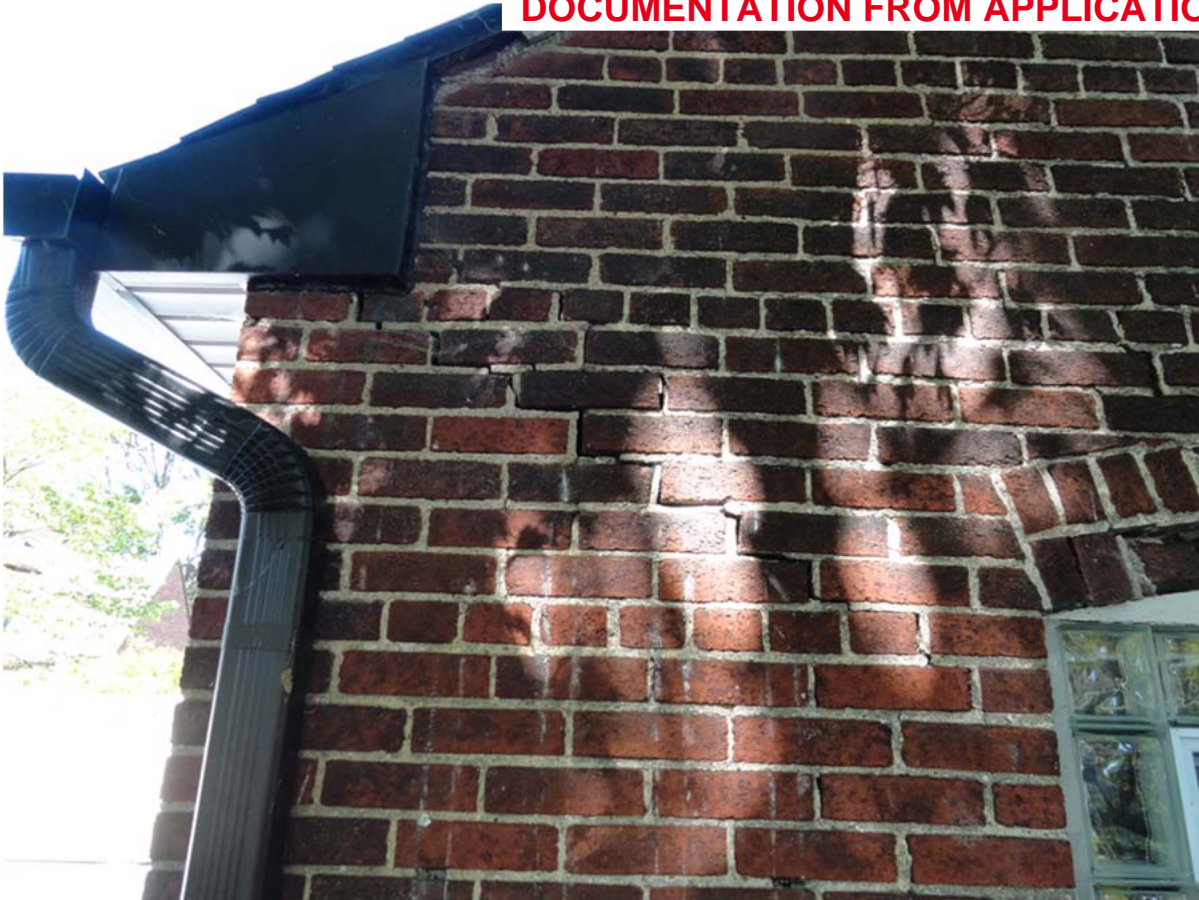
- Poor Condition. The shed foundation and walls showing signs of imminent failure (Pictures #4, #5, #15-#19).
- Poor Condition. The southwest corner of the garage exterior brick wall is cracking. The cracking is telegraphing the entire width of the wall. Evidence of this is shown on the interior plaster wall which has the same wall cracking location and pattern (Pictures #9 and #10). It is unclear if this damage was caused by water infiltration or the foundation failing at the southeast corner of the garage.
- Poor Condition. The CMU screen wall is also showing signs of imminent failure (Pictures #20 and #21)

- Poor Condition. The shed show signs of failure with walls cracking and door and window shifting (Pictures #8, #15-#19).
- Poor Condition. The southwest corner of the garage foundation is failing with signs of brick cracking (Pictures #9 and #10).
- Poor Condition. Existing tree is causing damage to the south garage foundation (Pictures #5 and #6)
- Poor Condition. Existing tree is causing damage to the CMU screen wall and is leaning out over the alley right of way (Pictures #20 and #21)

9-Southwest corner masonry issue

- The damage to the southwest corner of the garage appears salvageable through repairs to localized conditions without resorting to wholesale demolition.

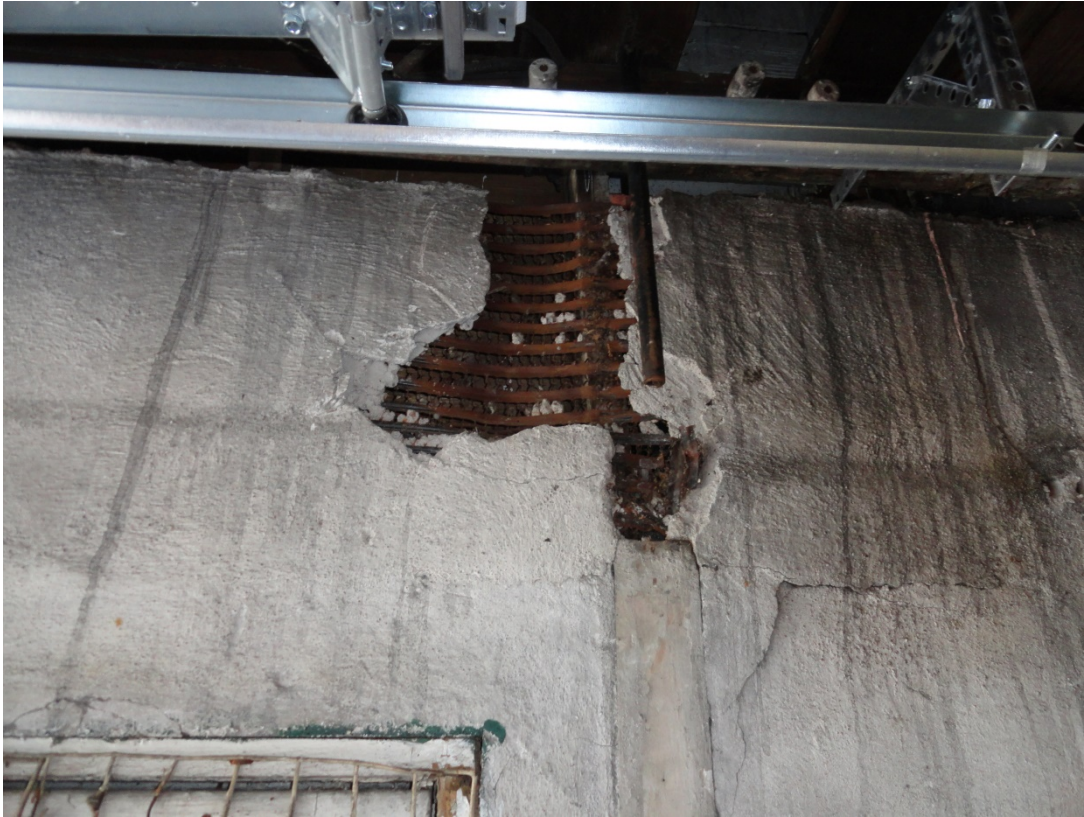
13- Interior wall deterioration at shed addition

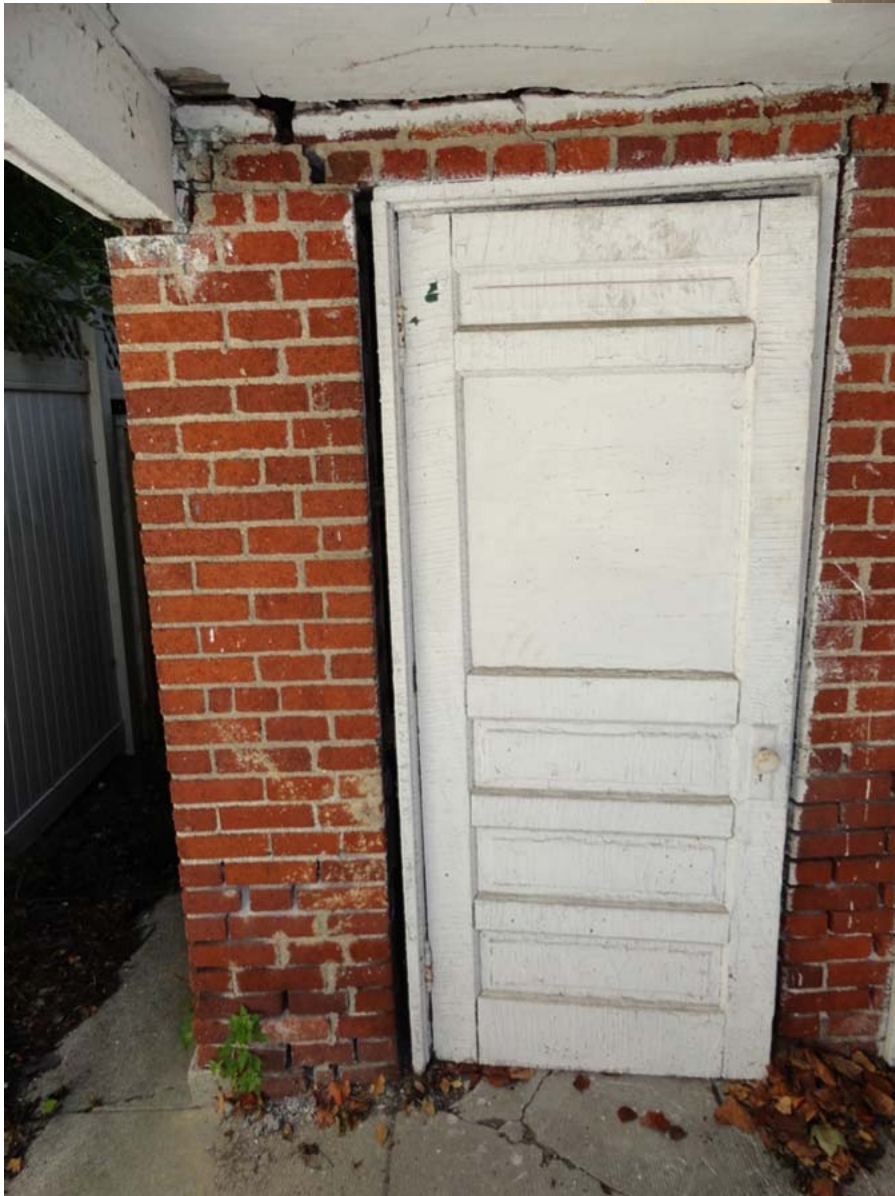
- Poor Condition. The shed show signs of the exterior wall shifting and is in need of reconstruction (Picture #8, #15-#19).
- Poor Condition. The CMU alley screen wall leaning towards the alley and is in danger of collapsing. (Pictures #20 and #21).

- Poor Condition. The shed shifting wall and foundations have damaged the window and door openings making them inoperable. (Pictures #4, #5, #15-#19).

16- Shed Addition structural
issue

- Staff concurs that repairs to the shed area at the north (side) elevation may be extensive enough to require significant demolition and reconstruction of that specific element.

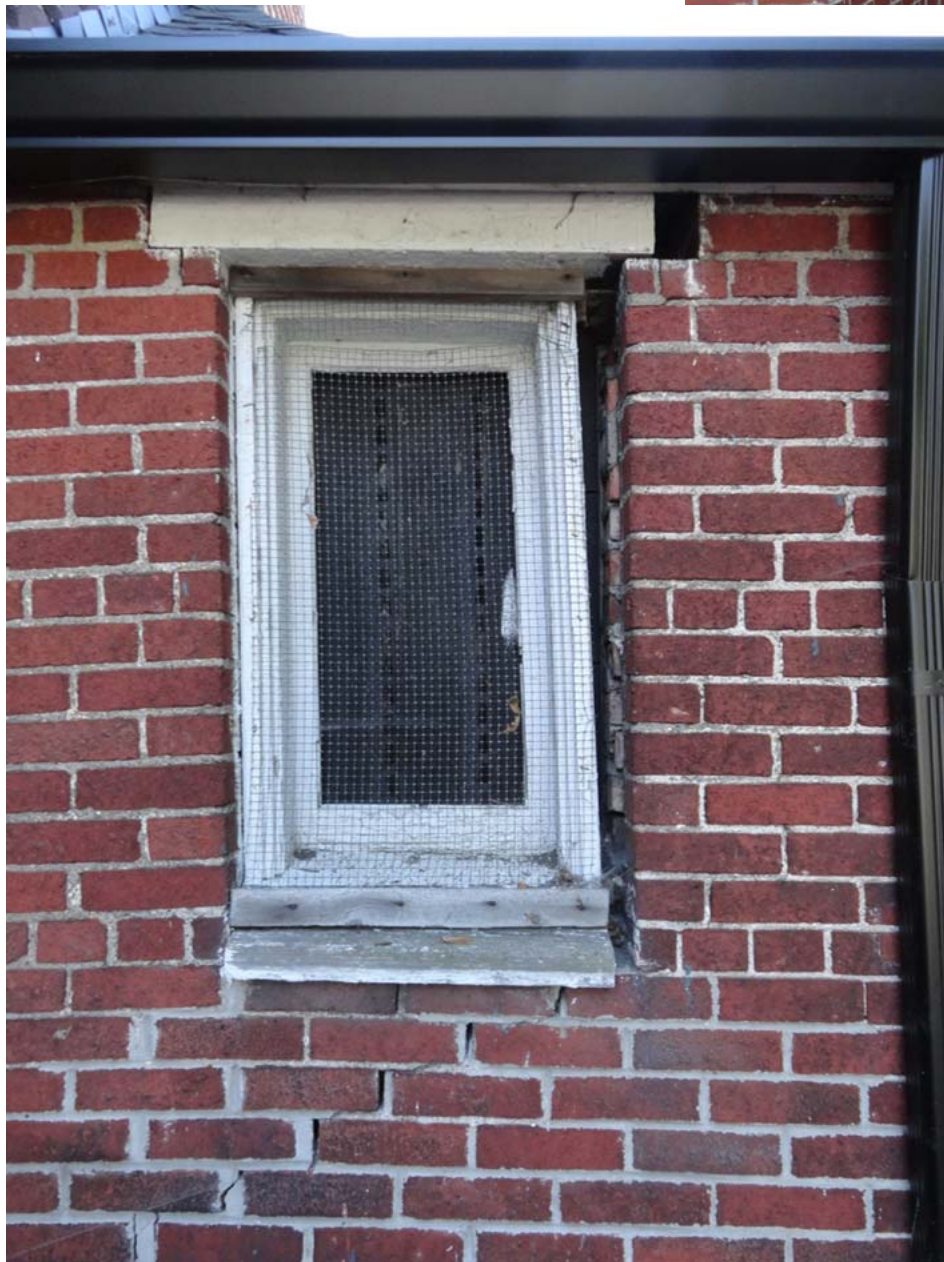
18- Shed Addition
structural issue

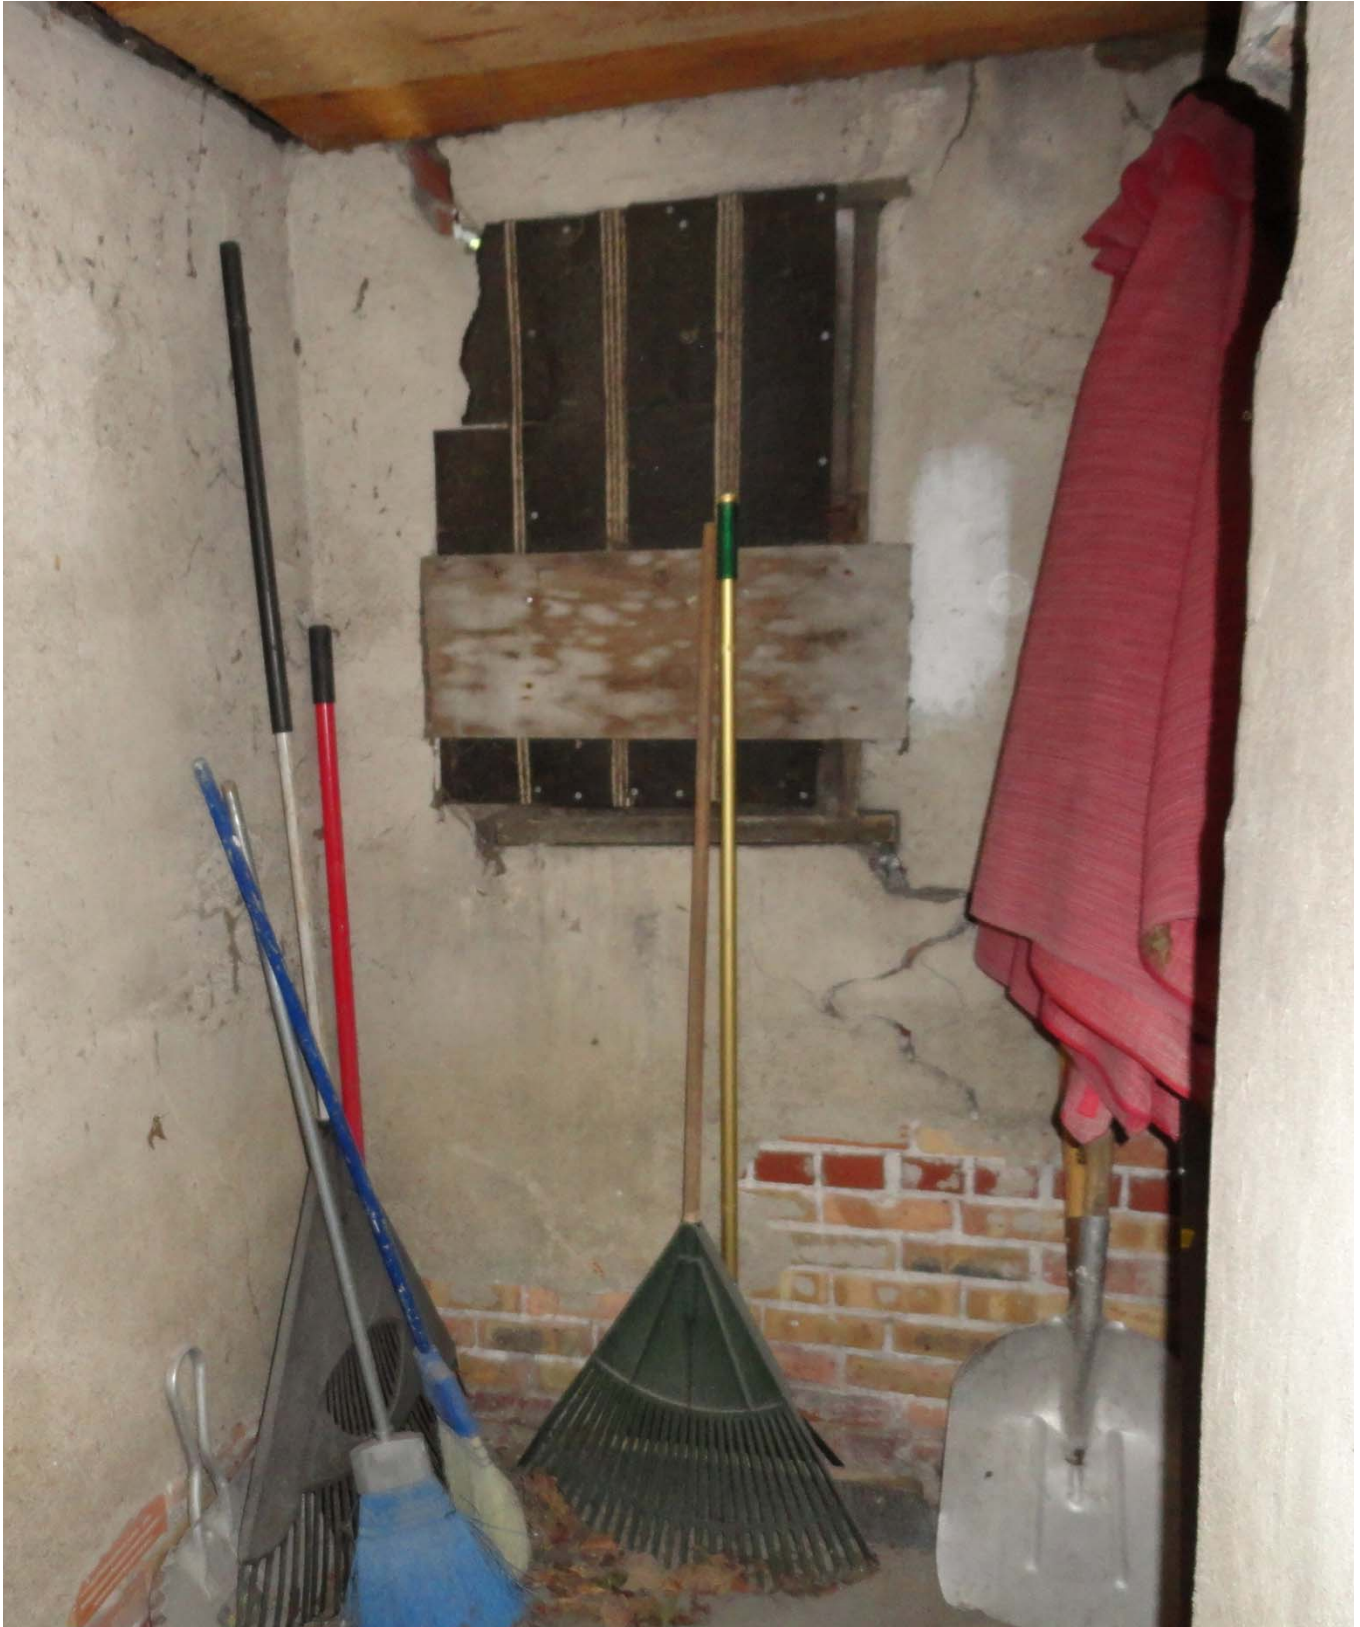
19-Interior of Shed Addition

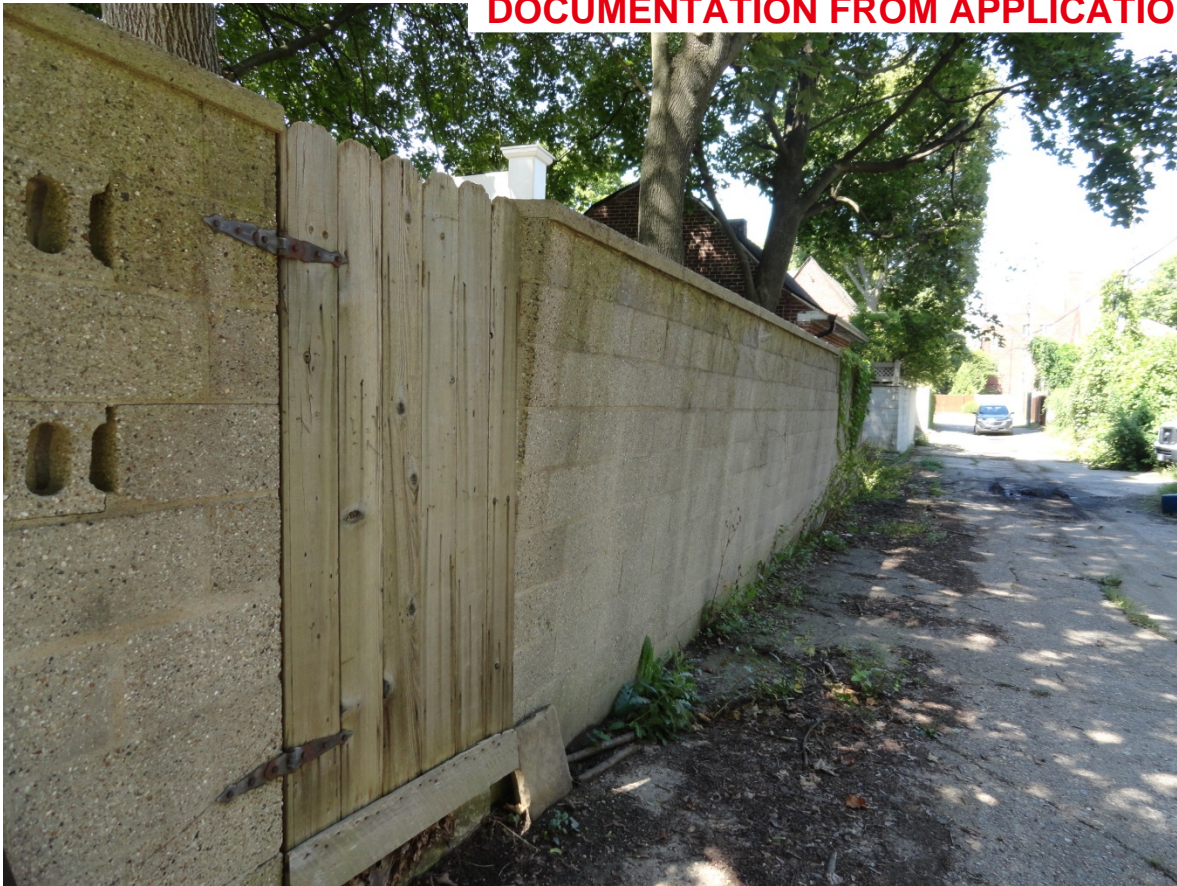
- Good Condition. The Chimney is intact
- Poor condition. The CMU screen wall is leaning out and showing signs of imminent failure (Pictures #20 and #21)

20-Retaining / Privacy Wall Failure

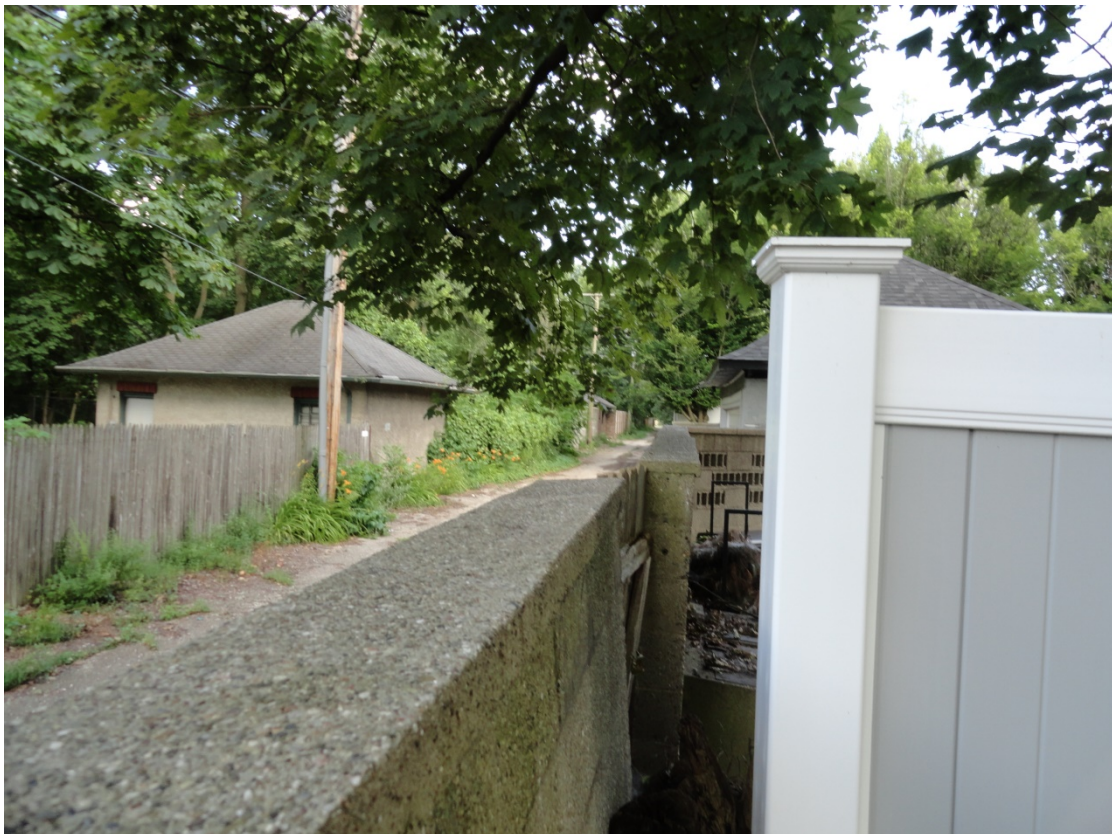
21- Retaining / Privacy Wall Failure
