**STAFF REPORT:** 01-22-2019 MEETING

**APPLICATION NUMBER:** 20-6607

**ADDRESS:** 3470 CAMBRIDGE

**SCOPE:** WORK DONE WITHOUT PERMIT

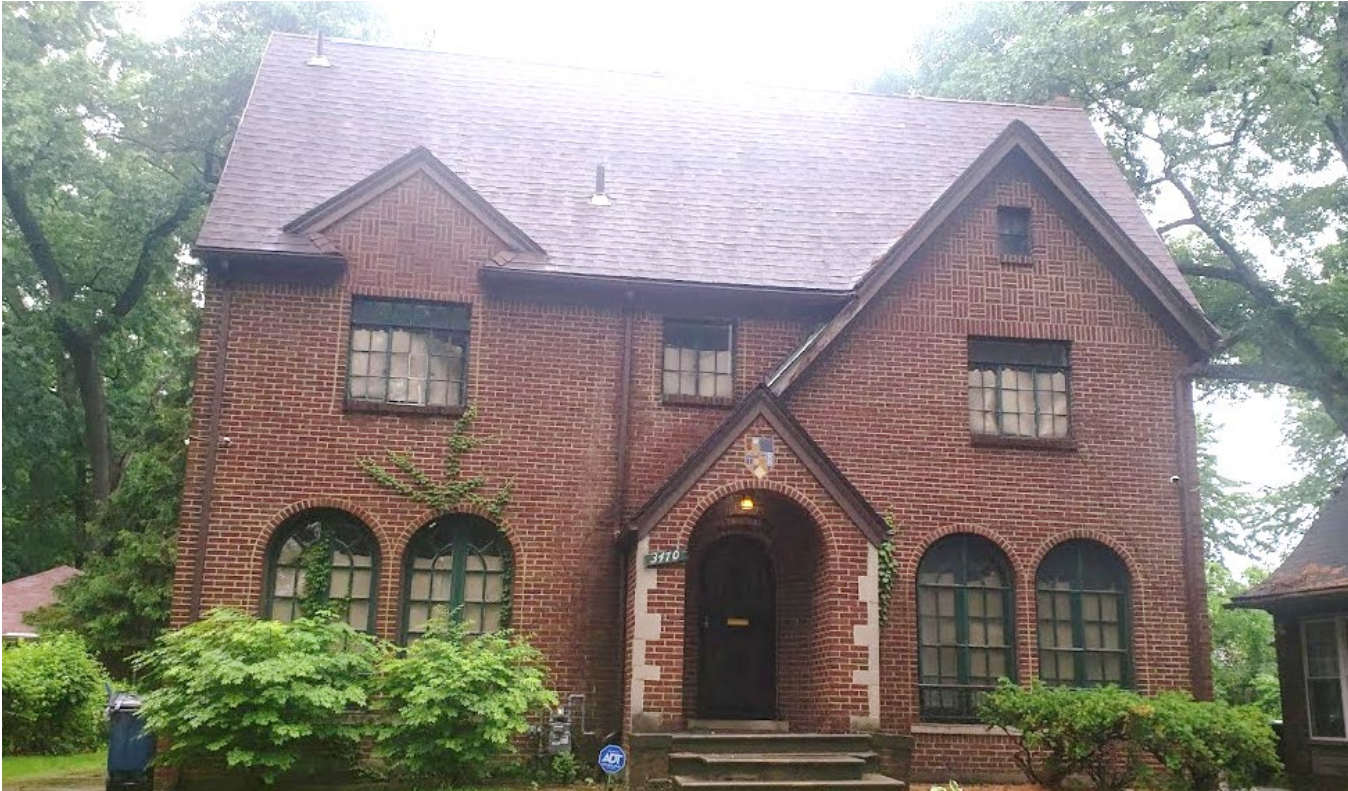
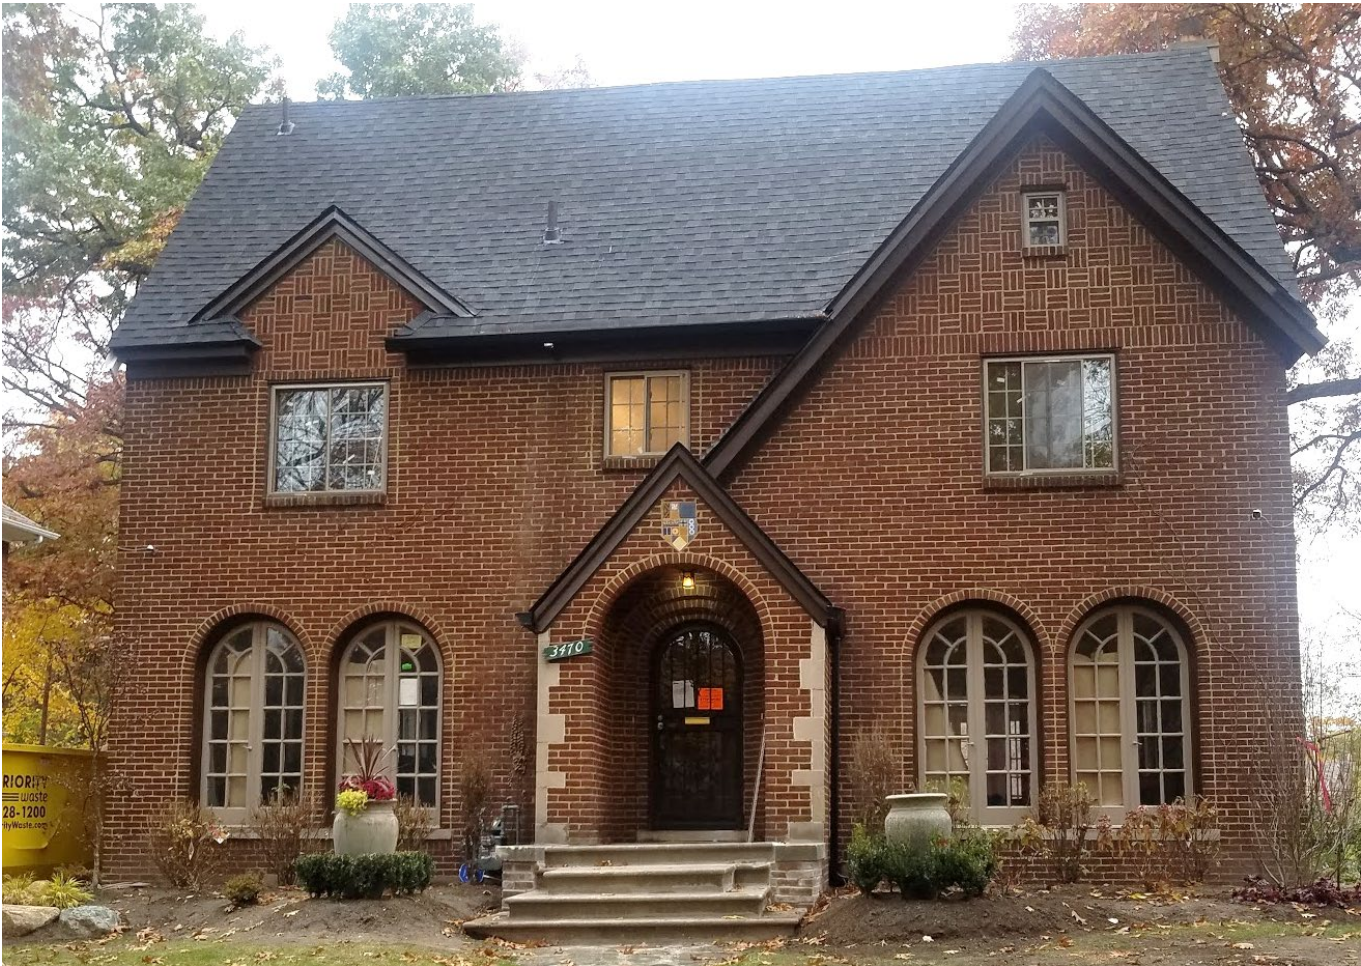
Install Black Gutters & Downspouts/Wrap Wood Fascia, Soffits with Dark Brown Aluminum –Page One

- Aluminum gutters and downspouts (reddish brown) replaced with 4" gutters and downspouts (black). *These were missing from most areas and damaged badly in the remaining spots; needed replacement (See before pics link). They are halfway done (See current pics link) but we were stopped by the city saying we needed approval for these too (we didn't know). The gutters we bought and started to hang are commercial grade black 4" gutters. The home is so big that regular grade gutters wouldn't flow water efficiently. If we can get this one approved quickly by staff so we can finish the job that would be ideal as they are needed to avoid water damage.*

- No collector boxes were identified on the “before” photographs – gutters and downspouts looks to be an in-kind replacement
- The removal of the vent in the west gable is an improvement to the west-facing gable, however additional work should be done to correct the window casing.

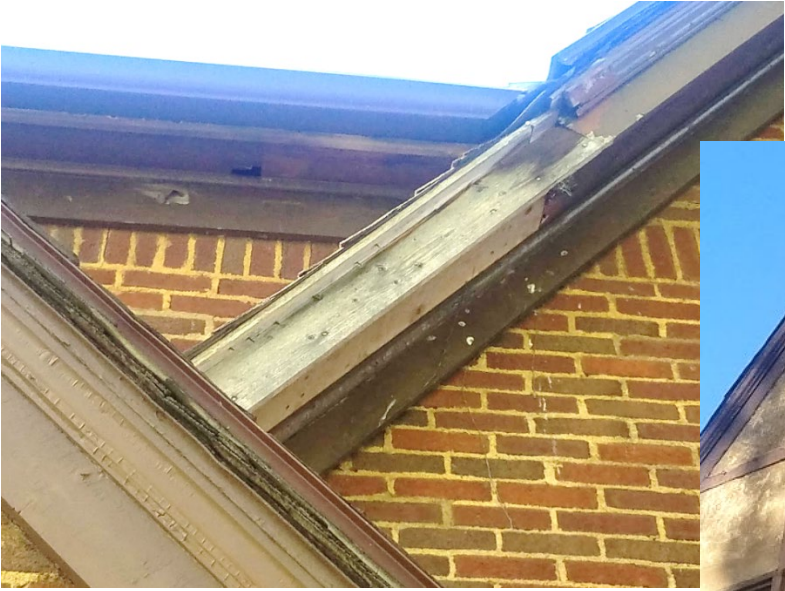
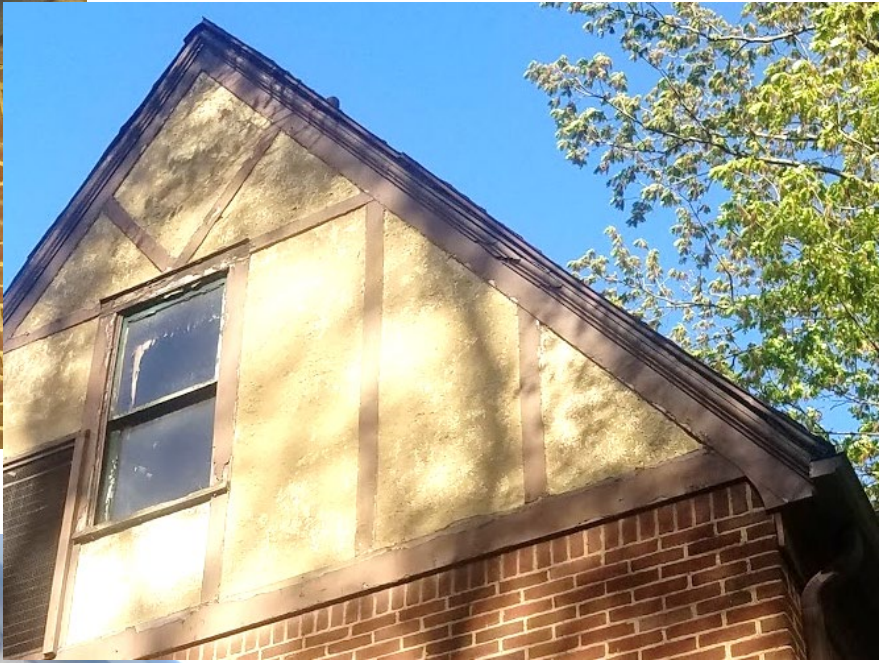
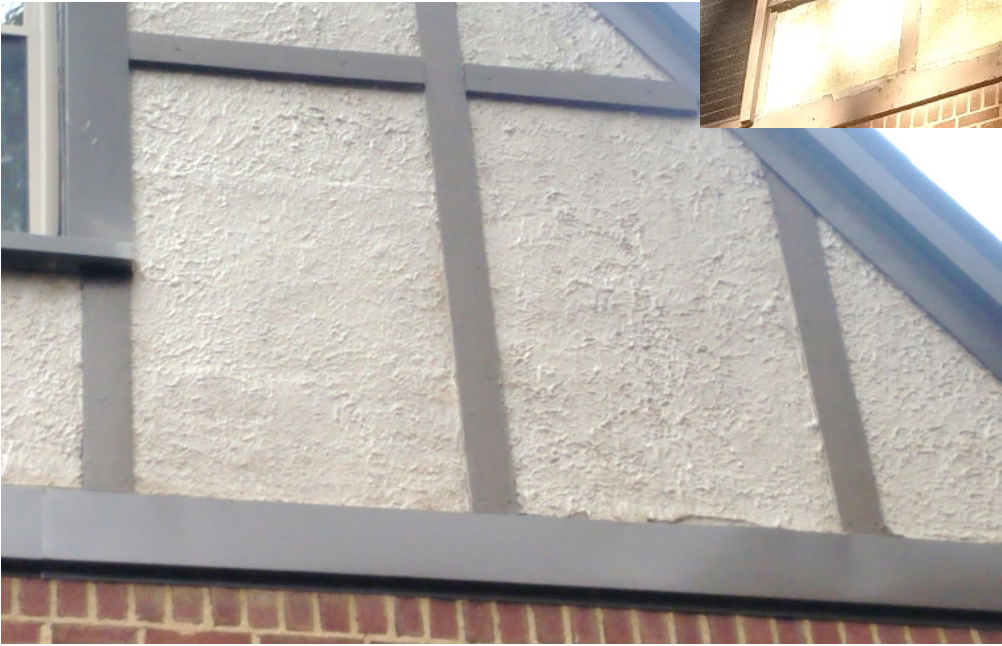
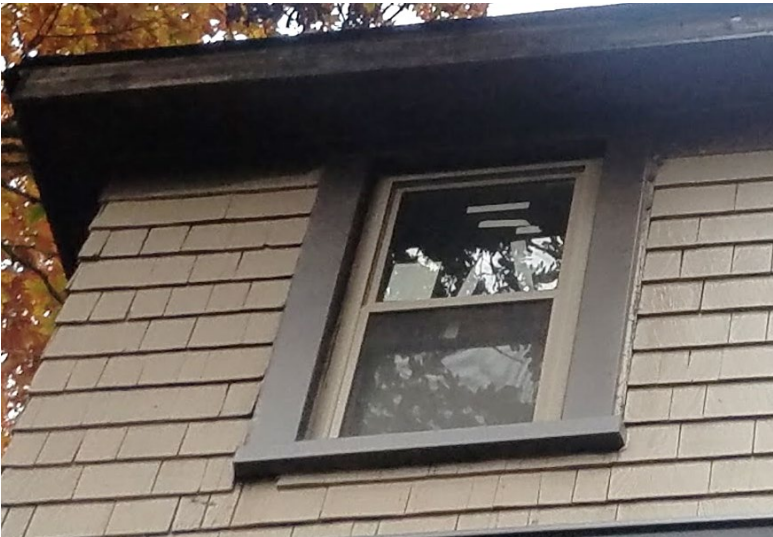
Wrap Wood Fascia, Soffits, Horizontal trim at edge of stucco gables, and double-hung window casings with Dark Brown Aluminum - Page Three

- Wood fascia, soffits, double-hung window casings and horizontal wood trim separating the stucco from the brick veneer at the gables, has been wrapped with brown aluminum. *Horizontal trim is wood and painted brown. Trim along roofline on downward slope is aluminum and to code.*

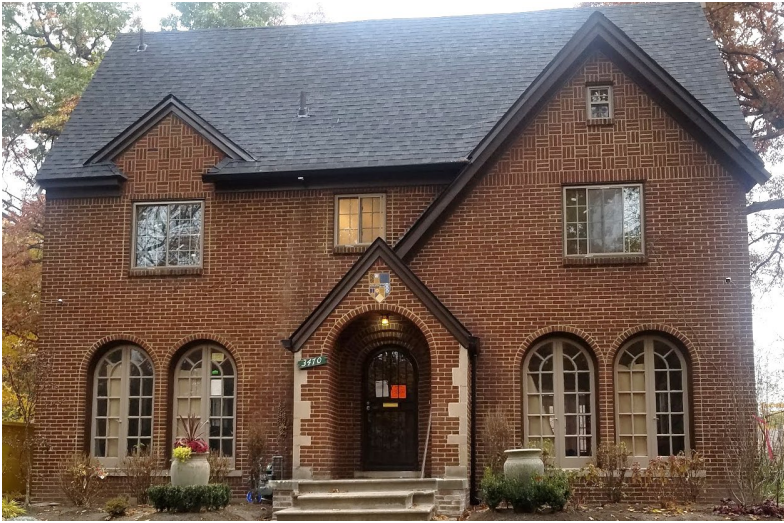
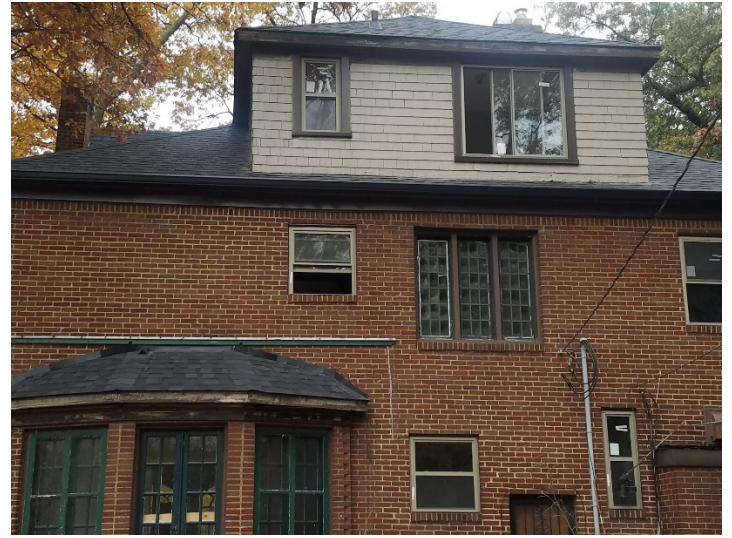
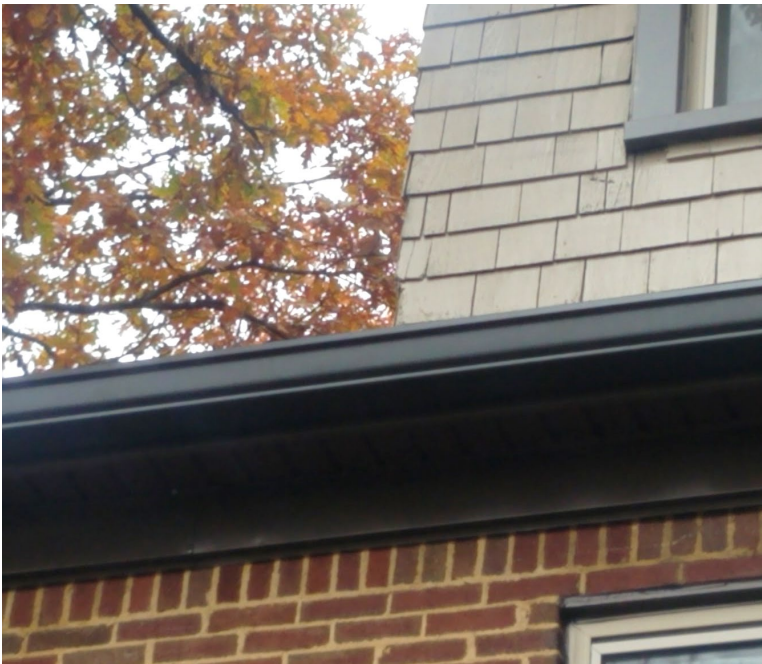
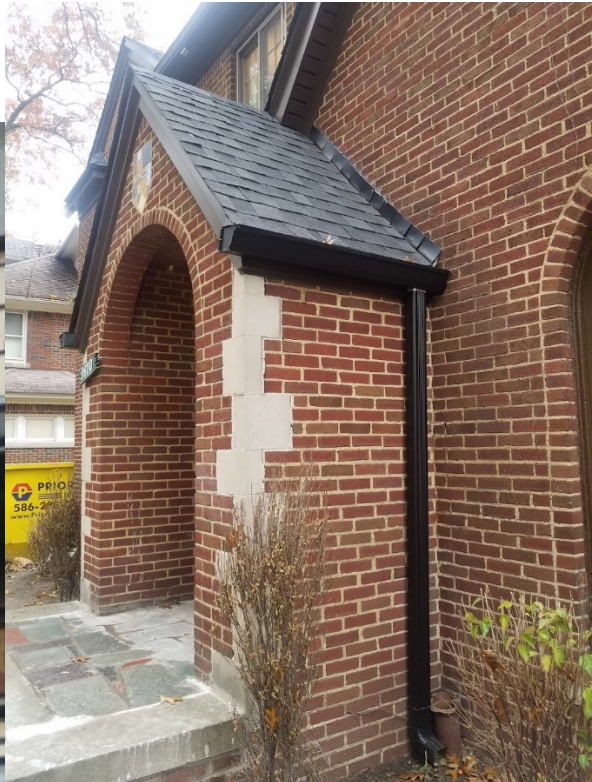
## After

- The color selected for the windows is close to a color found in Color System D, but the system specifies this color as an option for stucco, not window sash. The sash should match the half-timbering (which most options on the color chart are shades of dark brown/black).

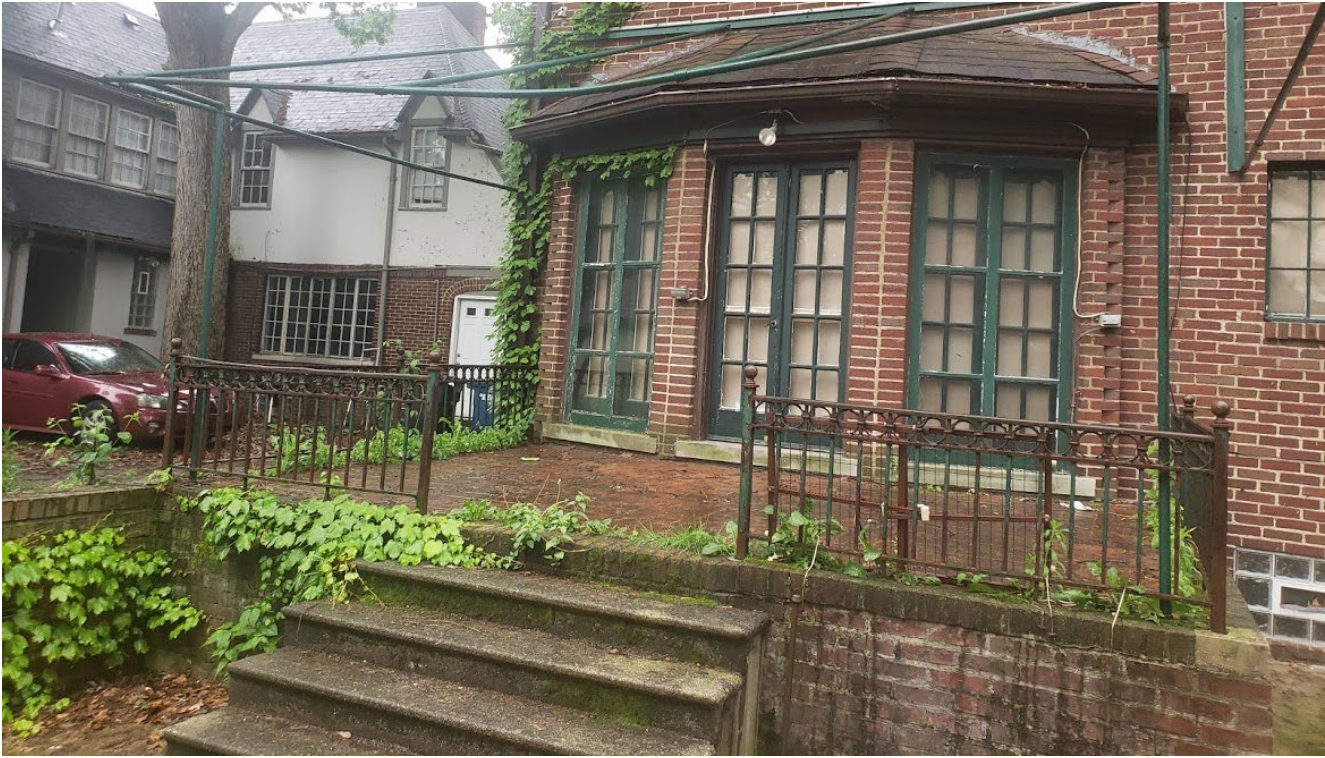
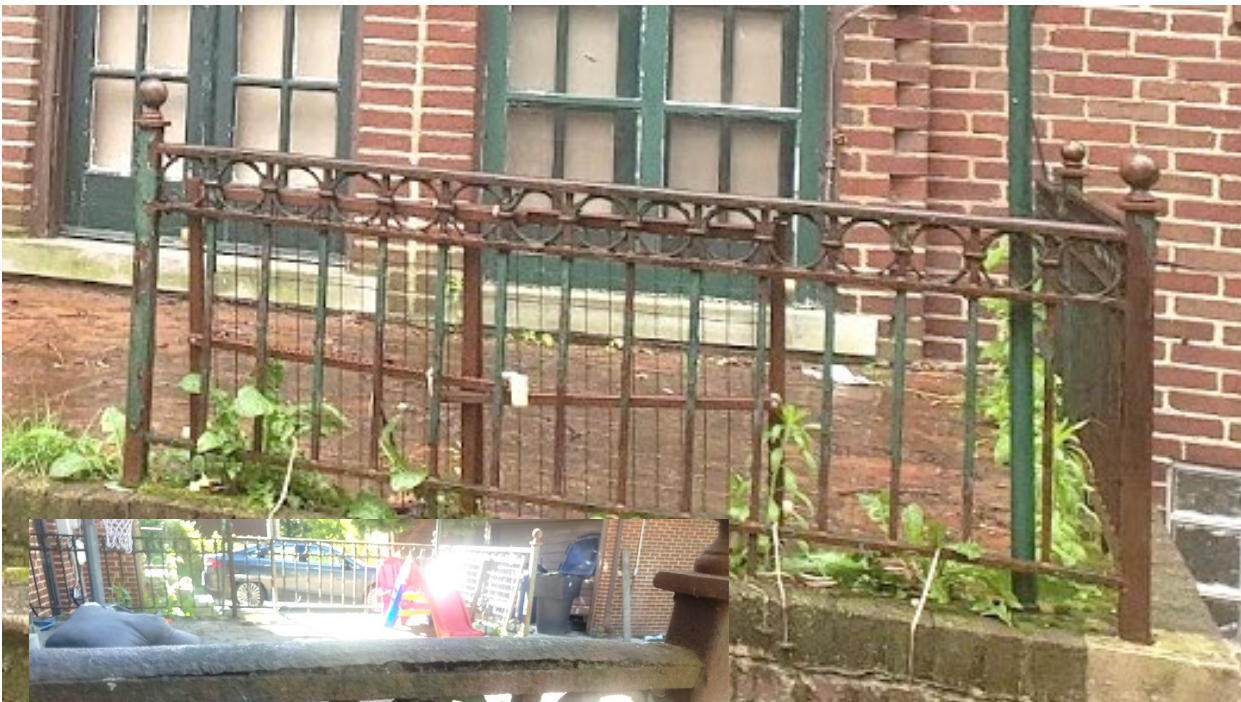
### Rear Porch Railings

Porch, rear entry and second floor rear porch railings have been removed. Concrete platform poured at rear door entry. Straight black

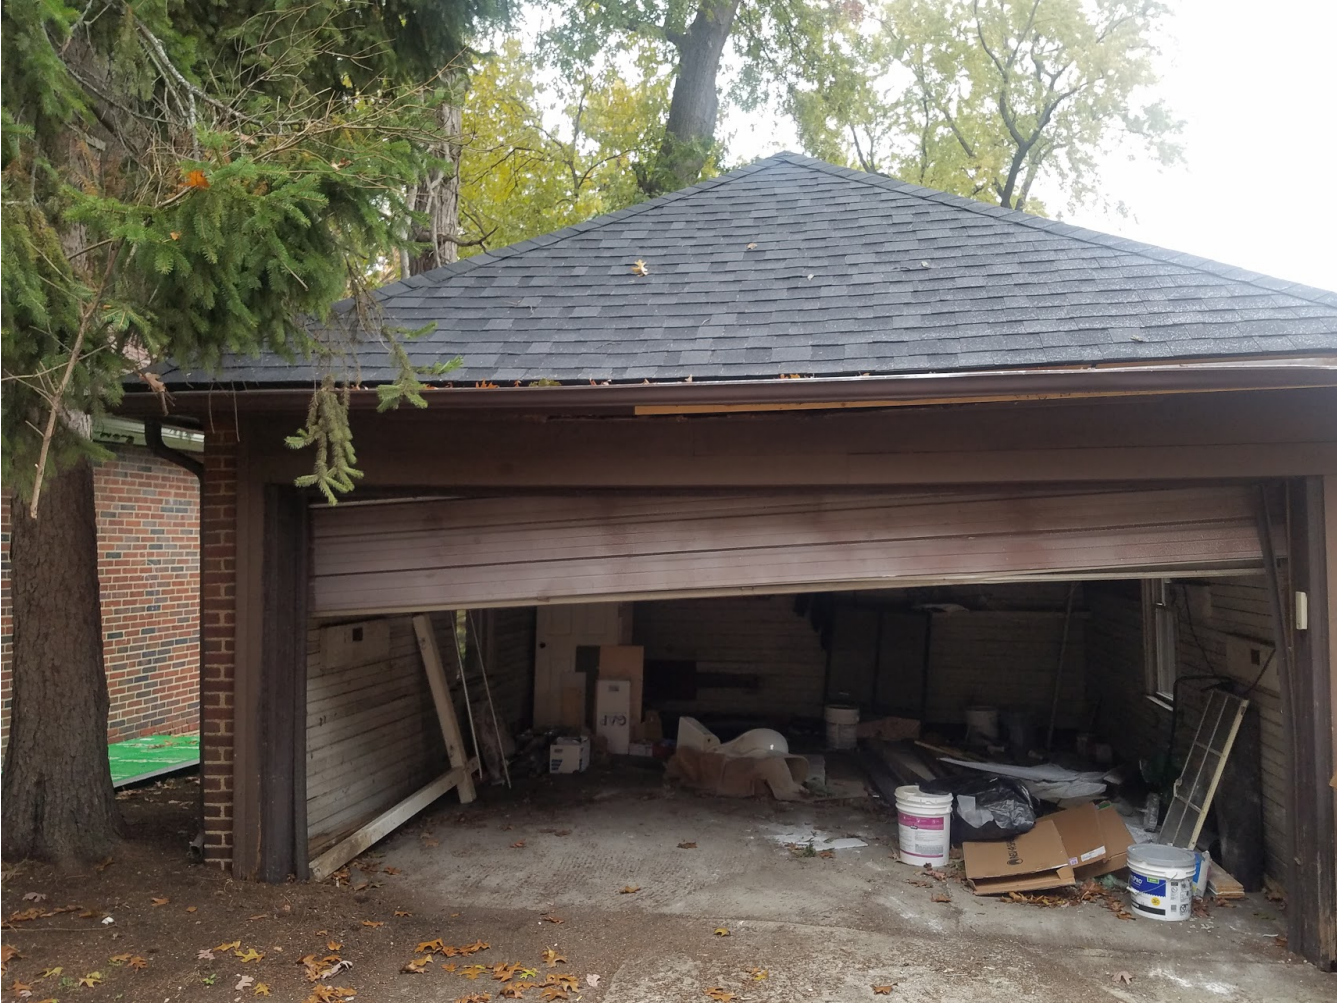
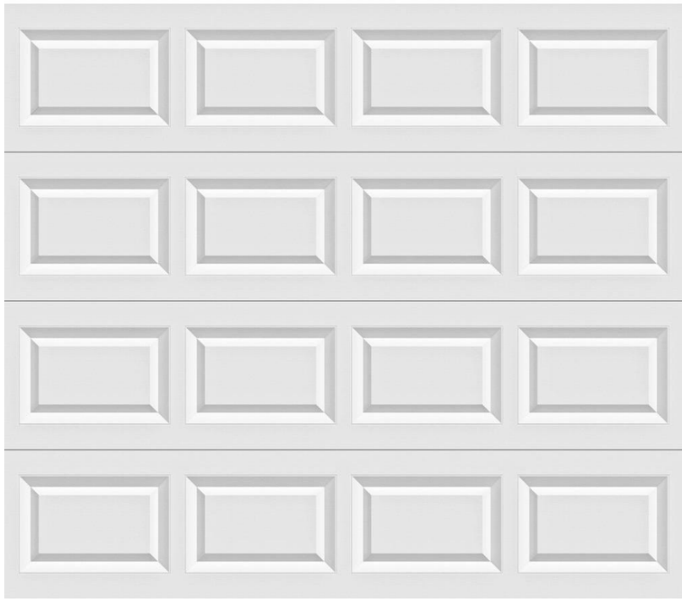
## Replace Garage Door

- Garage door (hasn't been completed yet) – single overhead steel door (reddish brown) to be replaced with a four panel overhead aluminum door (black). *This door is completely ruined and needs replacement to be functional and not look terrible (before pics). We were going to get a black or clay colored door to match the roof or windows, keeping the same style as the one that is there currently.*

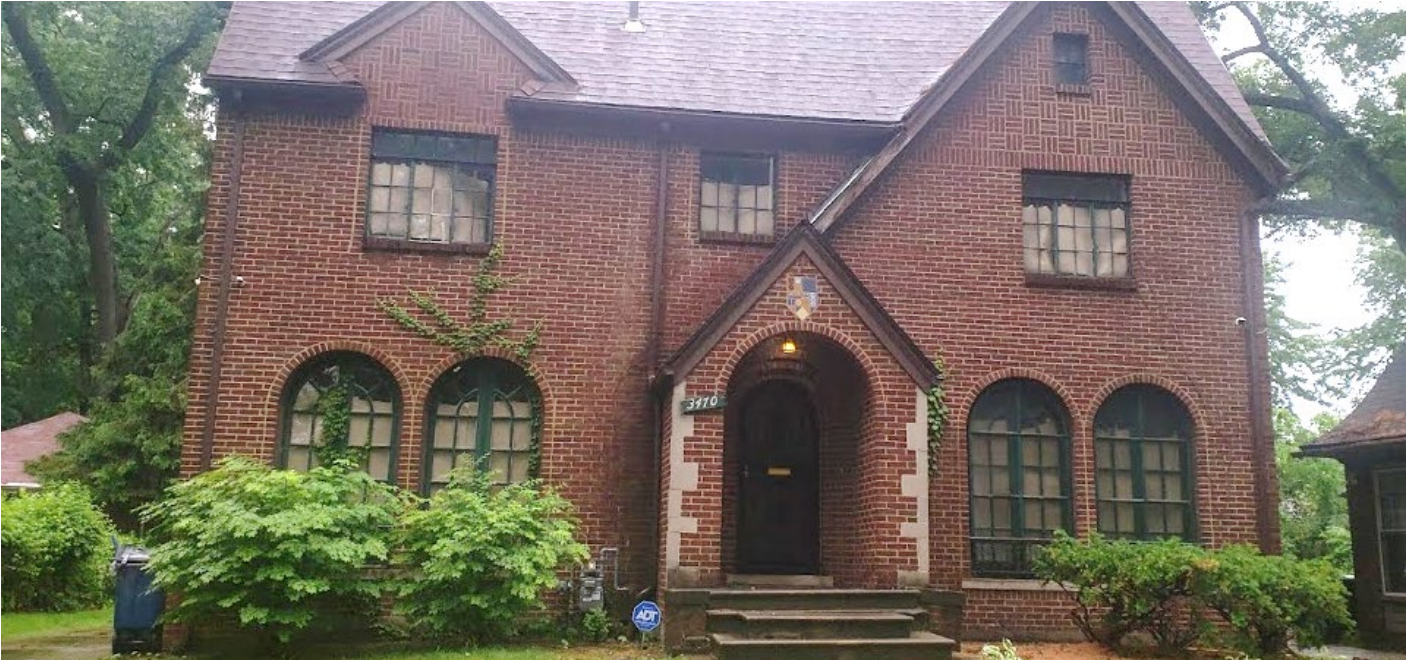
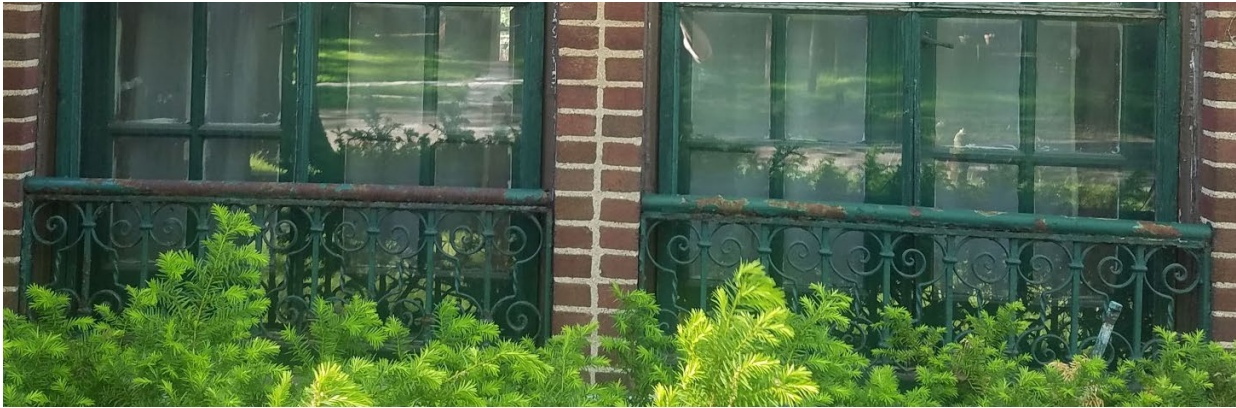
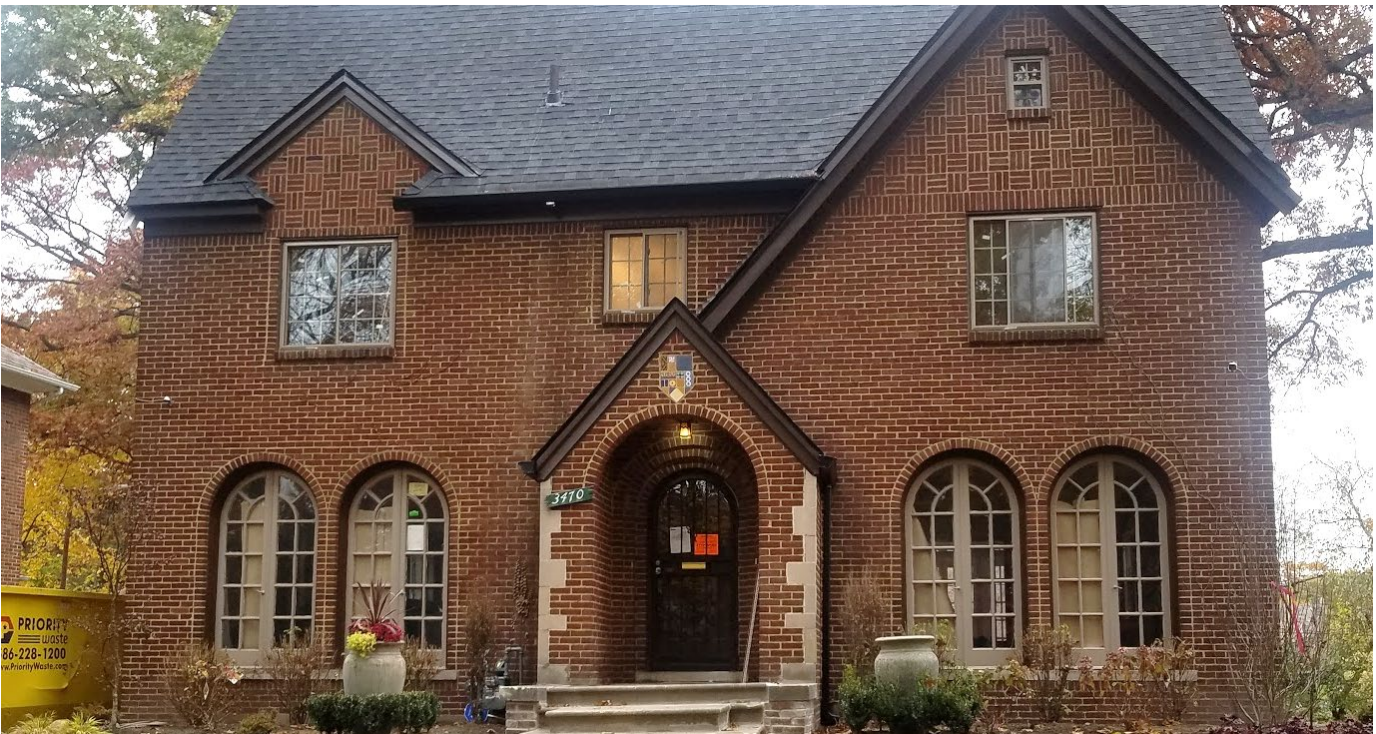
Window Replacement and removal of arched window railings

- The windows were replaced without detailed analysis as to the existing conditions and repair options/pricing from window companies with experience in steel window repair. Staff requested additional photographs of the windows before they were replaced showing the deterioration levels of the windows. They follow the photo narrative of the multiple projects.

- Vinyl windows are not compatible with the historic materials on the house and not appropriate within a local historic district.
- A standard black aluminum railing for the rear patio/entry/balcony suggested by the applicant is a contemporary design and appropriate for a property line fence, but not for the house itself.
- The white steel entry doors (on the rear of the house) do not comply with Color System D.
- A catalog cut confirming the fence design was not submitted.

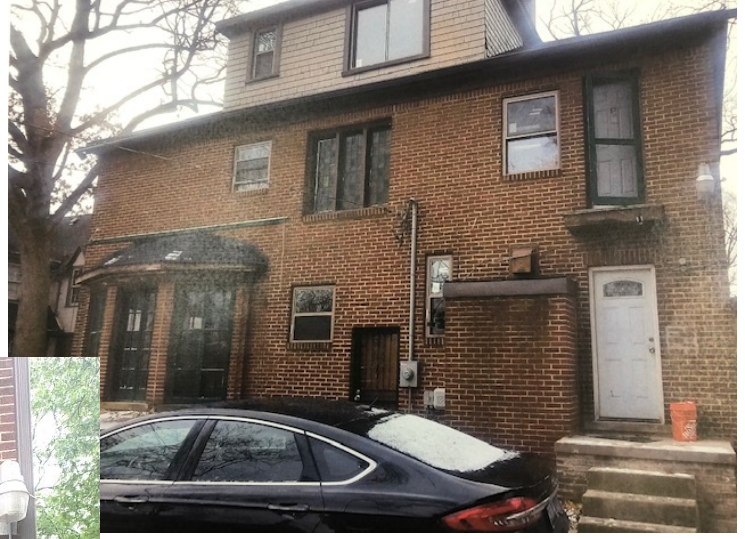
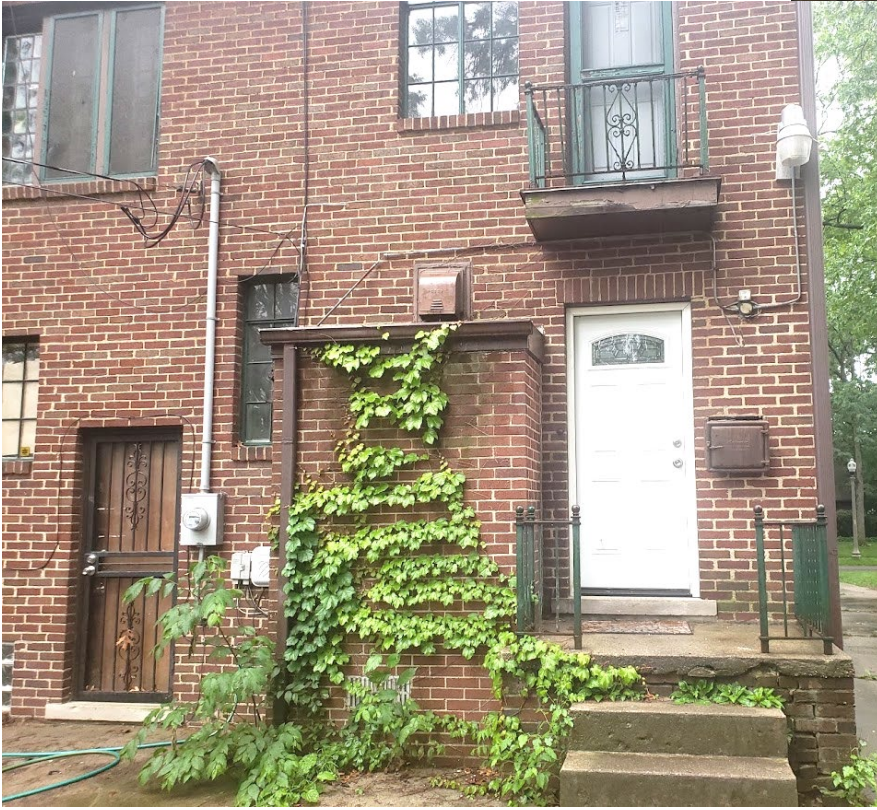
**New Exterior Doors**

Applicant claims these doors were already in place at time of house purchase. However, there is no previous HDC review for these doors.
