STAFF REPORT: 02-12-2020 MEETING APPLICATION NUMBER: 20-6618 ADDRESS: 1448 LONGFELLOW HISTORIC DISTRICT: BOSTON EDISON APPLICANT: JAMES HALL, JAY-BILT CONSTRUCTION COMPANY DATE OF COMPLETE APPLICATION: 01/17/2020 DATE OF STAFF SITE VISIT: 1/30/20

SCOPE: DEMOLITION OF GARAGE (WORK DONE WITHOUT PERMIT), ERECTION OF NEW GARAGE

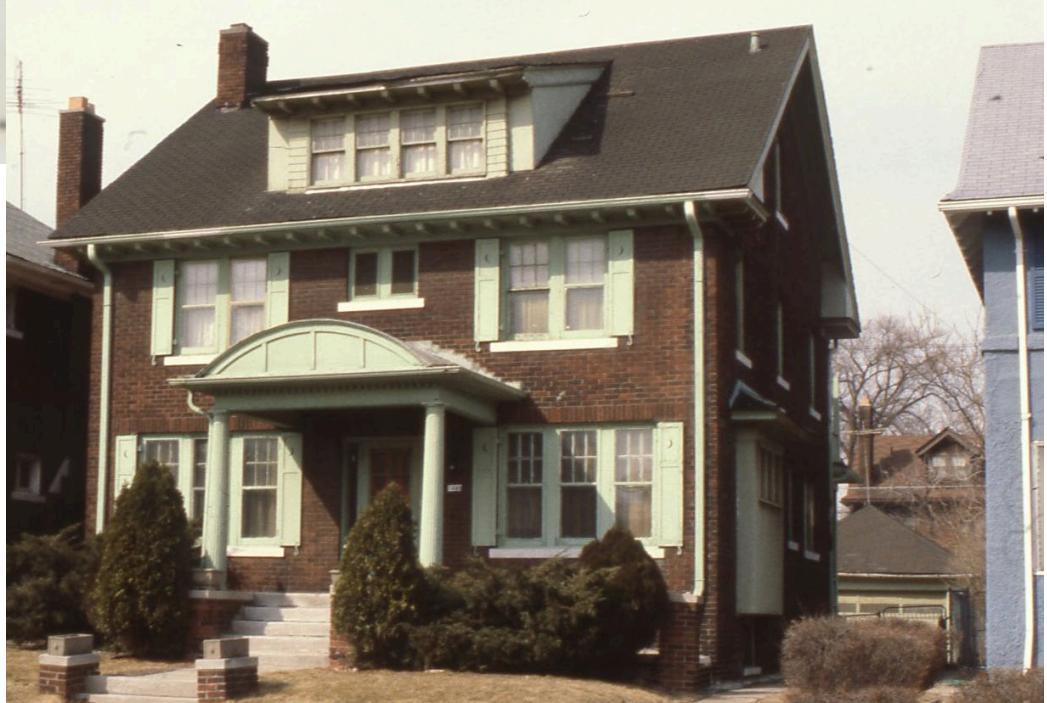
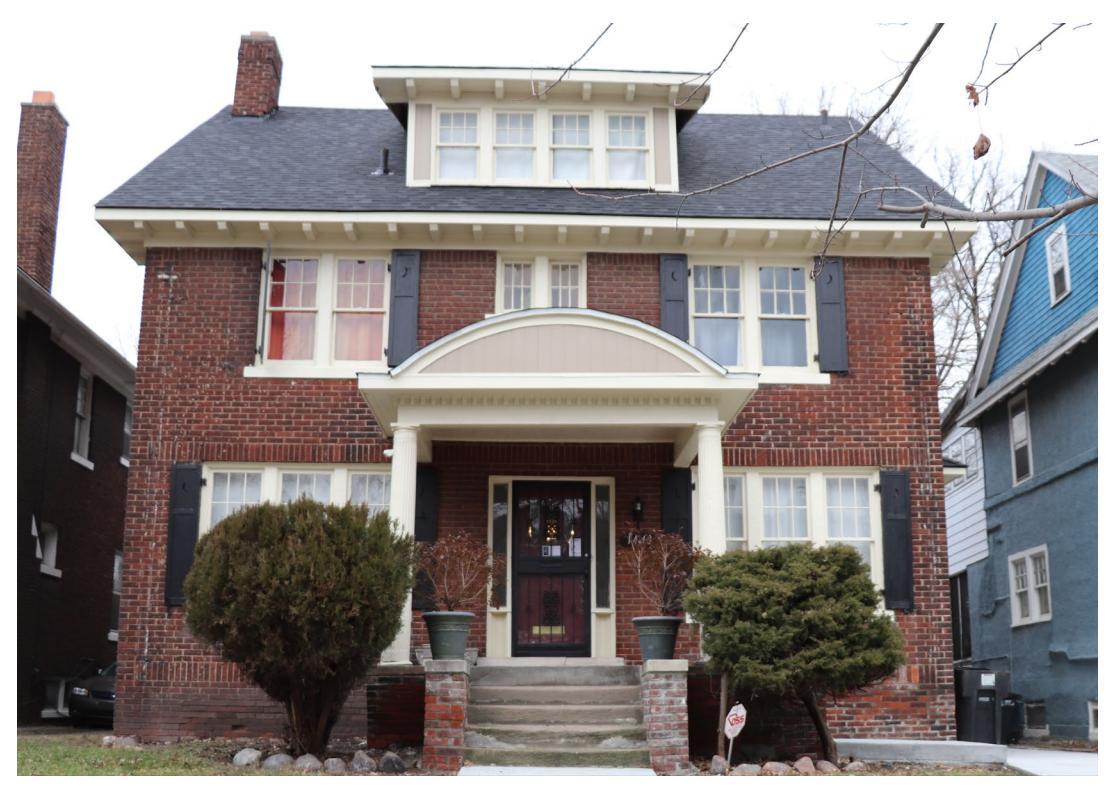
Current photo - taken by HDC staff on January 30, 2020

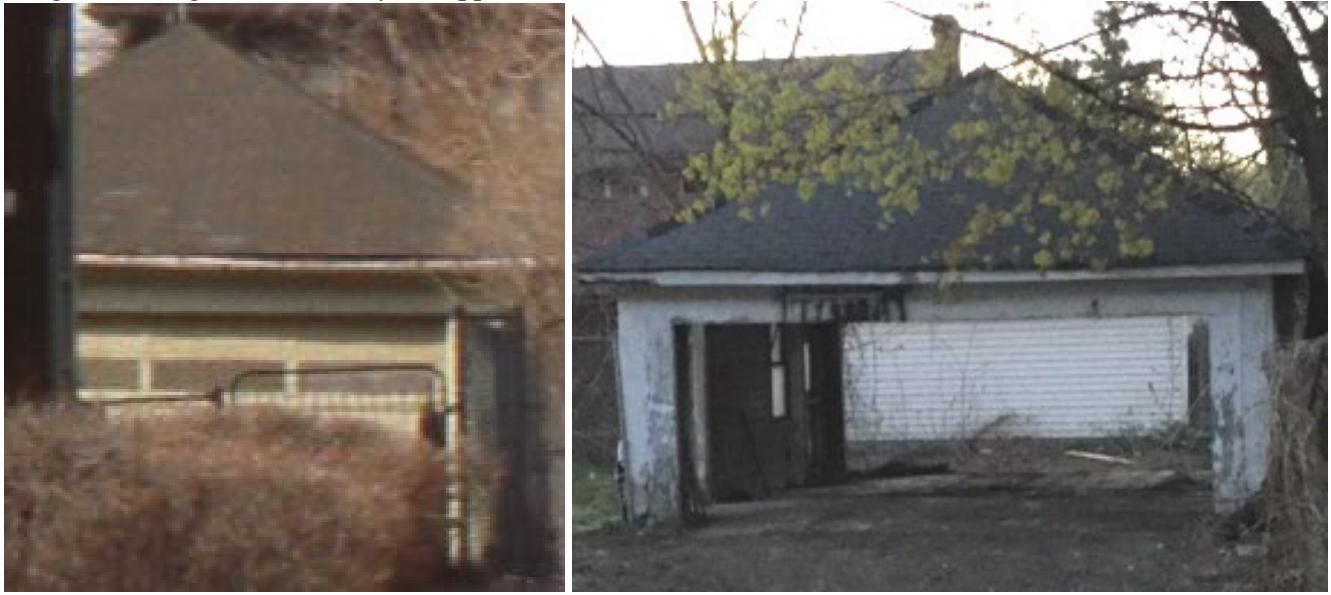
The original frame garage had a hip roof and possibly a stucco exterior finish, which staff identified from the below photos. The photo on the left is an expanded image from the 1980 site photo from the HDC arcives; the image on the right was taken by the applicant the summer of 2019.

- No structural analysis of the previous garage was completed, so staff has to rely on the submitted photographs to ascertain its condition prior to demolition. While the concrete pad did show multiple cracks and likely warranted replacement, and the front and rear elevation doors were missing, the garage did not appear to be leaning, the exterior roof and interior ceiling looked intact, as did the wood lath on the east interior wall. Only a structural analysis could confirm the structure was in such dilapidated condition to substantiate the claim that it crumbled when work was done to the concrete pad.

- Vinyl siding, due to its materiality (plastic) and associated appearance: visible seams, limited widths and profiles, and limited colors, does not mimic wood siding and therefore, is not compatible with the historic materials on the house and not appropriate within a local historic district.
- The original garage retained much of its historic integrity, as only the doors were missing.

Therefore, staff recommends the Commission deny a COA for the demolition of the garage as it does not meet the Secretary of the Interiors Standards for Rehabilitation, especially:

- The garage will have a hip roof; the dimensions of the garage will be modified as needed to accommodate this roof design.
- The exterior walls of the wood frame structure shall be faced with stucco. The stucco pattern will be a smooth texture with minimal aggregate. The color of the stucco should conform to Color System C; the color choice will be submitted to staff for approval.
- A revised site plan and construction drawings, including a catalog cut for the overhead door (and exterior lighting should it be planned), must be submitted to staff for final review.
